# SMITH BRANCH WATERSHED ASSESSMENT

MAY 20, 2016

CITY OF COLUMBIA  
UTILITY AND ENGINEERING DEPARTMENT  
1136 WASHINGTON STREET, 7TH FLOOR  
COLUMBIA, SOUTH CAROLINA 29201

McCormick Taylor Inc., supported by KCI Technologies, Inc., has been contracted by the City of Columbia, South Carolina to conduct an assessment of the Smith Branch watershed to identify potential improvement opportunities to identify existing flooding and water quality conditions.

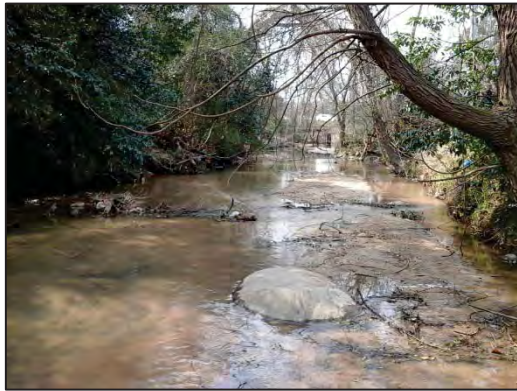
Within SW-I, the upstream extent of the mainstem of Smith Branch flows from a 10 foot wide by 10 foot tall double box culvert beneath Colonial Drive. There is a 30 inch baseflow water surface drop off at the end of the culvert apron and a deep scour pool immediately downstream. The floodplain and top of bank is heavily vegetated with thick underbrush and the 12-foot banks are relatively stable, with isolated areas of erosion. A beaver dam creates a significant backwater 650 feet downstream of the Colonial Drive culvert. Downstream of the beaver dam, the stream is shallow, with depositional midchannel and point bars. Substrate within this segment of stream is predominantly sand, with gravel, cobble, and boulder along the riffles. Riprap stabilizes the right bank and thick vegetation covers the left bank face as Smith Branch approaches the Harden Street Extension.

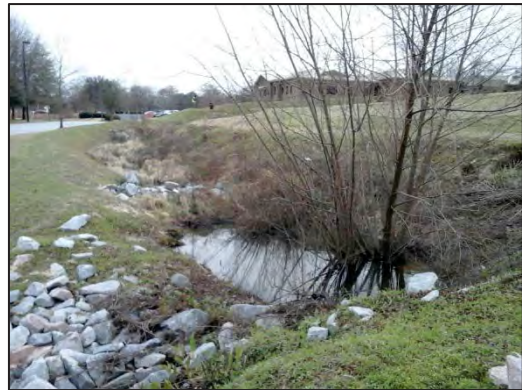
The Smith Branch mainstem flows west through the double box culvert underneath the Harden Street Extension. Infrastructure encroachment, excessive sediment deposition, and poor buffer management practices (mowed to top of bank) have resulted in bank instability and observed block failures extending 150 feet along the left bank, downstream (north) of the Harden Street Extension. Downstream, the banks are more heavily vegetated and stable. Two small tributaries contribute flow into this mainstem segment. The upstream tributary runs parallel to the Harden

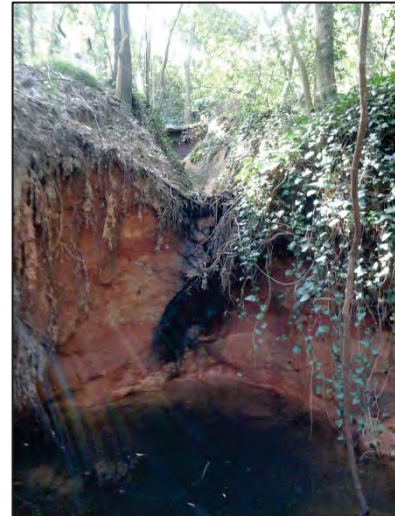
Downstream of SC-277, the Smith Branch mainstem flows through a forested parcel, with vegetated, stable banks and large points bars. Bay Branch joins the mainstem 260 feet downstream of the SC-277 culvert. Bank erosion and lateral migration threatens a utility right of way and manhole stack upstream of Main Street. The stream then flows through a 12 foot tall, 16 foot wide culvert under Main Street. Downstream of Main Street, Smith Branch enters Earlewood Park and is confined within brick and mortar walls for 70 feet, extending to the downstream side of the Parkside Drive bridge. The downstream boundary of SW-I crosses the mainstem at this point and Smith Branch continues to flow downstream through SW-J.

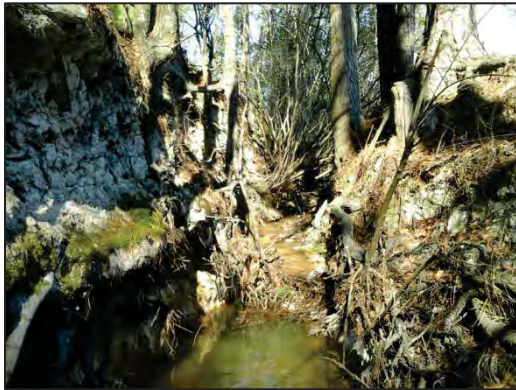
The upstream extent of the open channel network in SW-B begins north of the Truman and Scurry Street intersection. Channel bed substrate is primarily sand and silt. The right bank is near vertical and is much taller than the left bank. Both banks are vegetated yet show evidence of the channel downcutting and widening. The right bank has been heavily armored with riprap at the Burton-Pack Elementary School stormwater pond outfall and erosion on the left bank has begun to encroach upon adjacent properties. Near the northern end of Hammond Avenue, the stream channel becomes more highly incised, with bank stability decreasing and sedimentation increasing; erosion threatens adjacent residential properties, slope failures have exposed bedrock, and land clearing on the right bank has likely contributed to observed slumping.

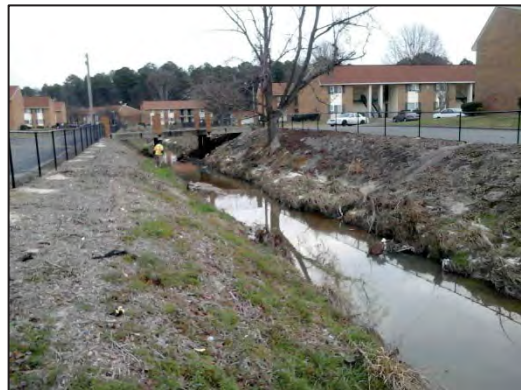
The stream then becomes channelized with concrete bed and banks, flowing parallel to Ripplemeyer Avenue. Channel conditions along this segment show signs of severe degradation of the concrete channel; soil slump has caused the right bank to fracture and sag. Downstream of the concrete channel, the stream returns to a natural state with earthen bed and banks. Debris caught in understory brush and saturated soils provides evidence of possible flooding. Stream banks are sparsely vegetated with herbaceous material and contain areas of instability. The stream then flows through an 8-foot wide, 6-foot high twin box culvert crossing westerly under Lester Drive. Large sand bars define the channel upon the streams emergence. The stream flows approximately 100 feet before being conveyed through a culvert beneath SC-277 and beyond the SW-B boundary.

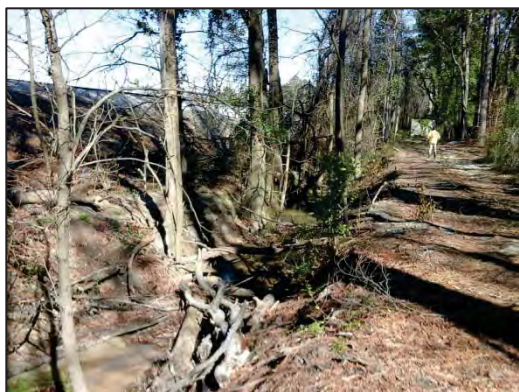
The easternmost open channel segment in SW-G is located between the railroad and C.A. Johnson High School. Flow initiates from two 36 inch RCPs that were submerged and backwatered at baseflow. Downstream, the channel is incised, pinched between the railroad embankment and residential properties along Dart Street. Woody bank vegetation adds stability through most of this segment and the channel bed material is primarily sand and silt. The main channel converges with two small tributaries before flowing east through a railroad culvert. The stream

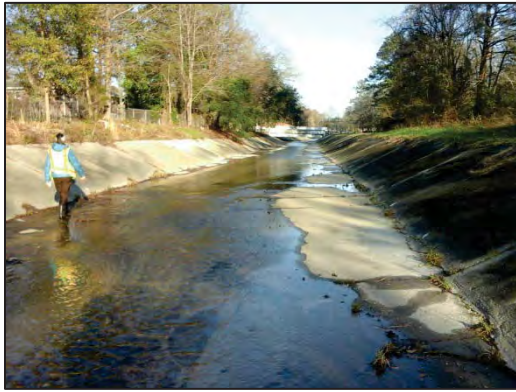
Within SW-D, the upstream extent of Bay Branch mainstem begins west of the culvert underneath SC-277. The stream flows west through a degraded trapezoidal cellular concrete channel. Large sand bars/benches are prevalent within the reach between SC-277 and Shaw Street. At Shaw Street, the condition of the channel changes, the concrete channel downstream of Shaw Street is smooth concrete, less degraded than the upstream reach, and with little to no deposition or vegetation present within the concrete margins. The channel becomes less degraded, with a

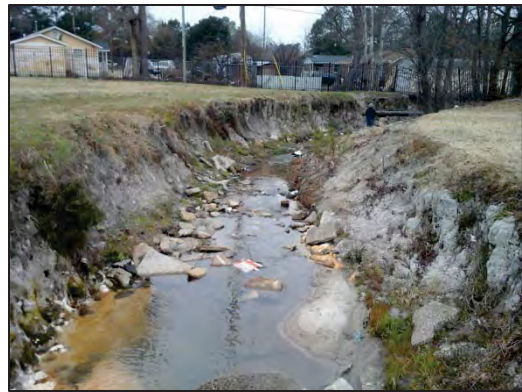
The second major tributary originates from south of SC-277 and west of Farrow Road. Open stream channel originates from a 36 inch RCP southwest of the intersection of Water Street and Adams Street. The tributary is then piped north under SC-277. Another segment of open channel originates from 52 inch RCP west of Water Street between Chappelle Street and Lorick Avenue. A third of the banks within this segment are actively eroding where the channel is tightly confined between private residential properties. The stream is piped underneath Chappelle Street then emerges from a 48 inch RCP into the Bay Branch mainstem east of Colonial Drive.

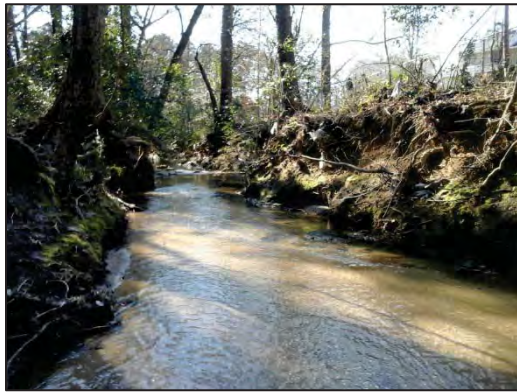
The upstream extent of the main channel (Bay Branch) in SW-E begins at the Lorick Avenue crossing. The channel bed and banks are initially concrete, changing to natural channel approximately 170 feet downstream of Lorick Avenue. Paralleling Lorick Circle and flowing in a south/southwest direction the channel is entrenched and straight. The cross-sectional area through this reach is significantly smaller than the concrete channel immediately upstream, combined with the increased roughness within the natural channel segment, a backwater condition would be anticipated

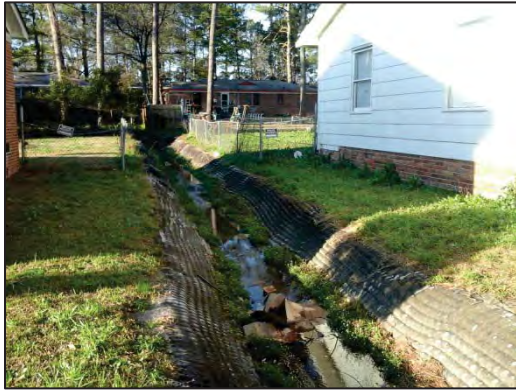
The upstream and northern extent of open stream channel within SW-A begins at an outfall emerging from underneath SC-277. The main outfall channel converges with a concrete flume extending along the northern shoulder of Oscar Street. The concrete flume is ephemeral, conveying roadway drainage during storm events. Erosion and flanking along the southern bank of the concrete channel has exposed the base of a fire hydrant. The stream extends downstream through a culvert beneath Oscar Street and opens into a natural stream bed within a forested parcel. Channel substrate

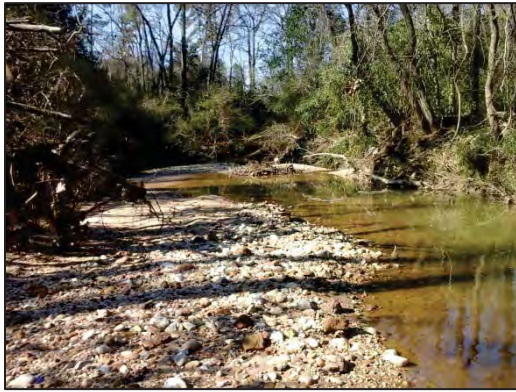
Within SW-K, the upstream extent of the Smith Branch mainstem channel begins southwest of the Sunset Drive and Summerlea Drive intersection. Smith Branch passes through a 9.8 foot wide by 9 foot high double box culvert under Sunset Drive and enters a forested floodplain parcel between residential communities. There are indications (lateral scour and fine sediment deposition) that suggest a severe meander bend immediately downstream of the Sunset Drive creates a backwater during storm events. This area (specifically the right bank downstream of Sunset

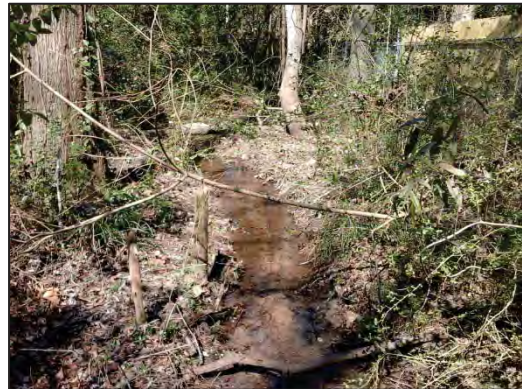
The second tributary begins southeast of the Makeway Drive and Sunset Drive intersection. Multiple headcuts have formed throughout the segmented channel network. At the upstream end, south of Sunset Drive, a 15-foot tall headcut is nearing the foundation of a single family home. The stream is then piped under Sunset Drive and Falling Springs Road. Downstream of Falling Springs Road, the channel has downcut and undermined the culvert and an additional

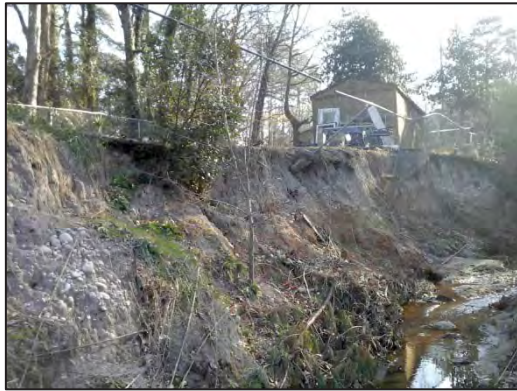
Upstream limits of the open channel network within SW-L begin between Steadham and Wildwood Avenue, west of Palmetto Avenue. Banks are low, stable, and well vegetated. Channel substrate is primarily sand, with gravel and cobble along riffles. The left bank is stabilized with a brick wall upstream of the Abingdon Road crossing. After the stream extends under Abingdon Road, the channel becomes deeply incised extending within a cleared utility right of way; raw vertical banks threaten infrastructure and private property on both sides. Bedrock intrusion

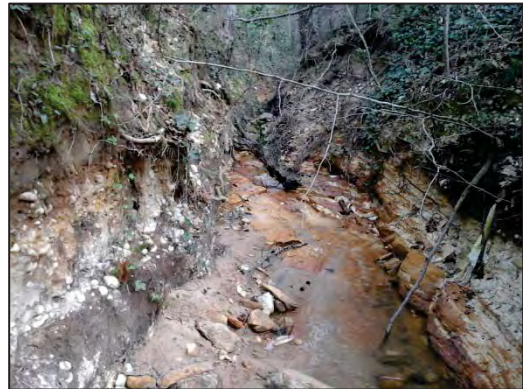
Downstream of the confluence of the two tributaries previously described, the channel incision continues, with 6 to 8 foot banks. Downtcutting into bedrock has created a series of steep cascades with large scour pools downstream. Substrate in this segment is mainly bedrock with sand in the pools and gravel and cobble along the riffles. The stream then extends through a 42 inch road culvert under Woodridge Drive.
