# ROCKY BRANCH WATERSHED ASSESSMENT

MAY 20, 2016

CITY OF COLUMBIA  
UTILITY AND ENGINEERING DEPARTMENT  
1136 WASHINGTON STREET, 7TH FLOOR  
COLUMBIA, SOUTH CAROLINA 29201

McCormick Taylor Inc., supported by KCI Technologies, Inc., has been contracted by the City of Columbia, South Carolina to conduct an assessment of the Rocky Branch watershed to identify potential improvement opportunities to identify existing flooding and water quality conditions.

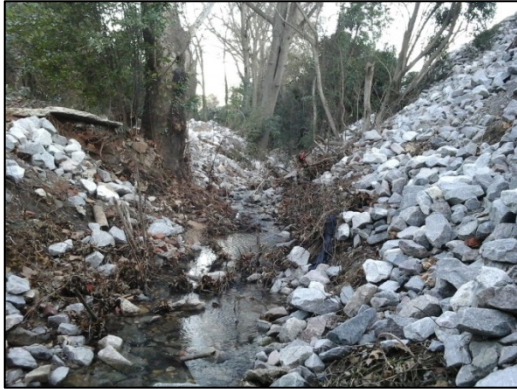
The northern most section of open stream channel lies between two parking lots southeast the intersection of Harden and Hampton Street. The stream emerges from an outfall, flows for 25 feet and then is piped underneath the southern parking lot. A 110-foot long dry swale converges from the east with the channel. There is some herbaceous vegetation in the channel and a large amount of residential trash has accumulated around the northern outfall.

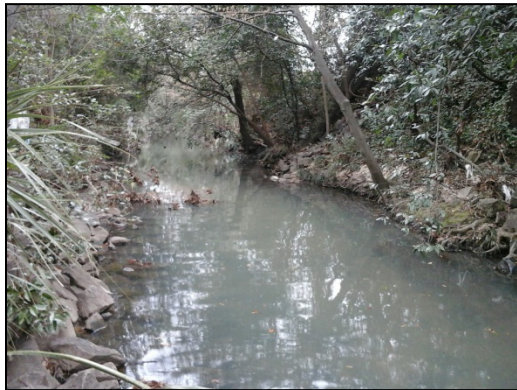
The upstream limit of open stream channel in the USC subwatershed is the Rocky Branch Mainstem within Maxcy Gregg Park. Stream banks are steep yet stable, with a thick layer of small trees and shrubs. Past riprap stabilization can be seen scattered along banks and in the stream bed. The channel substrate is primarily boulder and cobble material. The channel passes through a triple box culvert under Pickens Street and then continues downstream with similar channel conditions. This segment ends at the twin box culvert under Wheat Street.

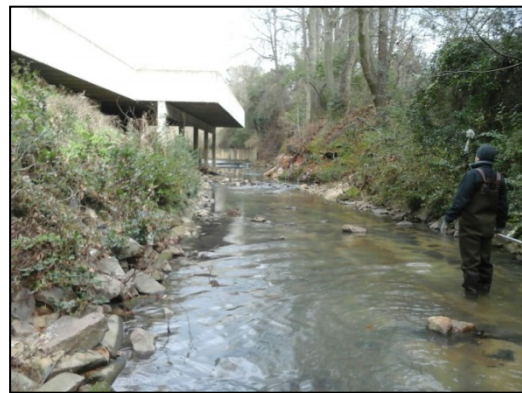
South (downstream) of Wheat Street, the entire stream channel has been straightened and converted to a flat bottom concrete bed and vertical concrete banks. The concrete channel ends 500 feet downstream of Wheat Street. The channel bed is downcut into a large scour pool at the downstream limit of the concrete channel and the left bank is also highly unstable in this location. The channel is highly confined through this reach with the Solomon Blatt Physical Education Center and athletic fields along the right bank and the railroad embankment along the steep left bank. A balcony from the Physical Education Center overhangs the stream channel with pier supports within the active bed. The channel substrate is mostly coarse, with some fine deposition in the pools and some coarse mid-channel bars. The stream takes an abrupt turn at Sumter Street, through a road culvert identified as being in severe condition. This area acts as a pinch point and is modeled to produce a backwater condition at a 2-year storm event. The mainstem channel downstream of Sumter Street has concrete bed and banks that extend to the subwatershed boundary.

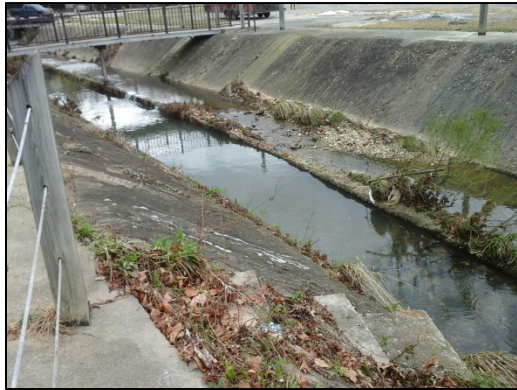
The mainstem channel in the MV-A subwatershed begins just downstream of the Sumter Street crossing. The bed and banks are contained within a concrete trapezoidal channel with approximately 7-foot tall banks. The stream is open for a short segment before being covered by a 160-foot long bridge adjacent to the USC College of Engineering and Information Technology building. The stream emerges as open channel for 270 feet before passing under Catawba Street. The culvert at Catawba Street and the concrete crossing adjacent to the Engineering building were

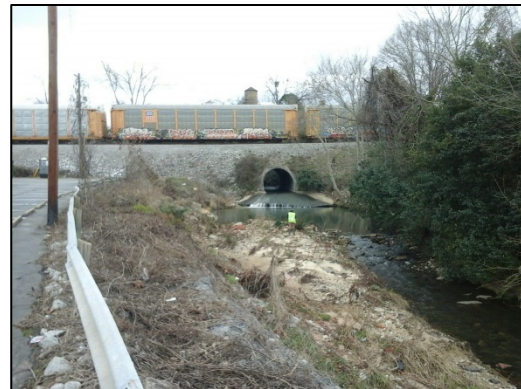
The downstream end of the culvert under Whaley Street opens up into a scour pool with large deposits of sand and gravel. A brick wall with multiple pipe outfalls stabilizes the left bank at the corner of Whaley and Main Street. The bed is mostly sand with cobble and gravel along the riffles. The stream passes through a large CMP culvert underneath a railroad crossing that show signs of bed incision and headwall cracking upstream. The skewed angle of entry and volume of flow at this junction likely contributes to reported flooding upstream. There is a steep concrete apron downstream of the culvert outfall and a deep scour pool immediately downstream of the apron. The concrete apron and scour pool may hinder fish passage due to the relatively large difference in elevation between the apron and the downstream channel and the shallow fast flow along the apron. The right bank downstream is approximately 12-foot tall and eroded, with pockets of gabion basket and riprap stabilization. The left bank is low and vegetated. The channel substrate is primarily sand, with some boulder, cobble, gravel and exposed bedrock along riffles. The downstream limit of this segment is at a double box culvert that conveys the stream under Assembly Street.

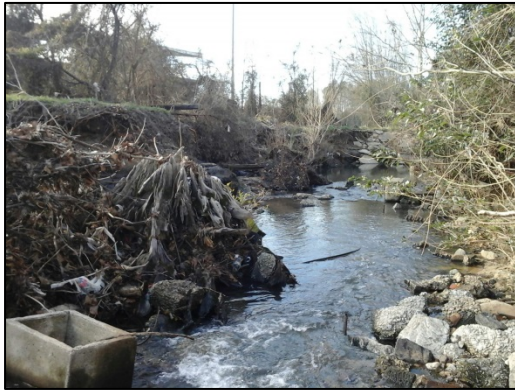
A tributary converges with the mainstem upstream of the railroad culvert. The channel is narrow and deeply incised, with approximately 10- to 12-foot tall banks. The channel is eroding parts of the railroad embankment along the left bank, causing slumping of embankment material.

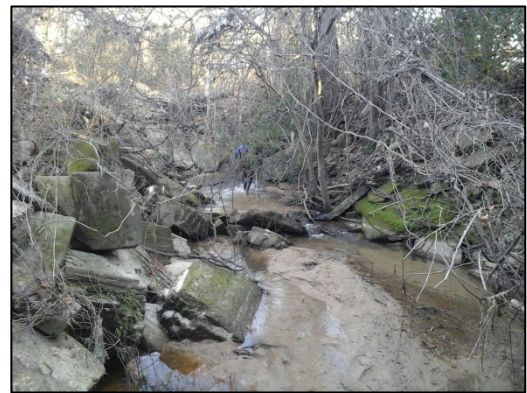
Upstream of the railroad trestle, a tributary converges with the mainstem on the right bank. The tributary is pinched between the railroad embankment to the south and a church parking lot and residential development to the north. The tributary initiates from a piped segment northeast of the Bluff Road and Cottonplace Lane intersection. Bank erosion is jeopardizing a gravel parking lot on the left bank and the channel is eroding parts of the railroad embankment along the right bank, causing severe slumping of embankment material. The right bank is 12 feet tall with an exposed, raw bank face. The channel substrate is mostly sand, with some gravel and cobble in the riffles.

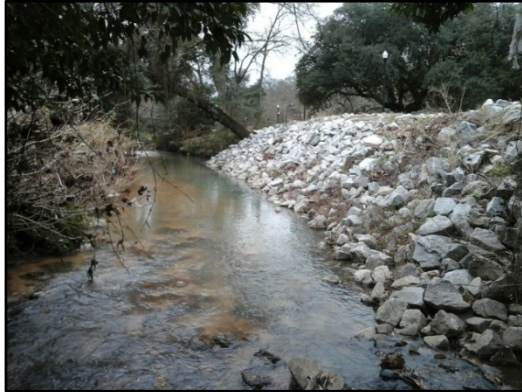
The UH subwatershed contains a small section of open channel along the mainstem of Rocky Branch and located entirely within Maxcy Gregg Park. The upstream limit is an old, degrading railroad trestle that crosses the stream at the subwatershed boundary. A sanitary line is exposed along the bed spanning 50 feet directly beneath the railroad trestle. Immediately downstream of the trestle, a stacked stone wall is along the right stream bank and riprap stabilizes the left. Several isolated sections of bank erosion occur along the right bank throughout Maxcy

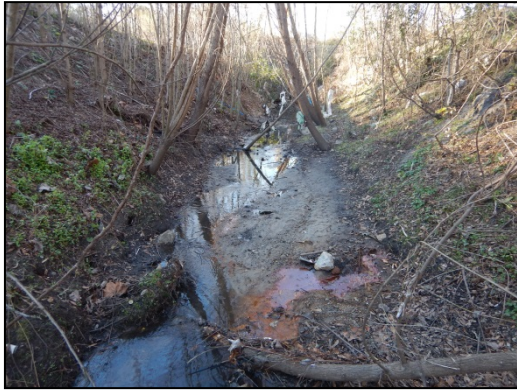
There are only two segments of open channel in the entire subwatershed. The first, and smaller of the two segments, is located in the northern portion of the subwatershed, east of the Hampton Street and North Millwood Avenue intersection. The channel segment begins at a gabion headwall at North Millwood Avenue and contains three individual stormwater outfalls. The banks are stabilized with thick vegetation primarily consisting of small trees and shrubs. The stream bed substrate consists primarily of sand and silt. Previous flooding levels are indicated

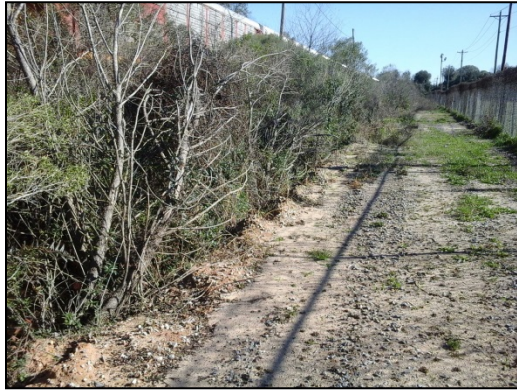
The channel network in the eastern portion of the RW subwatershed consists of two drainage swales adjacent to the railroad, one to the north of the railroad and one to the south. The channel on the southern side of the railroad is narrow and vegetated. The left bank is low and adjacent to a field used for overflow parking for the USC stadium. The right bank is limited by the railroad embankment. The channel on the northern side of the railroad is a wetland-like saturated system lacking defined banks for much of its length east of Rosewood Hills Drive. At the point where a second

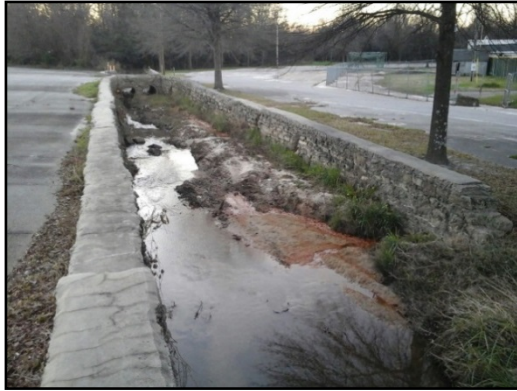
The final open channel segment, in the western part of the subwatershed, is located mostly within the City Stadium parking lot. This area is currently cited as a new Kroger Development. At the upstream end, the stream is confined to a masonry-lined channel that extends between parking lots. There are large sandy deposits in the bed and some vegetation has established along the margins and sand bars. There is one bridge crossing connecting parking lots within the masonry-lined portion. Downstream of the masonry-lined section, the bed and banks become natural

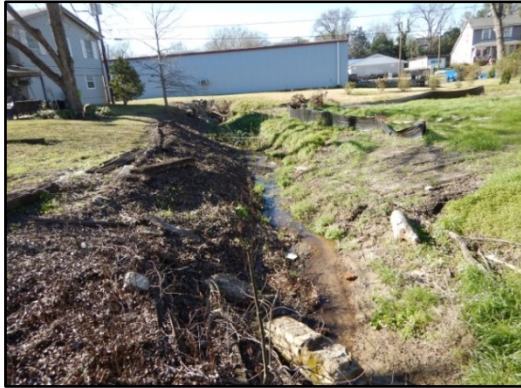
There is minimal open channel length in the FG subwatershed. There is one short section that flows underneath Ohio Street, between Whitney Street and Olympia Avenue. The stream is channelized, located between private properties, and has low, stable banks. The channel bed lacks feature diversity and the substrate includes mostly sand and silt.

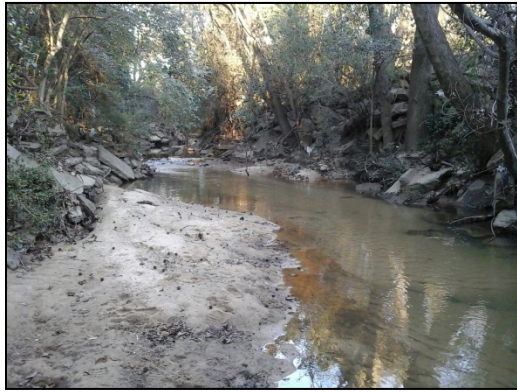
The MV-B subwatershed channel network begins at the confluence with a tributary on the left bank west of the Capital City Stadium, within a forested parcel. Large broken concrete slabs throughout the channel suggest past channelization and create small cascades within an otherwise sandy bed. The banks are approximately 5 to 7 feet tall and stabilized by the concrete and established vegetation. This segment ends at the culvert underneath Bluff Road.

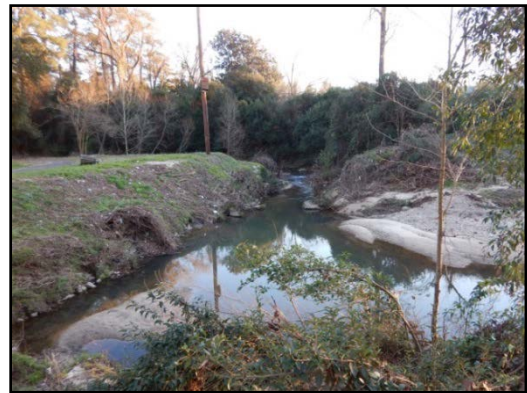
The stream is then conveyed through a road culvert at Olympia Avenue; the culvert was considered to be in very severe condition because of damage to the upstream headwall with the brick facade missing on the left side. There is a large scour hole immediately downstream of the Olympia Avenue culvert. The downstream channel segment has large sand and gravel deposits and an exposed sanitary line spanning over the mainstem supported by concrete and brick piers within the active bed. The stream runs between a parking lot for the Granby Apartments on the right bank and a utility right of way on the left.

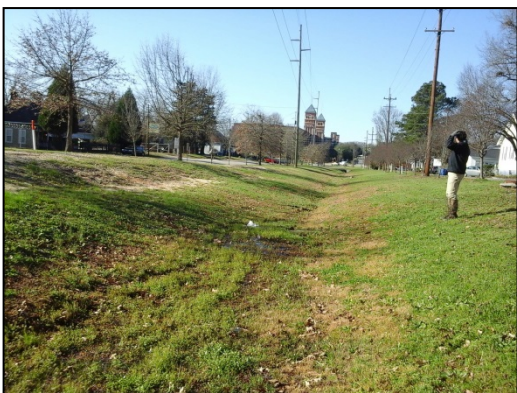
A small tributary converges with the mainstem on the right bank 130 feet upstream of Olympia Avenue. The tributary begins at a stormwater pond at the northeast corner of Heyward and Lincoln Street and continues downstream through a mowed grass swale in the median of Heyward Street. Within the median, the channel banks are low and stable and the channel bed is mostly sand. The channel is then piped into the mainstem at Olympia Park, with a small 80-foot open channel segment adjacent to the Olympia Park playground.

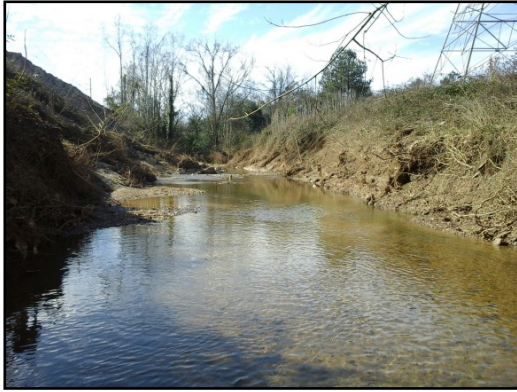
The channel network within the OT subwatershed begins along the Rocky Branch mainstem at the northern edge of the mine. Both banks are influenced by the mine throughout this segment, leading to steep banks and channel encroachment. There are two stretches of severe erosion where the channel traverses through the mine. The upstream instance of bank erosion is underneath overhead transmission lines and banks are raw and 30 to 35 feet tall. There are several bridges and utility crossings that span the channel. The channel is generally incised, with bank heights up
