# SMITH BRANCH WATERSHED ASSESSMENT

MAY 20, 2016

CITY OF COLUMBIA  
UTILITY AND ENGINEERING DEPARTMENT  
1136 WASHINGTON STREET, 7TH FLOOR  
COLUMBIA, SOUTH CAROLINA 29201

McCormick Taylor Inc., supported by KCI Technologies, Inc., has been contracted by the City of Columbia, South Carolina to conduct an assessment of the Smith Branch watershed to identify potential improvement opportunities to identify existing flooding and water quality conditions.

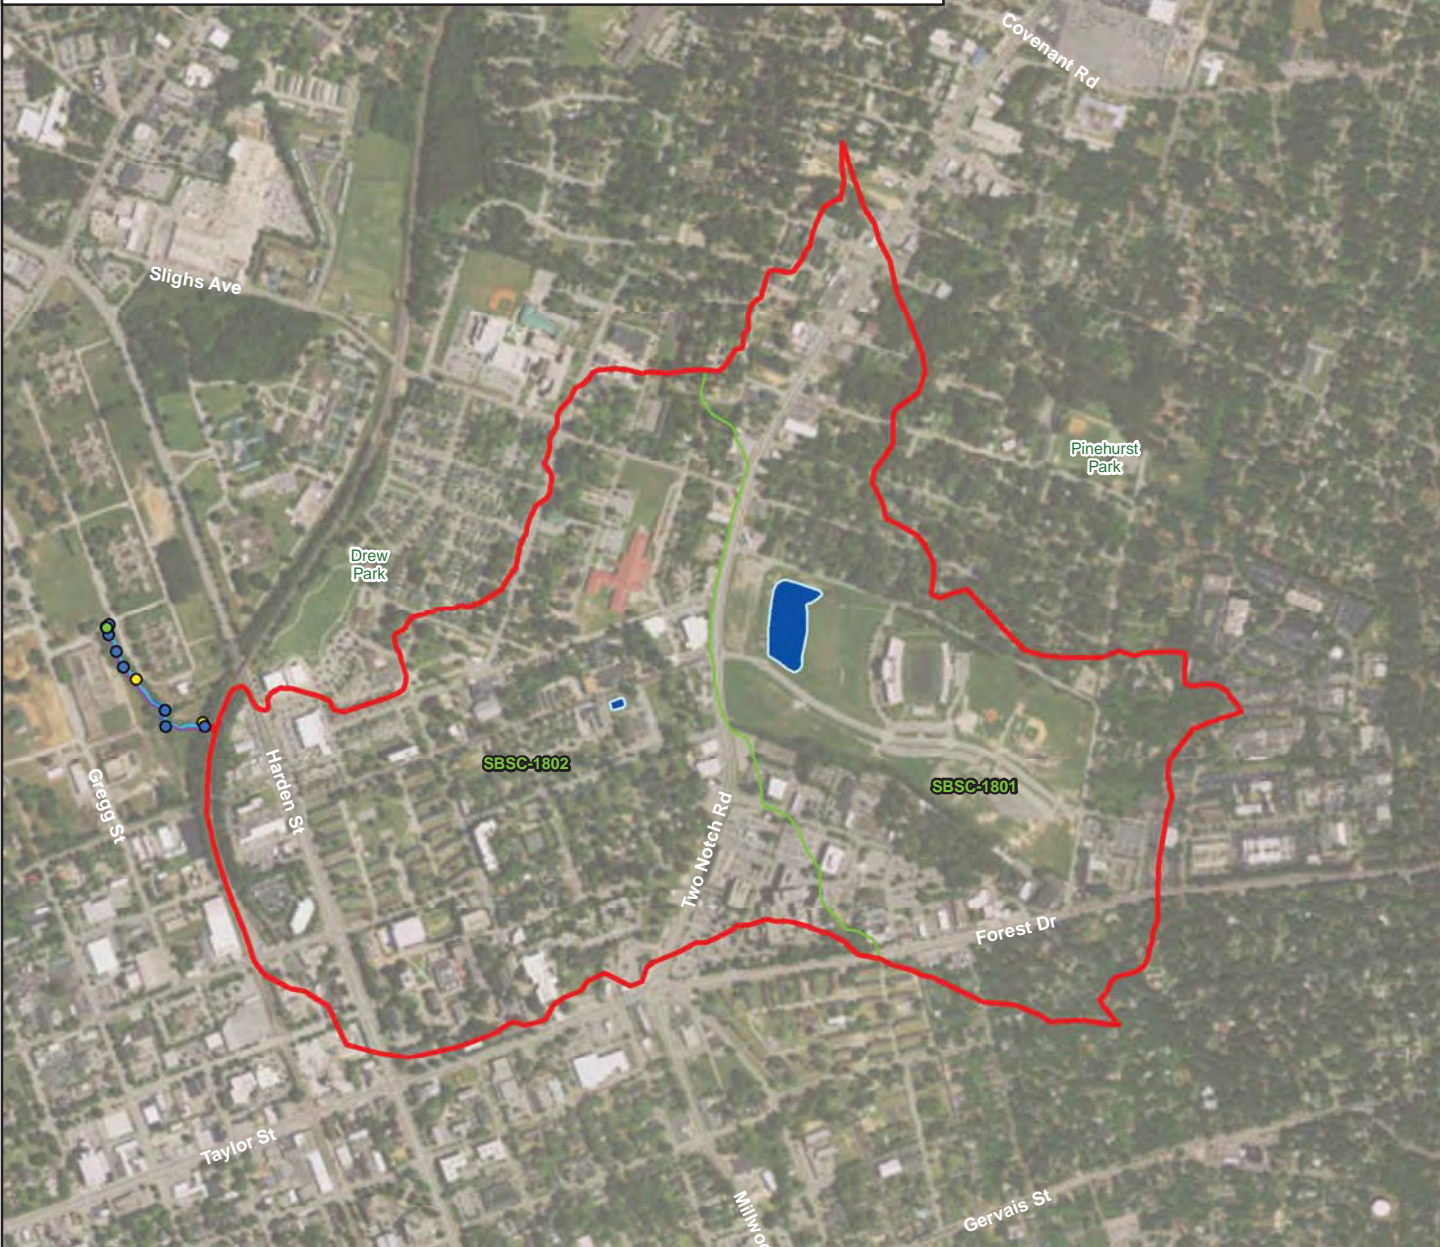
Existing Condition	Count
Exposed Pipes	0
Pipe Outfalls	8
Unmanaged Runoff	0
Unusual Condition	3
Trash Dumping	0
Possible Fish Barrier	1
Linear Feet	
Erosion Site	0
Channel Alteration	79
Inadequate Forest Buffer	1,909

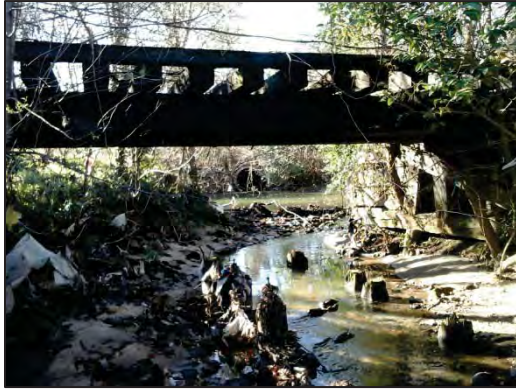
### Channel Conditions:

SW-F drains to a segment of open stream channel extending along the SW-H and SW-G boundary to the west. The upstream limit of open channel originates from a 52 inch concrete outfall under the railroad behind Andrews Auto Service (west of Harden Street and north of Calhoun Street). Expansion scour has likely contributed to widening and there is a large scour pool downstream of the outfall. Downstream, an abandoned degraded railroad bridge constricts the channel, and creates a pinch point. Stream banks are approximately 7-feet tall and are vegetated and stable.

Large coarse deposits define channel baseflow throughout this segment. Substrate within the stream bed is mainly sand, with gravel and cobble along the riffles. The stream enters a pipe at Preston Drive. Currently, the City of Columbia is restoring this stream segment and daylighting the piped segment extending downstream through the Bull Street Redevelopment Project.

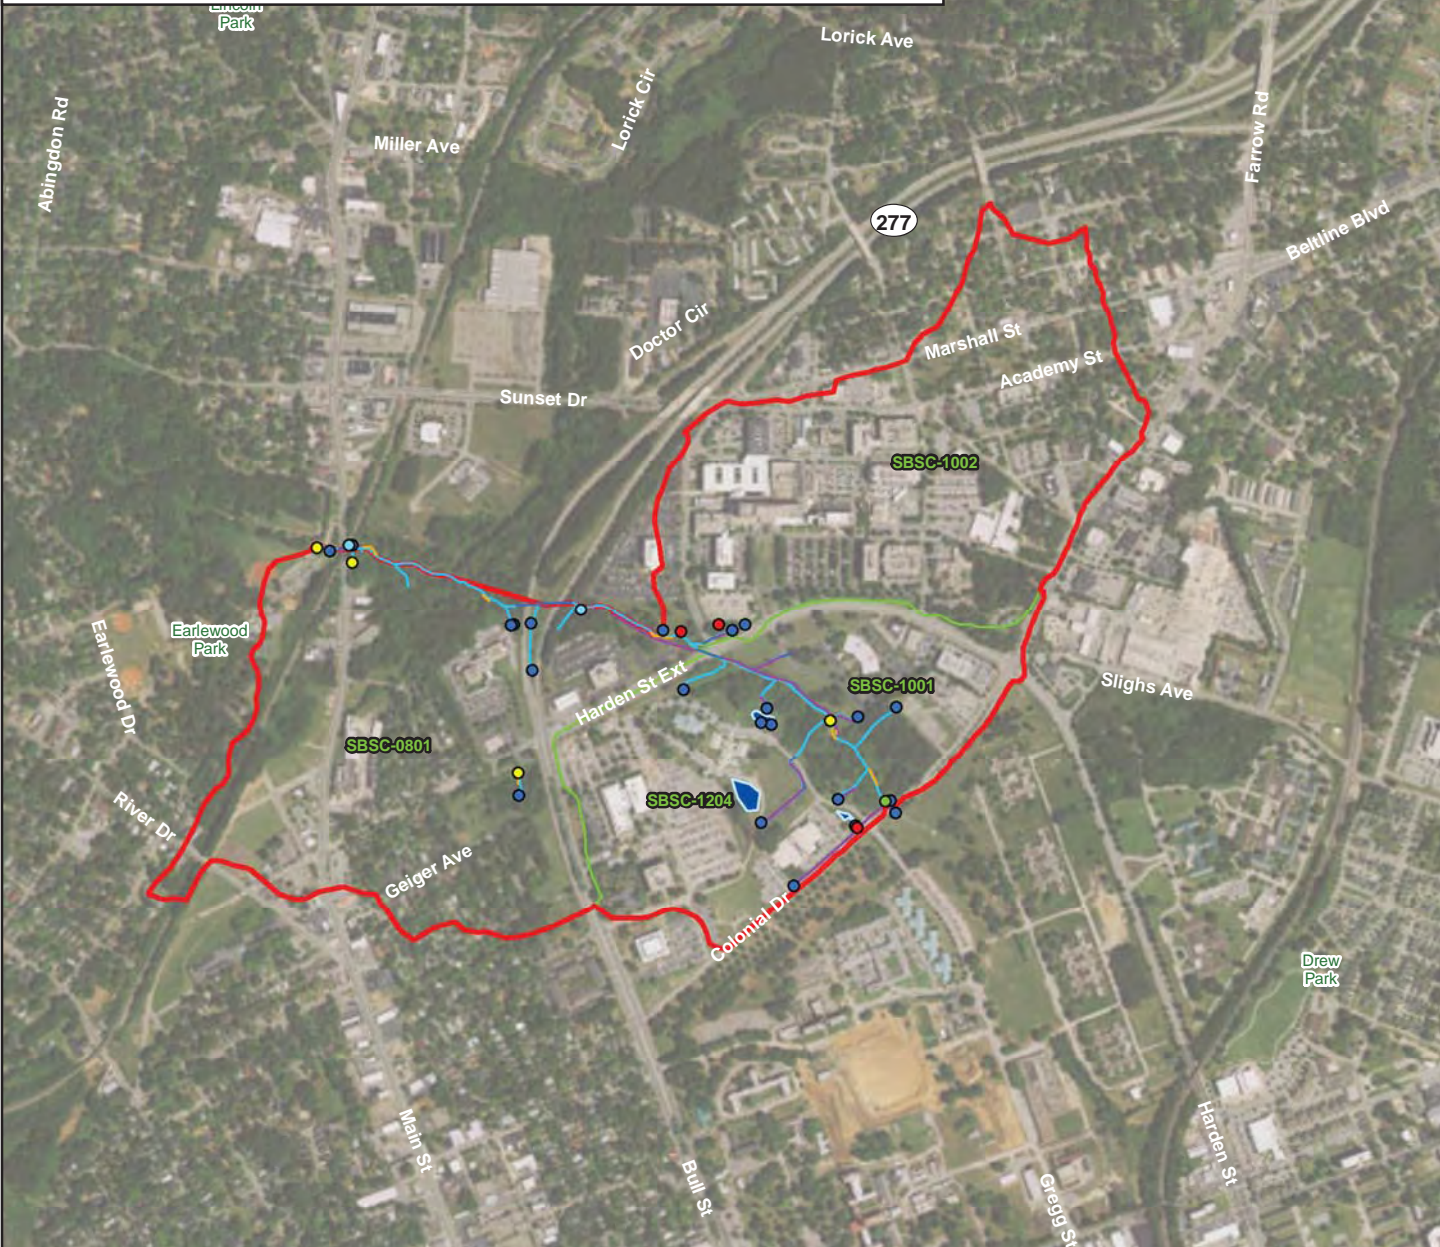
Existing Condition	Count
Exposed Pipes	2
Pipe Outfalls	22
Unmanaged Runoff	3
Unusual Condition	4
Trash Dumping	0
Possible Fish Barrier	1
	<b>Linear Feet</b>
Erosion Site	664
Channel Alteration	885
Inadequate Forest Buffer	6,795

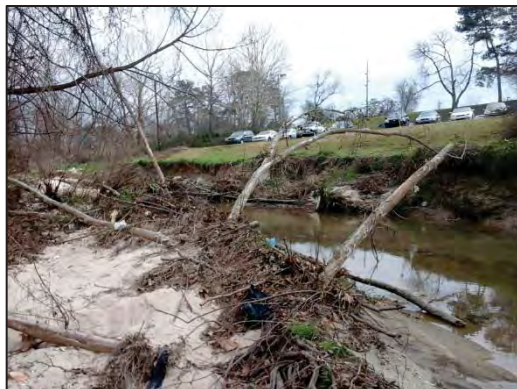
The Smith Branch mainstem flows west through the double box culvert underneath the Harden Street Extension. Infrastructure encroachment, excessive sediment deposition, and poor buffer management practices (mowed to top of bank) have resulted in bank instability and observed block failures extending 150 feet along the left bank, downstream (north) of the Harden Street Extension. Downstream, the banks are more heavily vegetated and stable. Two small tributaries contribute flow into this mainstem segment. The upstream tributary runs parallel to the Harden

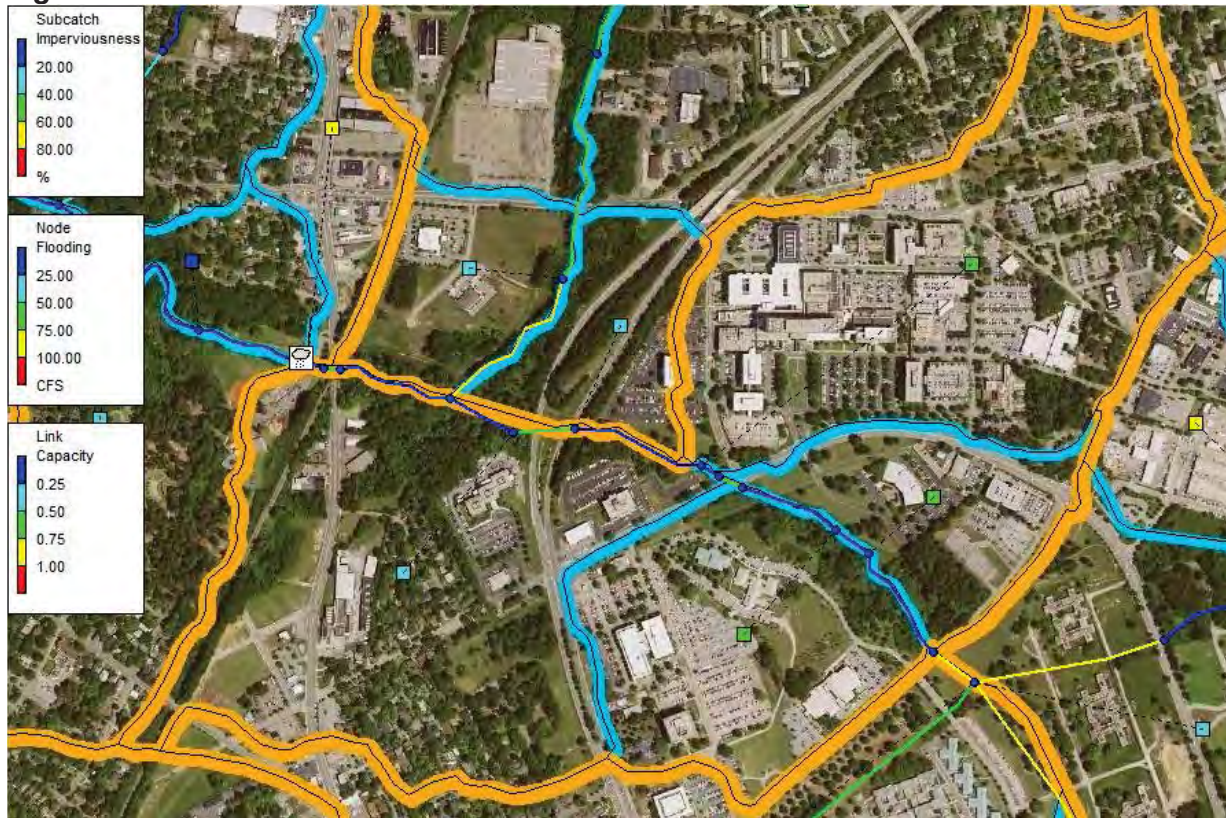
**Figure 6.15 SW-I SWMM Model**

SW-I is modeled as four subcatchments in SWMM that contribute flows directly to Smith Branch. The culvert crossings along Smith Branch can be seen as the green links in the model (**Figure 6.15**), meaning they have reached at least 50% capacity for the 2-year event. The arch culvert at Main Street, near the City's stream and rain gage SWIA, is recommended for upgrade.

- The bridge at Main Street over Smith Branch should be improved to dual 12' x 12' culverts. Currently it is creating a backwater condition during a 2-year storm event.

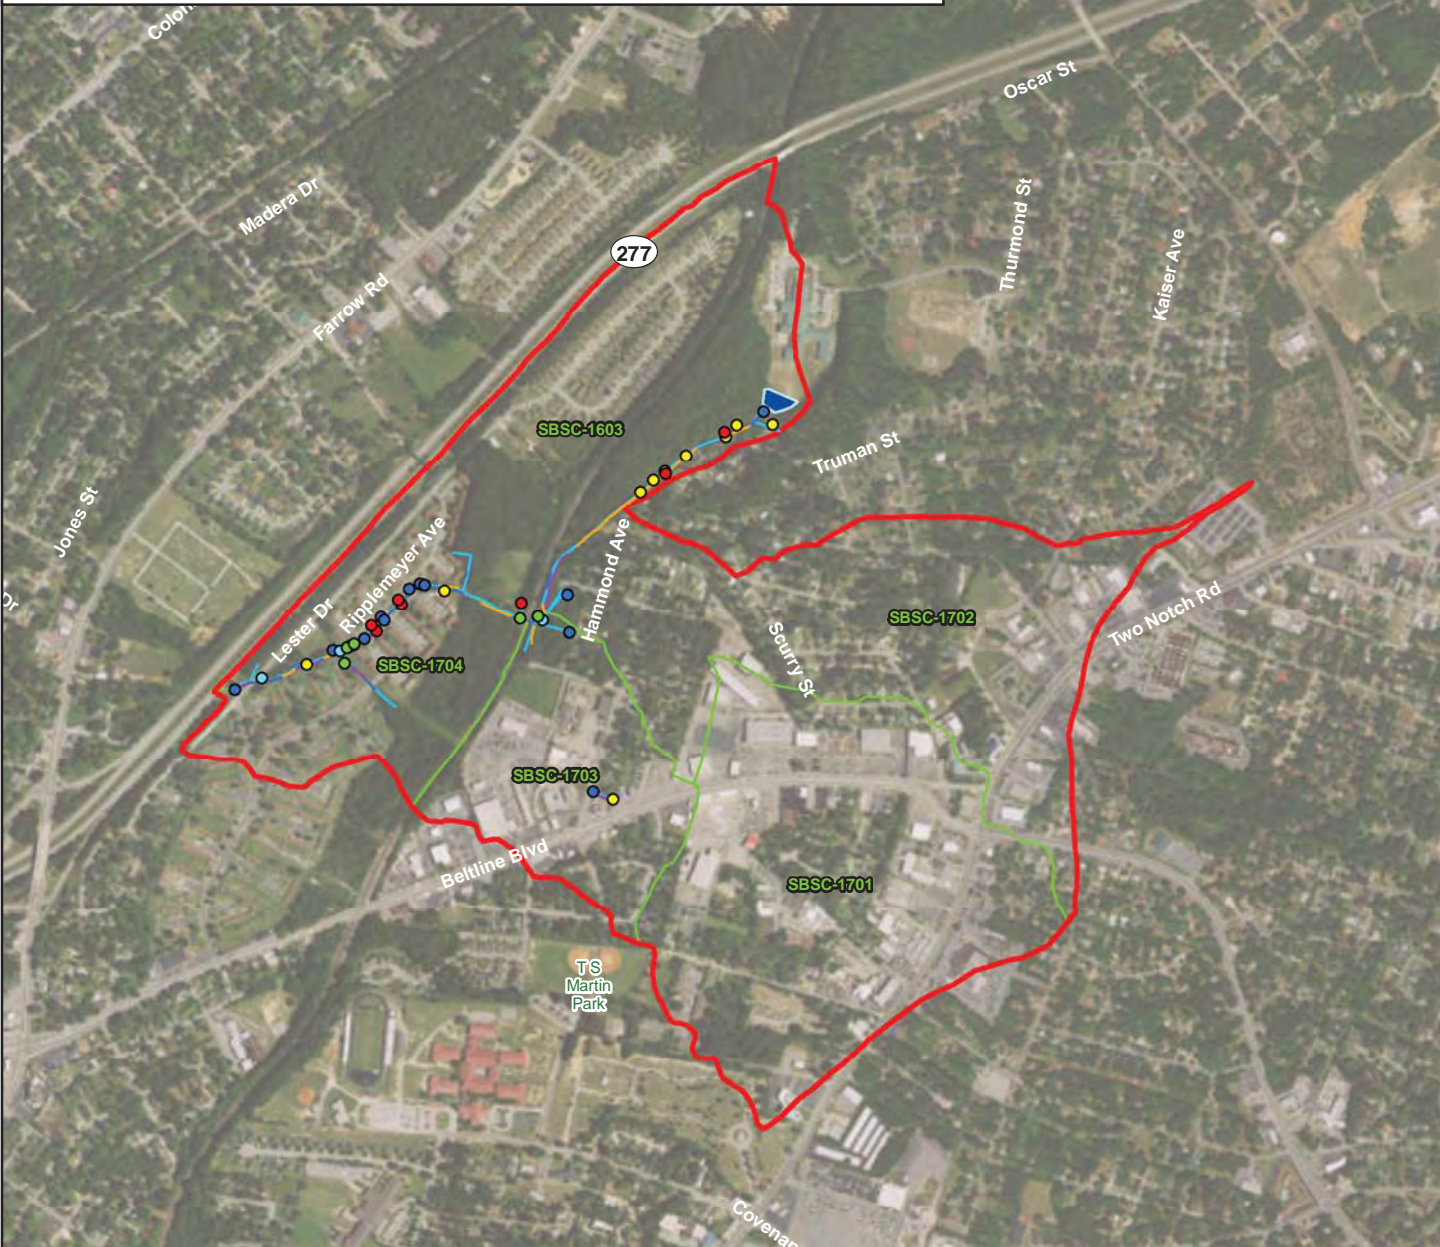
Figure 6.19:  
Subwatershed B  
Existing Conditions

Existing Condition	Count
Exposed Pipes	6
Pipe Outfalls	13
Unmanaged Runoff	7
Unusual Condition	11
Trash Dumping	0
Possible Fish Barrier	5
Linear Feet	
Erosion Site	2,241
Channel Alteration	1,507
Inadequate Forest Buffer	7,942

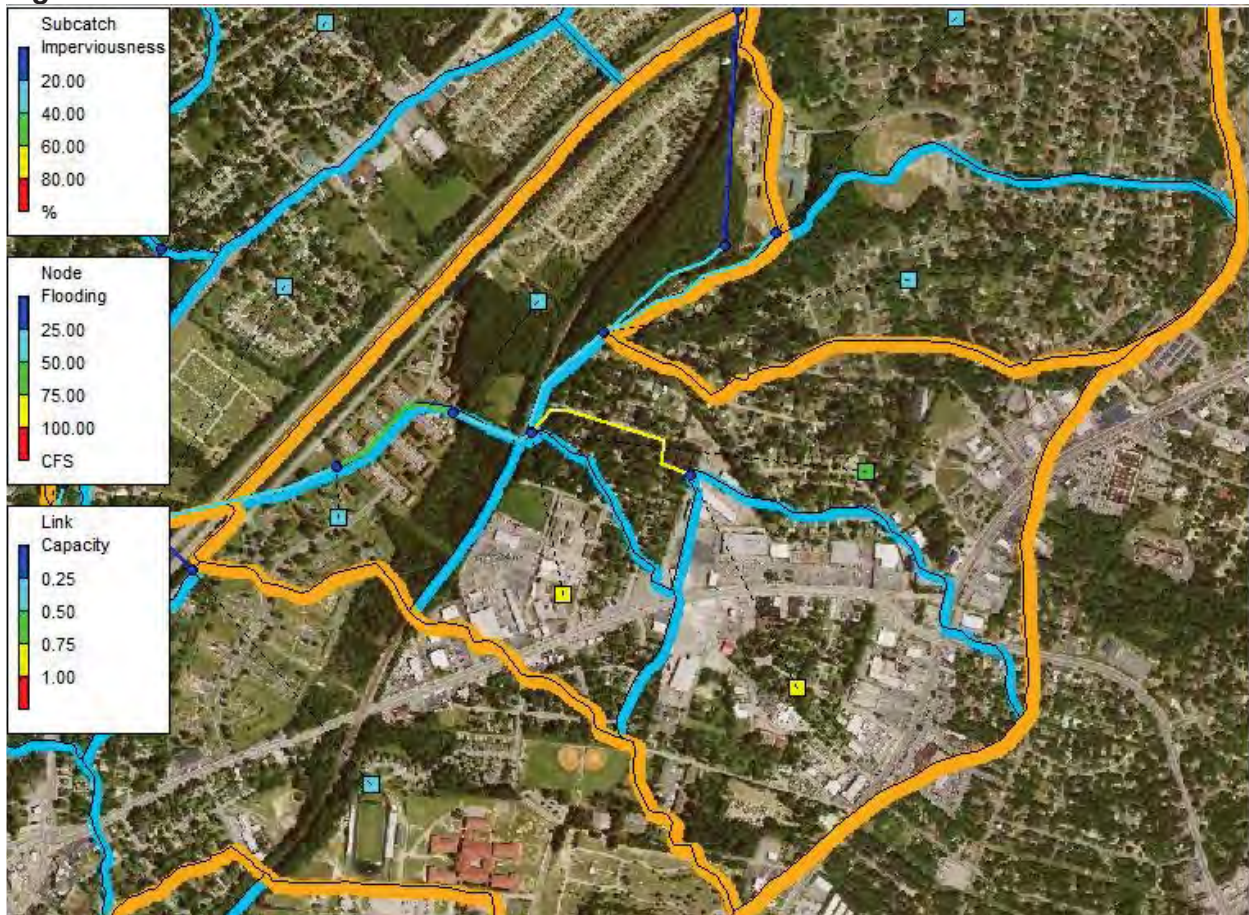
**Figure 6.20 SW-B SWMM Model**

SW-B is modeled in SWMM as five subcatchments draining to the pipe and open channel conveyance systems that make up the headwaters of Bay Branch. The large areas of impervious surface in this watershed are visible in the aerial imagery. At the modeled 2-year event in SWMM, the subwatershed's runoff is approaching capacity (81% modeled capacity) in the 54" RCP outlet pipe (seen mapped as yellow lines in **Figure 6.20**).

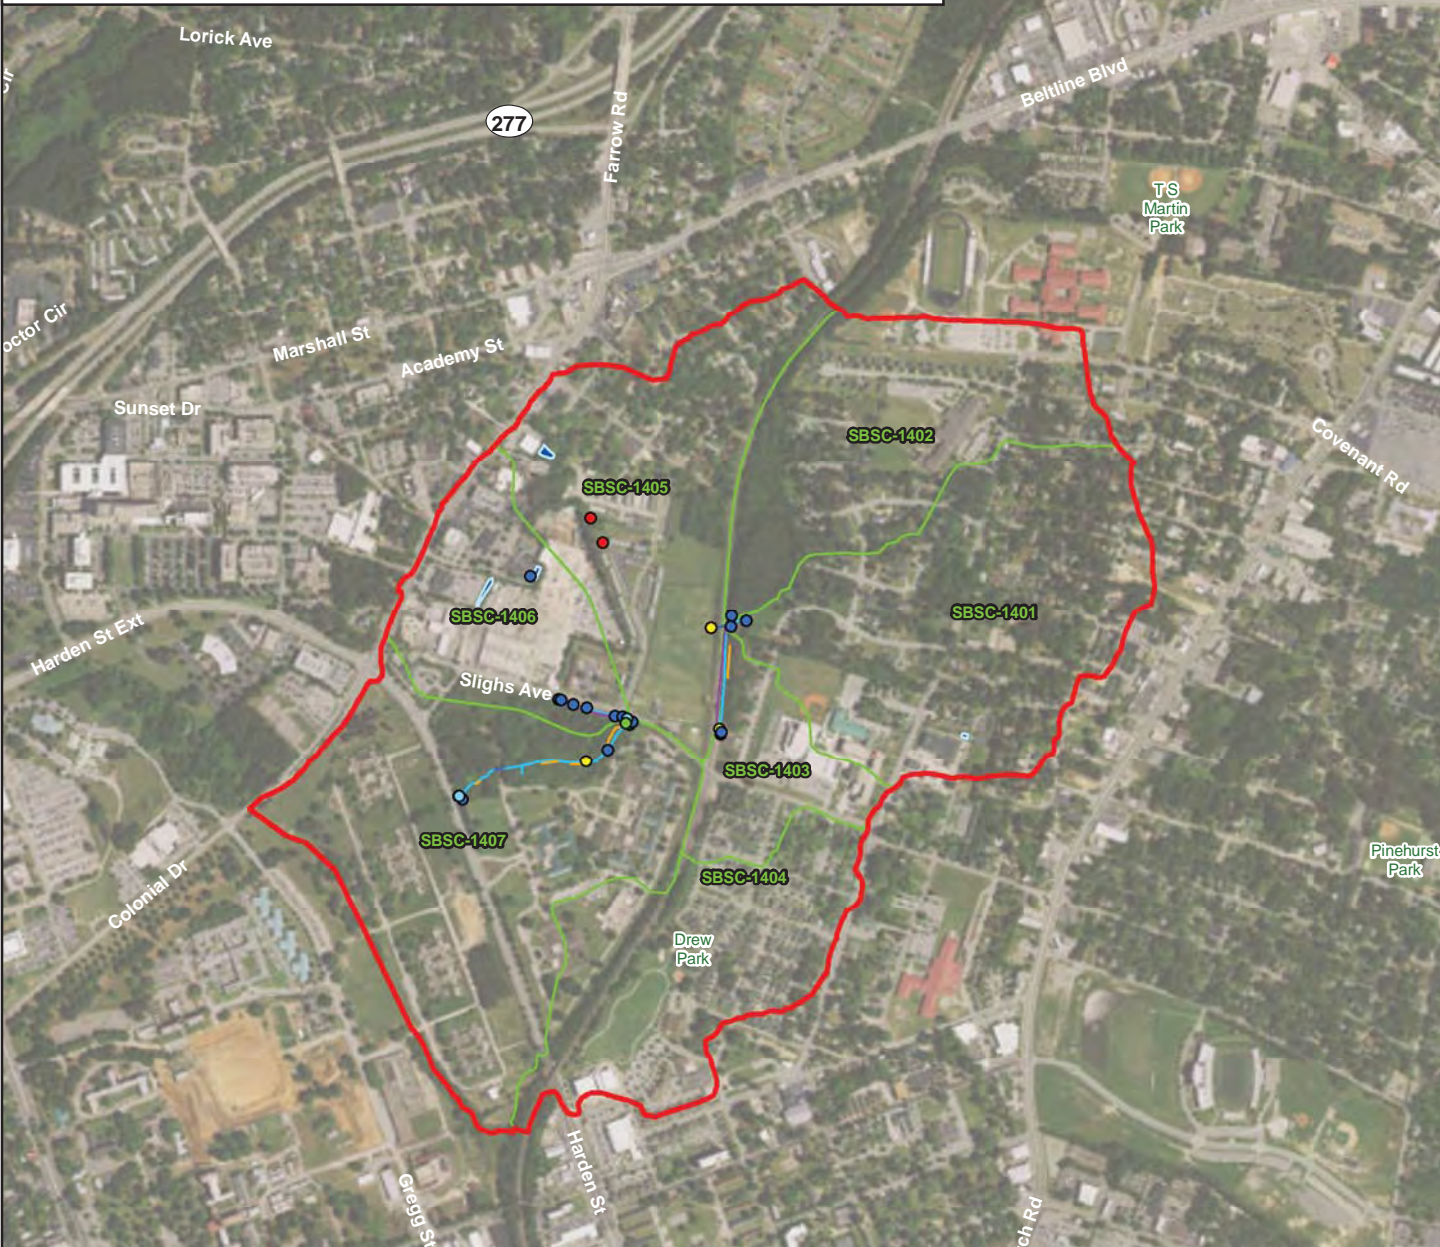
Figure 6.24:  
Subwatershed G  
Existing Conditions

Existing Condition	Count
Exposed Pipes	2
Pipe Outfalls	16
Unmanaged Runoff	2
Unusual Condition	4
Trash Dumping	0
Possible Fish Barrier	1
	<b>Linear Feet</b>
Erosion Site	1,006
Channel Alteration	121
Inadequate Forest Buffer	1,092

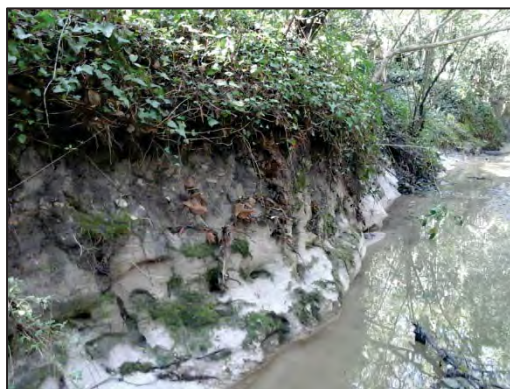
After the tributary flows into the receiving main channel, the channel becomes deeply incised downstream. The 10-foot tall banks are nearly vertical and composed mostly of silt with some bedrock at the toe. As the stream meanders west, bedrock intrusion becomes more frequent in the left bank and there are isolated areas of slumping, while the right bank is more densely vegetated and stable. Depositional mid-channel and point bars frequently constrict and divide baseflow. The stream extends through twin culverts at Eagle Avenue. Downstream

of the road crossing, there are isolated areas of erosion. The stream is then piped west under Harden Street and beyond the SW-G boundary onto the Bull Street Redevelopment property.

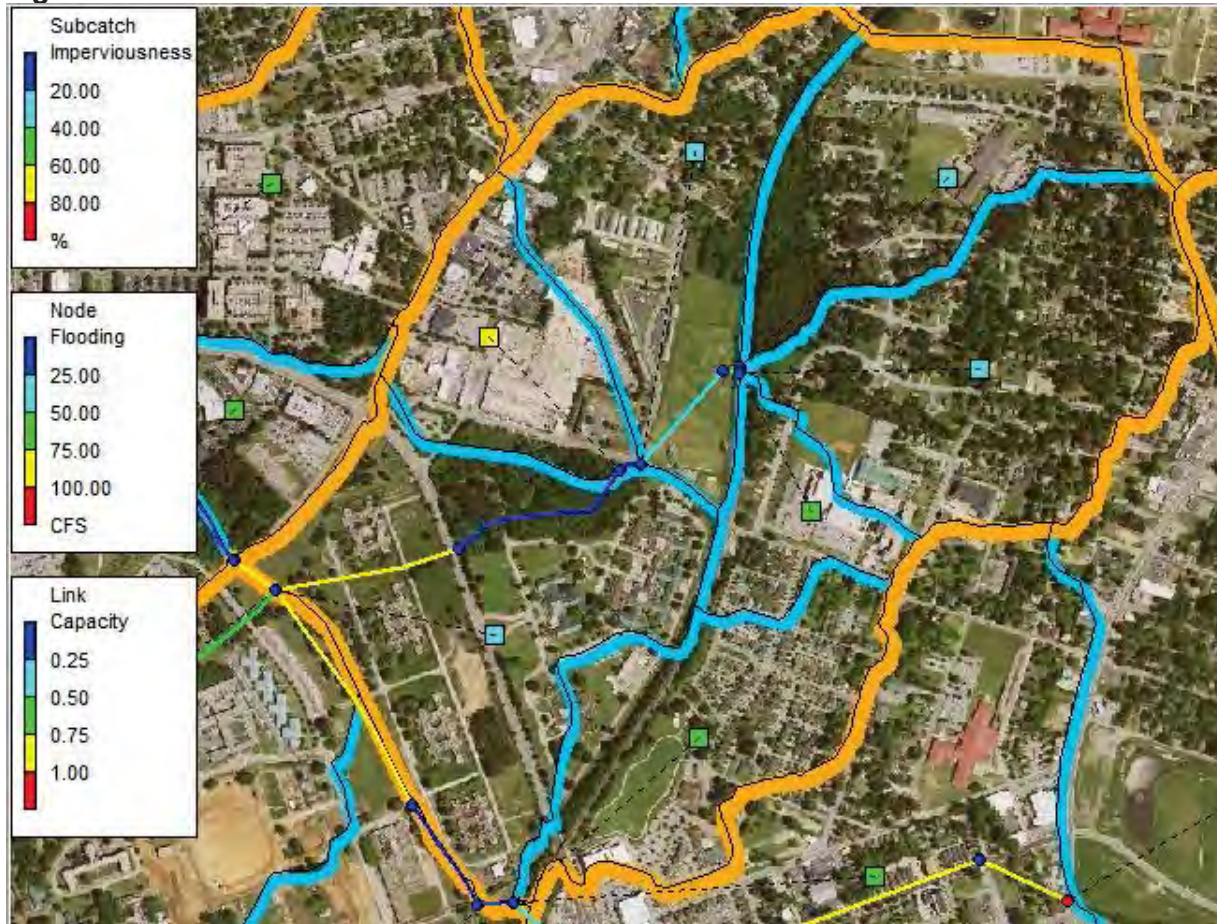
**Figure 6.25 SW-G SWMM Model**

SW-G is modeled as seven subcatchments (**Figure 6.25**). Six of these subcatchments drain to the 84 inch RCP at the western end of the subwatershed. The remaining subcatchment is modeled as draining to the upper end of the large dual culverts at Preston Drive. One subcatchment in this subwatershed is mostly commercial and approximately 70% impervious. The dual 84 inch RCPs that begin at Preston Drive are estimated to be at almost 80% capacity

due to the flows from SW-F and SW-G during a 2-year storm event. The undeveloped green space in this area should be further investigated for ways to store and infiltrate water.

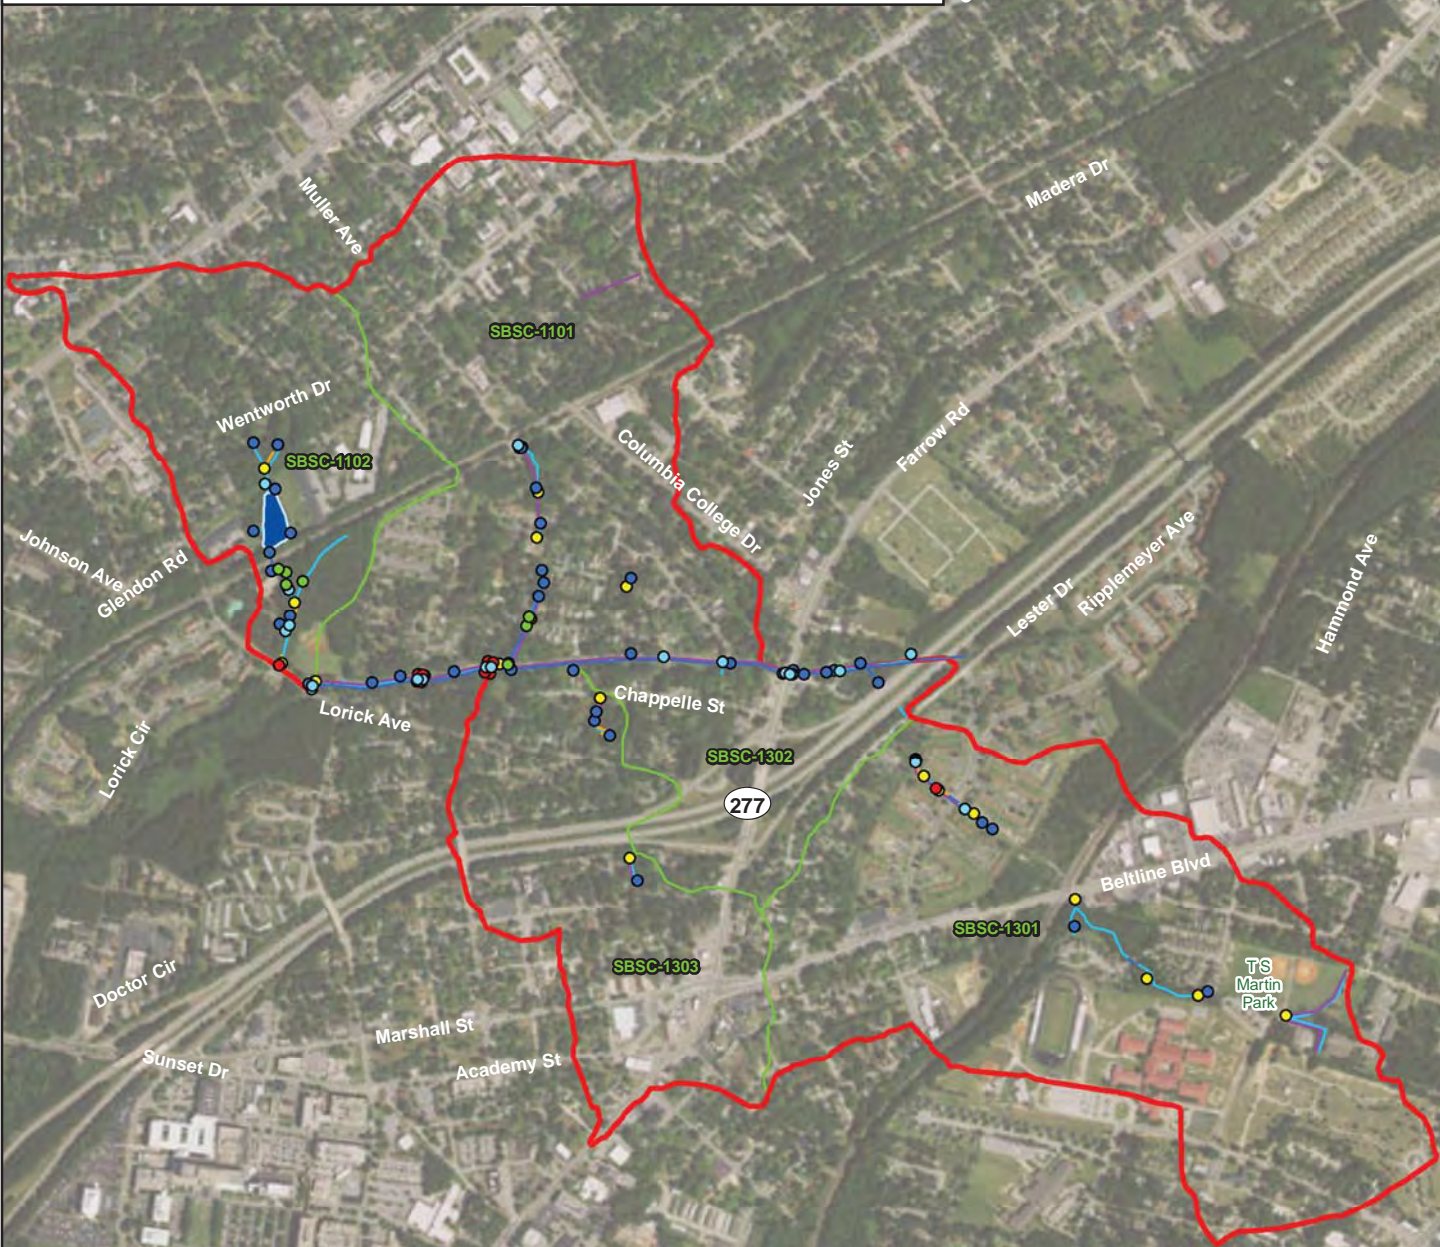
Figure 6.29:  
Subwatershed D  
Existing Conditions

Existing Condition	Count
Exposed Pipes	24
Pipe Outfalls	43
Unmanaged Runoff	11
Unusual Condition	19
Trash Dumping	0
Possible Fish Barrier	7
	<b>Linear Feet</b>
Erosion Site	1,268
Channel Alteration	5,121
Inadequate Forest Buffer	13,613

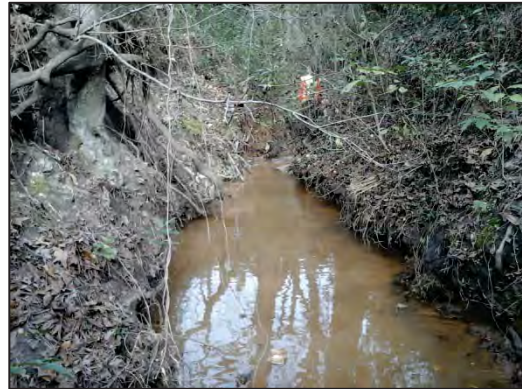
The upstream extent of the fourth major tributary initiates in a forested parcel south of Wentworth Drive and east of Kinderway Avenue. Streambanks are mostly stable and well vegetated, with some isolated areas of moderate erosion. Channel substrate consists of silt and sand, with some gravel along the riffles. Downstream, the stream is routed through a large pond before passing underneath railroad tracks to the south and entering Lorick Park. The railroad culvert appears to be blocked on the downstream side by riprap recently placed on the embankment face. Downstream of the railroad, the channel is incised with 7-foot banks, thick established vegetation, and bedrock at the toe and in the bed. A wetland seep flows into this tributary north of the baseball diamond. Stream conditions change downstream of the confluence; the bank heights lower and the understory vegetation thins as the stream enters the maintained section of the park. Bed substrate changes to primarily gravel with substantial quantities of sand and cobble. The stream is then piped along Lorick Avenue, and enters Bay Branch immediately upstream of the Lorick Avenue crossing.

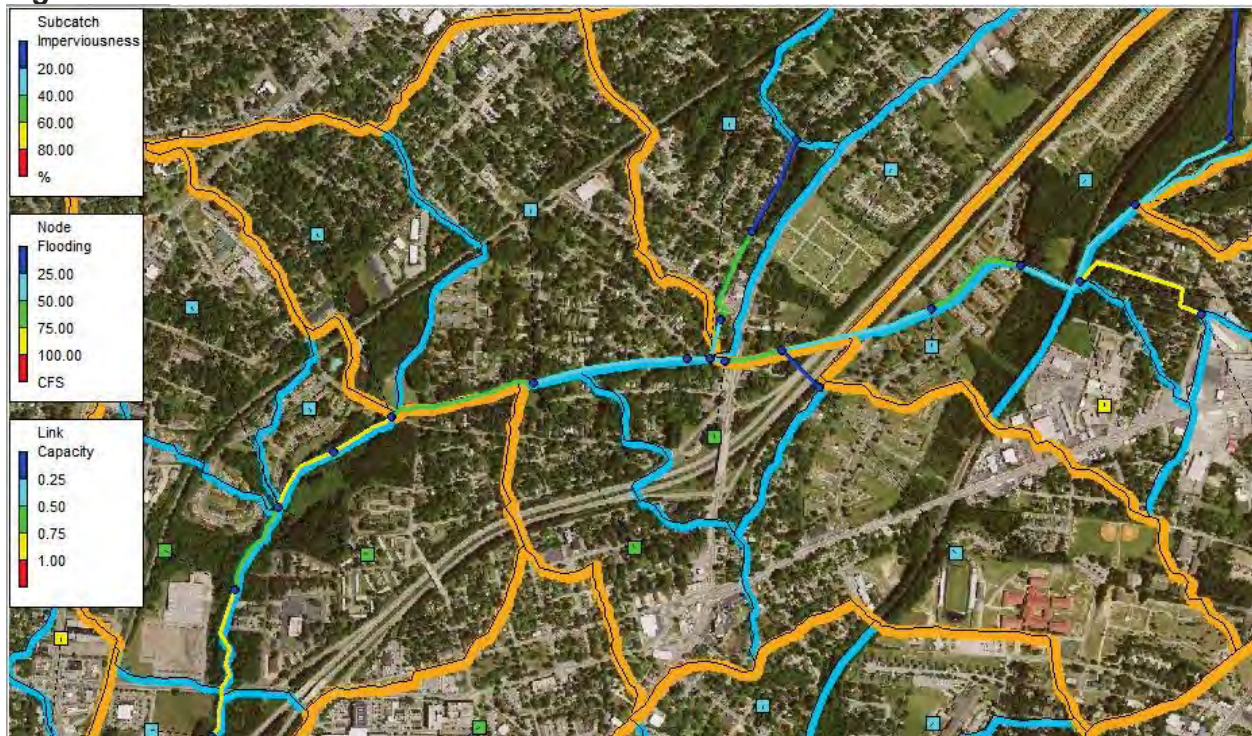
**Figure 6.30 SW-D SWMM Model**

SW-D is modeled in SWMM as five subcatchments on either side of Bay Branch. Bay Branch is a concrete-lined trapezoidal channel as it flows through the subwatershed. Due to the low Manning's roughness of concrete, water in this channel will flow at higher velocities. Where the concrete-lined portion of the channel ends, the flow is modeled to enter a backwater condition, causing the link to near its capacity, changing the mapped color to yellow (**Figure 6.30**) at 88% modeled capacity.

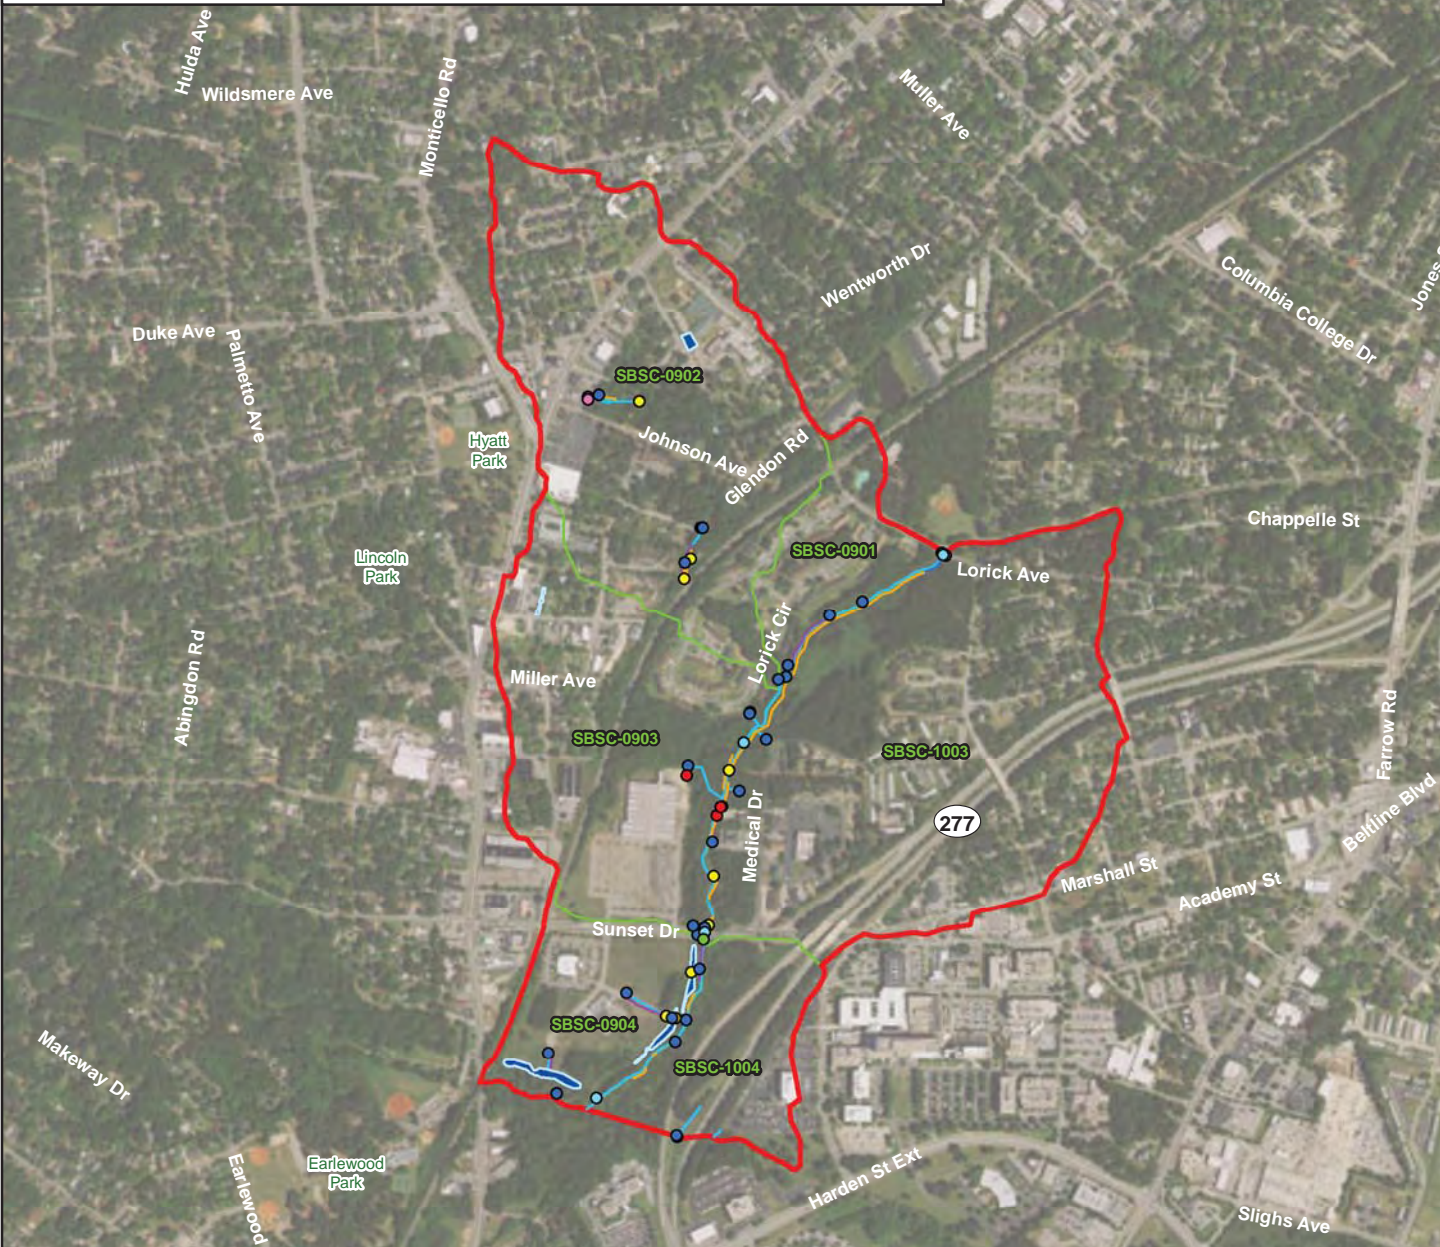
Figure 6.34:  
Subwatershed E  
Existing Conditions

Existing Condition	Count
Exposed Pipes	4
Pipe Outfalls	29
Unmanaged Runoff	3
Unusual Condition	11
Trash Dumping	1
Possible Fish Barrier	1
	<b>Linear Feet</b>
Erosion Site	4,901
Channel Alteration	234
Inadequate Forest Buffer	2,433

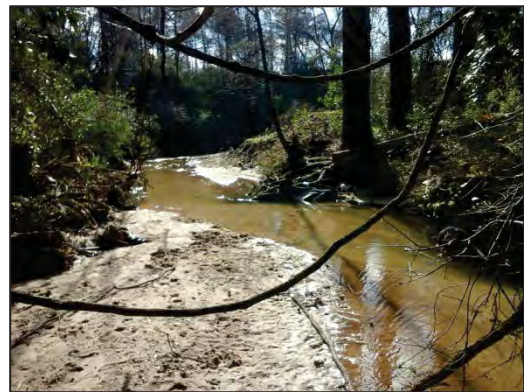
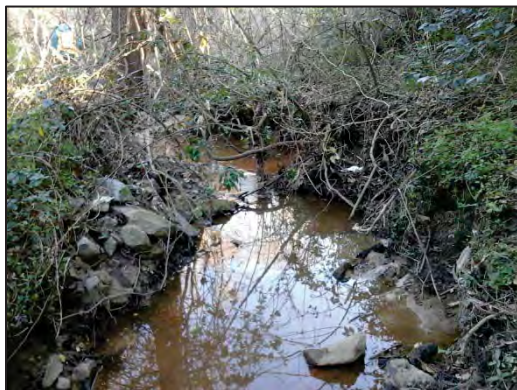
as flood flows leave the concrete channel downstream of Lorick Avenue. Channel incision and widening has begun to threaten surrounding infrastructure through this reach. Bedrock is now likely slowing the rate of incision and widening as past erosion has exposed bedrock in the bed and banks. Channel substrate consists of a mix of sand, gravel, and cobble, with bedrock exposed in cascades and riffles.

Along Bay Branch downstream of Lorick Circle, erosion continues to impact the streams surrounding environment and threatens overhead utility poles, sanitary lines, and the parking lot of the Alston Wilkes Veterans Home off Medical Drive. Downstream of the Veterans Home parking lot, sinuosity increases, and there is isolated erosion at the outside of bends with depositional point bars on the inside. The percent sand increases within the bed through this reach, with some gravel and cobble along riffles. The stream extends through a quad box culvert under Sunset Drive. Downstream of the quad culvert is an 18-inch vertical baseflow water surface drop. Downstream of Sunset Drive, the substrate is primarily sand. The banks are fairly stable and well established with woody vegetation. A few areas of isolated minor to moderate erosion exist, undercutting trees and scouring the outside of bends. Bay Branch within SW-E concludes at the downstream subwatershed boundary, where it flows into the mainstem of Smith Branch.

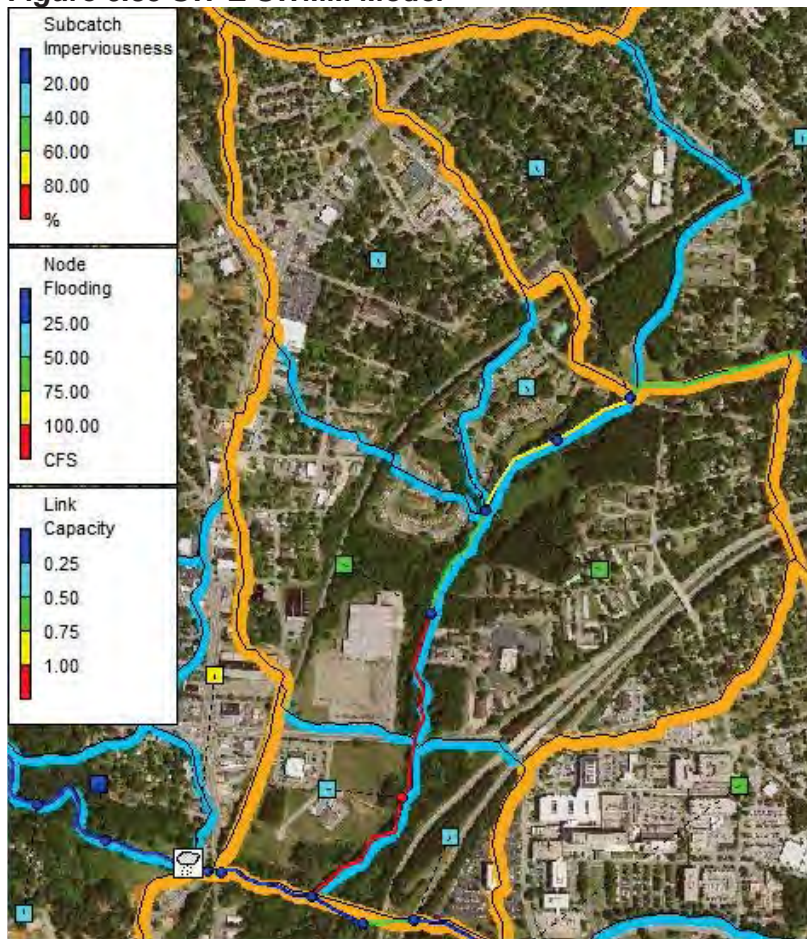
**Figure 6.35 SW-E SWMM Model**

SW-E is modeled as six subcatchments in SWMM. It makes up the lower portion of Bay Branch. The more impervious commercial areas of this subwatershed can be seen along the western boundary in the aerial imagery (**Figure 6.35**). Where Bay Branch meets Smith Branch, flooding issues are modeled to occur during the 2-year event as this area of the tributary reaches 100% capacity and water begins to flow into the overbank areas. Bay Branch itself has been highly

altered in areas with concrete linings at the top of this catchment that cause more rapid stream flow peaks down the tributary to Smith Branch, resulting in more flooding issues downstream.

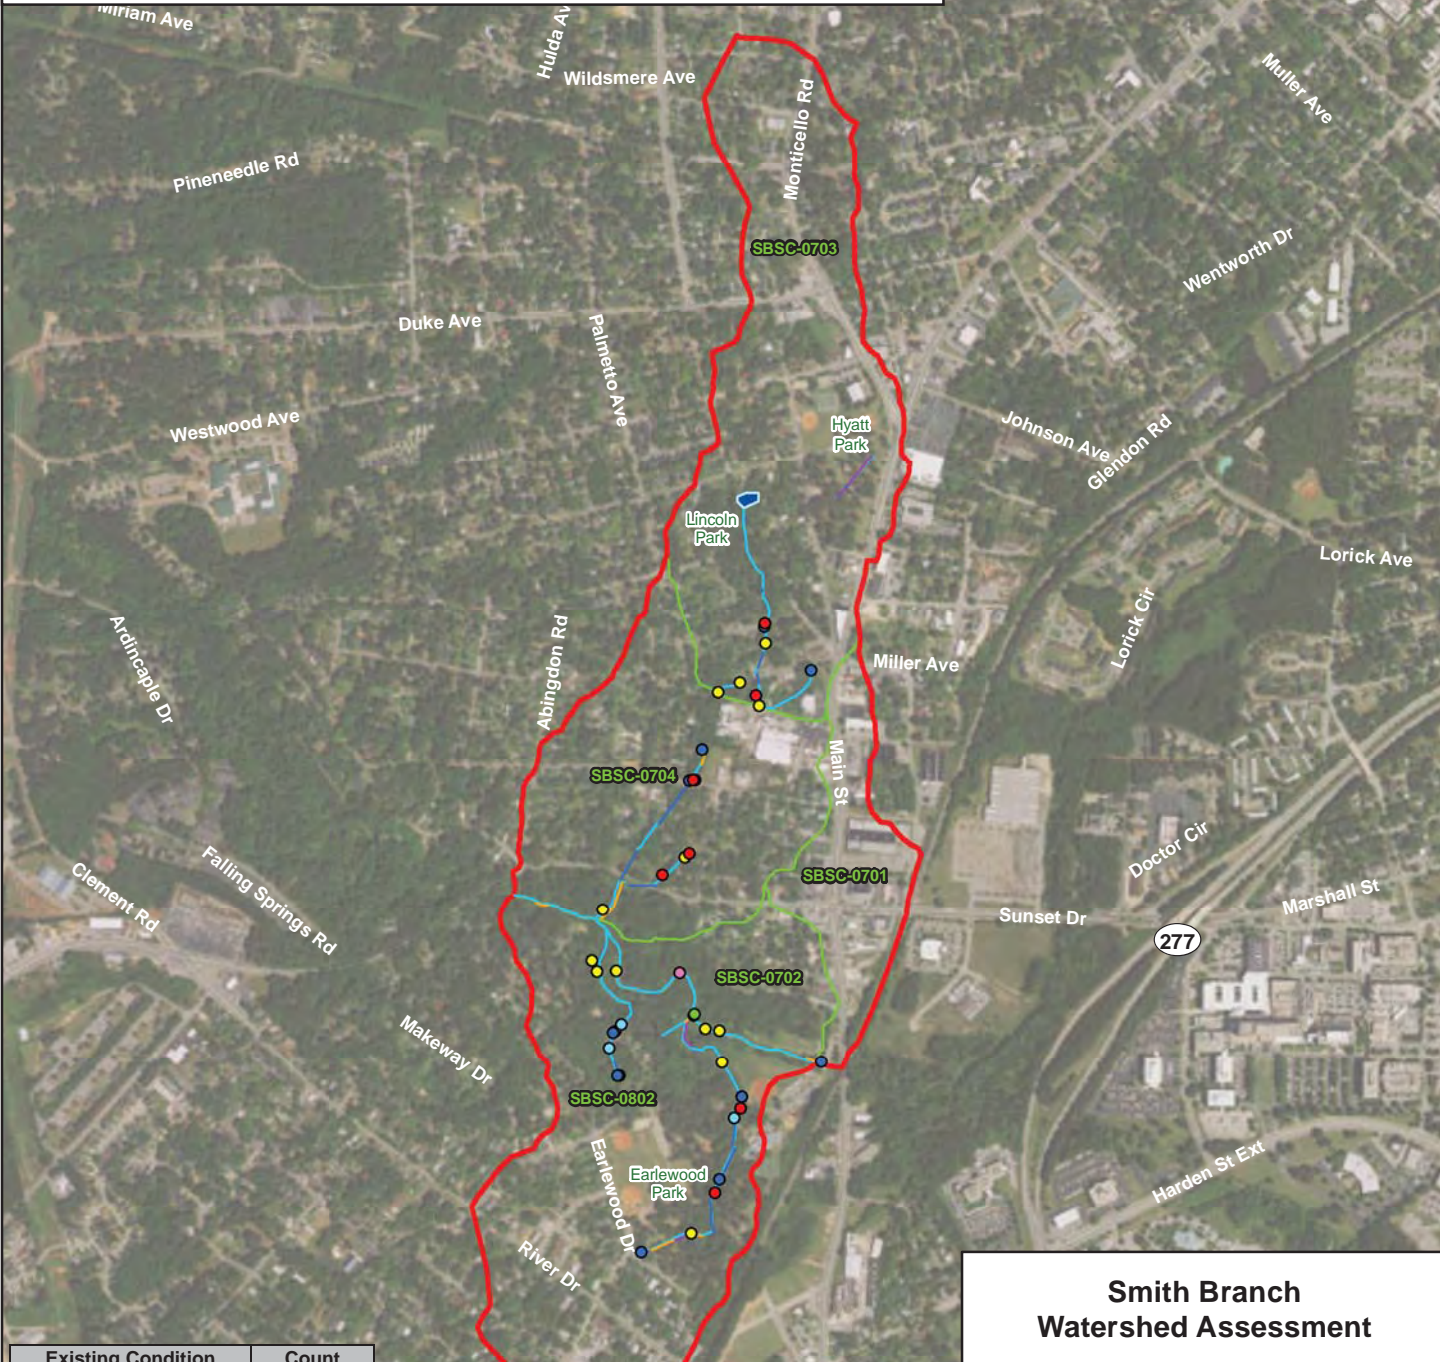
Figure 6.39:  
Subwatershed J  
Existing Conditions

Existing Condition	Count
Exposed Pipes	3
Pipe Outfalls	12
Unmanaged Runoff	7
Unusual Condition	15
Trash Dumping	1
Possible Fish Barrier	1
	<b>Linear Feet</b>
Erosion Site	1,380
Channel Alteration	1,934
Inadequate Forest Buffer	2,670

During the field review, a total of 12 storm drain outfalls were identified within SW-J, two of which were rated severe in condition. The first severe outfall, located along Miller Avenue, is a 55 inch RCP with a three foot vertical drop to the mainstem. It has been given a severe rating due to undercutting of erodible materials weakening the base of the structure. The second severe outfall is within Earlewood Park; this structure is a 24 inch CMP with a blue/green colored discharge that is backwatered into the outfall.

- Stabilize the outfall south of Miller Avenue.
- Repair the outfall east of Earlewood Drive, check for source of blue/green discharge and stabilize the banks downstream of the outfall.
- Plant trees where feasible within Hyatt Park, Earlewood Park, and northeast of the intersection of Sunset Drive and Margrave Road.
- Install bioretention areas and downspout disconnection for parking lots at the Burton-Pack Elementary School and the associated recreational area.
- Development in flood-prone areas near Smith Branch should be restricted. In addition, open space floodplains where Smith Branch flows through this catchment should be investigated for permanent protection under easements or restrictive covenants.
