# SMITH BRANCH WATERSHED ASSESSMENT

MAY 20, 2016

CITY OF COLUMBIA  
UTILITY AND ENGINEERING DEPARTMENT  
1136 WASHINGTON STREET, 7TH FLOOR  
COLUMBIA, SOUTH CAROLINA 29201

McCormick Taylor Inc., supported by KCI Technologies, Inc., has been contracted by the City of Columbia, South Carolina to conduct an assessment of the Smith Branch watershed to identify potential improvement opportunities to identify existing flooding and water quality conditions.

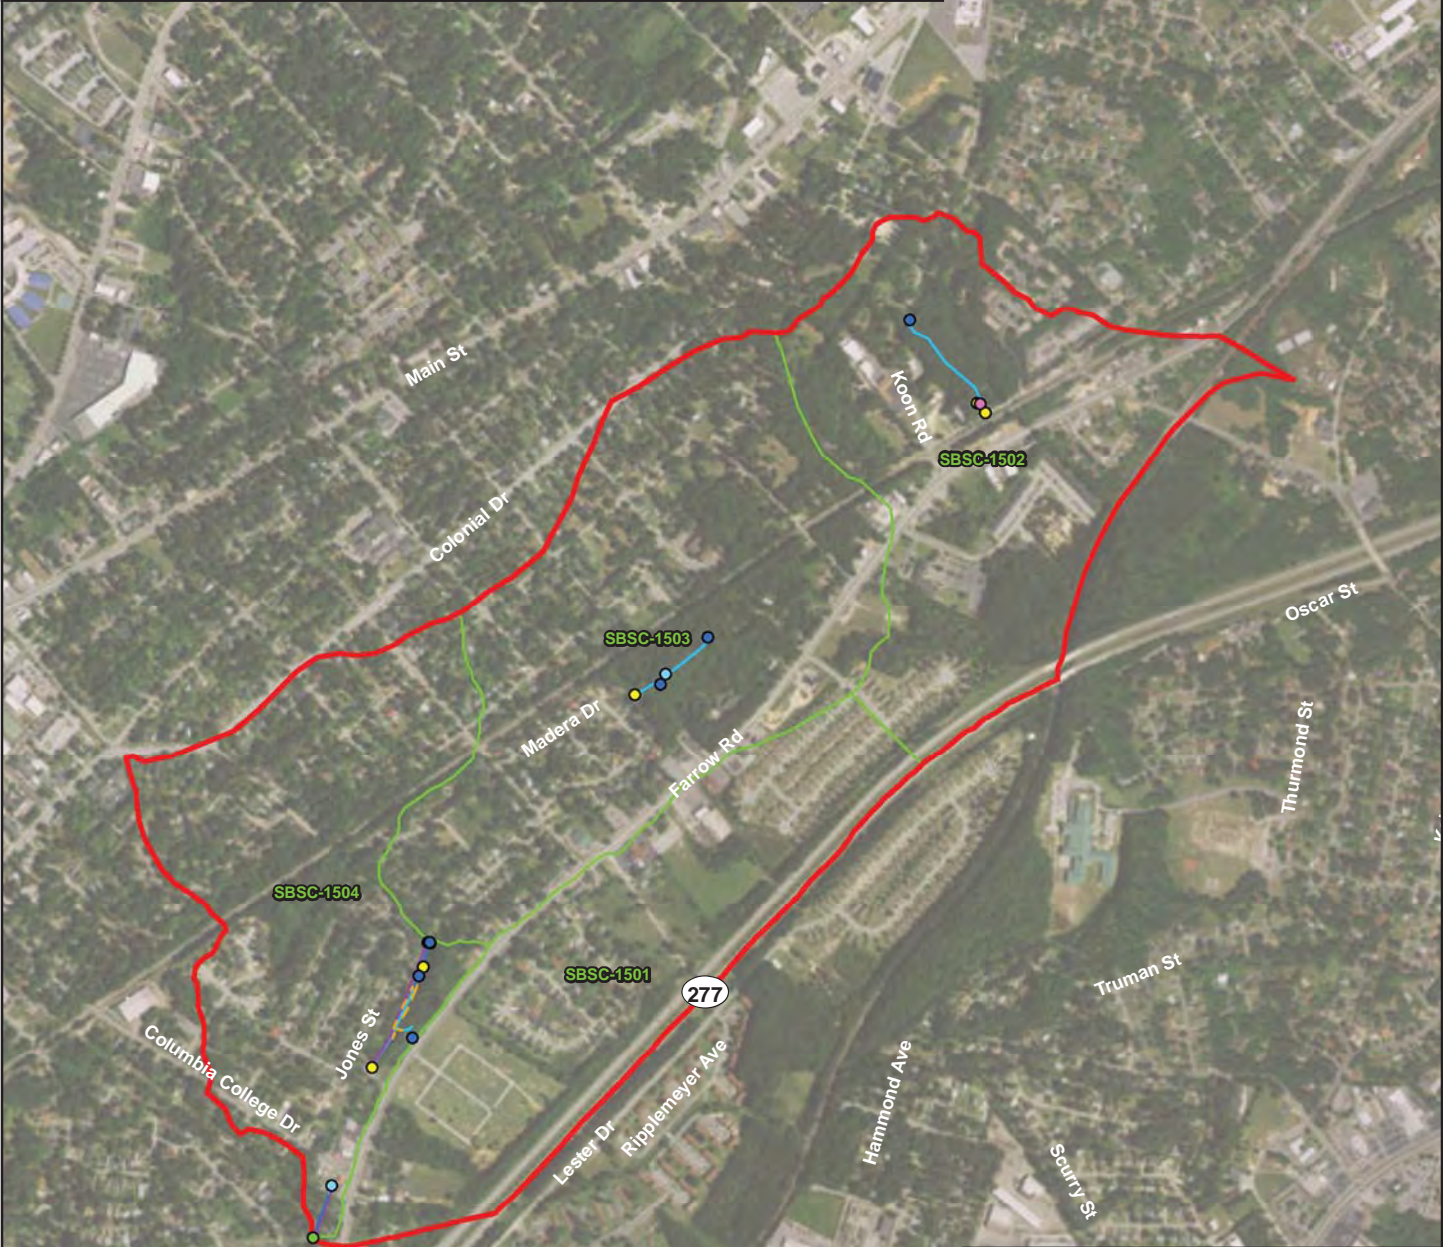
Figure 6.44:  
Subwatershed C  
Existing Conditions

Existing Condition	Count
Exposed Pipes	2
Pipe Outfalls	9
Unmanaged Runoff	0
Unusual Condition	5
Trash Dumping	1
Possible Fish Barrier	1
	<b>Linear Feet</b>
Erosion Site	403
Channel Alteration	631
Inadequate Forest Buffer	1,554

There were nine outfalls identified within SW-C. Only one outfall in SW-C was determined to be in severe condition. This outfall is located west of Lincoln Cemetery, along the western side of Farrow Road. The outfall was not actually clearly identified though drainage patterns and a scoured sump with standing water suggested the presence of an outfall. An outfall point was collected to characterize the severity of the drainage patterns and downstream headcutting observed.

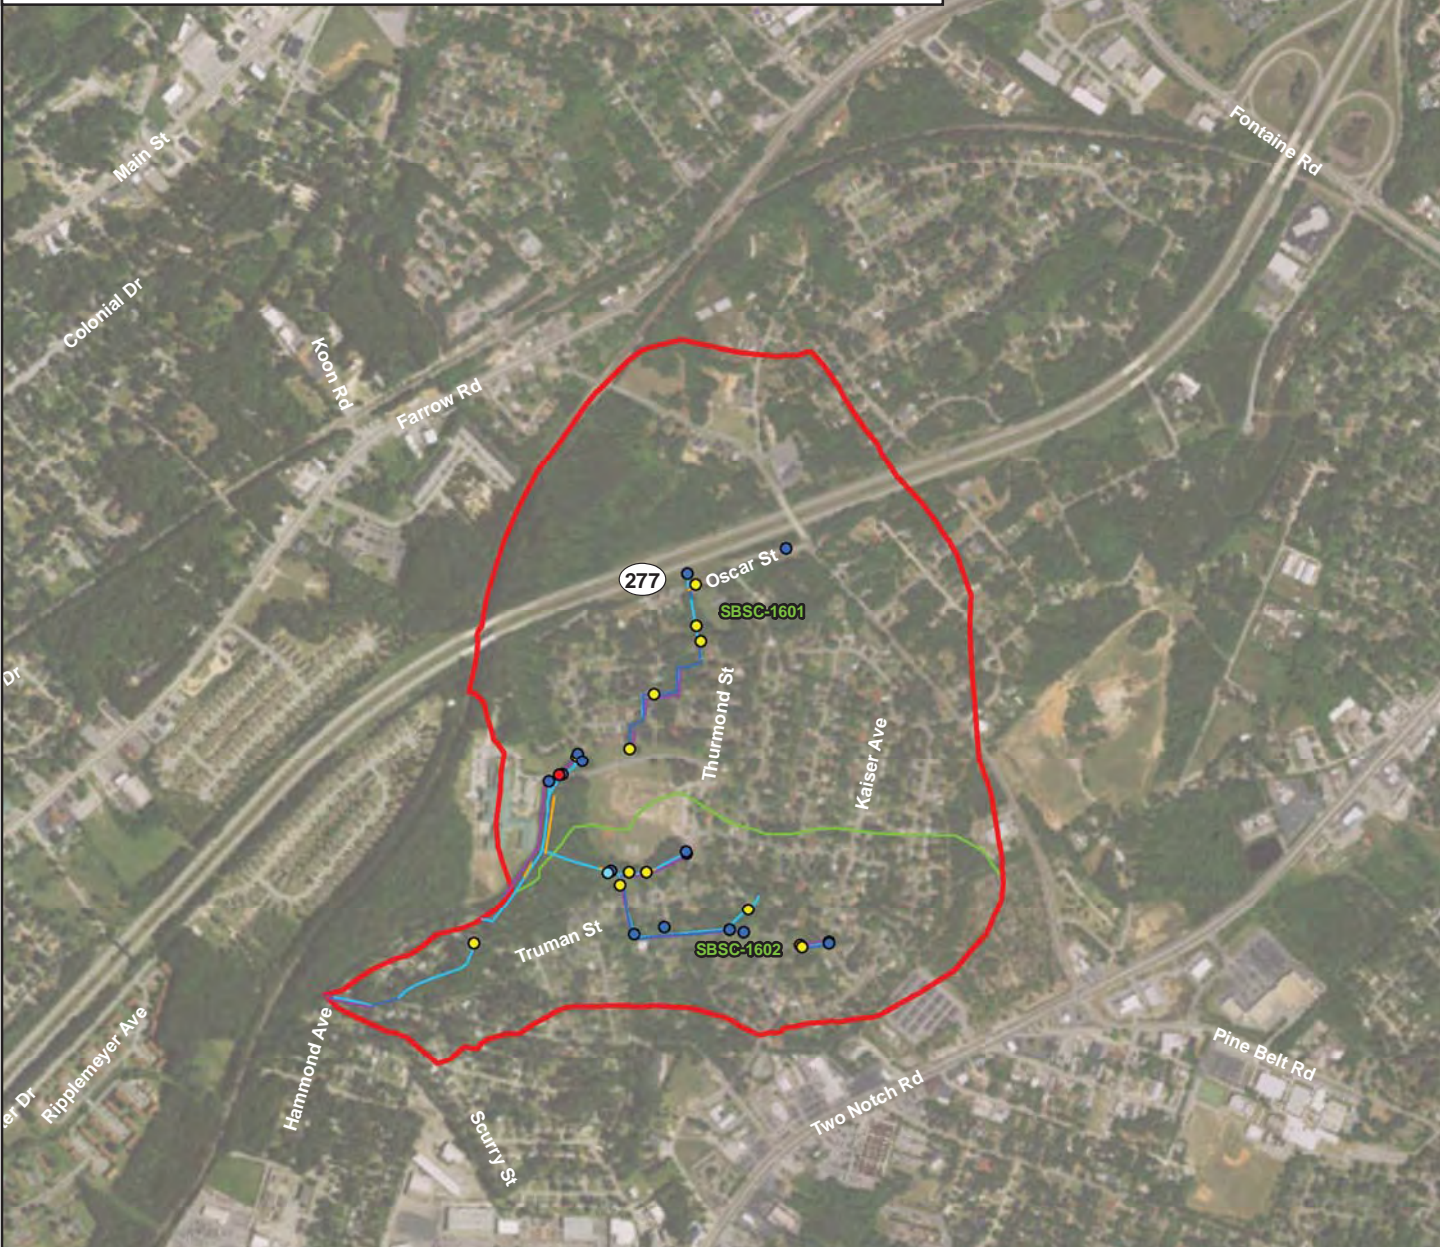
Figure 6.49:  
Subwatershed A  
Existing Conditions

Existing Condition	Count
Exposed Pipes	1
Pipe Outfalls	15
Unmanaged Runoff	1
Unusual Condition	13
Trash Dumping	0
Possible Fish Barrier	0
	<b>Linear Feet</b>
Erosion Site	1,001
Channel Alteration	2,475
Inadequate Forest Buffer	6,125

During the field review, a total of 15 storm drain outfalls were identified within SW-A. All observed outfalls were rated minor to moderate in severity.

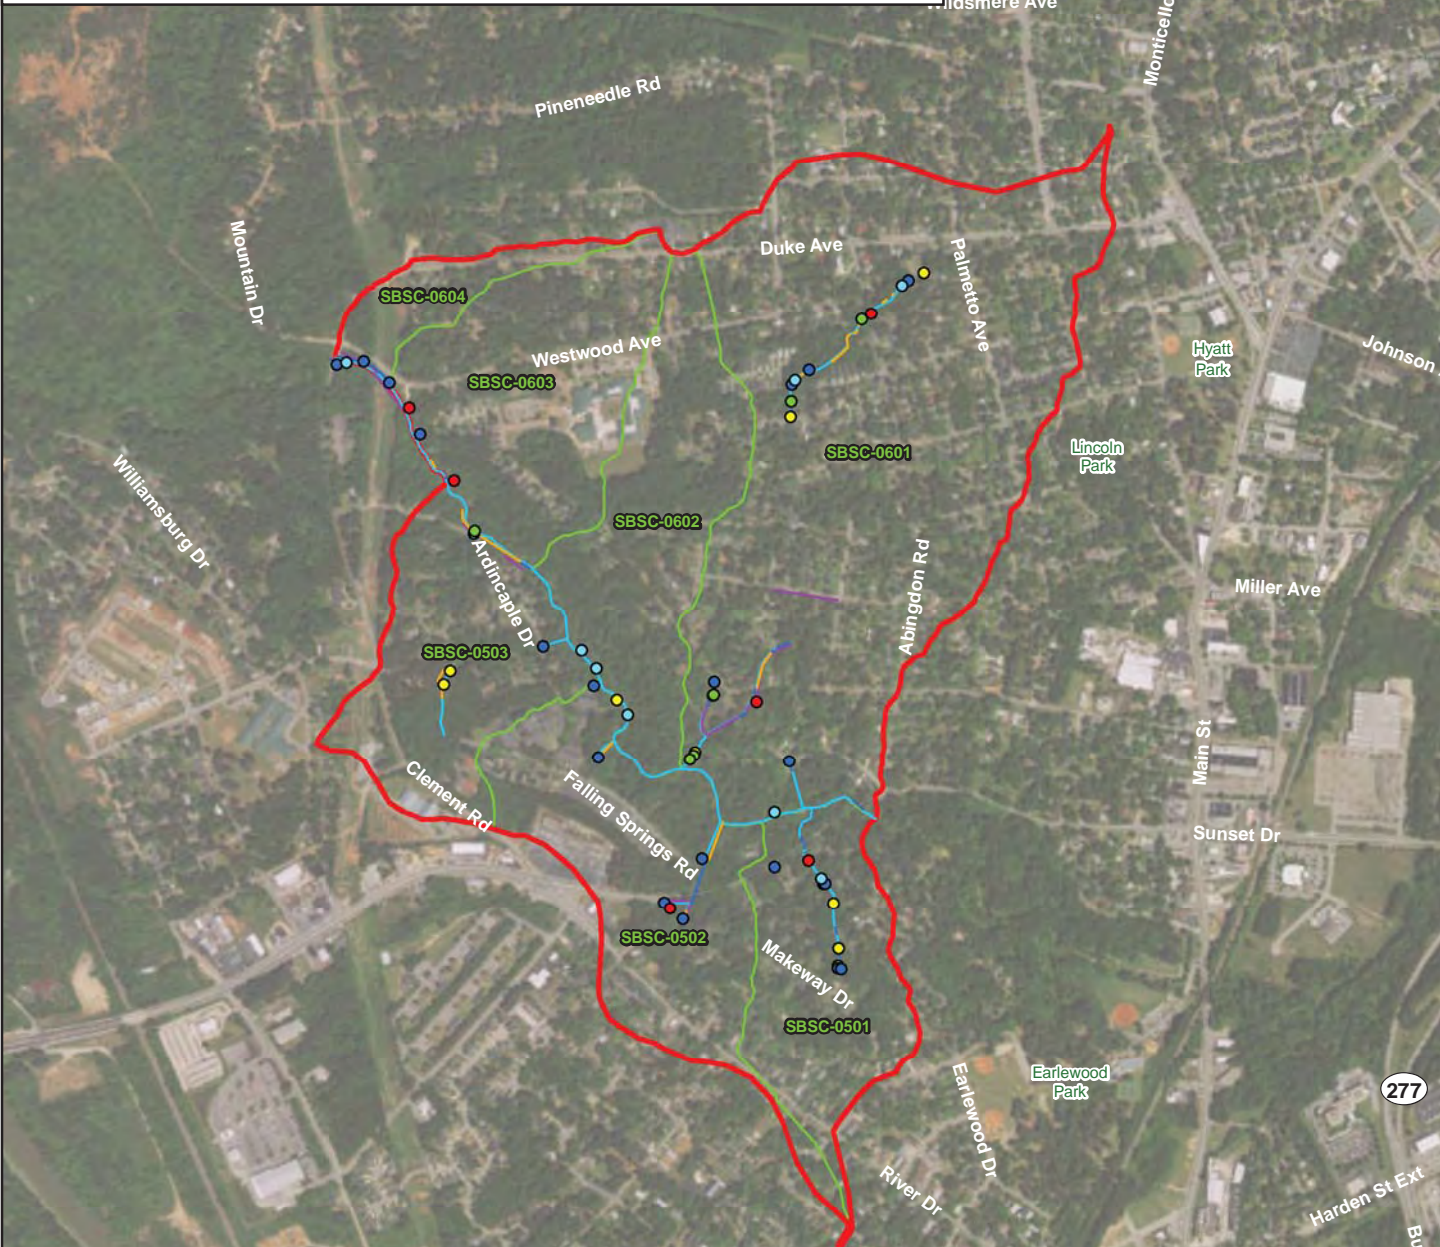
Figure 6.54:  
Subwatershed K  
Existing Conditions

Existing Condition	Count
Exposed Pipes	10
Pipe Outfalls	19
Unmanaged Runoff	6
Unusual Condition	10
Trash Dumping	0
Possible Fish Barrier	6
Linear Feet	
Erosion Site	2,912
Channel Alteration	1,674
Inadequate Forest Buffer	4,413

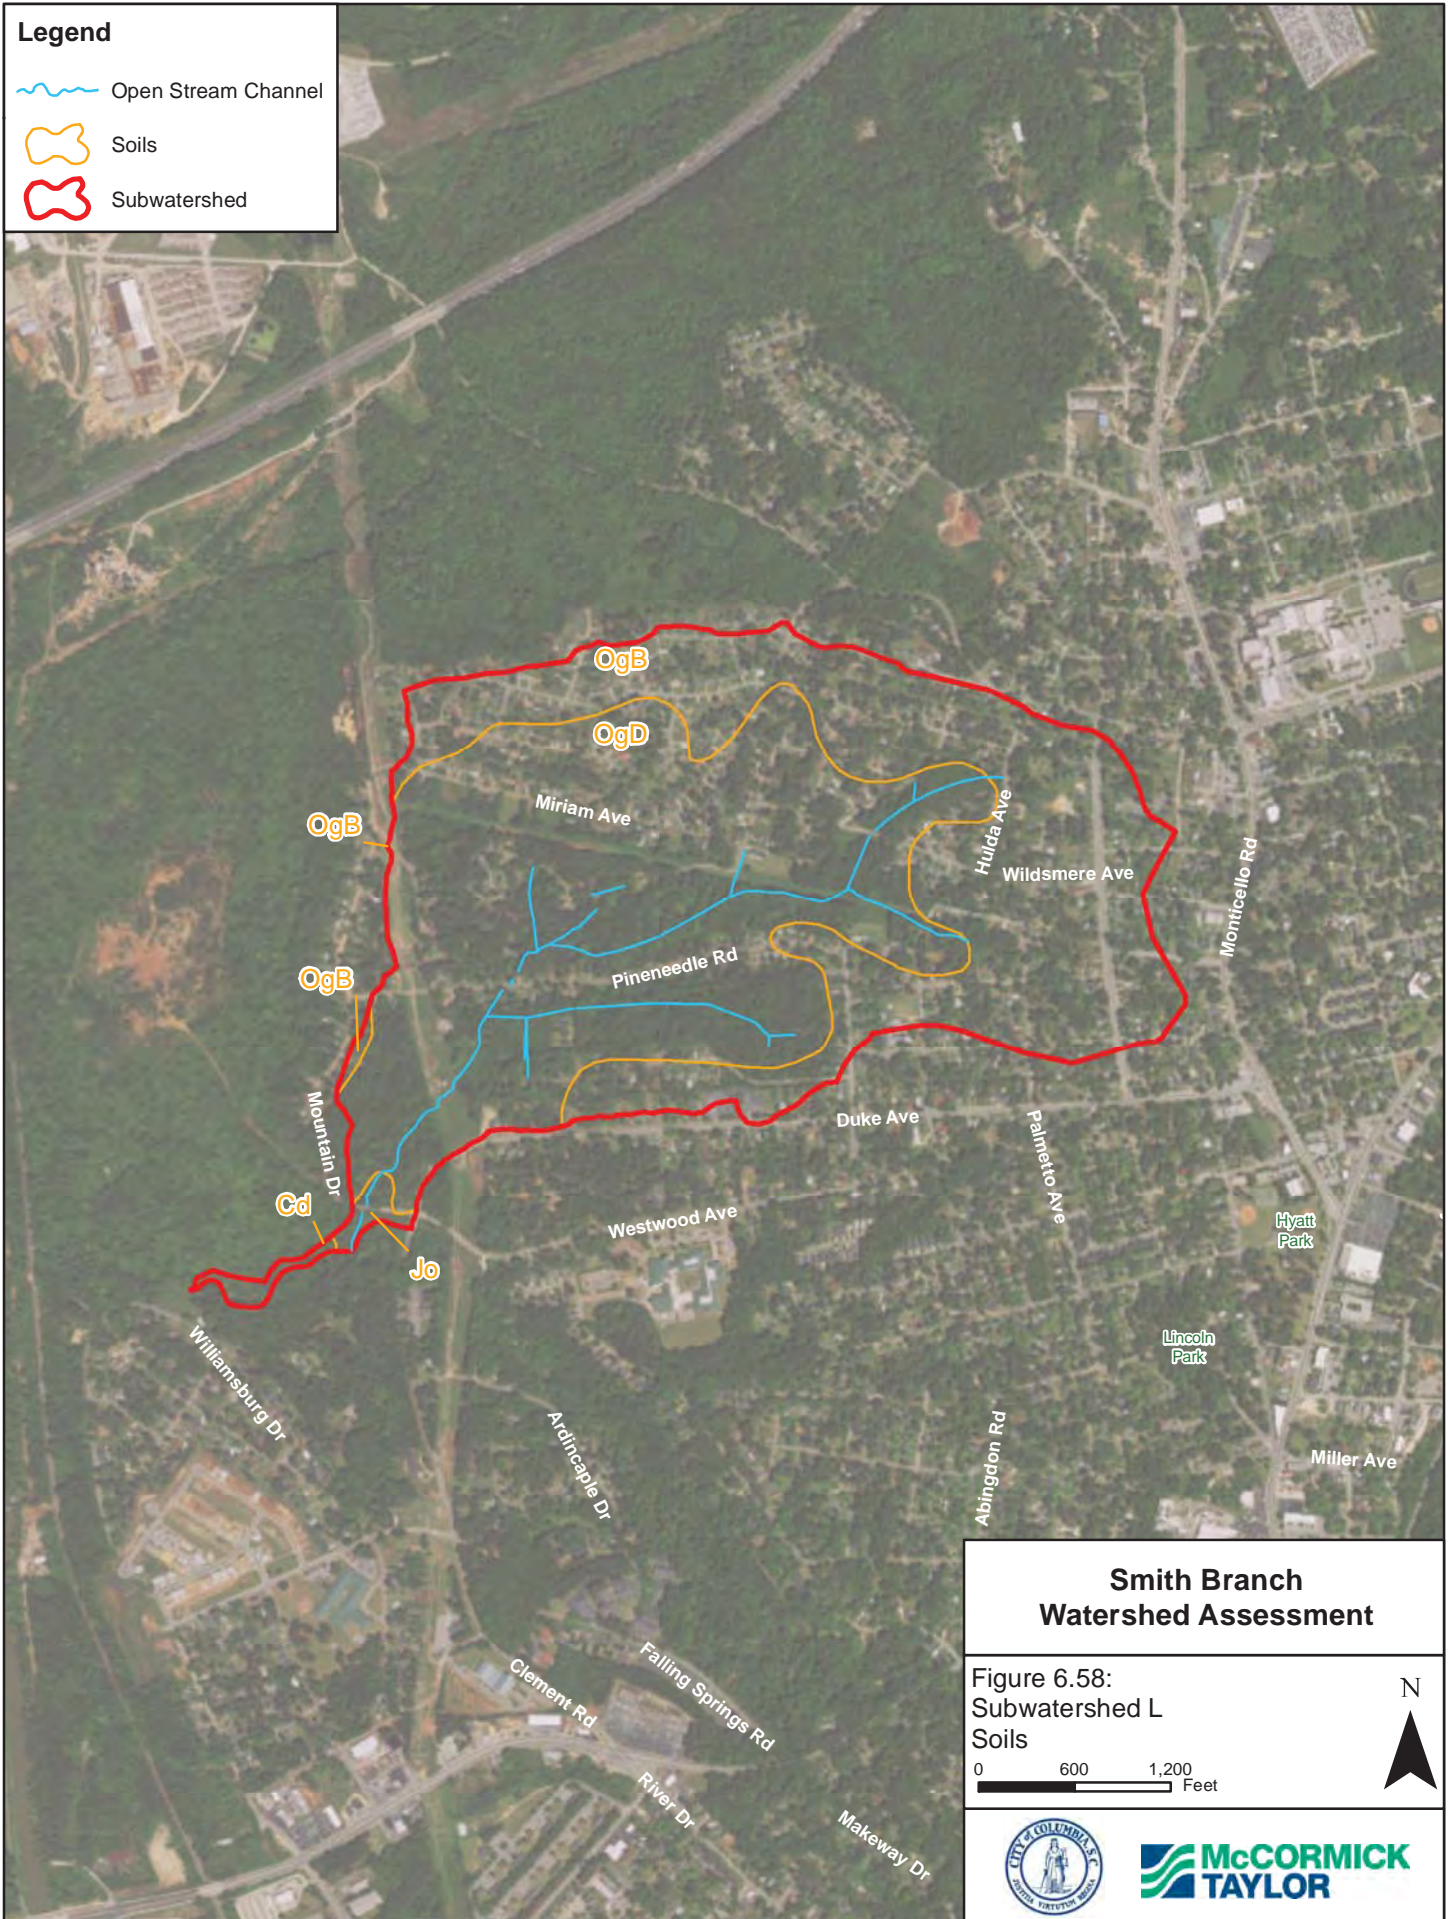
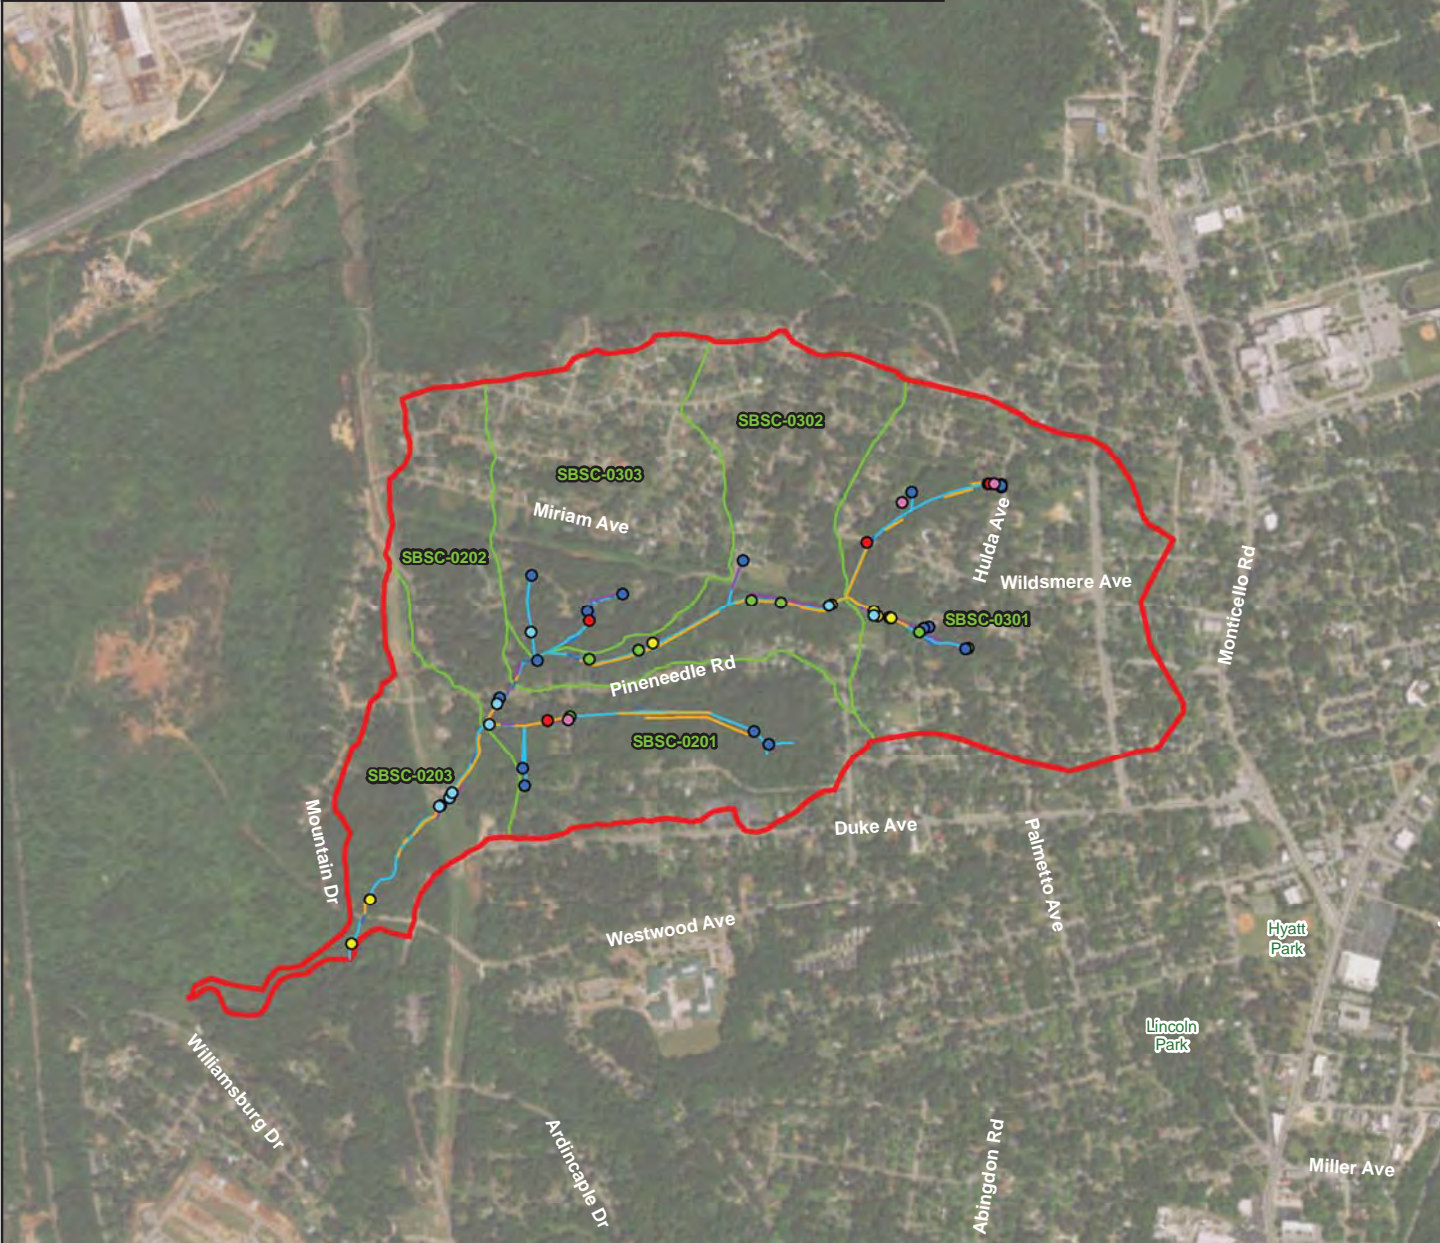
Figure 6.59:  
Subwatershed L  
Existing Conditions

Existing Condition	Count
Exposed Pipes	8
Pipe Outfalls	17
Unmanaged Runoff	5
Unusual Condition	10
Trash Dumping	3
Possible Fish Barrier	6
	<b>Linear Feet</b>
Erosion Site	9,534
Channel Alteration	843
Inadequate Forest Buffer	3,515

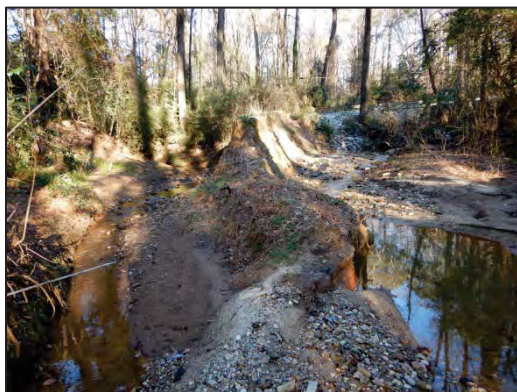
Downstream of the confluence of the two tributaries previously described, the channel incision continues, with 6 to 8 foot banks. Downtcutting into bedrock has created a series of steep cascades with large scour pools downstream. Substrate in this segment is mainly bedrock with sand in the pools and gravel and cobble along the riffles. The stream then extends through a 42 inch road culvert under Woodridge Drive.

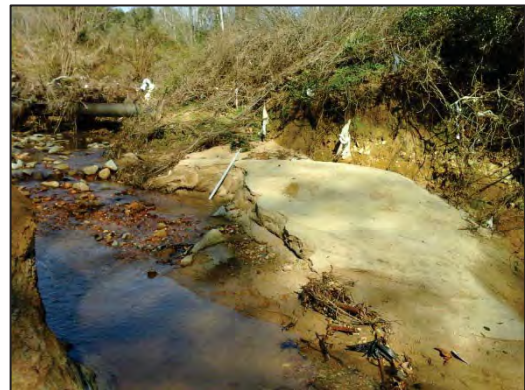
Incision down to bedrock exposure resumes in the main channel downstream of the confluence mentioned above. The stream crosses a large cleared utility right of way, where downcutting has exposed multiple utility lines within the bed. Banks become lower, well vegetated and stable approximately 350 feet downstream of the right of way. Substrate dominance shifts from bedrock to sand. The stream then extends under Mountain Drive through a 48 inch road culvert. Although the upstream face of the culvert has been recently stabilized with riprap, there is slumping around and above the pipe and the pipe itself shows signs of degradation. At the southern end of the subwatershed, the tributary converges with the Smith Branch mainstem. It appears likely that incision of these streams is endemic, however, the October 2015 flood event exacerbated more channel erosion and is evident by a large splay deposition of sands and gravels prior to the confluence with Smith Branch at Mountain Road.

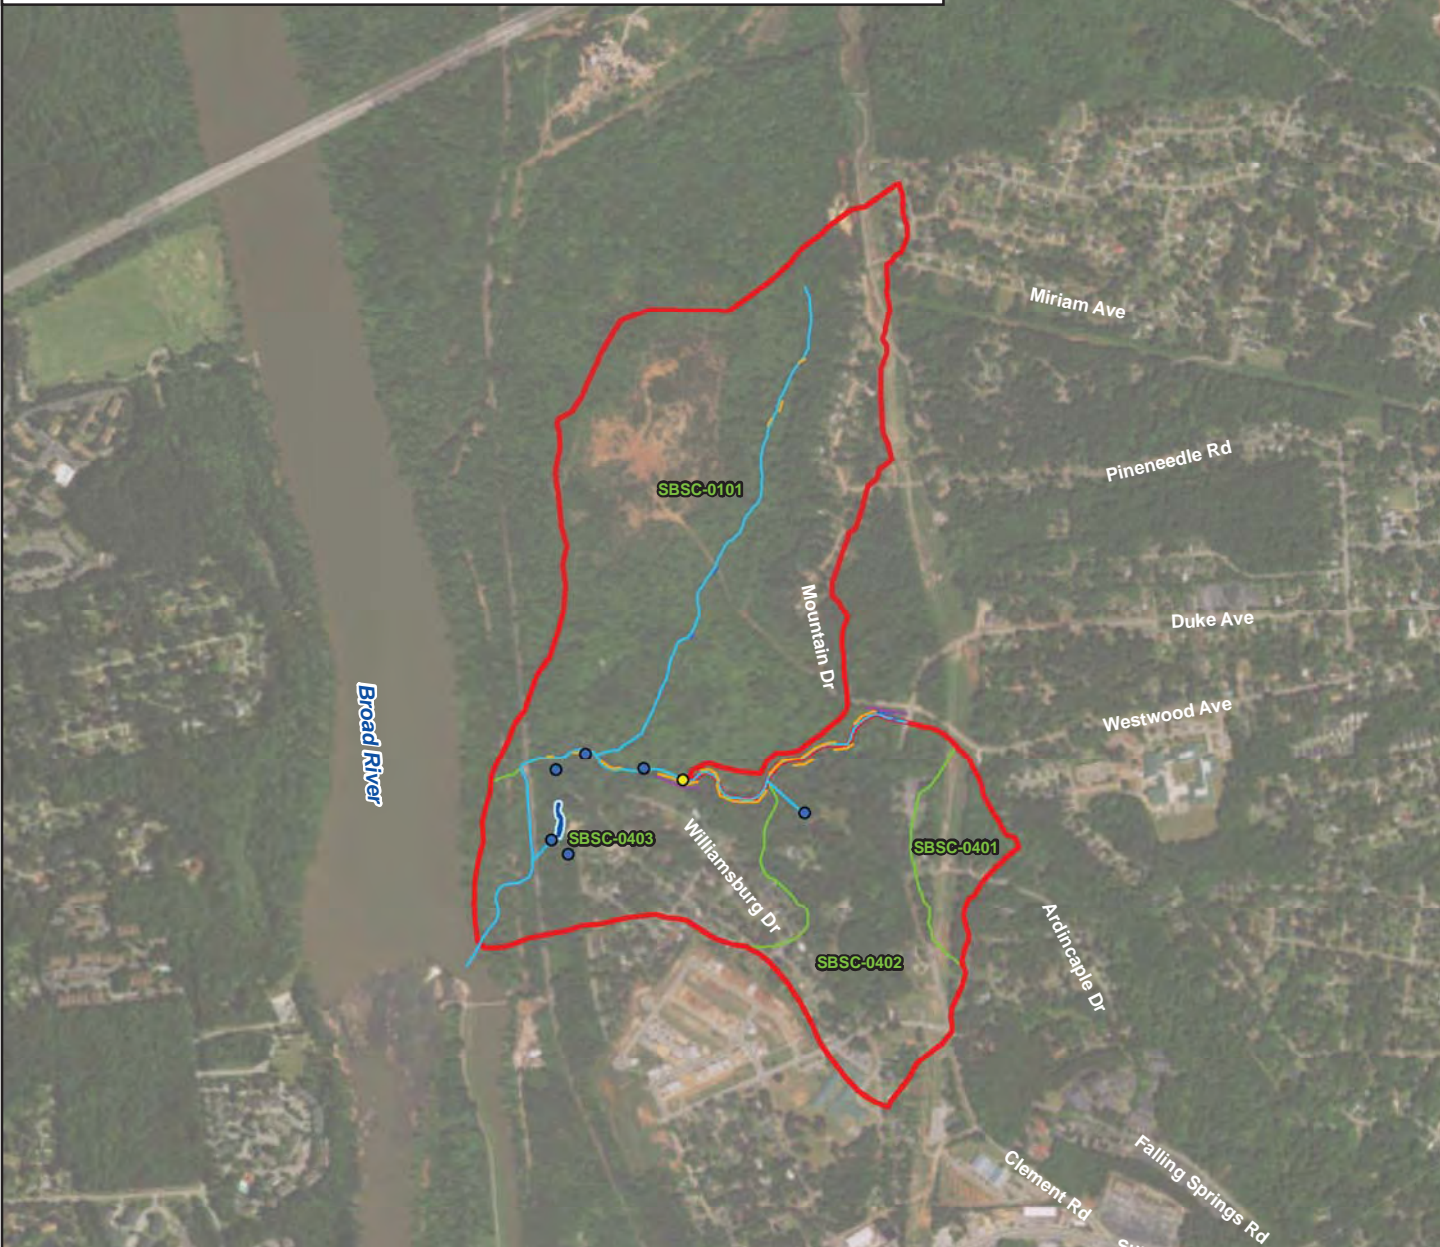
Figure 6.64:  
Subwatershed M  
Existing Conditions

Existing Condition	Count
Exposed Pipes	0
Pipe Outfalls	6
Unmanaged Runoff	0
Unusual Condition	1
Trash Dumping	0
Possible Fish Barrier	0
	<b>Linear Feet</b>
Erosion Site	2,255
Channel Alteration	226
Inadequate Forest Buffer	532

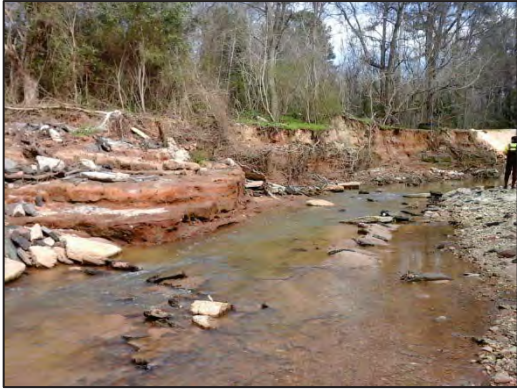
Within SW-M, the Smith Branch mainstem begins at the subwatershed's eastern most boundary from a bridge crossing at Clement Road. Riprap and gabion baskets have been placed on the right bank to mitigate severe bank erosion that has endangered Mountain Drive. Downstream of the riprap, the right bank is severely eroded, slumping into the bed and migrating towards Mountain Drive. A large coarse point bar has formed on the left bank. Downstream, a large debris jam at the confluence with the major tributary from SW-L has obstructed flow, resulting in flanking and scour around the obstruction on the left bank. Substrate consists of mostly sand, with significant quantities of cobble and gravel along the riffles and point bars. Erosional activity continues downstream, impacting the outside of bends. Large depositional bars have formed on the inside of bends. A small tributary originating from a pond outfall contributes flow from the left bank. As the channel approaches Williamsburg Drive, another significant debris jam obstructs flow, storing large amounts of fine sediment upstream of the obstruction. Downstream of the debris jam, the 40-foot tall left bank becomes raw, with no vegetation on the bank face or at the top of the bank. As the channel moves away from Williamsburg Drive, banks stabilize. Cobble and gravel quantities diminish within the bed. A significant tributary that runs roughly parallel to Mountain Drive joins the Smith Branch mainstem north of Williamsburg Drive. The channel then passes under a railroad, turning sharply south where it is confined between the railroad trestle on the left and an access road on the right. Backwater from the Broad River and associated dam influences the channel from this point to the confluence with the Broad River.

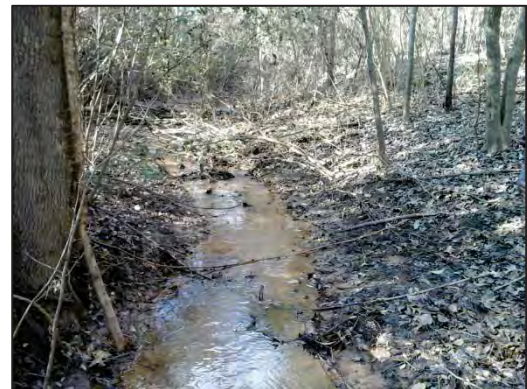
A large tributary within SW-M flows southwest to the mainstem through a forested parcel along Mountain Drive, beginning approximately 350 feet west of Miriam Avenue. The upstream extent of the tributary is a braided headwater system. A seep evolves into an established perennial stream as it flows downstream. Substrate consists of mostly clay within the bed. Approximately 2,000 feet downstream from the headwaters, a gravel access road has dammed the stream, causing the single-thread channel to be inundated by ponded water upstream of the crossing and filled by deposited sediments downstream. A second access road cuts through the stream channel approximately 450 feet downstream, interrupting flow. Downstream of the access roads, the stream continues as braided and lacks clear bank definition. The channel becomes more established near the confluence with the Smith Branch mainstem.

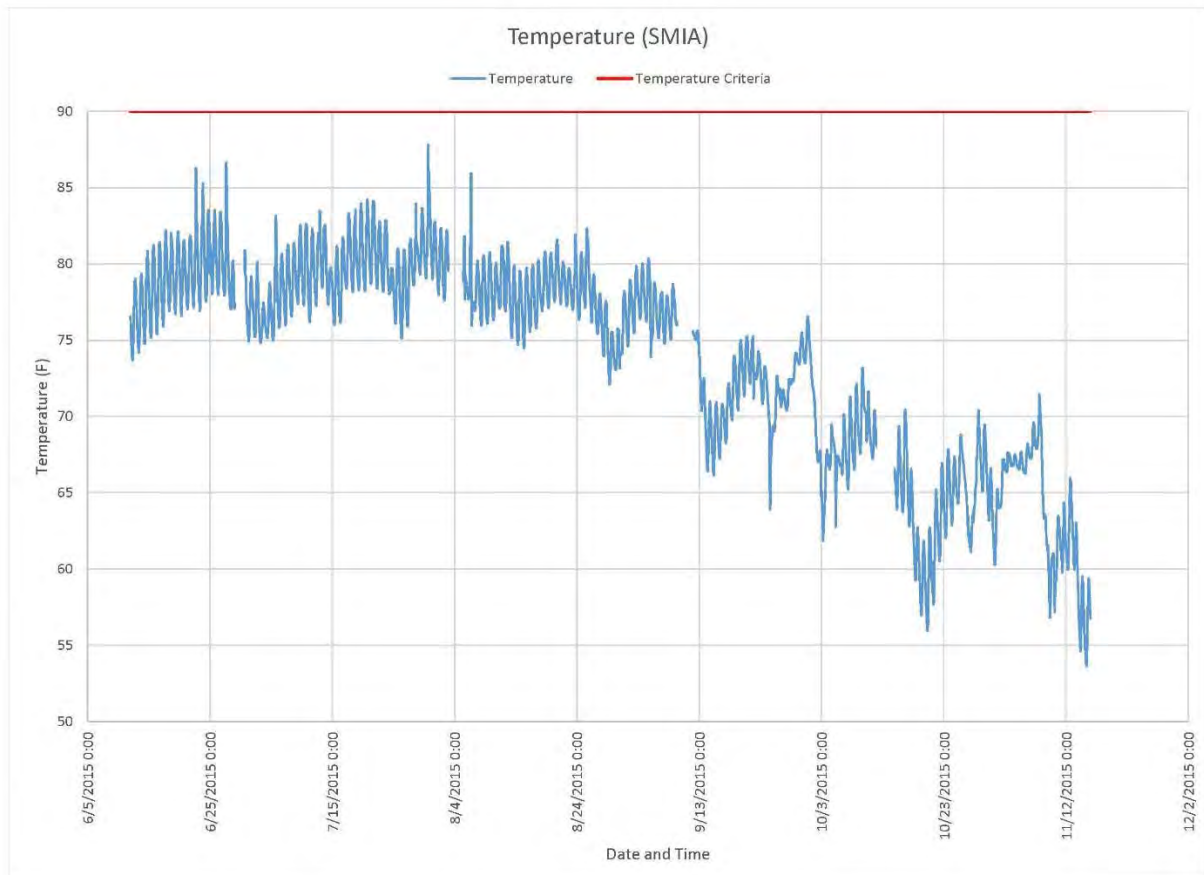
### *Water Temperature*

The water quality criteria for temperature of 90.0° F was not exceeded at SMIA. As expected, there is a seasonal and diurnal pattern to water temperature in Smith Branch. The highest measured water temperatures occurred during the summer time. Summer is the time of the year with the highest air temperatures, and the greatest amount of solar radiation. These factors help warm water throughout the day. The highest temperatures measured each day were in the afternoon. Afternoon is usually the period of time with the highest air temperature, and sunlight has been warming the water and stream substrates throughout the day.

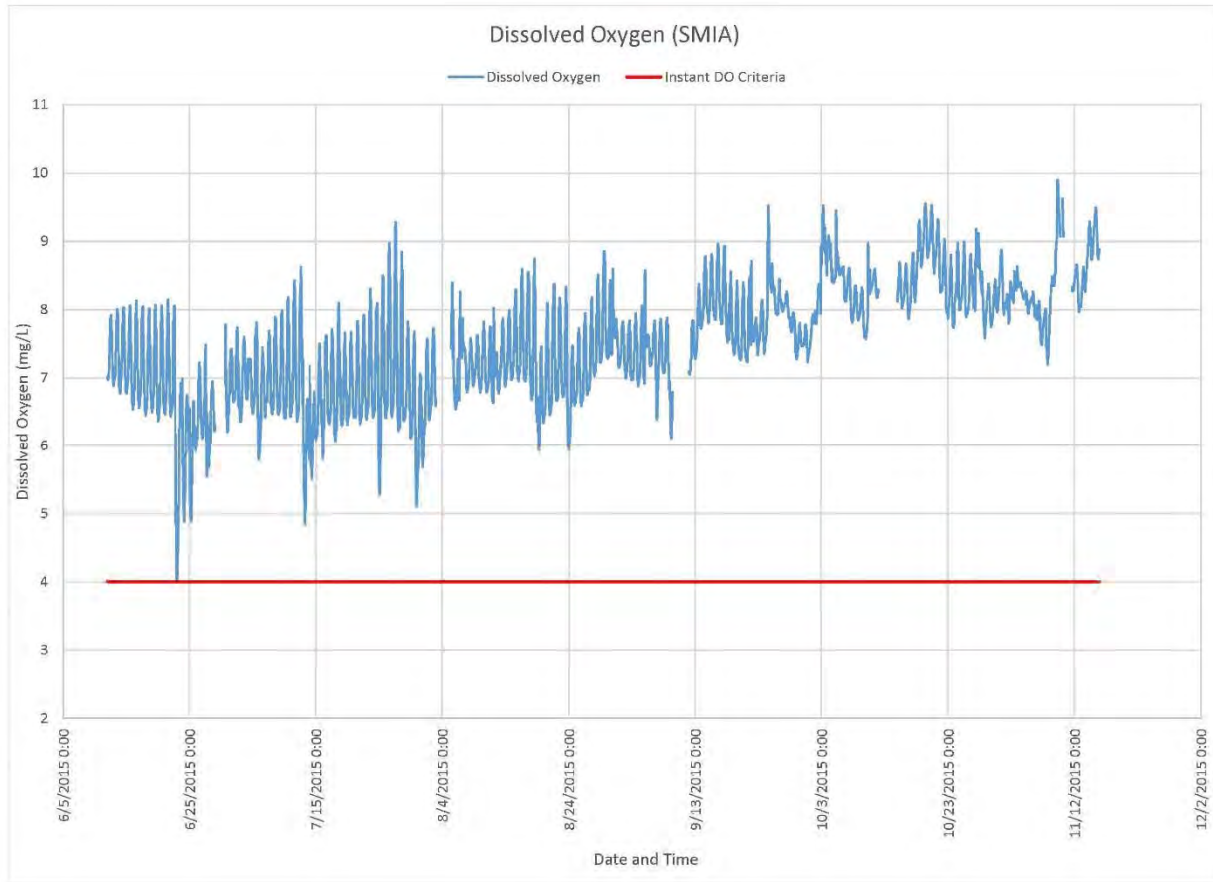
### *Dissolved Oxygen*

Water quality sonde data from site SMIA show that the instantaneous water quality standard for dissolved oxygen of 4.0 mg/L was not violated over the period of record (0 out of 13,986). Over the same period of time, the water quality standard for daily average dissolved oxygen of 5.0 mg/L was also not violated (0 out of 149 days). June 23<sup>rd</sup>, 2015 had the lowest observed daily average dissolved oxygen concentration of 5.82 mg/L.

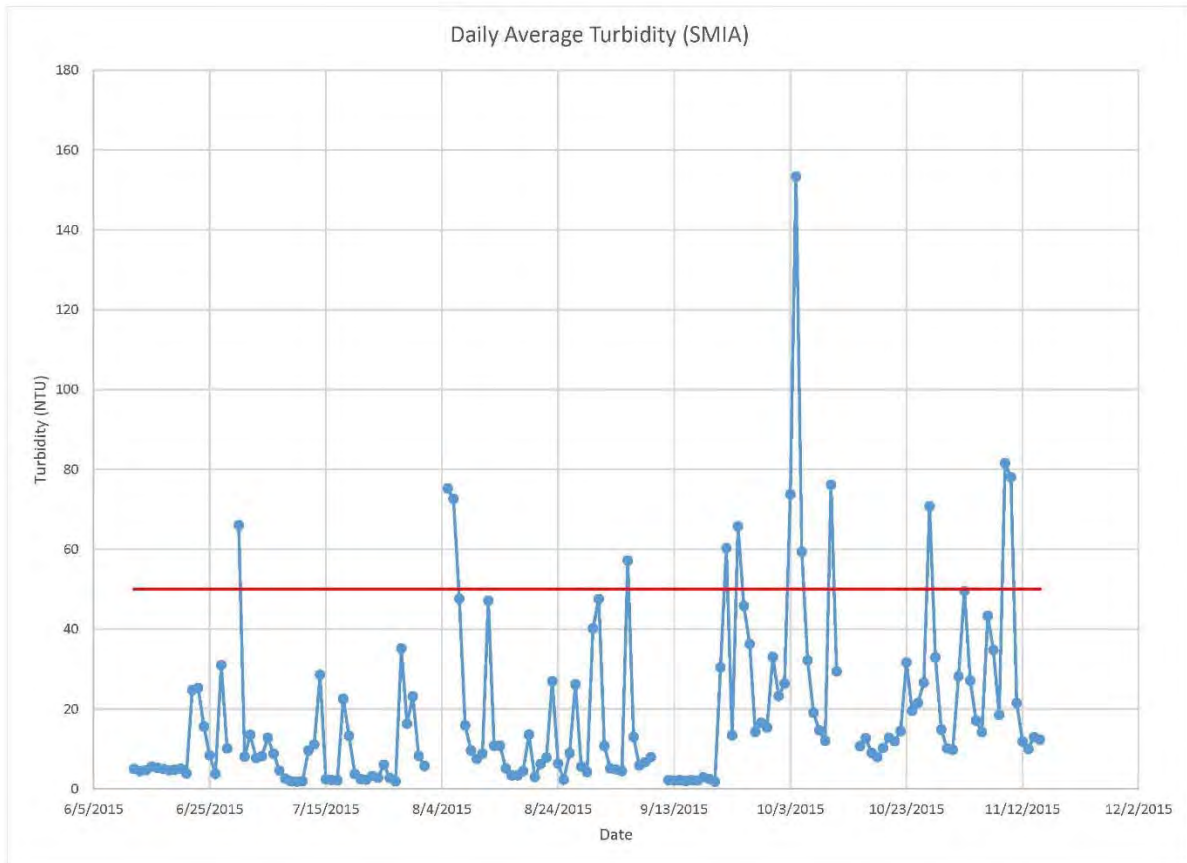
### *Turbidity*

Results of turbidity data from the water quality sonde at SMIA show that the turbidity water quality standard of 50.0 NTU was exceeded 8.18% of the time (1122 records out of a total 13,713 records). High turbidity values were mostly seen during periods of intense rainfall when stormwater flow increases.

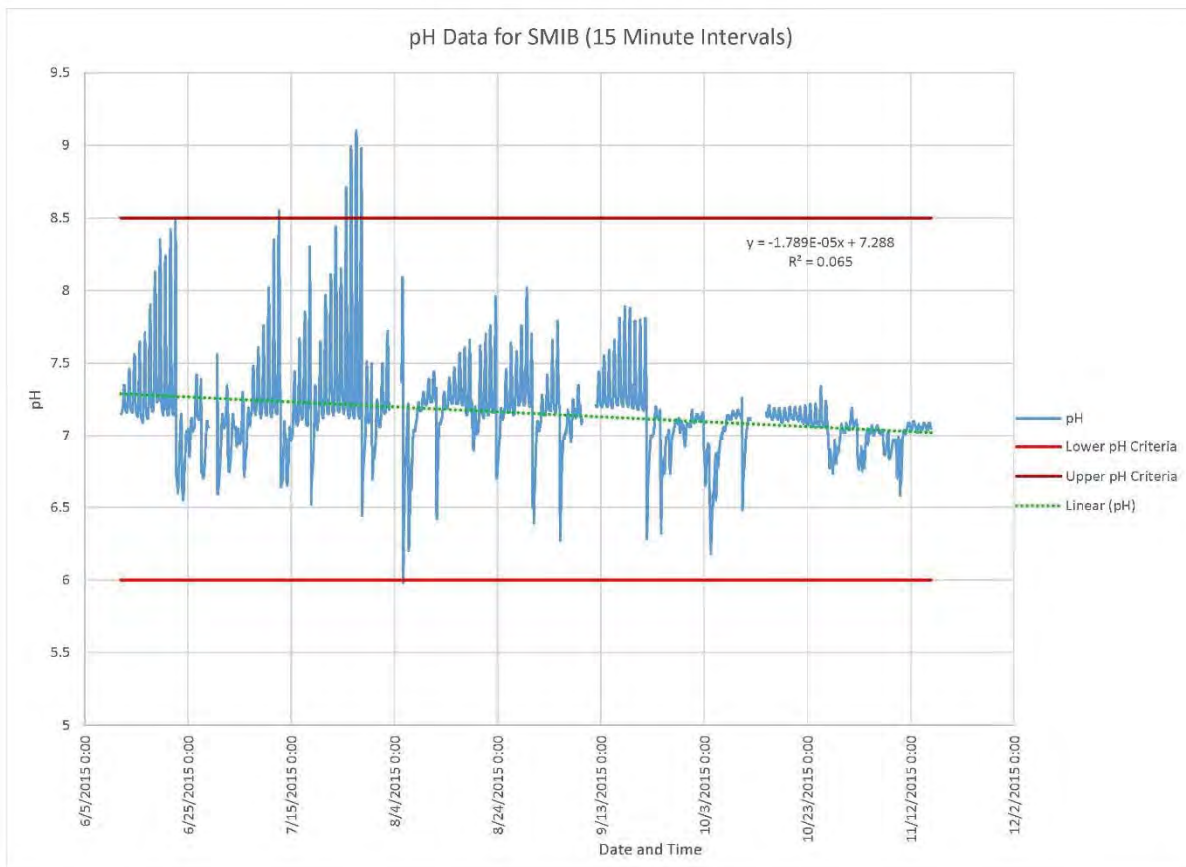
A linear regression analysis was performed for 15-minute interval pH data. The results of the linear regression analysis show a slight negative slope (-1.78904E-05), which was significant at the  $p < 0.01$  level ( $p < 0.001$ ). This indicates that the likelihood of this decreasing pH relationship occurring by chance is very small. The negative slope of the line indicates that pH values are decreasing very slightly throughout this dataset. This rate of change is so small that changes in observed pH values would happen over several tens of thousands of measurements. If this relationship holds true with data collected over additional time periods, it would take over a 1.5 years for a realized 1.0 decrease in pH value.

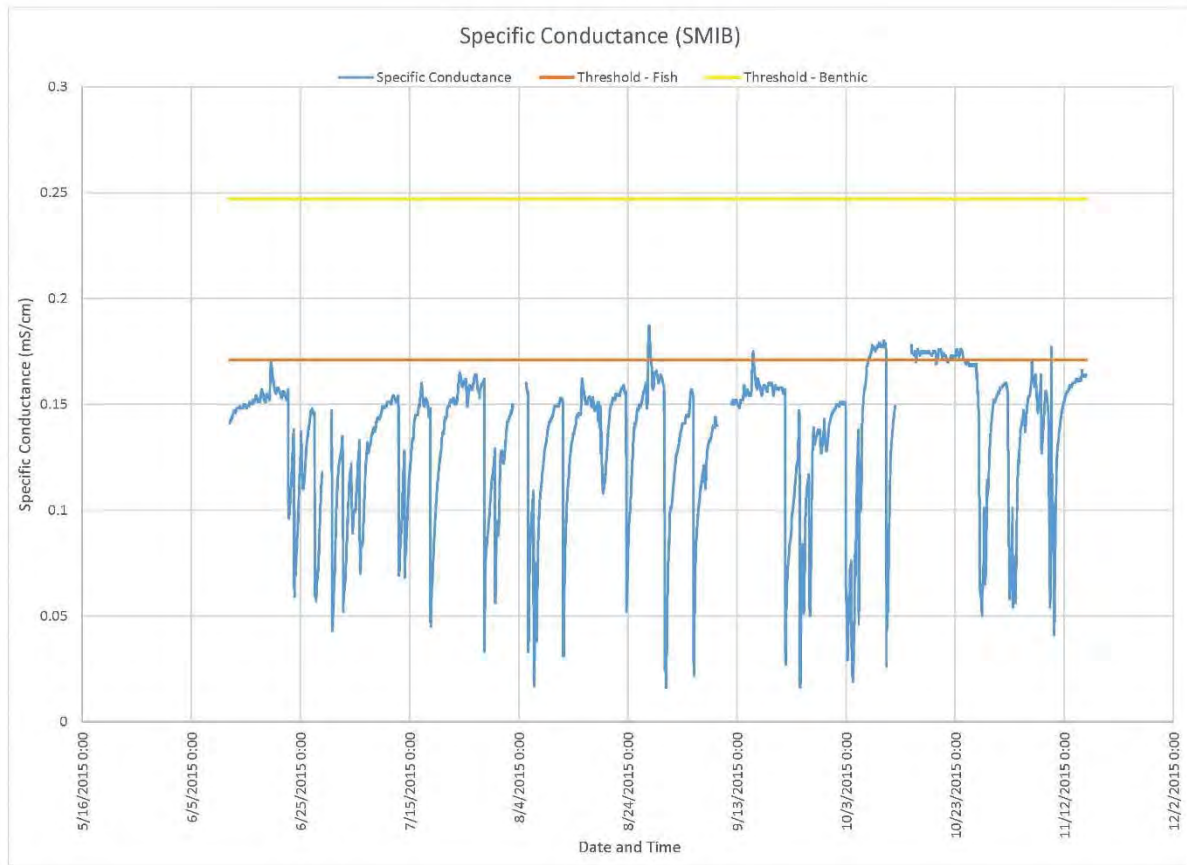
### *Specific Conductance*

South Carolina does not have water quality criteria for specific conductance, which is a measure of dissolved inorganic ions such as chloride, nitrate, sulfate and phosphate anions and sodium, magnesium, calcium, iron, and aluminum cations. Morgan et al., 2007, found biological assemblage impairment thresholds for biological impairment of 0.247 mS/cm for benthic macroinvertebrates and 0.171 mS/cm for fish in urban streams in Maryland. Smith Branch is an urban stream so the impairment thresholds from Maryland data may be applicable. When compared against these values, the possible specific conductance impairment thresholds were exceeded in SMIB for fish assemblage 9.22% of the time (1,304 out of 14,145 total records). Specific conductance was not exceeded for benthic macroinvertebrates.

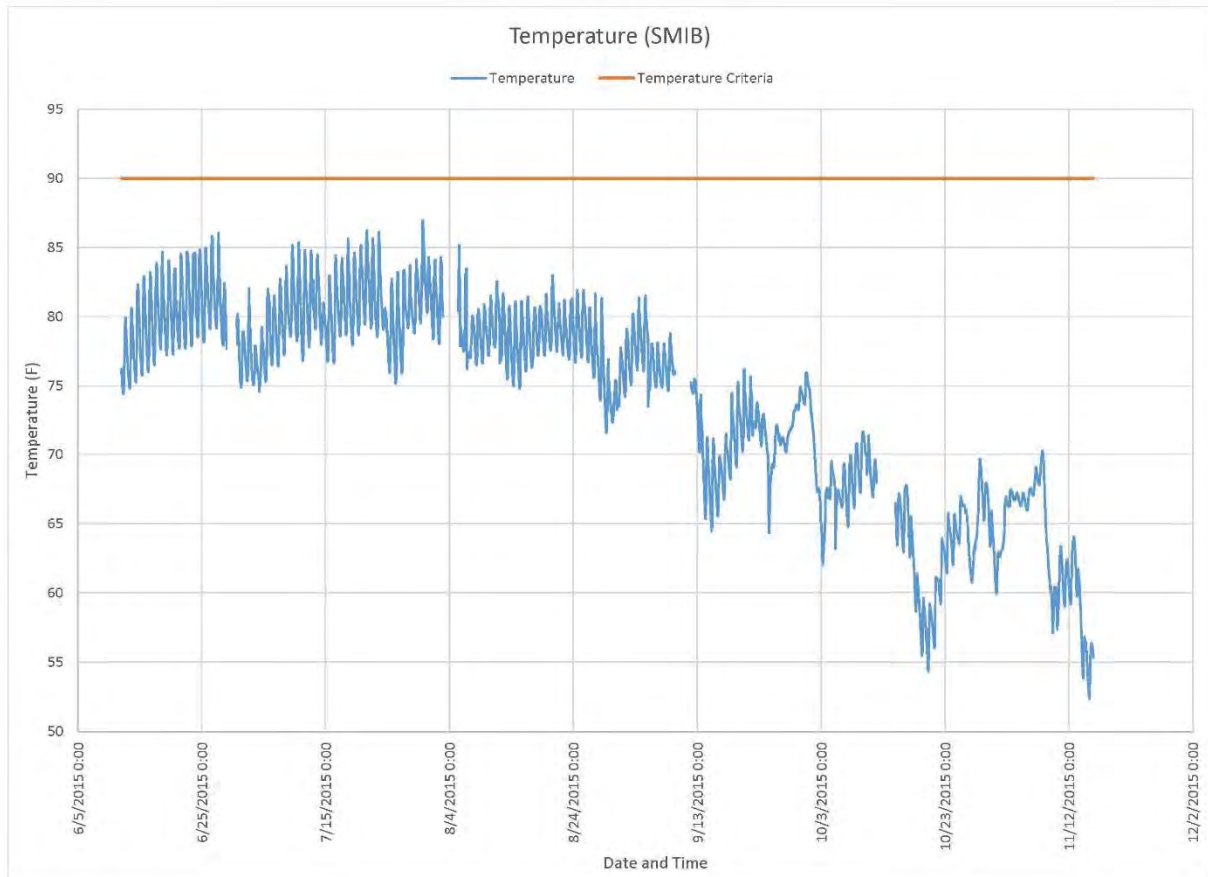
### *Water Temperature*

The water quality criteria for temperature of 90.0° F was not exceeded at SMIB. As expected, there is a seasonal and diurnal pattern to water temperature in Smith Branch. The highest measured water temperatures occurred during the summer time. Summer is the time of the year with the highest air temperatures, and the greatest amount of solar radiation. These factors help warm water throughout the day. The highest temperatures measured each day were in the afternoon. Afternoon is usually the period of time with the highest air temperature, and sunlight has been warming the water and stream substrates throughout the day.

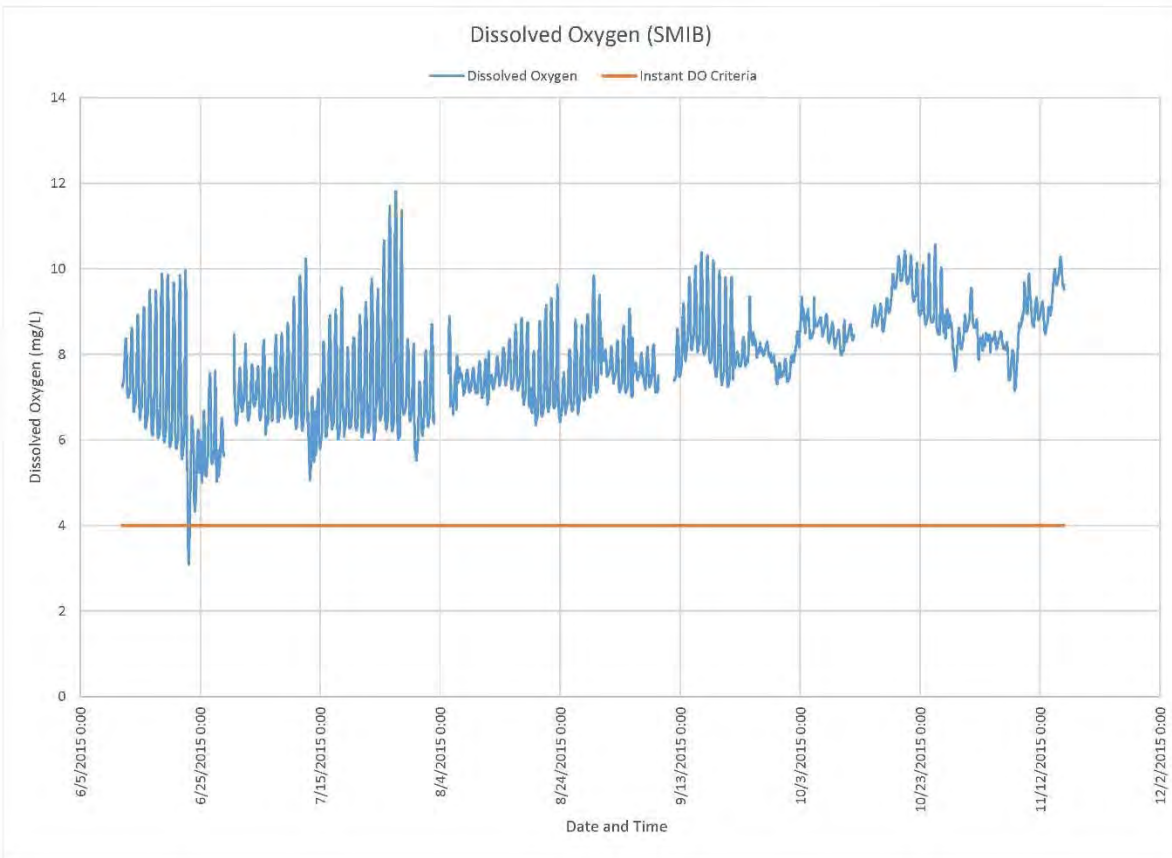
### *Dissolved Oxygen*

Water quality sonde data from site SMIB show that the instantaneous water quality standard for dissolved oxygen of 4.0 mg/L was violated 0.18% of the time (25 out of 14,144 records) over the period of record. Over the same period of time, the water quality standard for daily average dissolved oxygen of 5.0 mg/L was not violated (0 out of 149 days). June 23<sup>rd</sup>, 2015 had the lowest observed daily average dissolved oxygen concentration of 5.12 mg/L.
