# SMITH BRANCH WATERSHED ASSESSMENT

MAY 20, 2016

CITY OF COLUMBIA  
UTILITY AND ENGINEERING DEPARTMENT  
1136 WASHINGTON STREET, 7TH FLOOR  
COLUMBIA, SOUTH CAROLINA 29201

McCormick Taylor Inc., supported by KCI Technologies, Inc., has been contracted by the City of Columbia, South Carolina to conduct an assessment of the Smith Branch watershed to identify potential improvement opportunities to identify existing flooding and water quality conditions.

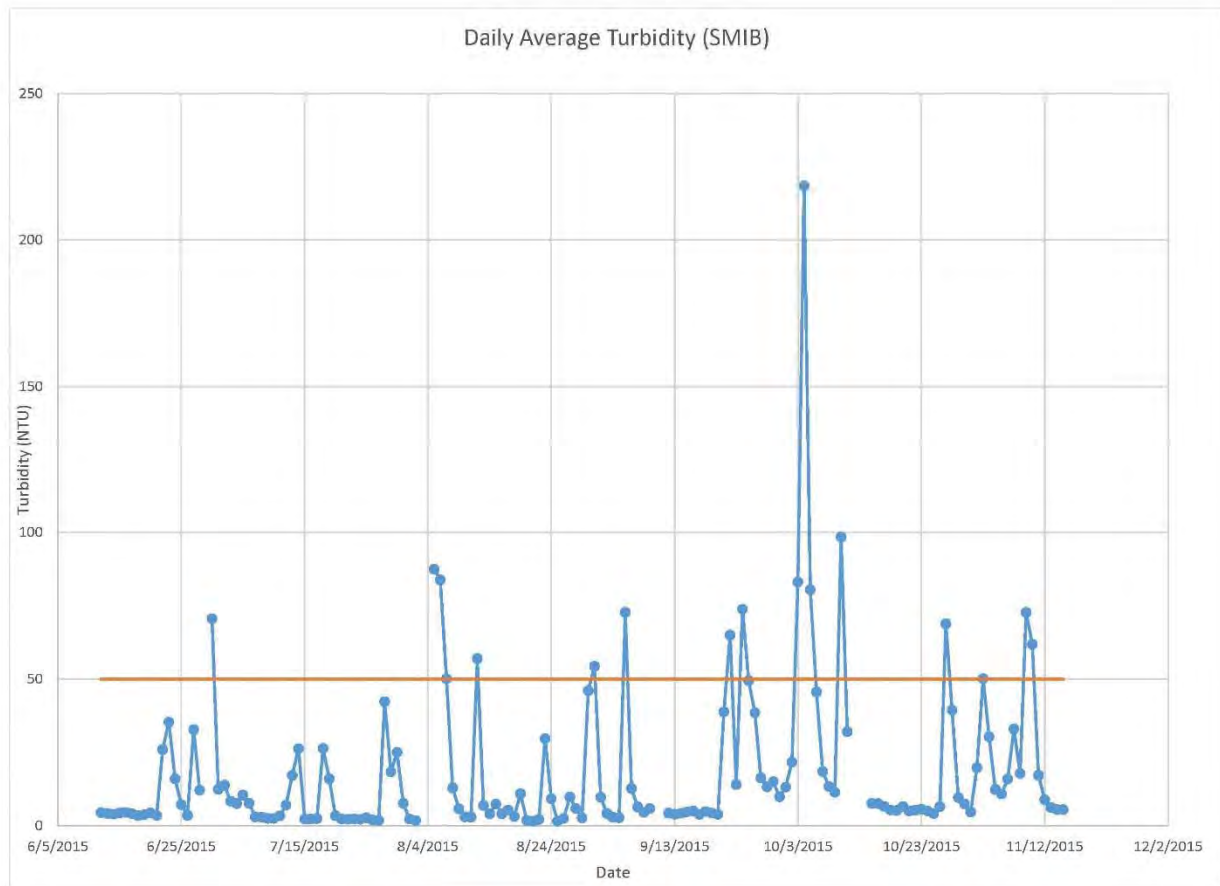
### *Turbidity*

Water quality sonde data from site SMIB show that water quality standard for turbidity of 50 NTU was violated 8.70 % of the time (1,231 out of 14,144 records) over the period of record. High turbidity values were mostly seen during periods of intense rainfall when stormwater flow increases.
