# ROCKY BRANCH WATERSHED ASSESSMENT

MAY 20, 2016

CITY OF COLUMBIA  
UTILITY AND ENGINEERING DEPARTMENT  
1136 WASHINGTON STREET, 7TH FLOOR  
COLUMBIA, SOUTH CAROLINA 29201

McCormick Taylor Inc., supported by KCI Technologies, Inc., has been contracted by the City of Columbia, South Carolina to conduct an assessment of the Rocky Branch watershed to identify potential improvement opportunities to identify existing flooding and water quality conditions.

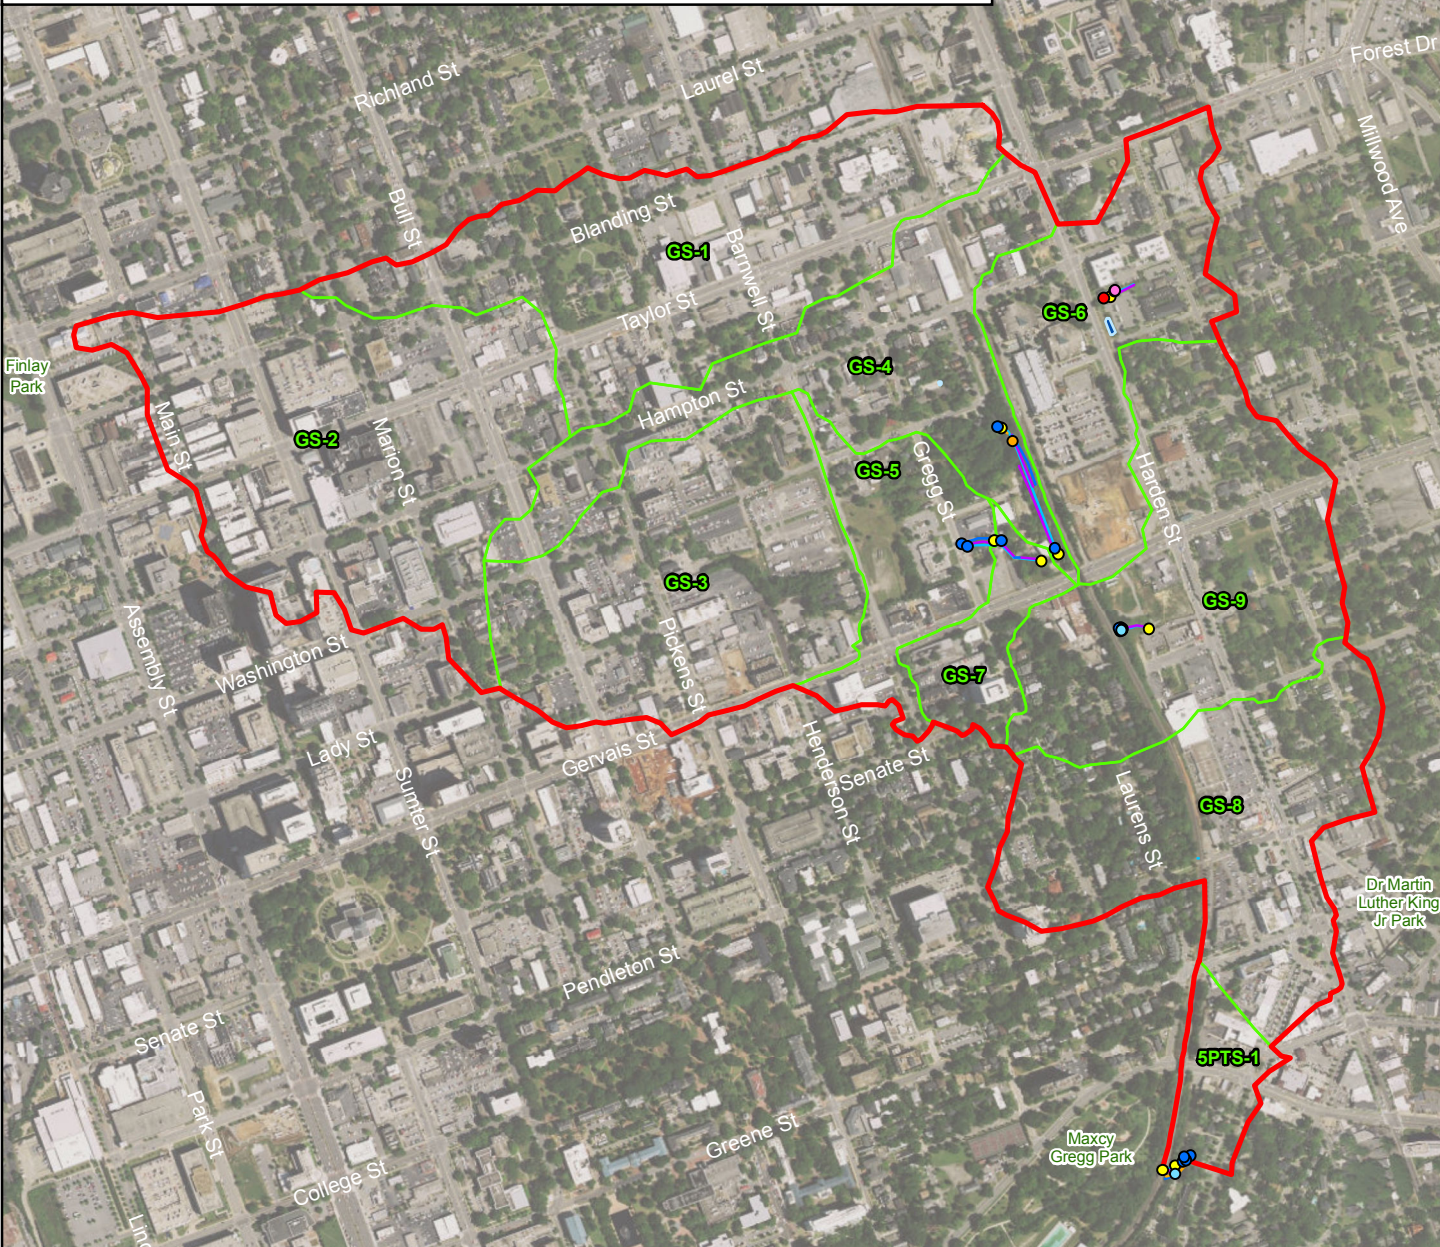
Existing Condition	Count
Exposed Pipes	5
Pipe Outfalls	13
Unmanaged Runoff	1
Unusual Condition	8
Trash Dumping	1
Possible Fish Barrier	0
Linear Feet	
Erosion Site	204
Channel Alteration	625
Inadequate Forest Buffer	2,580

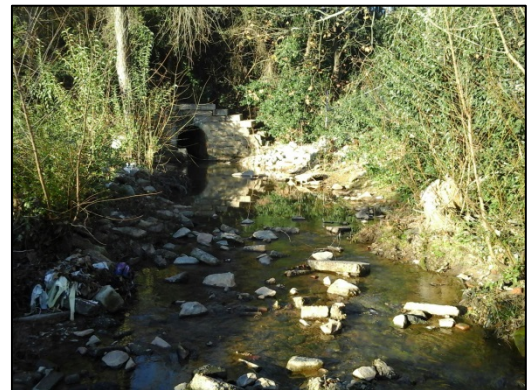
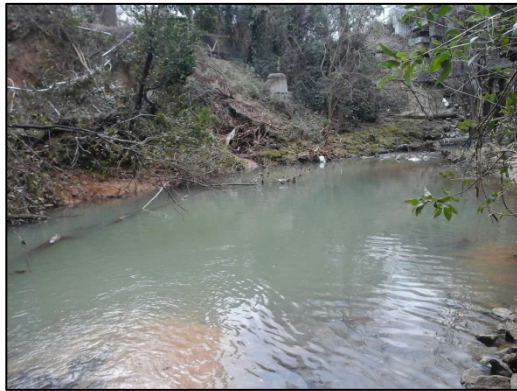
Another small segment of open stream channel is located south of the intersection of Gervais and Laurens Street. This stream segment receives all flow from previously described open channel. The stream originates from a stone block masonry arch emerging from underneath the railroad. Two 36-inch reinforced concrete pipes enter the channel from the left bank. A significant headcut has formed behind the pipes as a result of overland flow and concentrated runoff from Laurens Street and a parking lot adjacent to the stream. Two sanitary lines are exposed in the stream bed and one sanitary line runs along the right bank from a manhole stack into the railroad culvert. The 3 to 4-foot tall banks are vegetated with herbaceous cover and are stable. The channel substrate consists primarily of cobble, with some concrete and rubble from the banks slumped into the bed. The stream then flows into twin concrete pipes flanked by stone walls on either side.

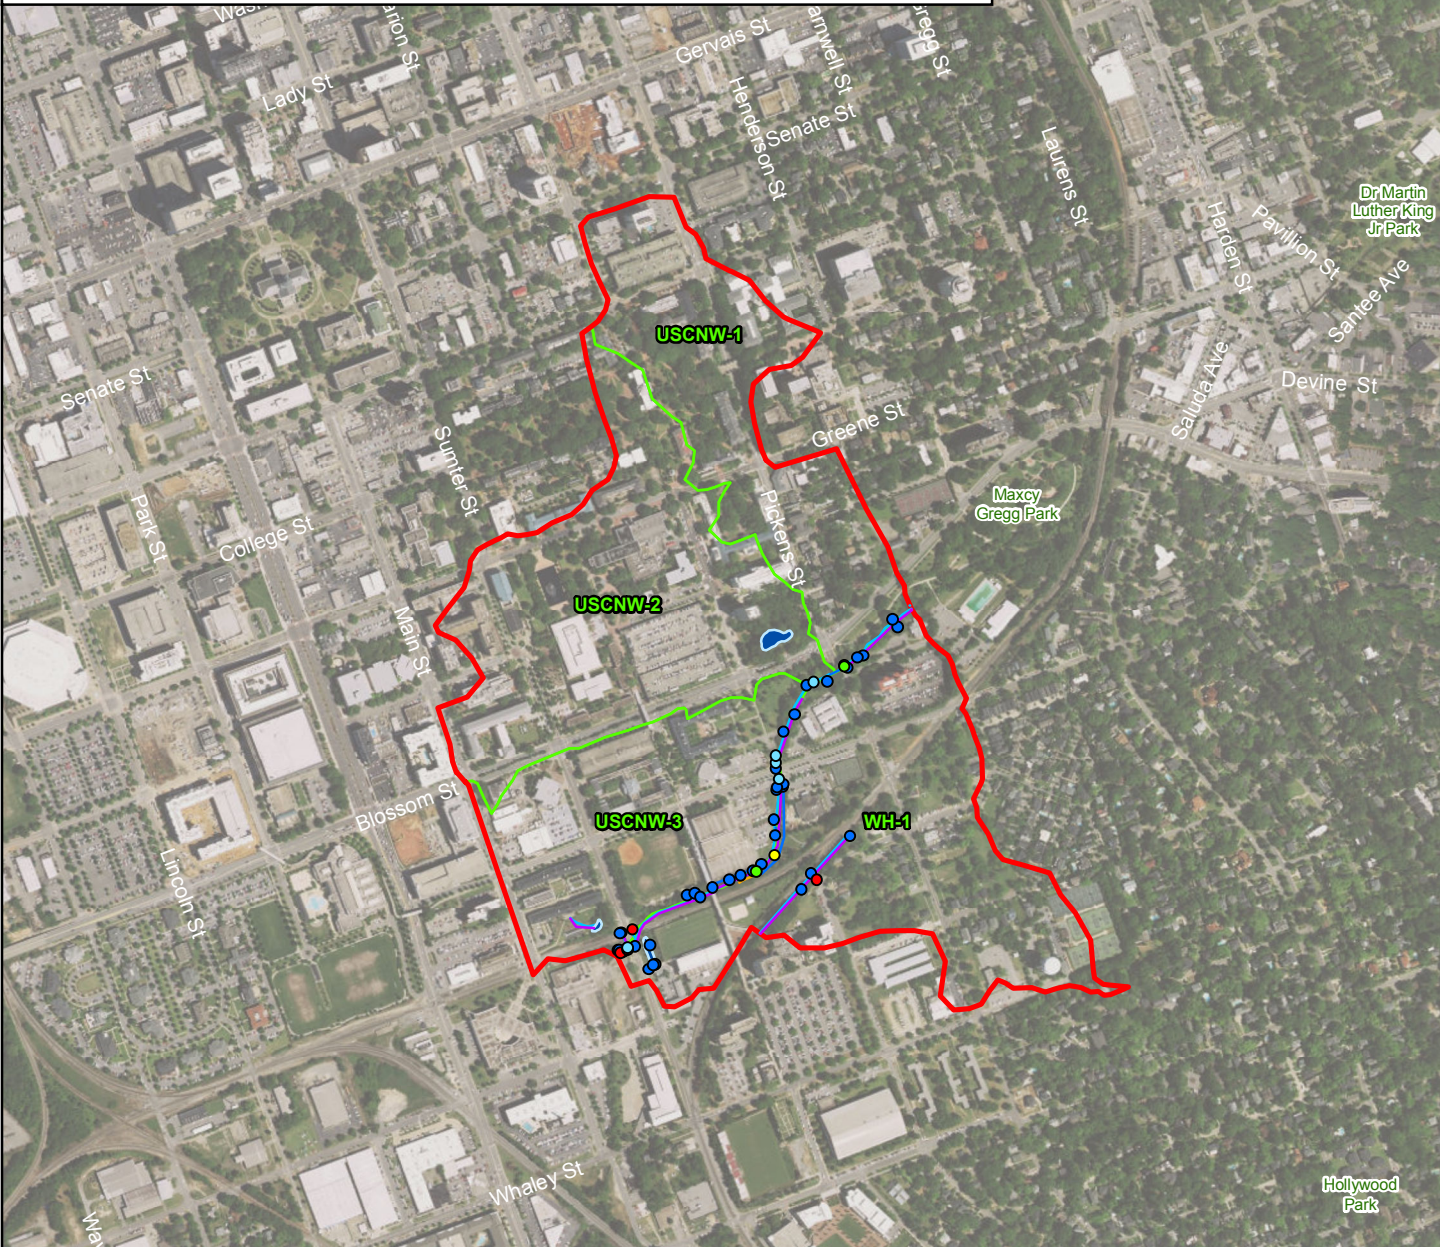
Existing Condition	Count
Exposed Pipes	5
Pipe Outfalls	38
Unmanaged Runoff	4
Unusual Condition	2
Trash Dumping	0
Possible Fish Barrier	2
	<b>Linear Feet</b>
Erosion Site	98
Channel Alteration	983
Inadequate Forest Buffer	6,039

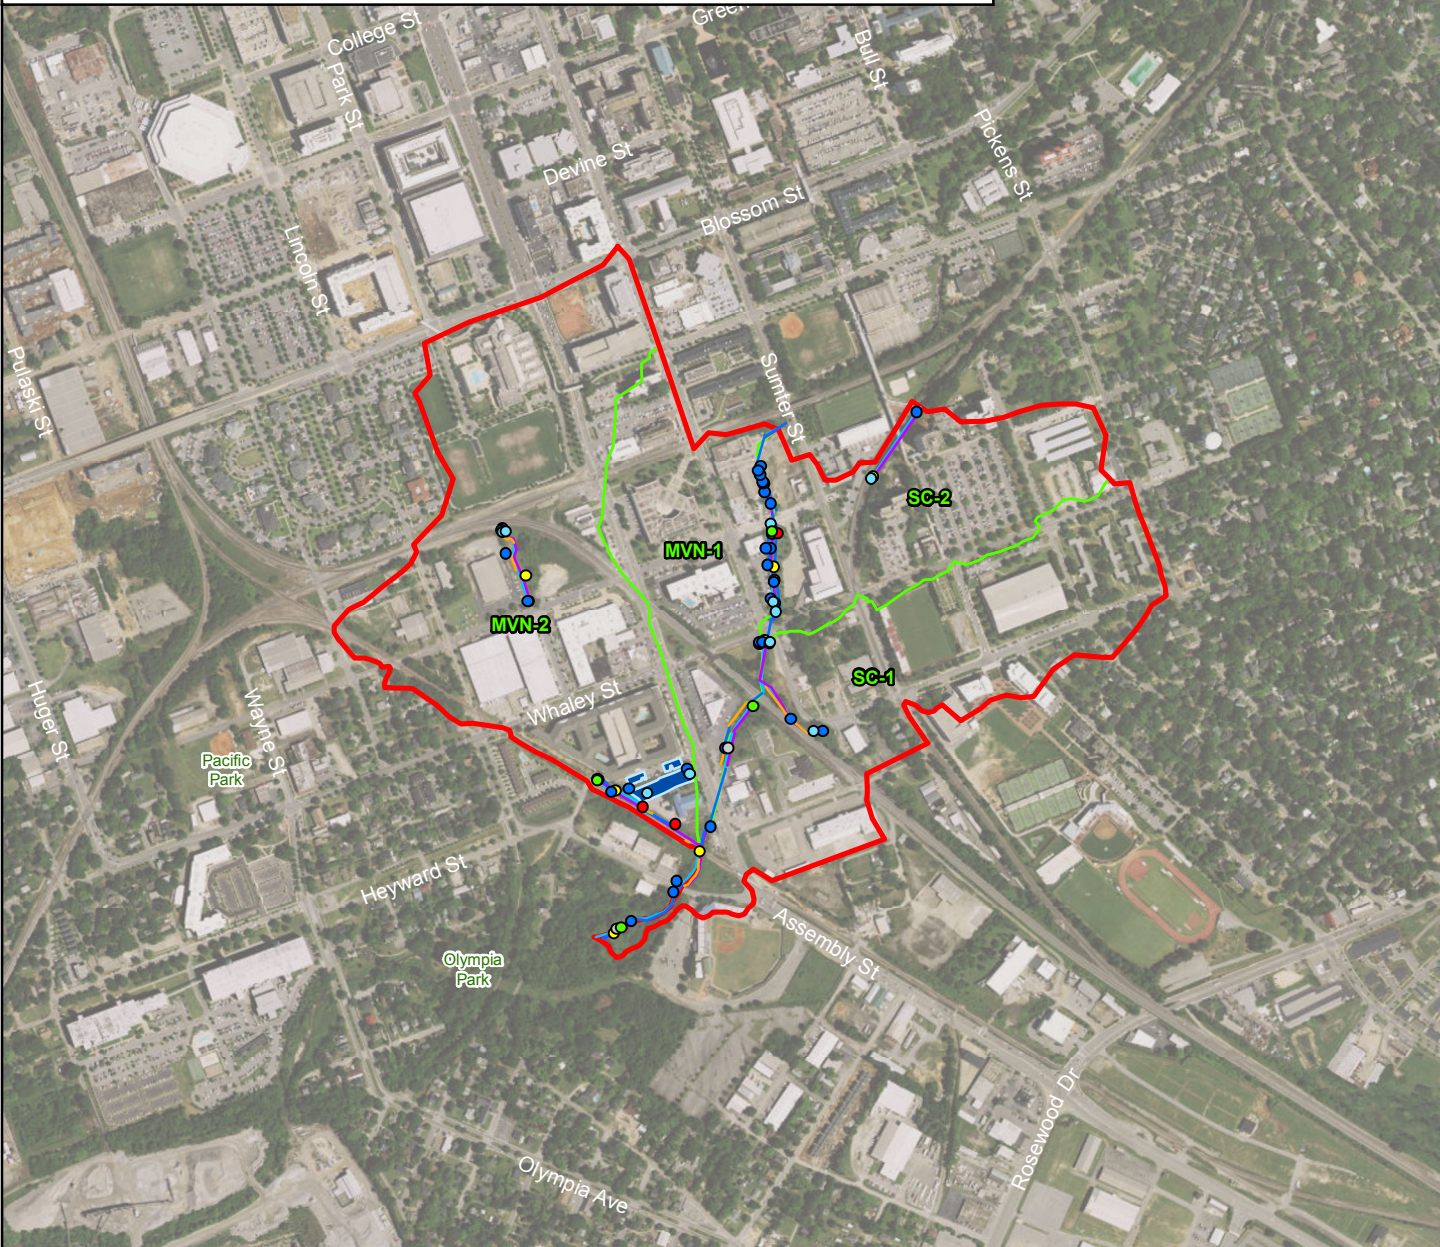
Figure 6.14:  
Mill Villages A Subwatershed  
Existing Conditions

Existing Condition	Count
Exposed Pipes	5
Pipe Outfalls	13
Unmanaged Runoff	1
Unusual Condition	8
Trash Dumping	1
Possible Fish Barrier	0
	<b>Linear Feet</b>
Erosion Site	204
Channel Alteration	625
Inadequate Forest Buffer	2,580

both considered to be in severe condition due to the extent and condition of channel alteration and evidence of recent flooding. Downstream of Catawba Street, the concrete channel continues for 190 feet. Buckling and cracks were observed along the concrete bed downstream of Catawba. Downstream from the end of the concrete bed, the banks are stabilized with concrete for a short length along the right bank and timber retaining walls over the remainder of the bank surface. The channel then passes through a double box culvert under Whaley Street.

The downstream end of the culvert under Whaley Street opens up into a scour pool with large deposits of sand and gravel. A brick wall with multiple pipe outfalls stabilizes the left bank at the corner of Whaley and Main Street. The bed is mostly sand with cobble and gravel along the riffles. The stream passes through a large CMP culvert underneath a railroad crossing that show signs of bed incision and headwall cracking upstream. The skewed angle of entry and volume of flow at this junction likely contributes to reported flooding upstream. There is a steep concrete apron downstream of the culvert outfall and a deep scour pool immediately downstream of the apron. The concrete apron and scour pool may hinder fish passage due to the relatively large difference in elevation between the apron and the downstream channel and the shallow fast flow along the apron. The right bank downstream is approximately 12-foot tall and eroded, with pockets of gabion basket and riprap stabilization. The left bank is low and vegetated. The channel substrate is primarily sand, with some boulder, cobble, gravel and exposed bedrock along riffles. The downstream limit of this segment is at a double box culvert that conveys the stream under Assembly Street.

Downstream of the road culvert at Assembly Street, the channel appears to have been historically straightened, with broken concrete, riprap, and gabion baskets stabilizing the 15-foot tall banks. The bed substrate consists primarily of sand, riprap and concrete. The stream passes under a railroad trestle and the substrate shifts to a higher concentration of boulder and cobble. Higher concentrations of trash were observed in this section, including a dumpster lodged underneath the railroad trestle. Bank heights are similar to the upstream region, although the left bank is eroding along most of the length between the railroad trestle and the culvert at Dreyfuss Road.

The last mainstem segment passes through a forested parcel located west of the City baseball stadium and downstream of the culvert at Dreyfuss Road. Large broken concrete slabs are present throughout the channel, which may indicate past channelization or attempts to stabilize the banks. Despite the unnatural appearance of concrete rubble, stream banks are stable. The concrete slabs in the channel create small cascades that could potentially block fish passage. The channel substrate is primarily sand, with some large boulder, exposed bedrock, cobble and gravel.

Thirty-eight outfalls were identified within the MV-A subwatershed during the field assessment. Two of these outfalls rated severe and one was rated very severe. The outfall rated very severe and one outfall rated severe are located south of the railroad at the head of the channel north of the Catawba Street and Park Street intersection. The railroad embankment has scoured and slumped behind the headwall, the headwall is undermined and cracked. Erodible soils and heavy erosion above and around the pipe are endangering the railroad embankment from which the outfall emerges. The other outfall in severe condition is located in the channel segment south of Catawba street. The pipe is fully inundated at baseflow, with 75% of the opening blocked with deposition

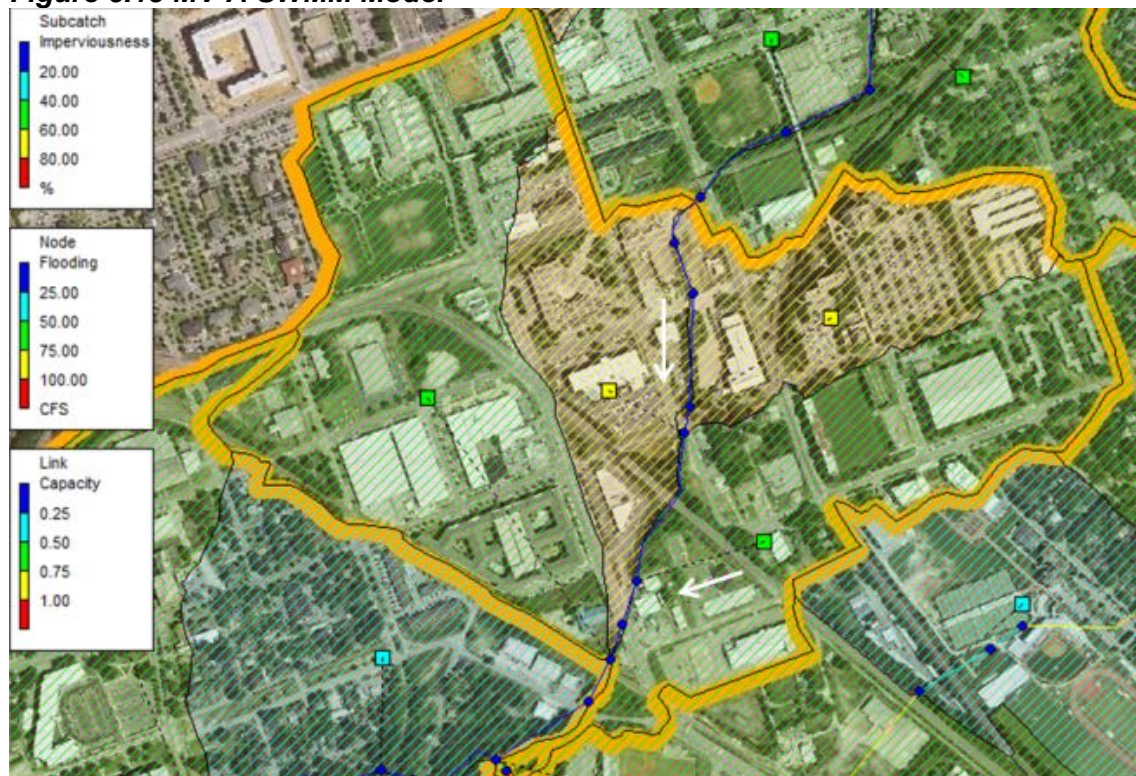
**Figure 6.15 MV-A SWMM Model**

The MV-A subwatershed lies to the south of the USC area and has the second highest value of impervious surface at 54%. The MV-A subwatershed is only 175 acres, but the SWMM model predicts for a 2-year storm event that the area will produce 11.4 million gallons of runoff, which is the fourth highest in the watershed. The discharge per acre for a 2-year storm event is modeled at 5.7 peak cfs/acre, putting it at the third highest amount within Rocky Branch, and 8,675 cubic feet/acre, which is fourth highest among the subwatersheds. As a result, the MV-A subwatershed received a higher subwatershed runoff ranking.

This subwatershed is modeled as four subcatchments in SWMM. The flows from these subcatchments are linked directly to Rocky Branch. The model does not indicate any flooding occurring in the subcatchments as a result of overburdened drainage pipes.

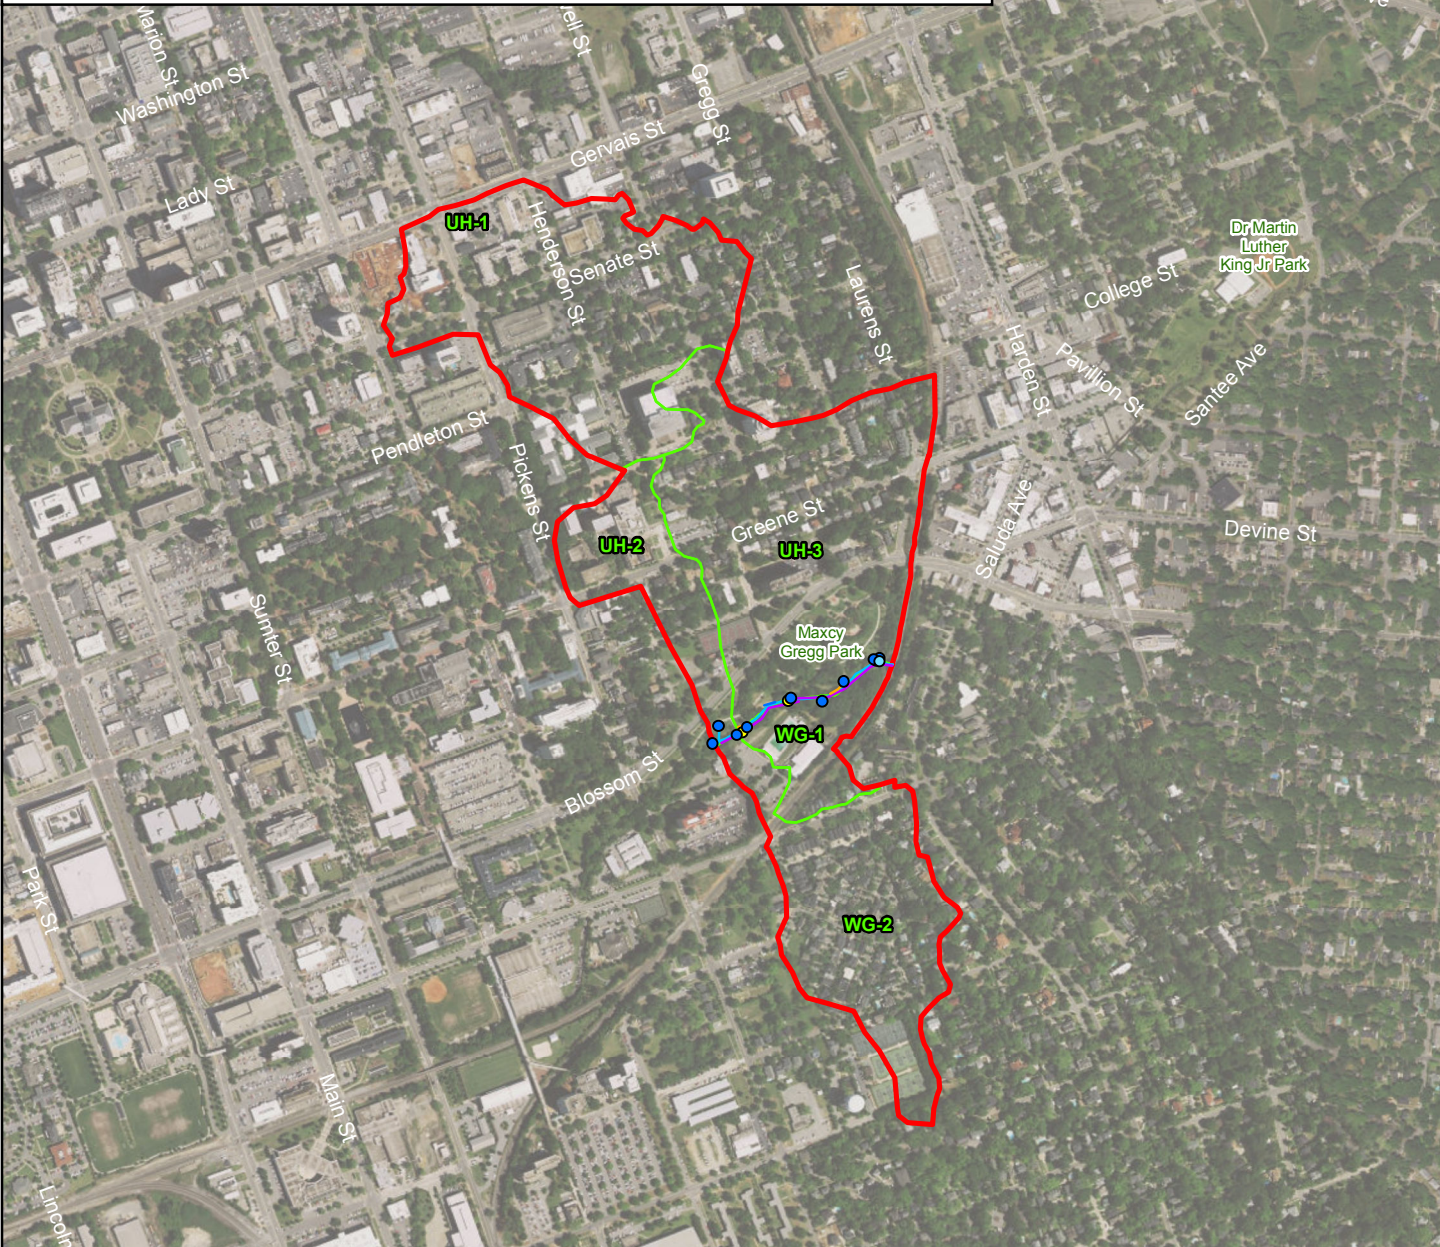
Figure 6.19:  
University Hill Subwatershed  
Existing Conditions

Existing Condition	Count
Exposed Pipes	1
Pipe Outfalls	9
Unmanaged Runoff	0
Unusual Condition	3
Trash Dumping	0
Possible Fish Barrier	0
	<b>Linear Feet</b>
Erosion Site	173
Channel Alteration	59
Inadequate Forest Buffer	1,501

The UH subwatershed contains a small section of open channel along the mainstem of Rocky Branch and located entirely within Maxcy Gregg Park. The upstream limit is an old, degrading railroad trestle that crosses the stream at the subwatershed boundary. A sanitary line is exposed along the bed spanning 50 feet directly beneath the railroad trestle. Immediately downstream of the trestle, a stacked stone wall is along the right stream bank and riprap stabilizes the left. Several isolated sections of bank erosion occur along the right bank throughout Maxcy

Stream habitat is in fair condition within the UH subwatershed. Sedimentation issues, a poor velocity/depth regime and a lack of epifaunal substrate/ available cover were the greatest impairments to the general habitat quality. At the upstream end near the railroad trestle, a very strong chemical odor and cloudy, green water color was observed. Approximately 70% of the stream banks had less than a 35-foot riparian buffer width. The upstream portion of the left bank had the most established vegetative growth. The remainder of the buffer had sporadic mature tree growth among mowed grass and low herbaceous vegetation.

All outfalls within the UH subwatershed were observed to be in minor to moderate condition.

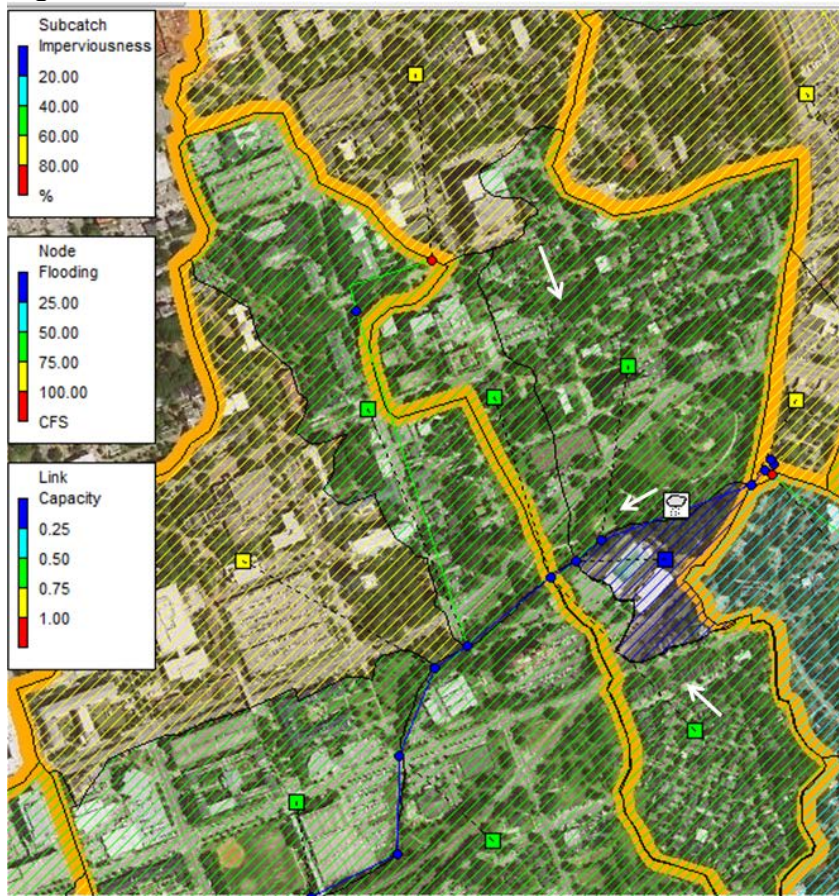
**Figure 6.20 UH SWMM Model**

The UH subwatershed is one of the smaller subwatersheds at 125 acres, but it has a higher than average amount of impervious surface at 54%. As a result, the SWMM model predicts that a 2-year storm event will produce 5.9 peak cfs/acre, the second highest value for the watershed. The total runoff volume is below the watershed average (12.8) at 8.6 million gallons for a 2-year storm event. However, the runoff per area is the second highest in the watershed at 9,224 cubic feet/acre. The higher impervious surface and runoff per area values lead to this subwatershed being ranked in the upper subwatershed runoff rankings as shown below.

The UH subwatershed consists of five subcatchments in SWMM, with four of them having flows connecting directly to Rocky Branch. At the 2-year event, the pipes modeled are at approximately 70% capacity and flooding is indicated at the upper end of the watershed.

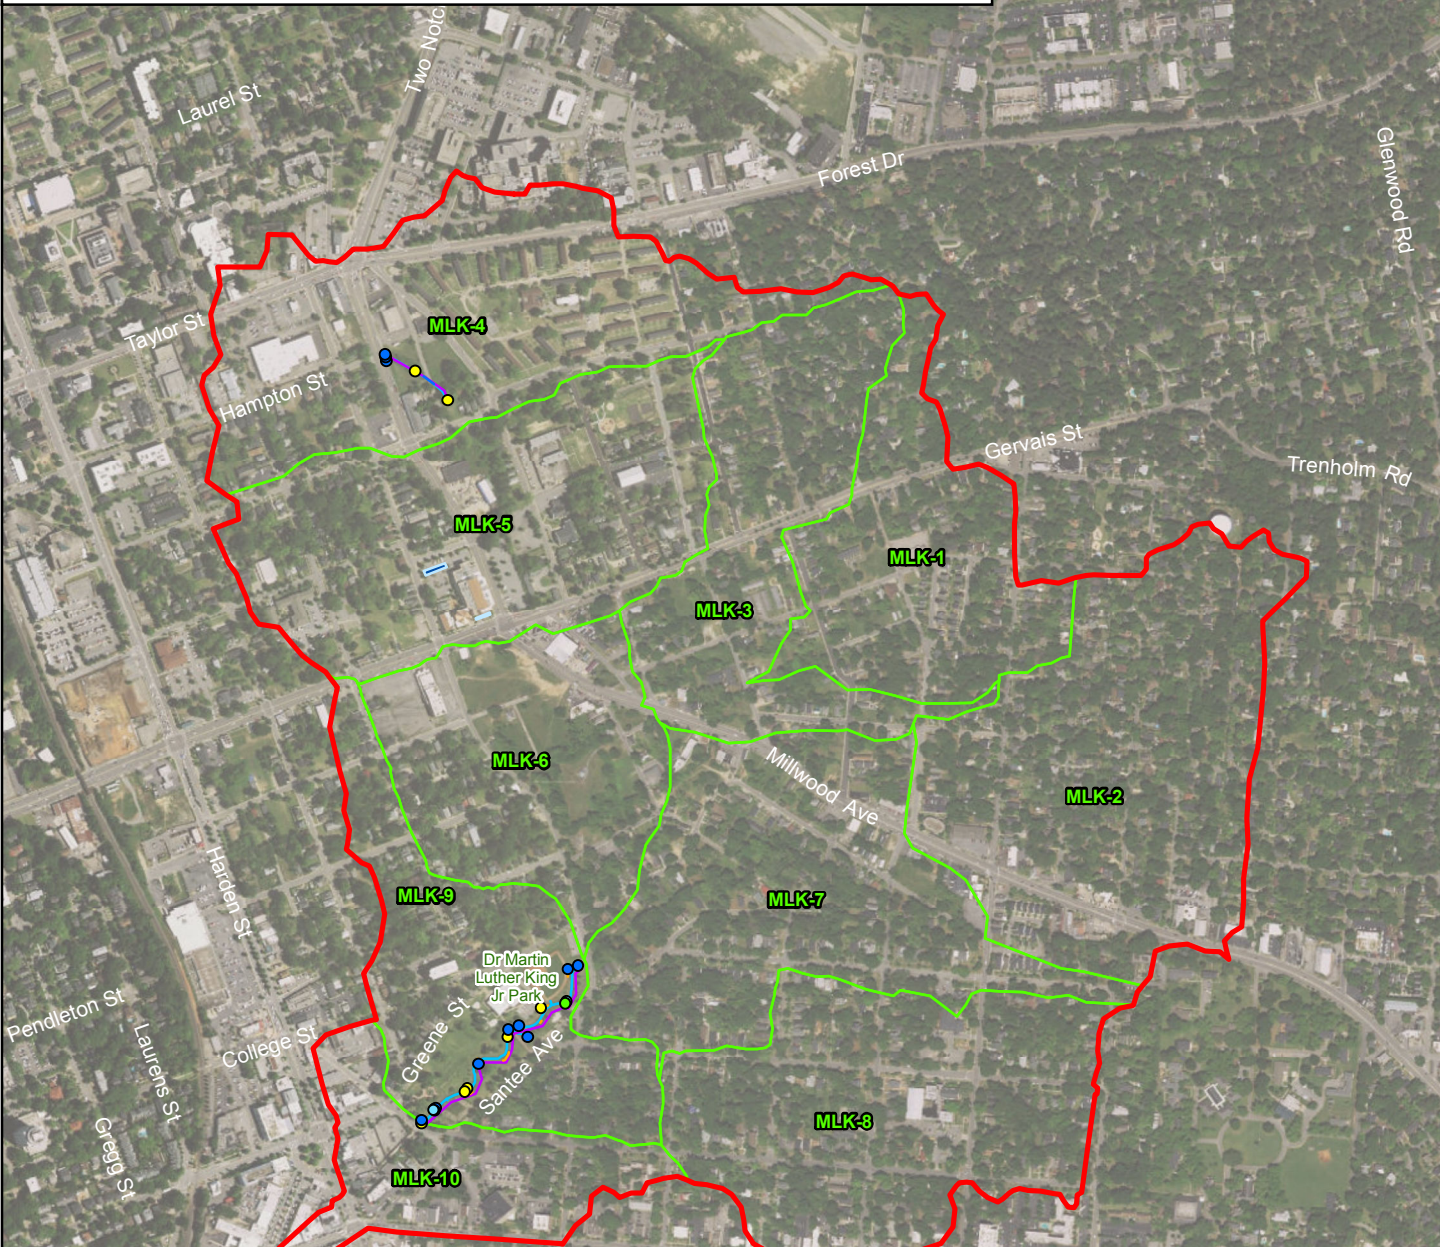
Figure 6.24:  
Martin Luther King Jr. Subwatershed  
Existing Conditions

Existing Condition	Count
Exposed Pipes	2
Pipe Outfalls	13
Unmanaged Runoff	0
Unusual Condition	7
Trash Dumping	0
Possible Fish Barrier	1
Linear Feet	
Erosion Site	274
Channel Alteration	88
Inadequate Forest Buffer	3,491

by organic matter along the stream banks and refuse scattered throughout tree limbs approximately three to four feet above the channel bed. Ground cover and soils directly adjacent to the current stream channel appear to be saturated. The stream is conveyed through a road culvert at Ontario Street and is open for a short segment before entering the piped network north of Washington Street.

The second open channel segment in this subwatershed begins at the northeastern edge of MLK Park, where the stream emerges from underneath Heidt Street. The open channel section within MLK Park was recently restored using natural channel design and stabilization techniques. The entire stream corridor within the park is fenced in. Grade controls including large boulders across the bed and bank stabilization are present throughout this segment. Isolated areas of erosion are located along the outsides of bends, resulting in sediment sloughing off of the 6 to 7-foot banks and portions of the park fence falling down the eroding slopes. Adjacent to Heidt Street, an exposed 18-inch sanitary pipe was observed crossing the stream. A cross vane structure is located immediately downstream of this pipe crossing. Erosion was observed along the left bank caused by the channel flanking the structure. A beaver dam located downstream of the park pedestrian bridge has altered the restored channel by causing localized backwater conditions. Further downstream, another exposed sanitary pipe was observed, and is spanning above base flow. The stream then enters a culvert beneath Pavilion Avenue and is piped through the Five Points neighborhood, eventually emerging in the southern portion of the Gregg Street subwatershed.

Stream habitat quality is generally poor along both of the open channel segments in the MLK subwatershed. Common impairments observed included lack of riparian buffer, sedimentation issues and poor epifaunal substrate/available cover. The segment in the northern part of the subwatershed also had poor channel flow status (baseflow condition) and inadequate velocity/depth regime representation. Petroleum (fuel-like) odors were observed within this

Fifteen outfalls were identified within the MLK subwatershed. All outfalls were characterized in fair to good condition.

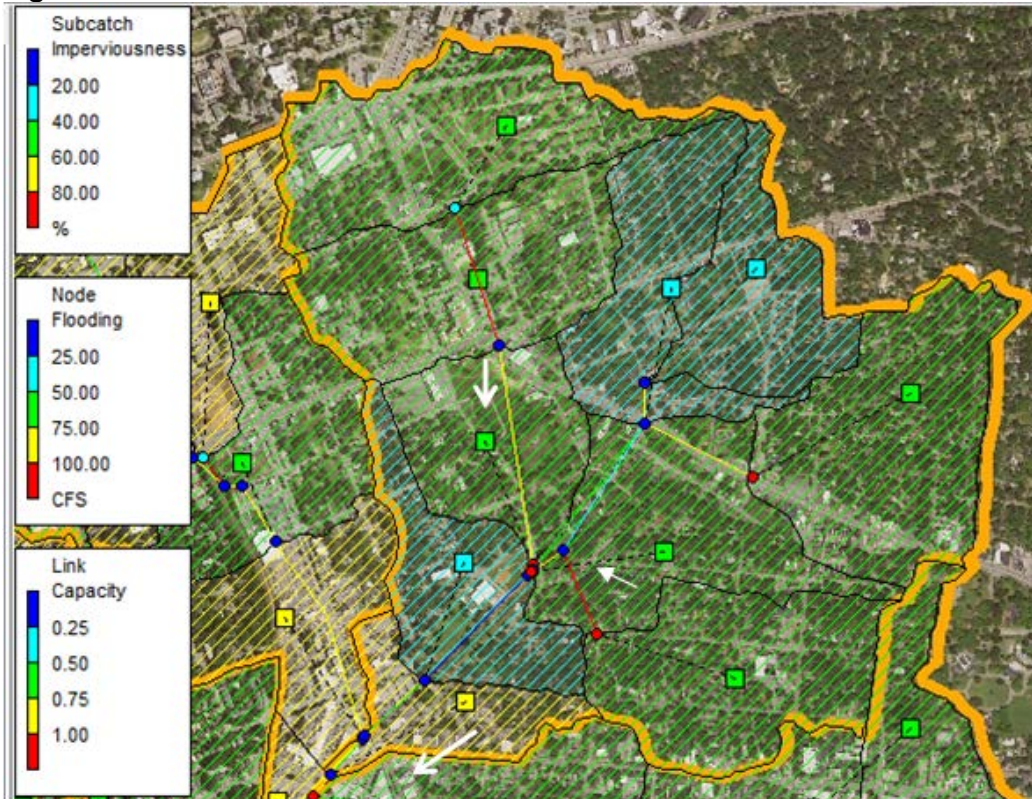
**Figure 6.25 MLK SWMM Model**

within the watershed. However, its runoff per area is modeled at 6,828 cubic feet/acre, which is only the fifth highest among the subwatersheds.

The MLK subwatershed was modeled as 10 subcatchments draining through various trunk lines to final outlets at MLK Park. Flooding is modeled to begin at the 2-year event, as the storm drains are at or near capacity.

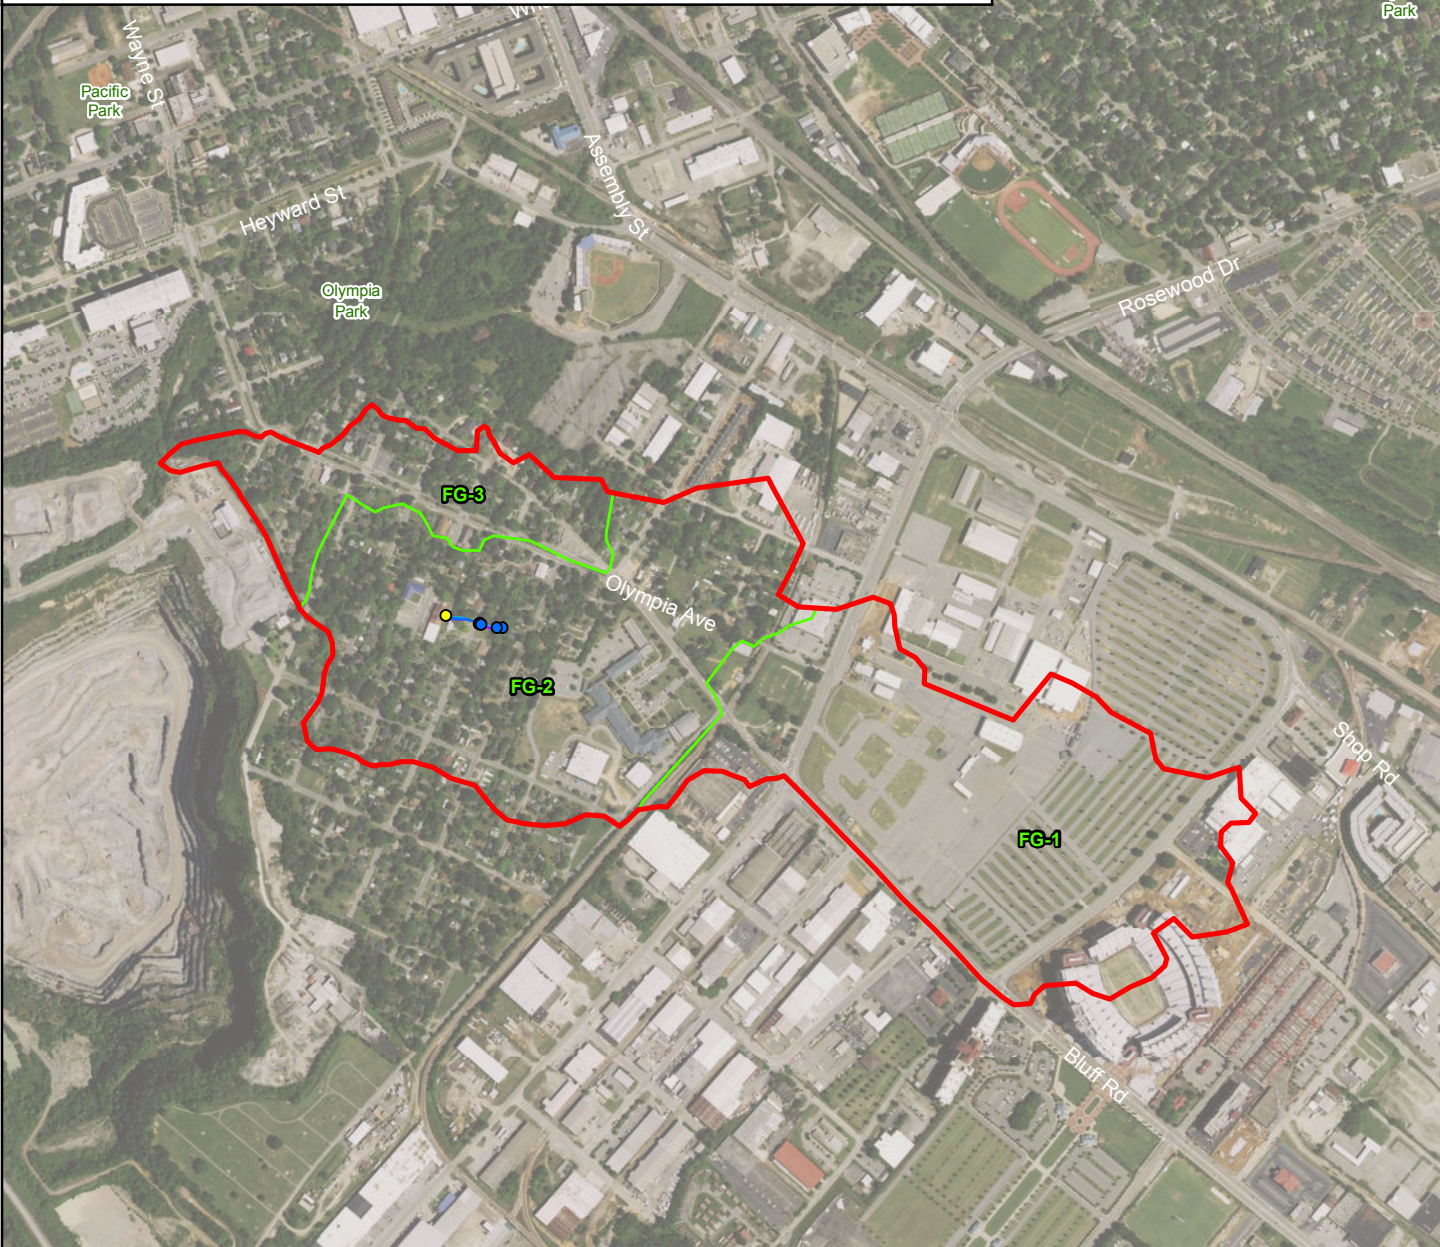
Figure 6.44:  
Fairgrounds Subwatershed  
Existing Conditions

Existing Condition	Count
Exposed Pipes	0
Pipe Outfalls	4
Unmanaged Runoff	0
Unusual Condition	2
Trash Dumping	0
Possible Fish Barrier	0
Erosion Site	0
Channel Alteration	174
Inadequate Forest Buffer	336

The habitat in this stream segment is poor overall. The main habitat impairments observed include embeddedness, lack of riparian buffer, little bed feature diversity, and poor epifaunal substrate/available cover. Approximately 70% of the open channel segment lacks a 35-foot wide or greater riparian buffer, with herbaceous vegetation typically mowed, including portions of the stream banks. Some small shrubs and vines are present along the right bank toward upstream end of the reach.

Four outfalls were identified within the FG subwatershed, all of which were considered to be in minor or moderate condition.

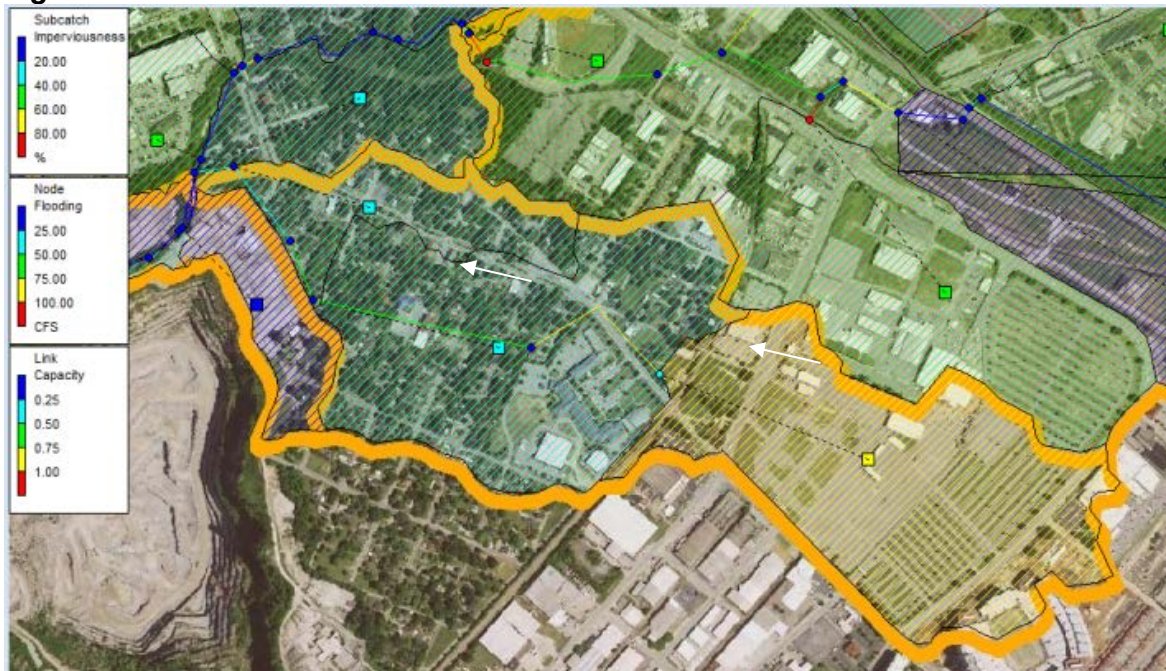
**Figure 6.45 FG SWMM Model**

The SWMM modeling of existing conditions showed that the FG subwatershed has a simulated 2.8 peak cfs/acre for a typical 2-year storm event, which is the lowest amount for the Rocky Branch Watershed. The 171-acre subwatershed is modeled to create approximately 7.7 million gallons of runoff during the 2-year event, which is also on the lower end for the watershed, and 6,029 cubic feet/acre, which is mid-range for the watershed. The FG subwatershed is approximately 46% impervious, which is just above the average value for the watershed. The lower slopes in this subwatershed likely contribute to less peak discharge being modeled during storm events.

The FG subwatershed consists of 3 modeled subcatchments. Most of the drainage flows from east to west through a 60 inch RCP. Even though this RCP was determined to outfall into the Vulcan Materials mine, it was modeled as if it is attached to Rocky Branch in order to simulate flows. The line is very close to capacity during the 2-year event, and flooding begins to occur at this point based on the model. The western portion of this subwatershed does not flood until the 10-year event at existing culvert capacities.

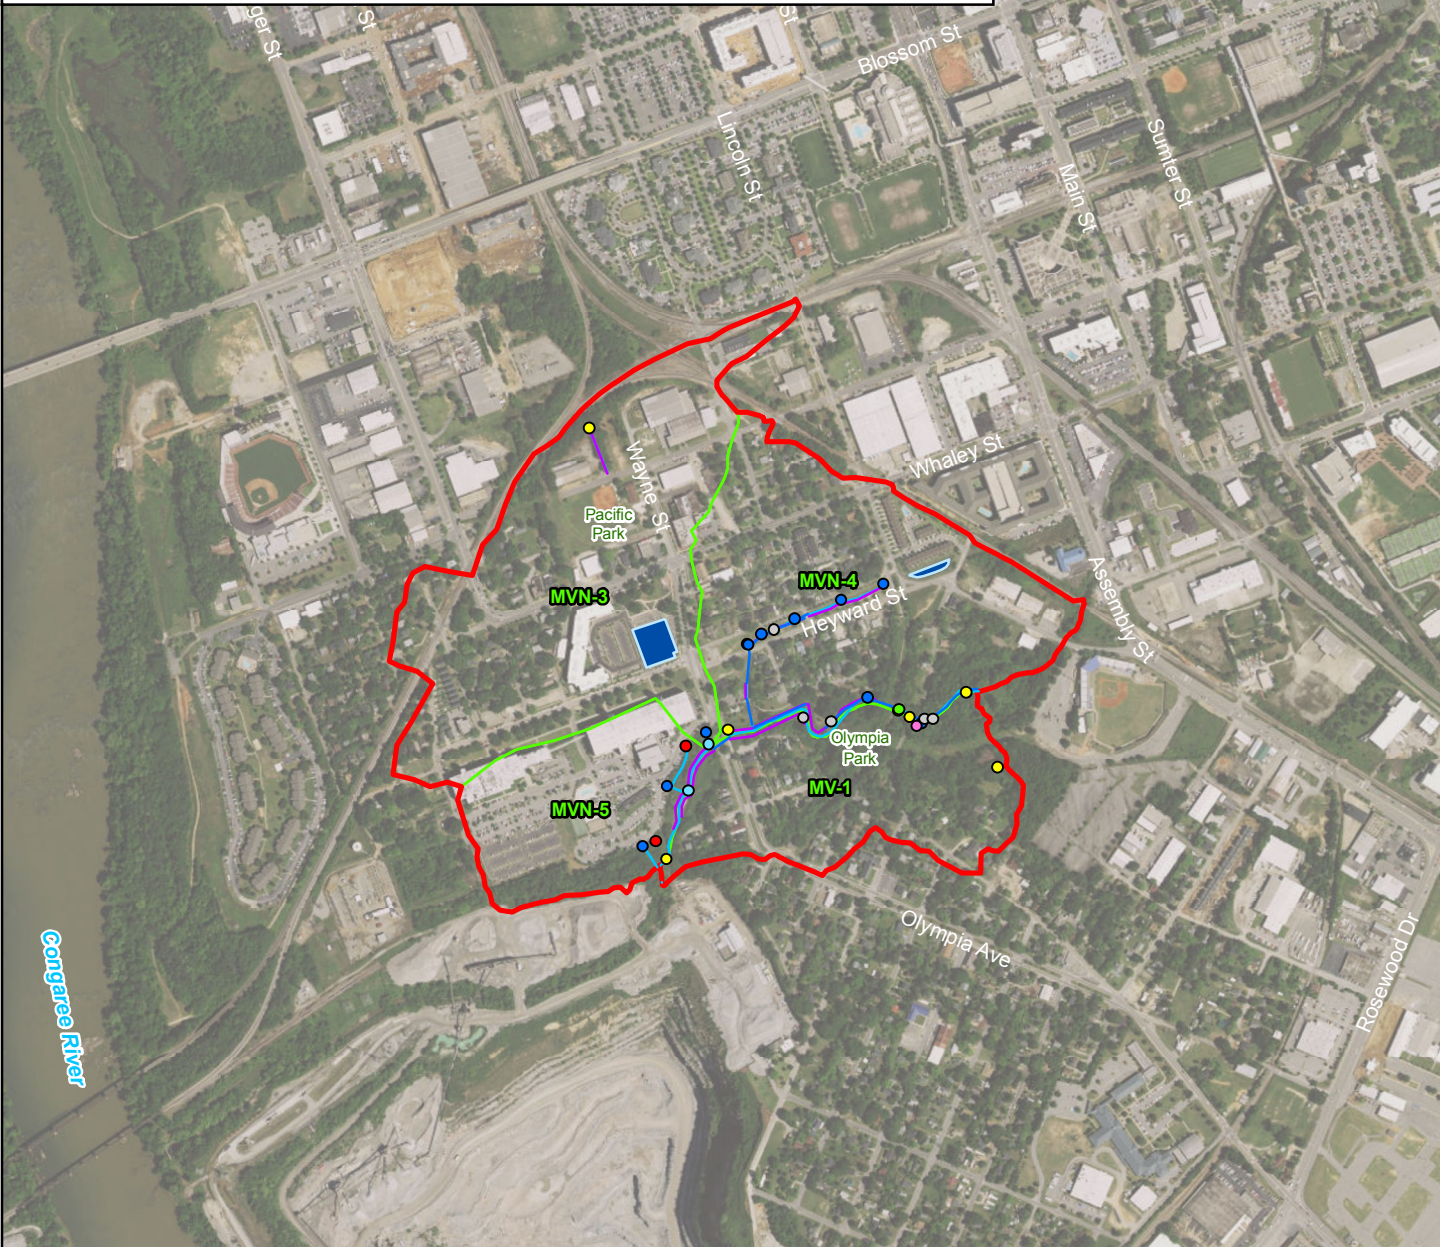
Figure 6.49:  
Mill Villages B Subwatershed  
Existing Conditions

Existing Condition	Count
Exposed Pipes	5
Pipe Outfalls	13
Unmanaged Runoff	1
Unusual Condition	8
Trash Dumping	1
Possible Fish Barrier	0
Linear Feet	
Erosion Site	204
Channel Alteration	625
Inadequate Forest Buffer	2,580

The MV-B subwatershed channel network begins at the confluence with a tributary on the left bank west of the Capital City Stadium, within a forested parcel. Large broken concrete slabs throughout the channel suggest past channelization and create small cascades within an otherwise sandy bed. The banks are approximately 5 to 7 feet tall and stabilized by the concrete and established vegetation. This segment ends at the culvert underneath Bluff Road.

Downstream of Bluff Road, the channel is open for 50 feet before flowing through a culvert underneath an abandoned railroad. This culvert was considered to be in very severe condition because of slope failure along the railroad embankment on the upstream side of the culvert. The segment downstream of the railroad is within Olympia Park. The right bank has been stabilized with riprap at the upstream end. There is a utility right of way with power lines that cross the stream 250 feet downstream of the abandoned railroad culvert. The bed consists of large deposits of sand, exposed bedrock outcroppings, and some riprap.

The stream is then conveyed through a road culvert at Olympia Avenue; the culvert was considered to be in very severe condition because of damage to the upstream headwall with the brick facade missing on the left side. There is a large scour hole immediately downstream of the Olympia Avenue culvert. The downstream channel segment has large sand and gravel deposits and an exposed sanitary line spanning over the mainstem supported by concrete and brick piers within the active bed. The stream runs between a parking lot for the Granby Apartments on the right bank and a utility right of way on the left.

Ten outfalls were identified within the MV-B subwatershed during the field investigation. One outfall was considered to be in severe condition, located northwest of the Olympia Avenue, Alabama Street intersection. The channel is incised and instability at the head of the channel, and water quality discharging into the mainstem is poor. The outfall is overgrown with roots, vines, and other vegetation, and overland flow enters the head of the channel from multiple directions, including unmanaged runoff from Olympia Avenue.

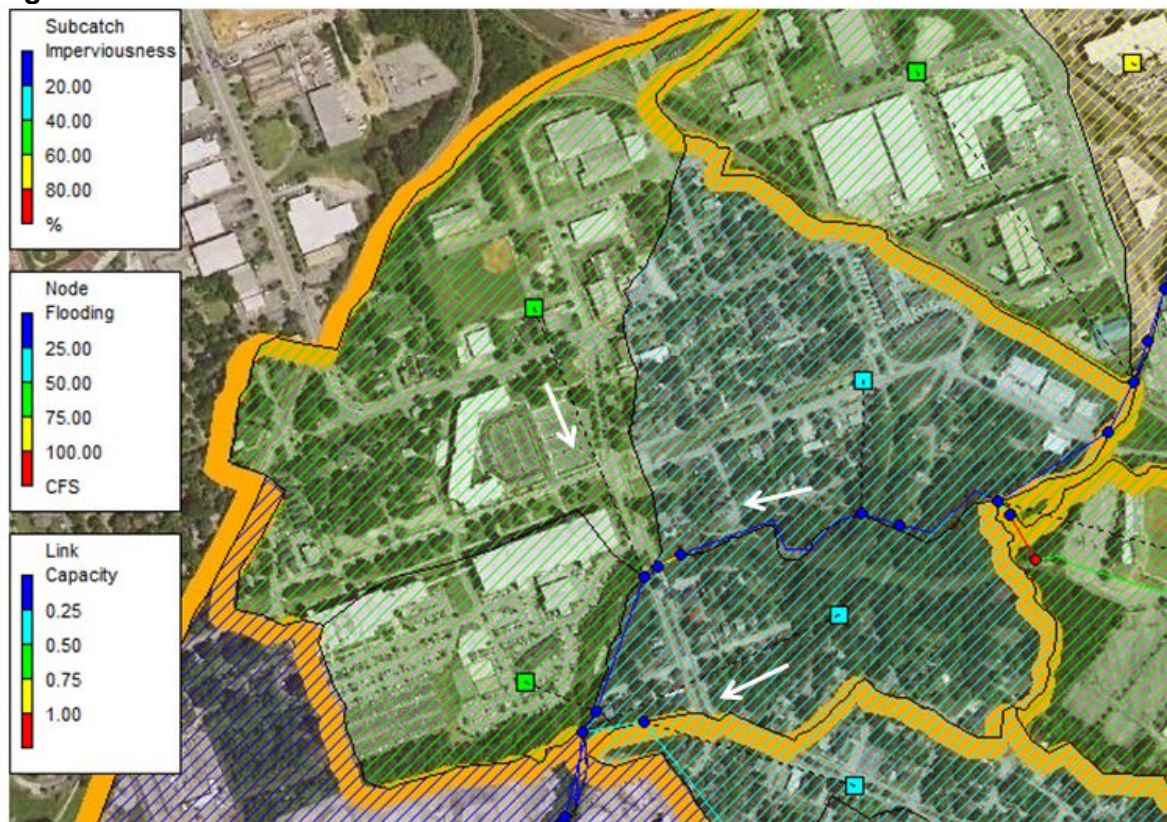
**Figure 6.50 MV-B SWMM Model**

The MV-B subwatershed is adjacent and to the south of MV-A. MV-B has almost 15% less impervious surface than its northern counterpart and the second lowest impervious value for the watershed. With its smaller size of 154 acres, the MV-B subwatershed is modeled with SWMM to produce only 6.1 million gallons of runoff for a 2-year storm event, the tenth lowest amount for the watershed. The runoff per area is also low at 5,283 cubic feet/acre. The discharge per acre for the 2-year event is in the mid-range at 4.3 peak cfs/acre. Due to these attributes, the MV-B subwatershed received the second lowest subwatershed runoff ranking.

The MV-B subwatershed was modeled as four subcatchments in SWMM. The flows from these subcatchments are linked directly to Rocky Branch, so the model does not indicate any flooding is occurring in the subcatchments as a result of overburdened drainage pipes. Portions of this subwatershed are within the 10-year floodplain for Rocky Branch.
