# ROCKY BRANCH WATERSHED ASSESSMENT

MAY 20, 2016

CITY OF COLUMBIA  
UTILITY AND ENGINEERING DEPARTMENT  
1136 WASHINGTON STREET, 7TH FLOOR  
COLUMBIA, SOUTH CAROLINA 29201

McCormick Taylor Inc., supported by KCI Technologies, Inc., has been contracted by the City of Columbia, South Carolina to conduct an assessment of the Rocky Branch watershed to identify potential improvement opportunities to identify existing flooding and water quality conditions.

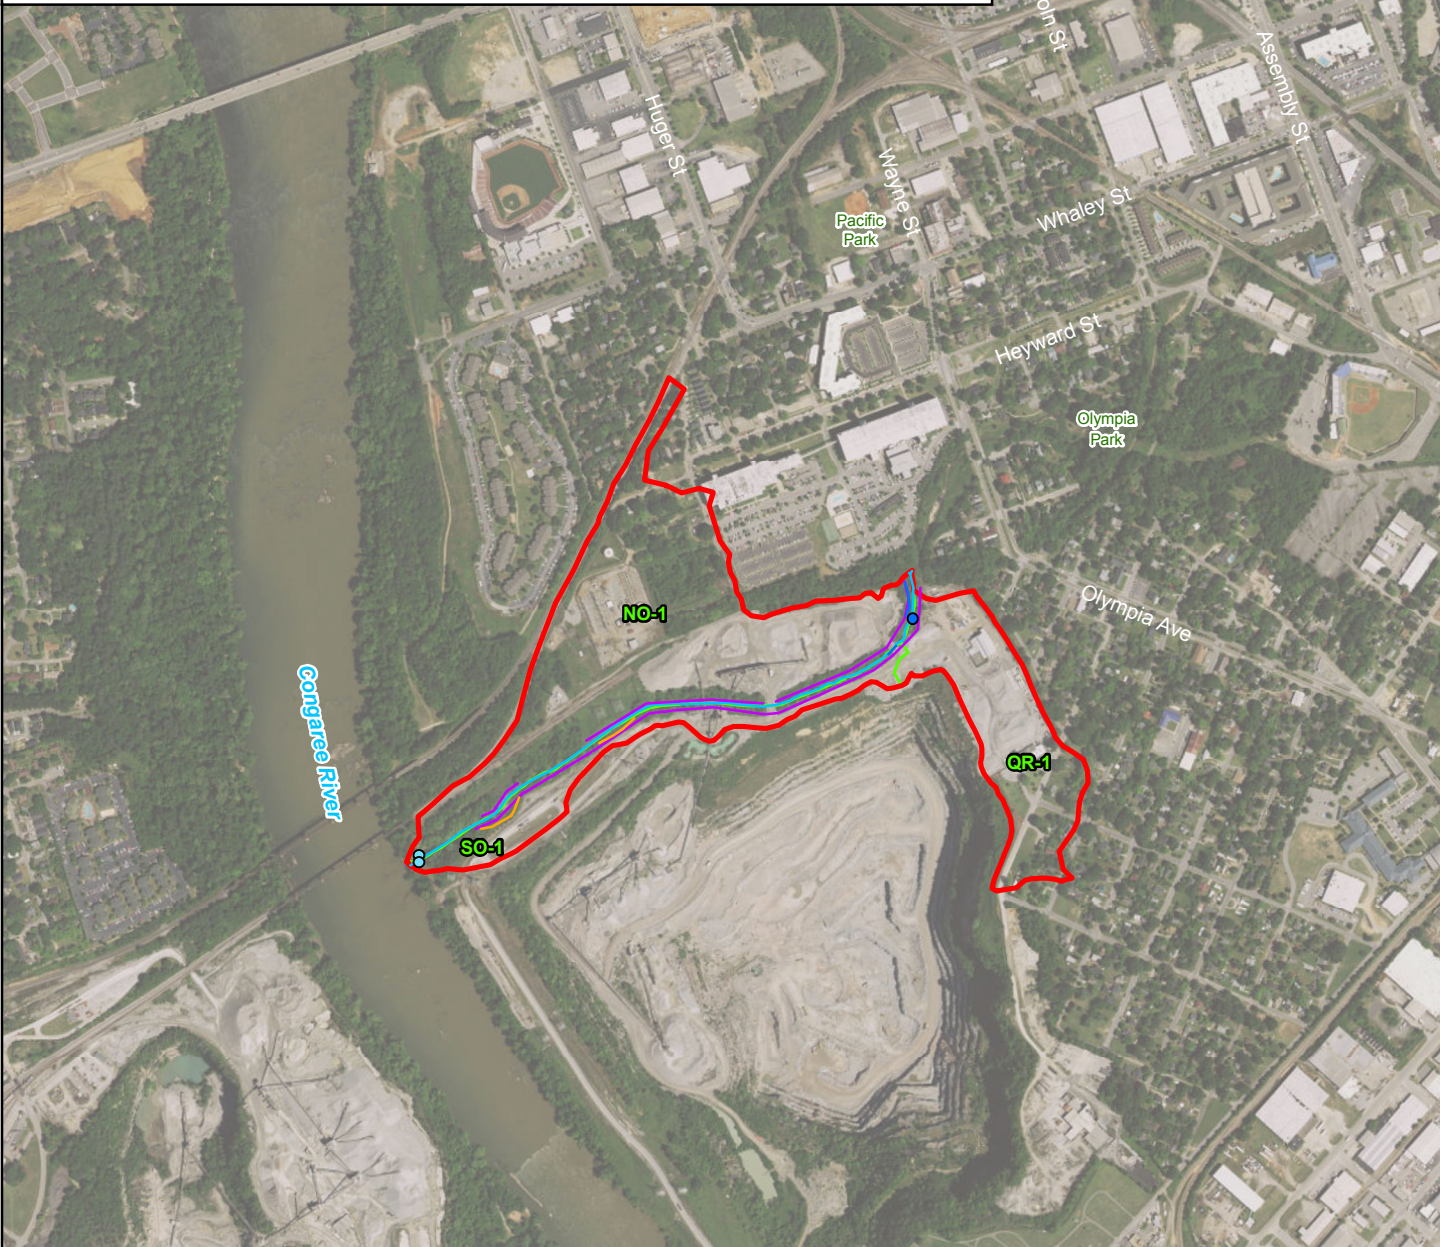
Figure 6.54:  
Outlet Subwatershed  
Existing Conditions

Existing Condition	Count
Exposed Pipes	2
Pipe Outfalls	1
Unmanaged Runoff	0
Unusual Condition	0
Trash Dumping	0
Possible Fish Barrier	0
	<b>Linear Feet</b>
Erosion Site	509
Channel Alteration	236
Inadequate Forest Buffer	5,065

Stream habitat quality throughout this segment is mostly fair, with decreasing impairment towards the upstream limit and poorer conditions observed near the confluence with the Congaree River. Embeddedness and heavy sediment deposition are common issues within the stream bed, while lack of vegetative protection on the banks and little to no riparian buffer is impacting overall bank stability. The backwater conditions at the mouth of Rocky Branch have created a deep pool with a thick layer of deposited sand and silt within the bed, greatly reducing the quality of the habitat in this segment.

The narrow stream valley and proximity to the mine and railroad has limited space available for a riparian buffer, though there are small pine trees growing on the steep banks in some locations. Approximately 80% of the stream banks were observed to be lacking a 35-foot or greater riparian buffer width. Some portions of the right bank at the downstream limits of the reach and on the left bank at the mouth of Rocky Branch had an adequate vegetated width.

Only one outfall was identified during a field review in the OT subwatershed. This outfall was observed to be in moderate condition.

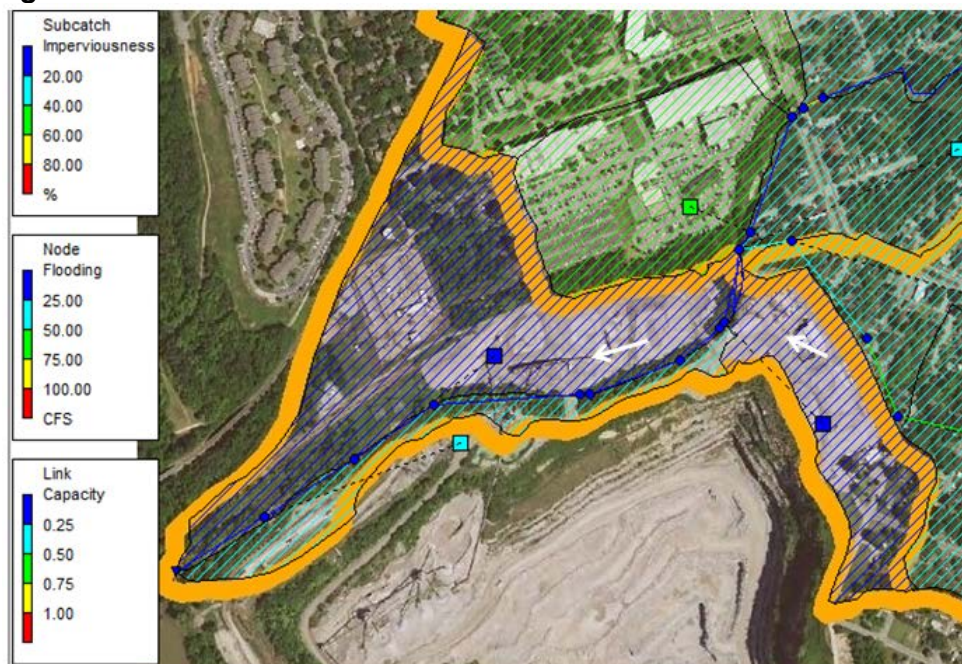
**Figure 6.55 OT SWMM Model**

The OT subwatershed is unique in that it occupies the very downstream limit of the watershed and is comprised of only 63 acres. With 11% impervious surface, the OT subwatershed is the lowest within the watershed. As a result, the values from the SWMM model for a 2-year event also place the OT subwatershed in the lower end: the subwatershed is modeled to produce 3.3 peak cfs/acre, the lowest overall in the watershed, and 1.1 million gallons of runoff, the second smallest amount in the watershed. The runoff per area is also modeled as the smallest value in the watershed at 2,387 cubic feet/acre. These existing conditions give the OT subwatershed the highest (least impaired) runoff ranking in the watershed and indicate that has the lowest relative need of hydraulic improvement in the Watershed.

The OT subwatershed was modeled as three subcatchments in SWMM. The flows from these subcatchments are linked directly to the Rocky Branch mainstem. Most of the OT subwatershed is within the Vulcan Materials mine.

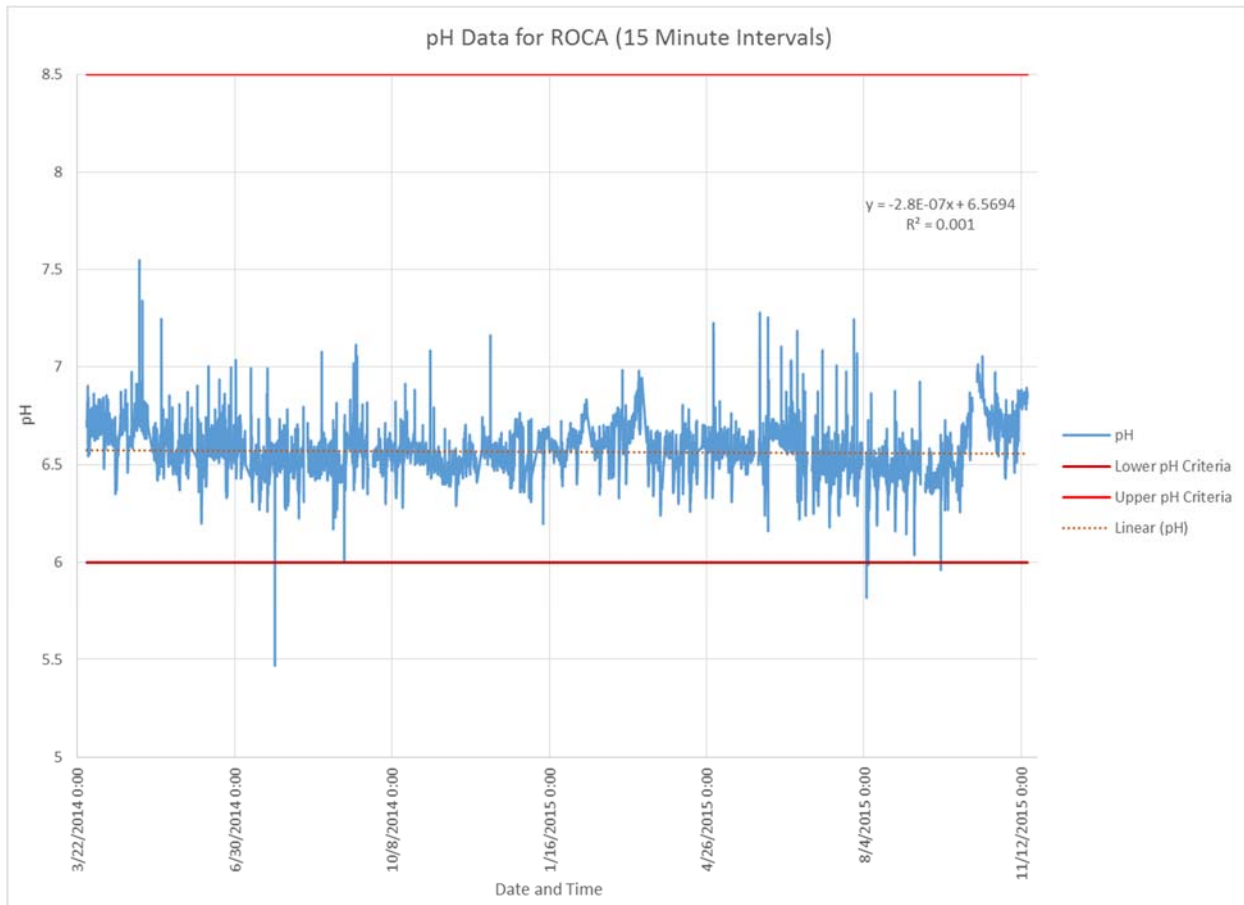
A linear regression analysis was performed for 15-minute interval pH data from ROCA. The results of the linear regression analysis show a slight negative slope (-2.8209E-07), which was significant at the  $p < 0.01$  level ( $p < 0.001$ ). This indicates that the likelihood of this decreasing pH relationship occurring by chance is very small. The negative slope of the line indicates that pH values are decreasing very slightly throughout this dataset. This rate of change is so small that changes in observed pH values would happen over several tens of thousands of measurements. If this relationship holds true with data collected over additional time periods, it would take over a year for a realized 0.01 decrease in pH value.

Monthly average pH and seasonal average pH were calculated for this site to investigate patterns and seasonality in the data. This created 21 monthly averages and seven seasonal averages. No patterns exist in monthly average nor seasonal average pH.

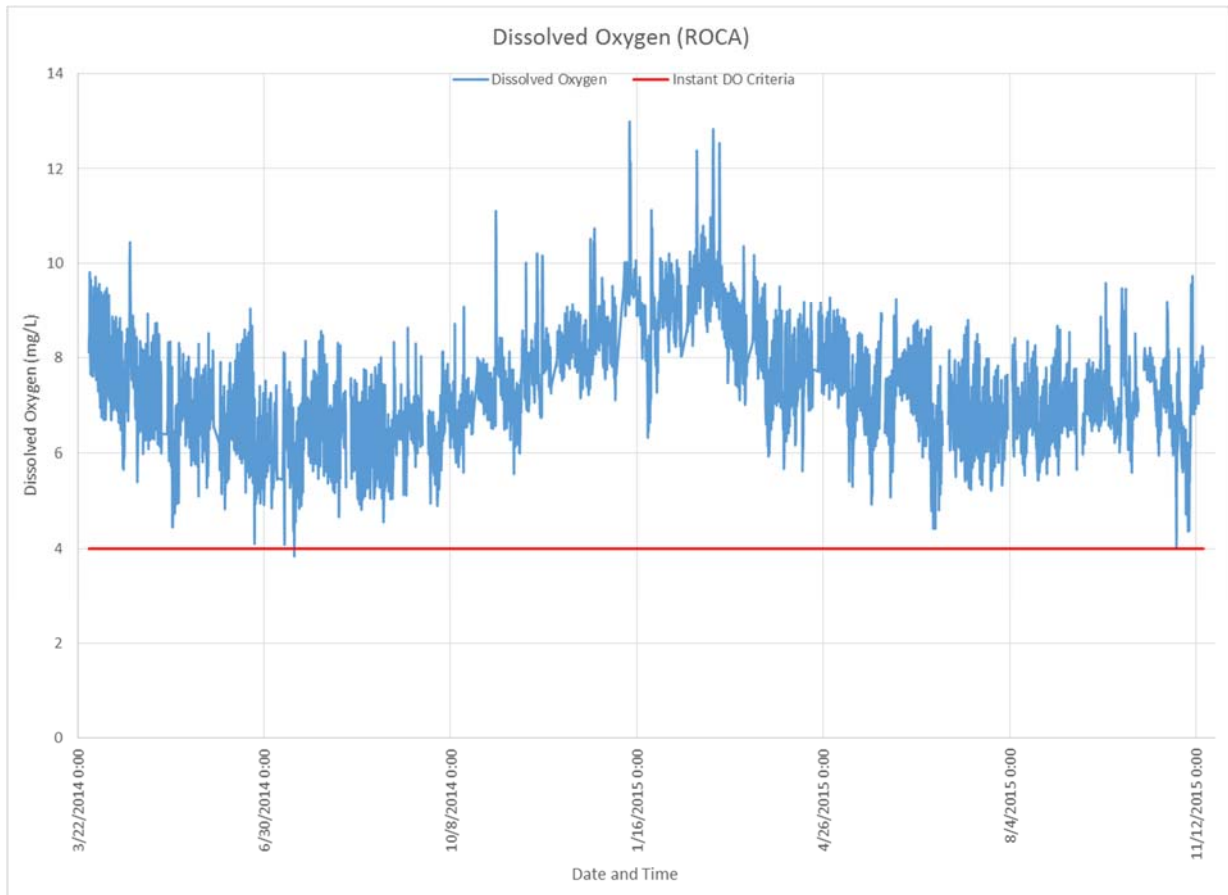
Water quality sonde data from site ROCA show that the instantaneous water quality standard for dissolved oxygen of 4.0 mg/L was violated 0.01% of the time (4 out of 52,929 records) over the period of record. Over the same period of time, the water quality standard for daily average dissolved oxygen of 5.0 mg/L was violated 0.00% of the time (0 out of 555 days). The instantaneous criteria violations happened over a 45-minute period on July 16<sup>th</sup>, 2014 from 05:15 to 06:00. July 16<sup>th</sup>, 2014 also had the lowest observed daily average dissolved oxygen concentration of 5.28 mg/L.

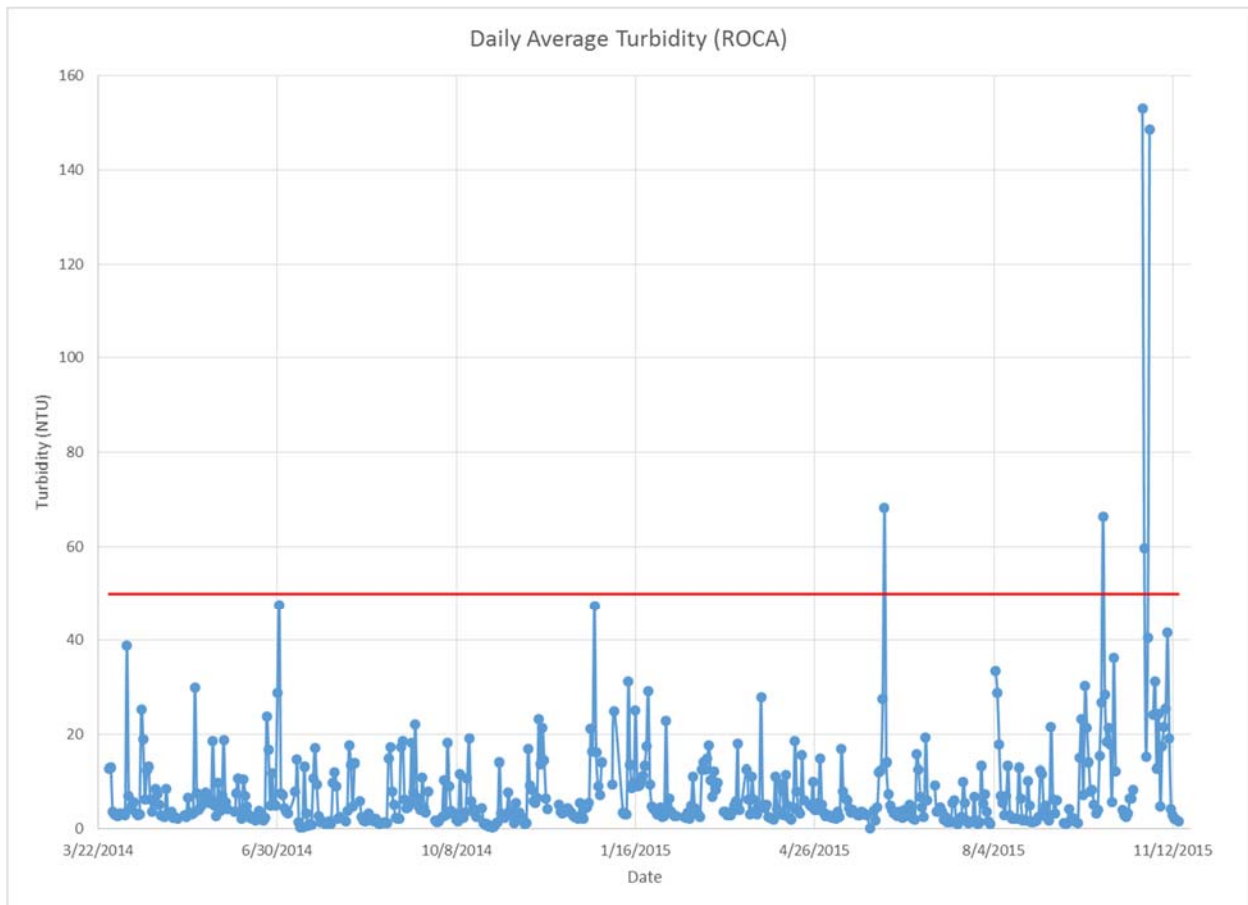
Results of turbidity data from the water quality sonde at ROCA show that the turbidity water quality standard of 50.0 NTU was exceeded 1.27% of the time (644 records out of a total 50,609 records).
