Clean Water 2020 Program

INFRASTRUCTURE REHABILITATION REPORT (IR Report)

August 2019

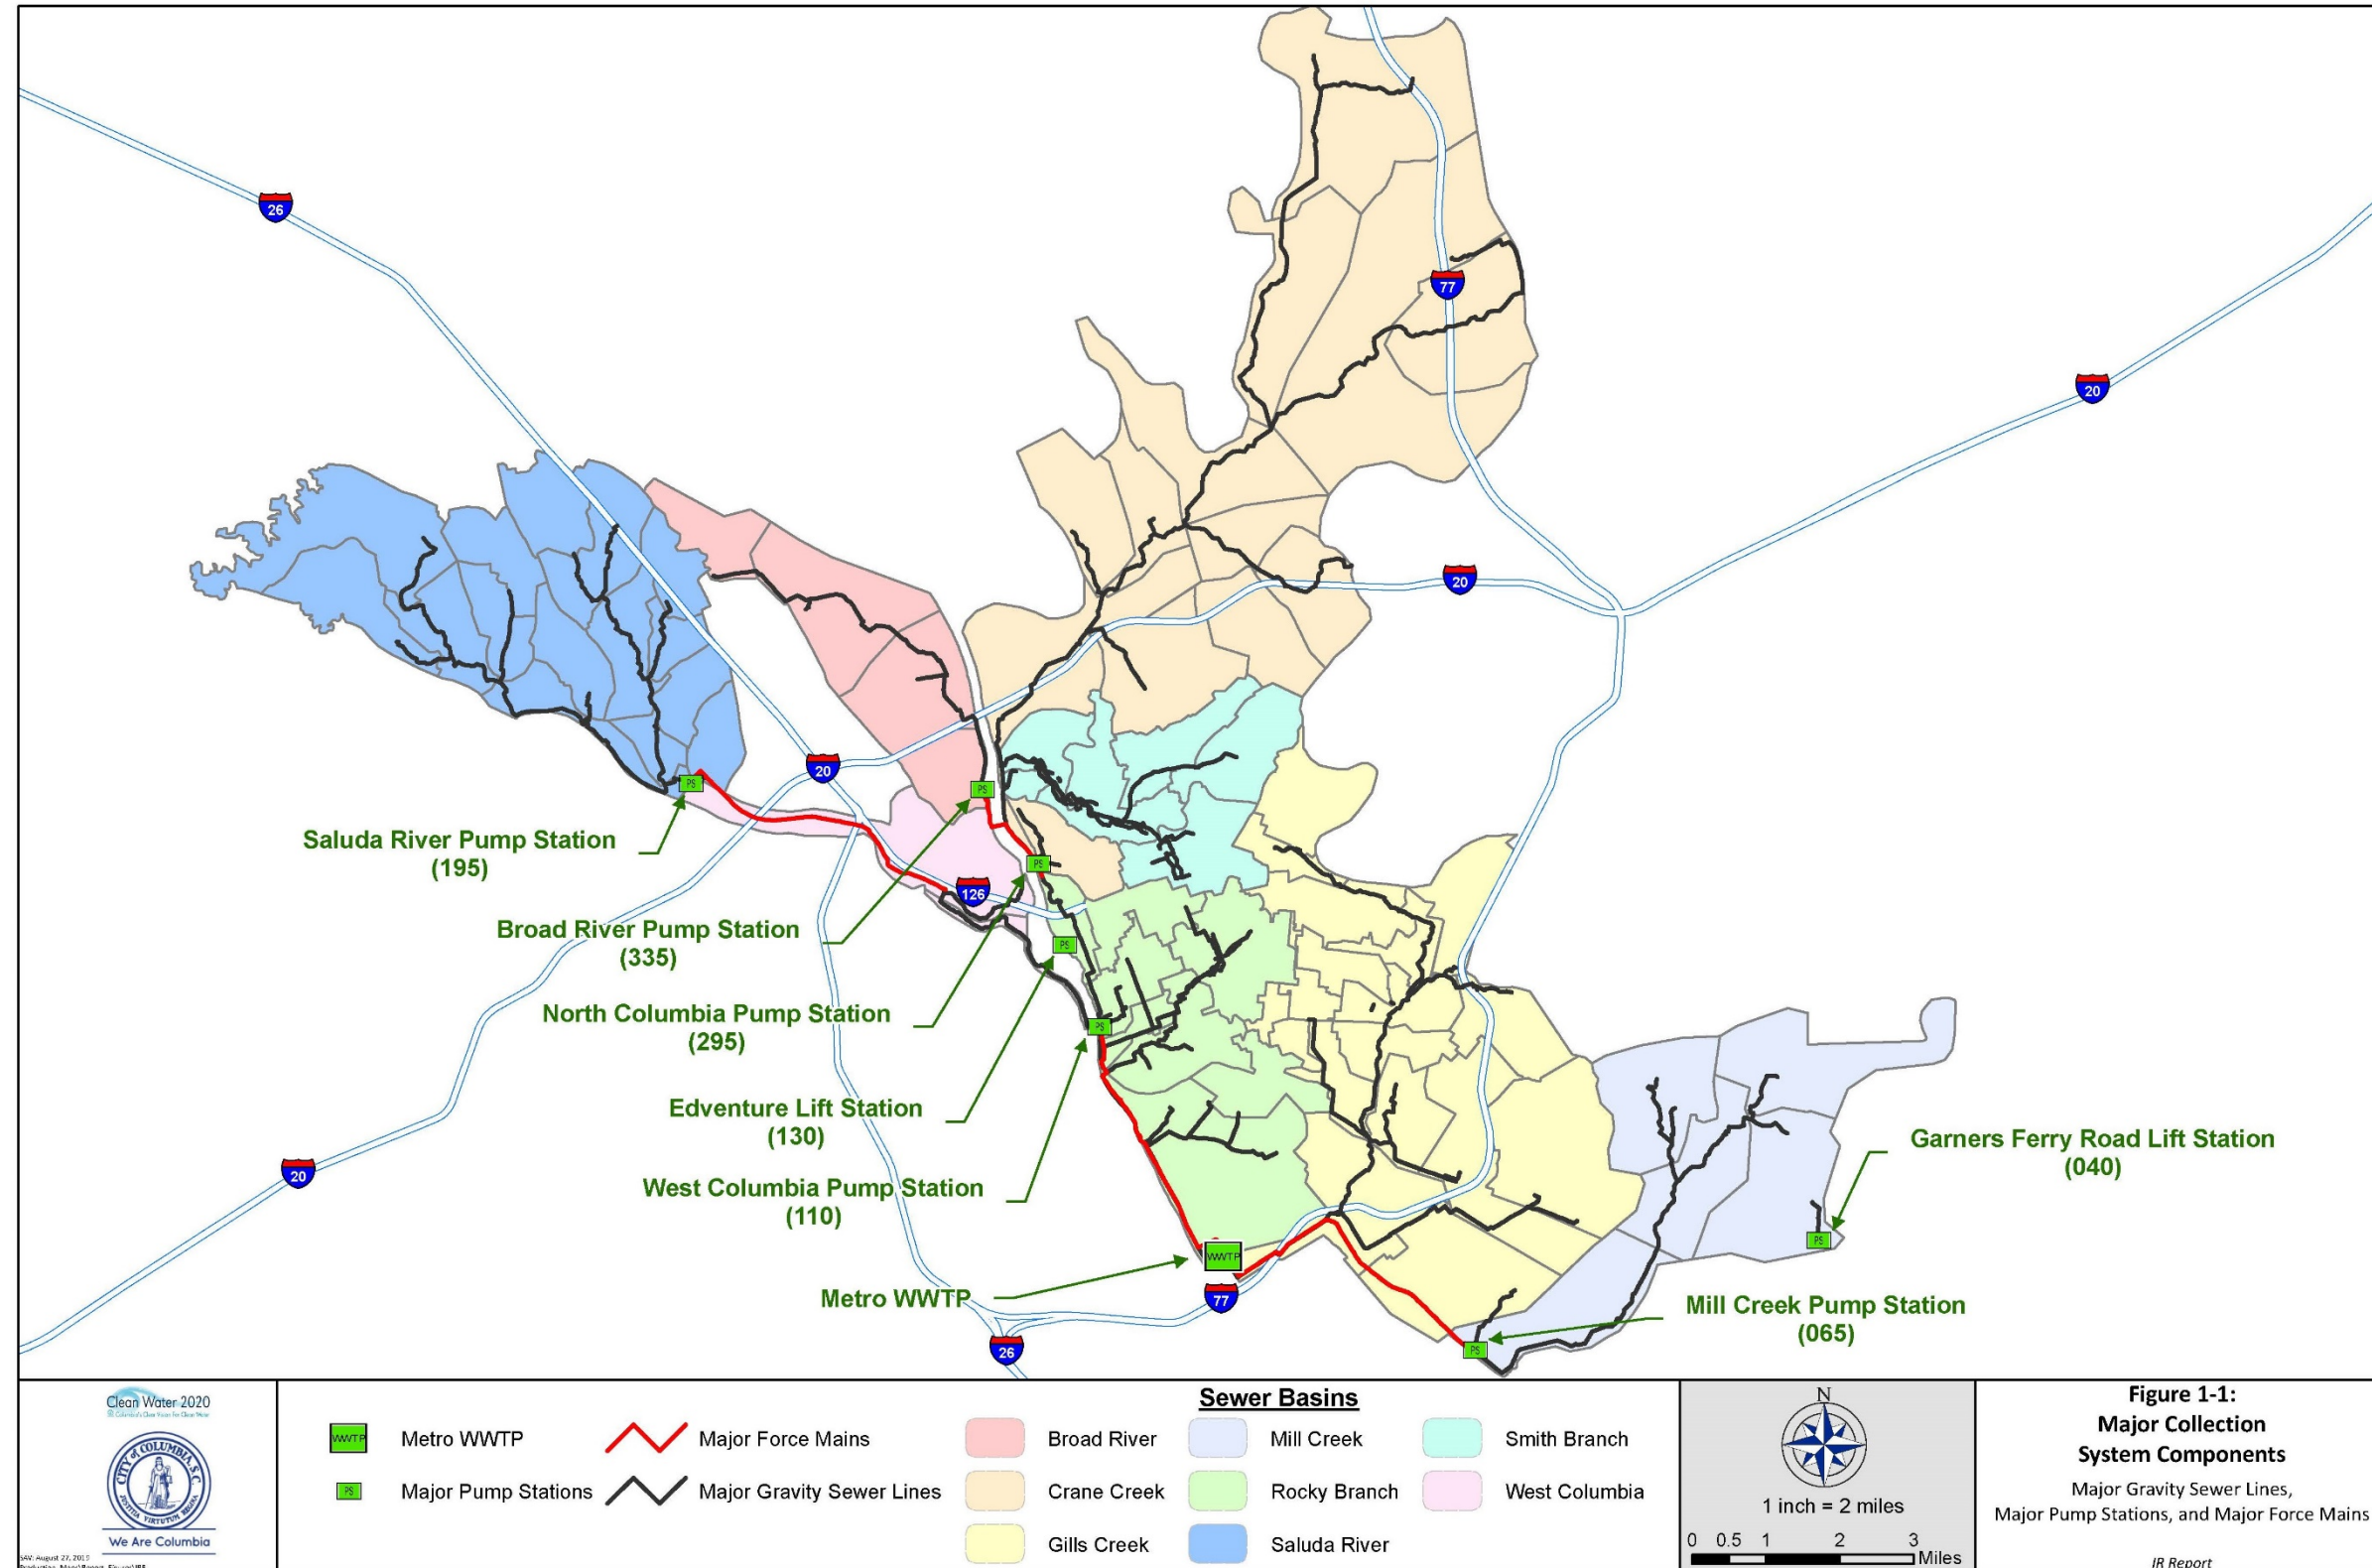
Figure 1-1 – Major Collection System Components

The WCTS currently consists of approximately 1,080 miles of mainline Gravity Sewer with diameters ranging from 6 inches to 60 inches, 56 Pump Stations, and approximately 40 miles of Force Main located both inside the city limits and in portions of Richland and Lexington Counties. The major components of the WCTS include all Gravity Sewer and Force Main with diameters 15 inches or larger and their appurtenances, such as manholes and Pump Stations. Major WCTS components are summarized in **Tables 1-1 through 1-3**. Major Gravity Sewer Lines, Major Pump Stations, and major Force Main are shown on **Figure 1-1**.

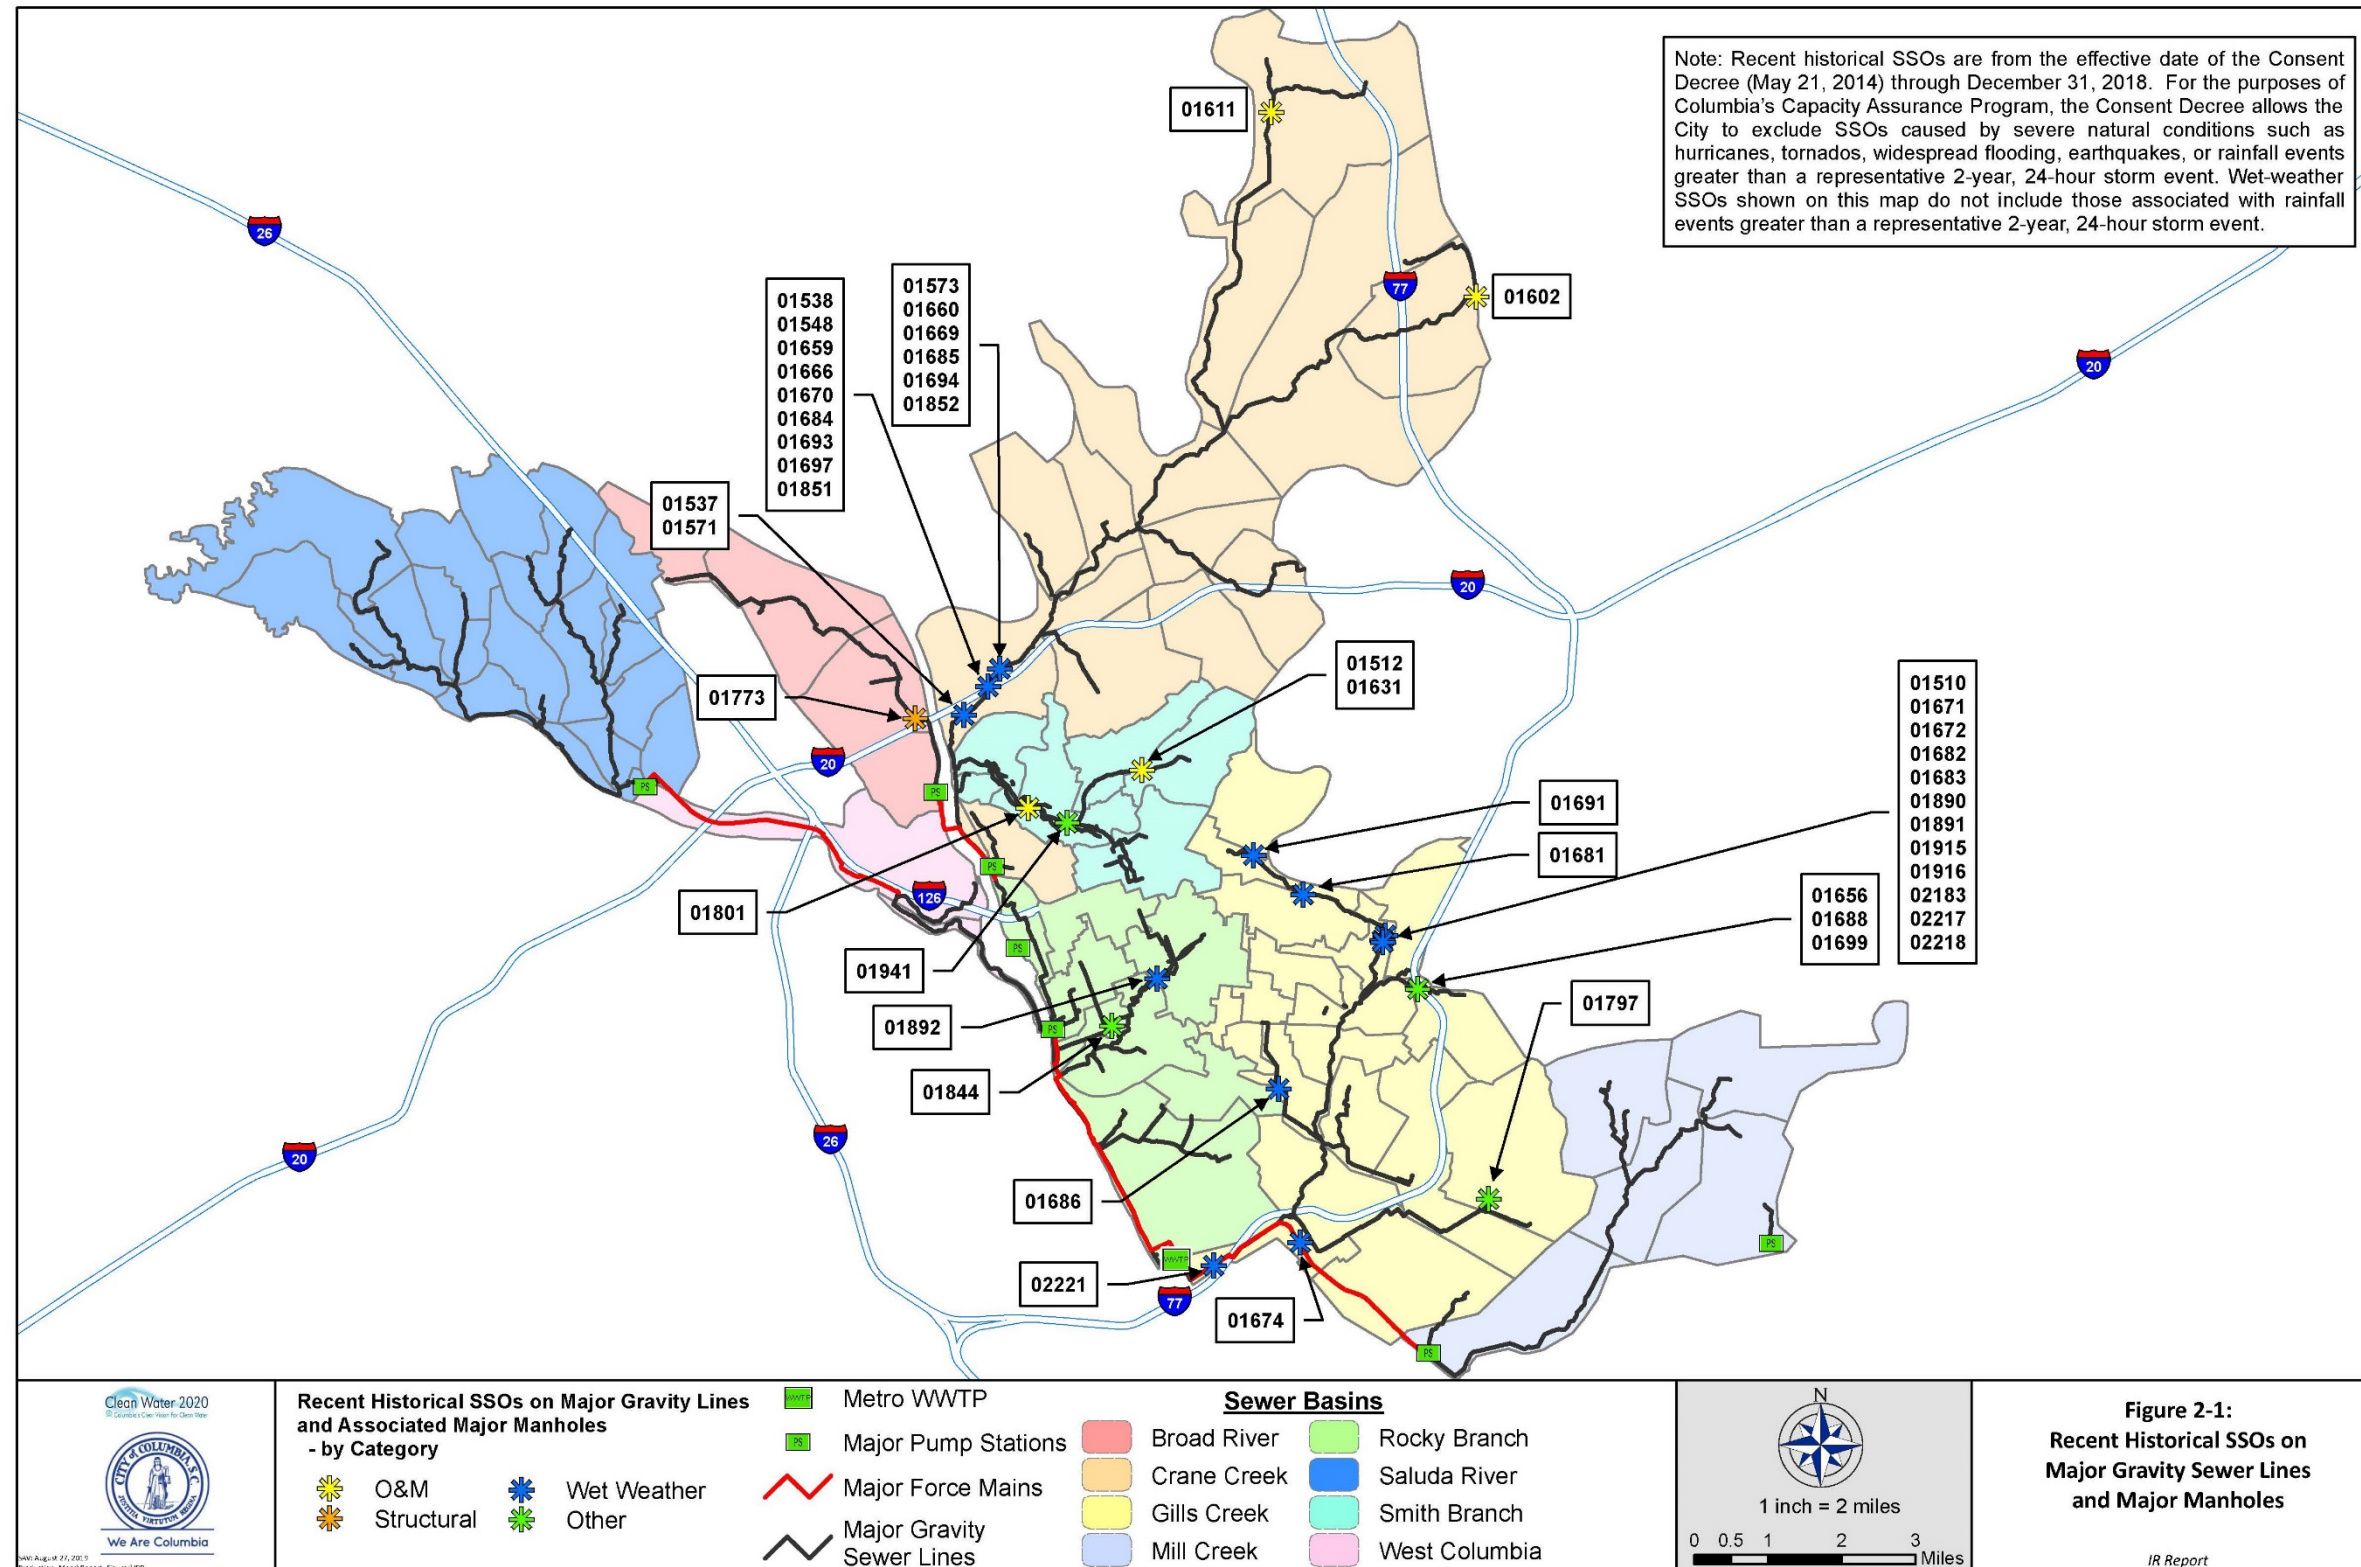
Figure 2-1 – Recent Historical SSOs on Major Gravity Sewer Lines and Major Manholes

SSOs that occurred on Major Gravity Sewer Lines and major manholes from May 21, 2014 (the Effective Date of the CD) through December 31, 2018, were used as recent historical SSOs for this evaluation. The cause of each SSO was recorded at the time of the SSO investigation per the Wastewater Spill Response Standard Operating Procedure (SOP). Causes of the recent historical SSOs on Major Gravity Sewer Lines and major manholes are grouped into the following categories:

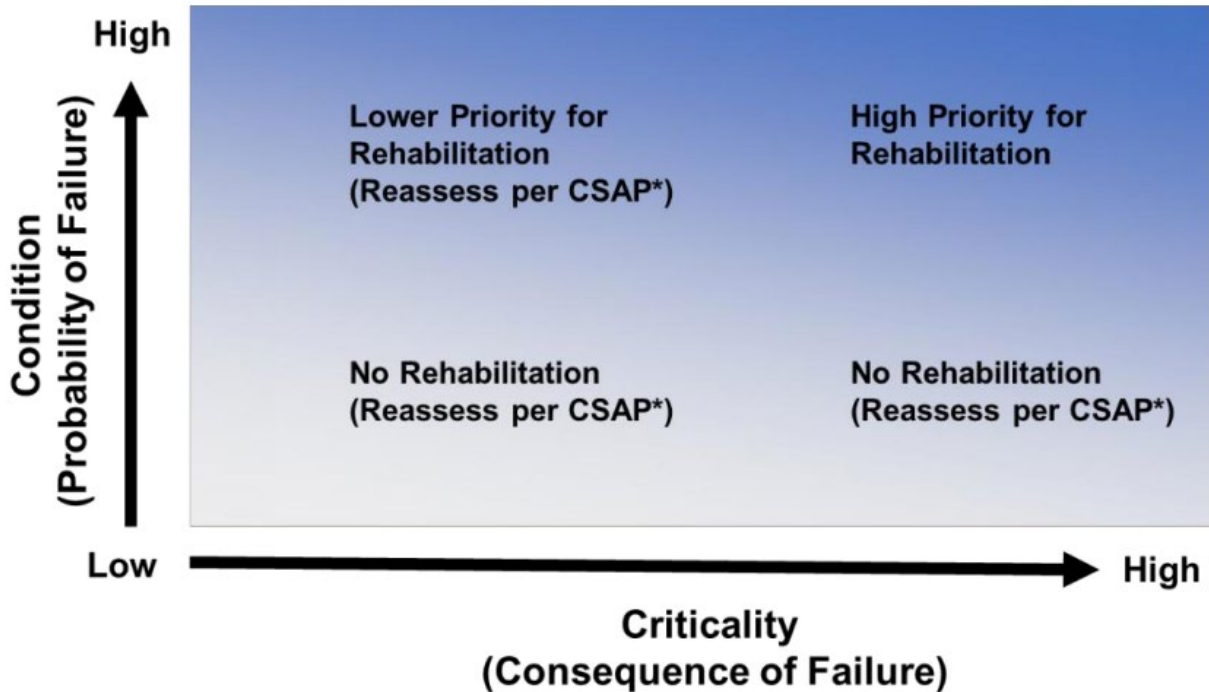
Figure 2-2 – Prioritization Matrix

Infrastructure rehabilitation is prioritized based on the combination of condition and criticality ratings as illustrated in **Figure 2-2**. Major Gravity Sewer Lines and major manholes determined to be in poor condition are considered for rehabilitation projects under the IR Program. Under this analysis, rehabilitation projects can refer to rehabilitation of the current asset, replacement of the current asset or O&M procedures when it is discovered that the condition rating is based on O&M issues.

*Assets that are not scheduled for rehabilitation should be reassessed, as needed, based on the frequencies given in the CSAP. Per Section 4.2 of the CSAP, high priority WCTS components, which are those that are both highly critical and suspected to be in poor condition, will receive the most frequent assessment. Other WCTS components that are highly critical, but not suspected to be in poor condition, will receive a medium frequency assessment to determine their condition. Remaining WCTS components will be assessed with lower frequency to determine if field investigations are needed.

Infrastructure rehabilitation is prioritized based on the combination of condition and criticality ratings as illustrated in Figure 2-2. Major Pump Stations determined to be in poor condition are considered for rehabilitation projects under the IR Program. Under this analysis, rehabilitation projects can refer to rehabilitation of the current asset, replacement of the current asset or O&M procedures when it is discovered that the condition rating is based on O&M issues.

Infrastructure rehabilitation is prioritized based on the combination of condition and criticality ratings as illustrated in Figures 2-2 and 2-3. Major Force Main segments determined to be in poor condition are considered for rehabilitation projects under the IR Program. Under this analysis, rehabilitation projects can refer to rehabilitation of the current asset, replacement of the current asset or O&M procedures when it is discovered that the condition rating is based on O&M issues.

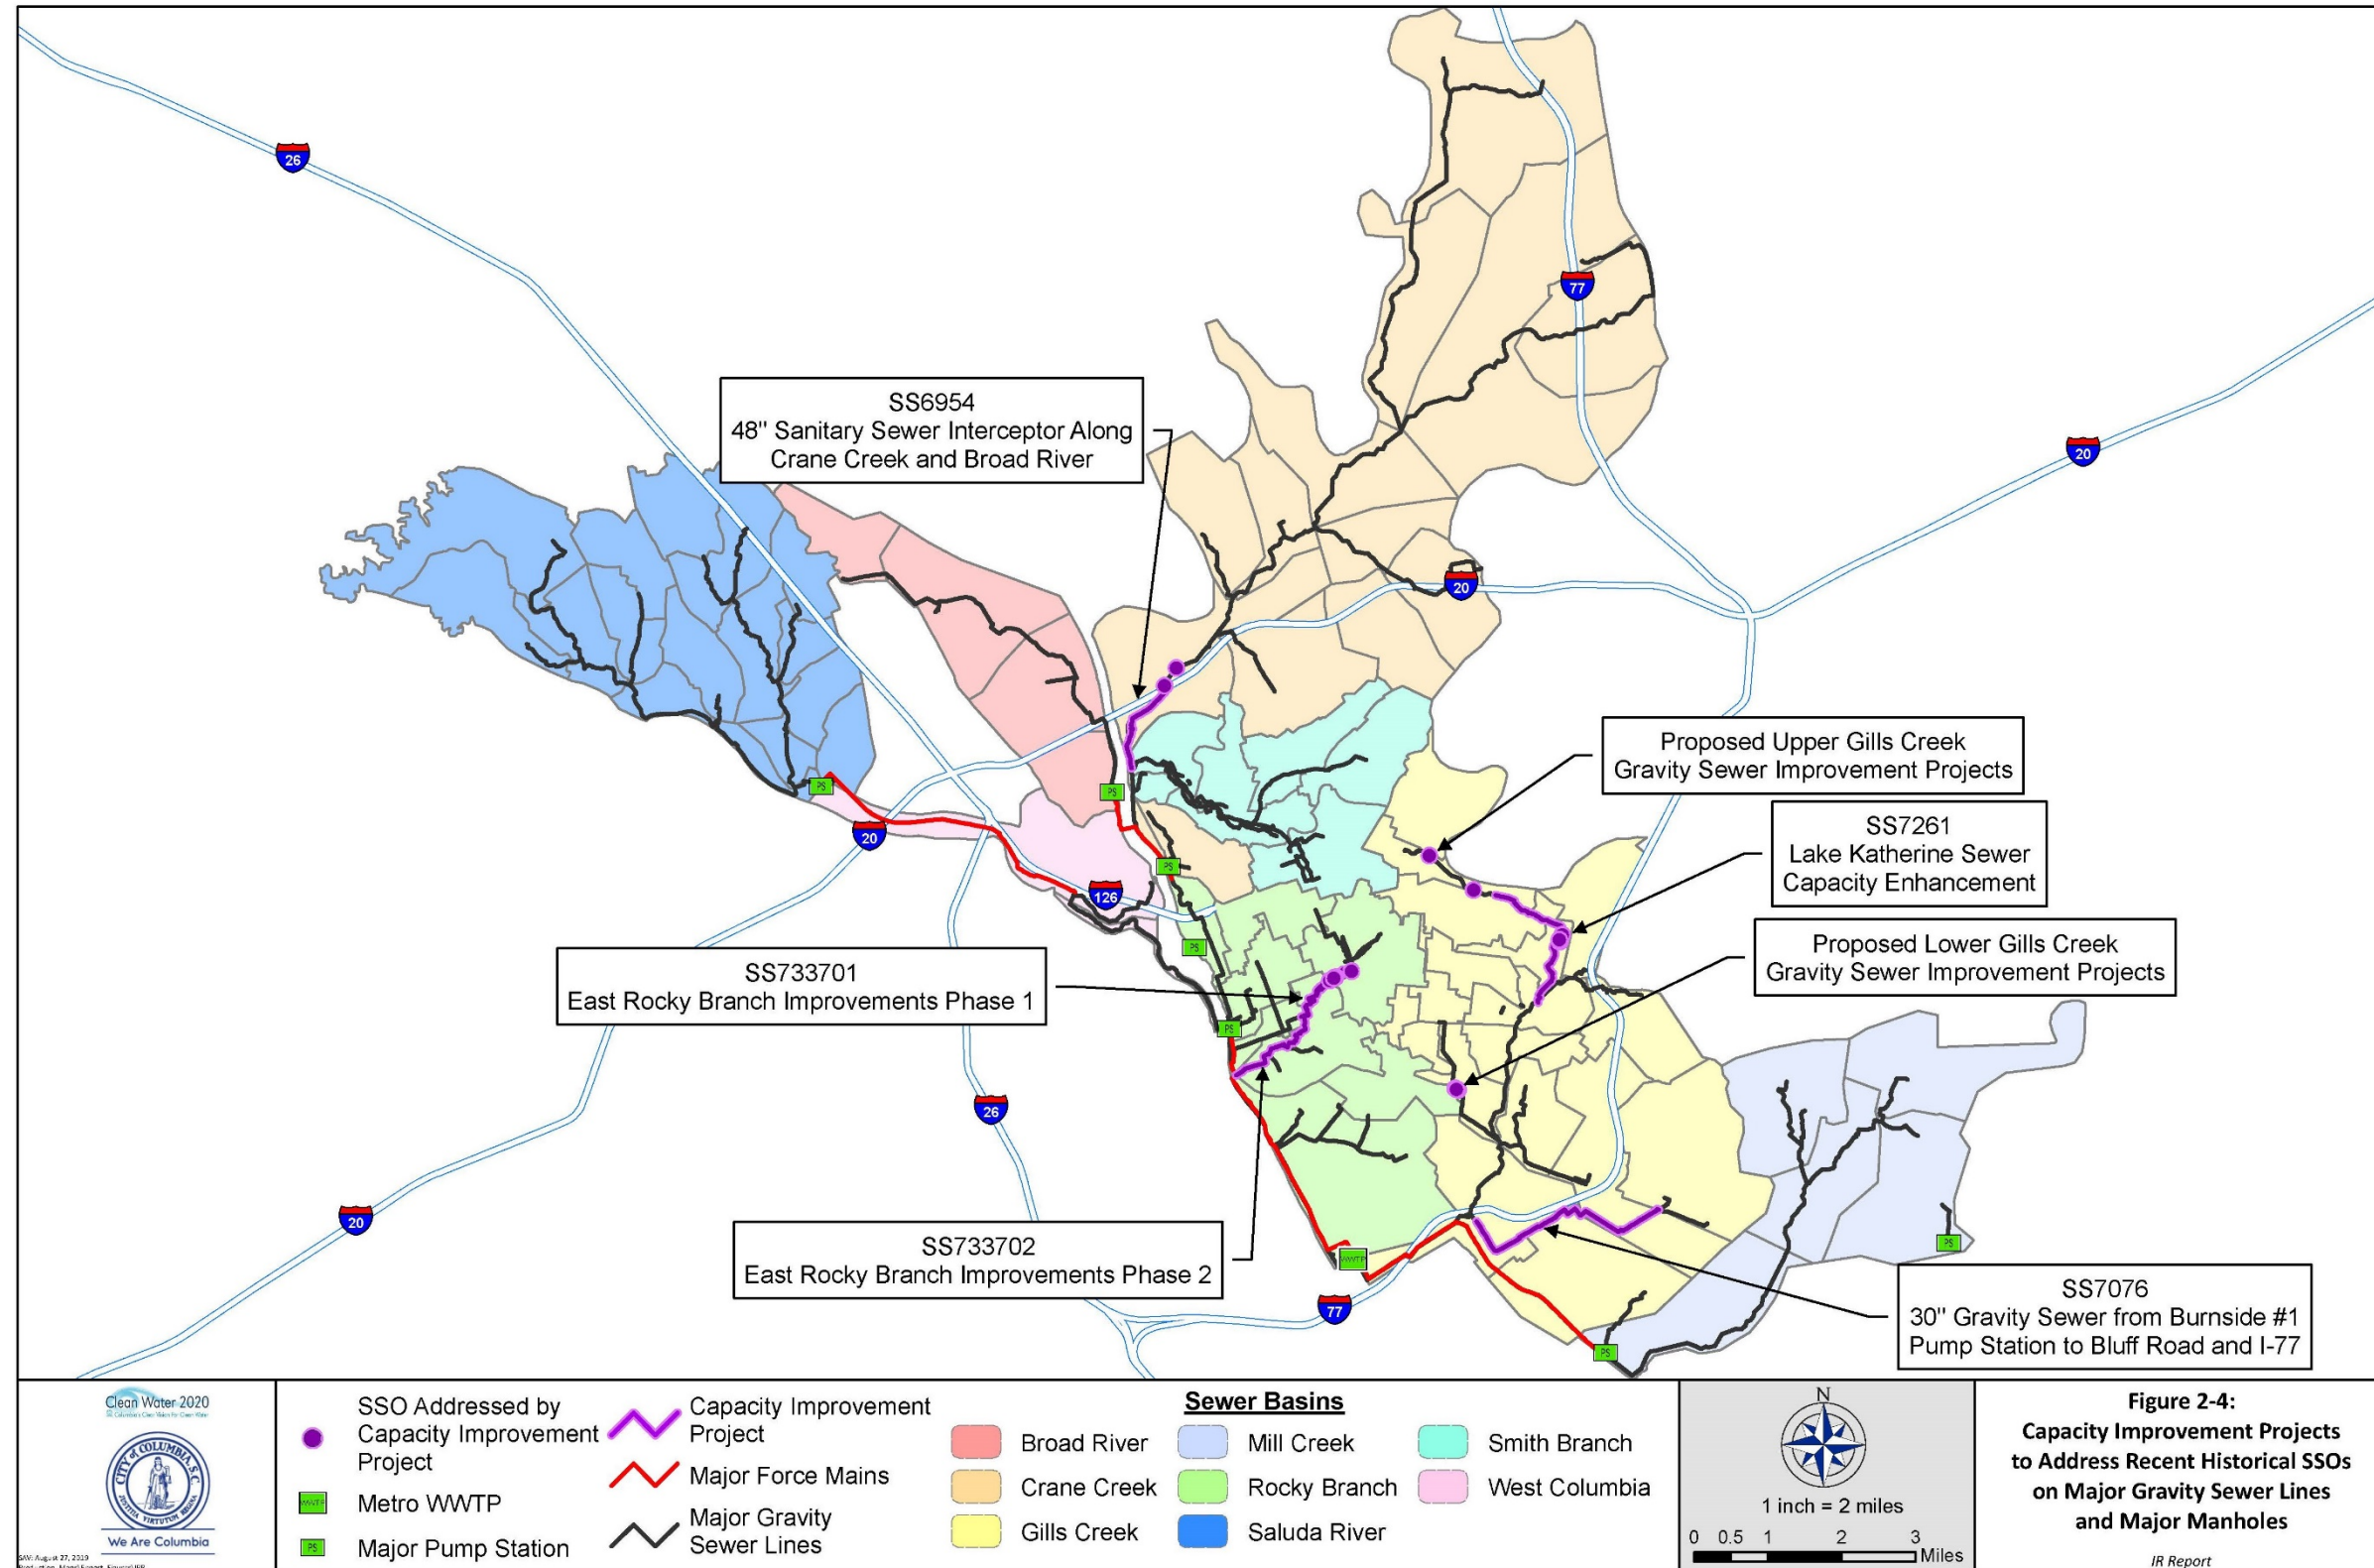
Figure 2-4 – Capacity Improvement Projects to Address Recent Historical SSOs on Major Gravity Sewer Lines and Major Manholes

The projects listed in **Table 2-4**, with locations shown on **Figure 2-4**, address the root cause of the SSOs as determined through review of SSO investigations, CSAP assessment, hydraulic modeling, or other information. Both projects listed in Table 2-4 are capacity improvements to address conditions causing multiple recent wet weather SSOs on Major Gravity Sewer Lines or major manholes.

The projects listed in **Table 2-5**, with locations shown on Figure 2-4, are capacity improvements to address the root cause of a single recent historical wet weather SSO as determined through review of SSO investigations, CSAP assessment, hydraulic modeling, or other information. Find and Fix actions, as listed

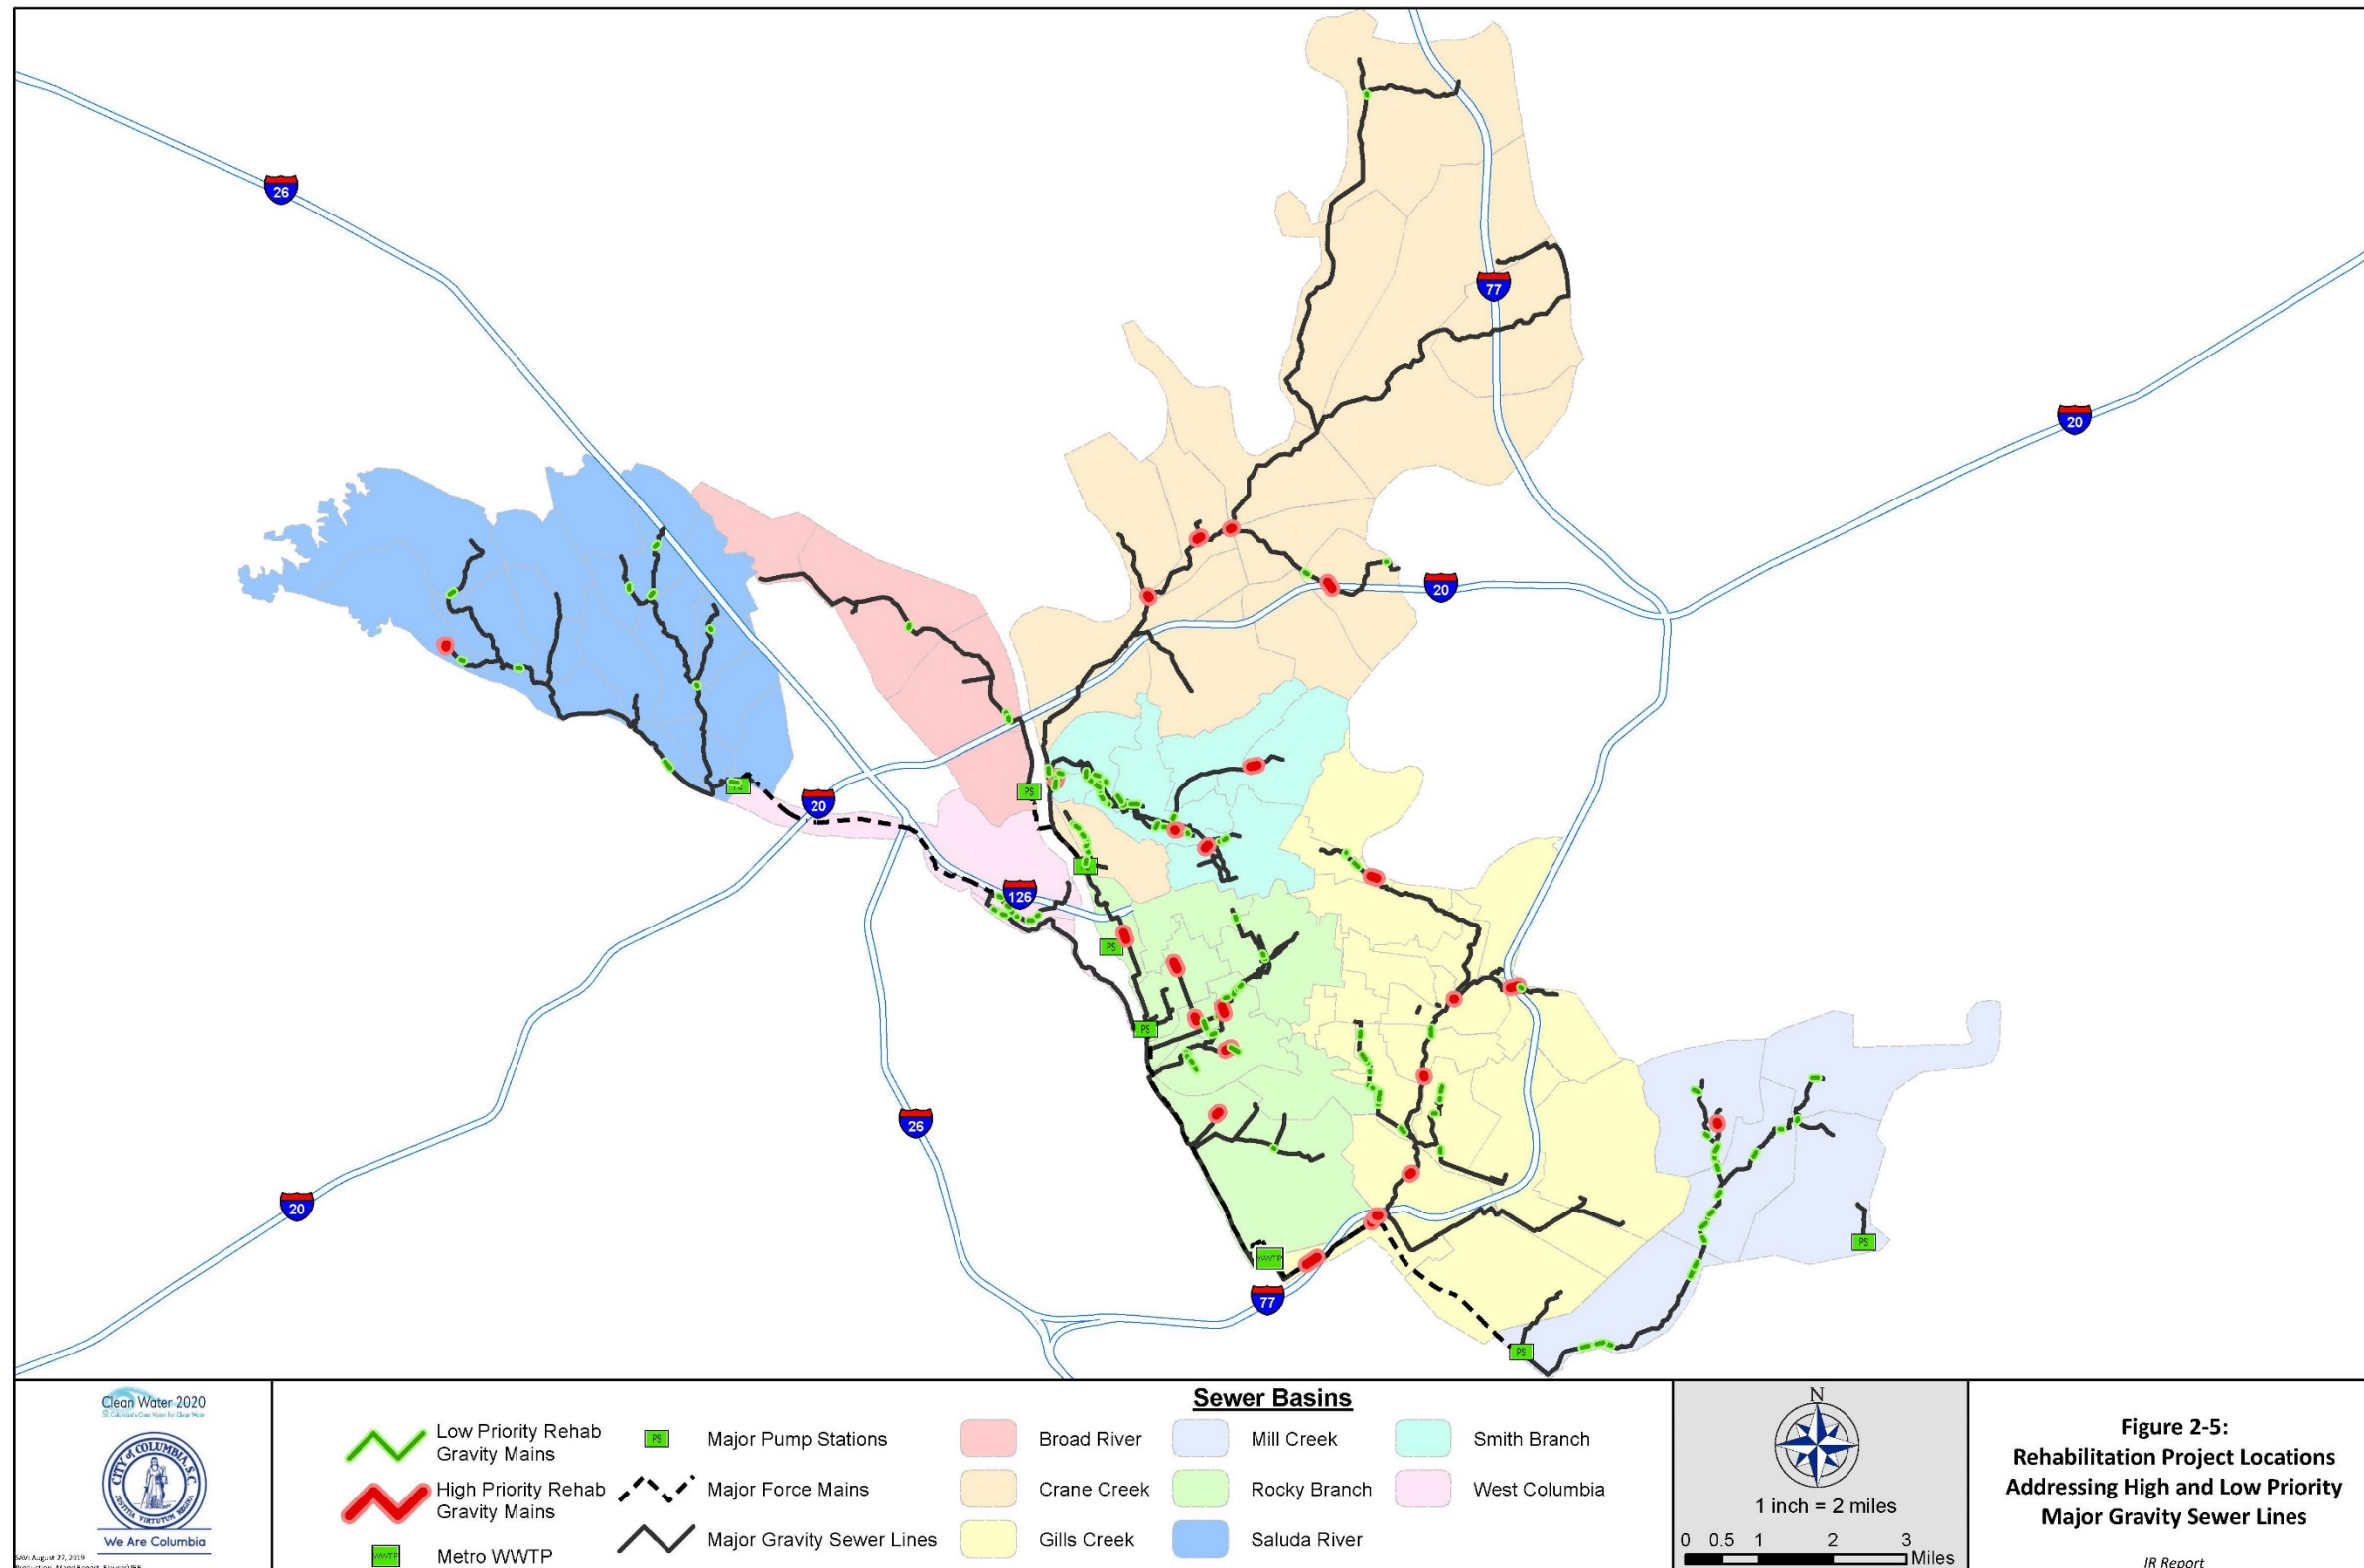
Figure 2-5 – Rehabilitation Project Locations Addressing High and Low Priority Major Gravity Sewer Lines

Additional proposed projects were identified to address the most critical Major Gravity Sewer Lines and major manholes in the poorest condition based on defect ratings or other information collected through the CSAP assessments and professional judgment, but that have not resulted in a recent historical SSO. Within the prioritization matrix, these assets have the next highest condition ratings after those assets with recent historical SSO(s). These assets are further prioritized based on criticality with one group considered high (most critical) priority for rehabilitation and the other considered low (less critical) priority for rehabilitation.

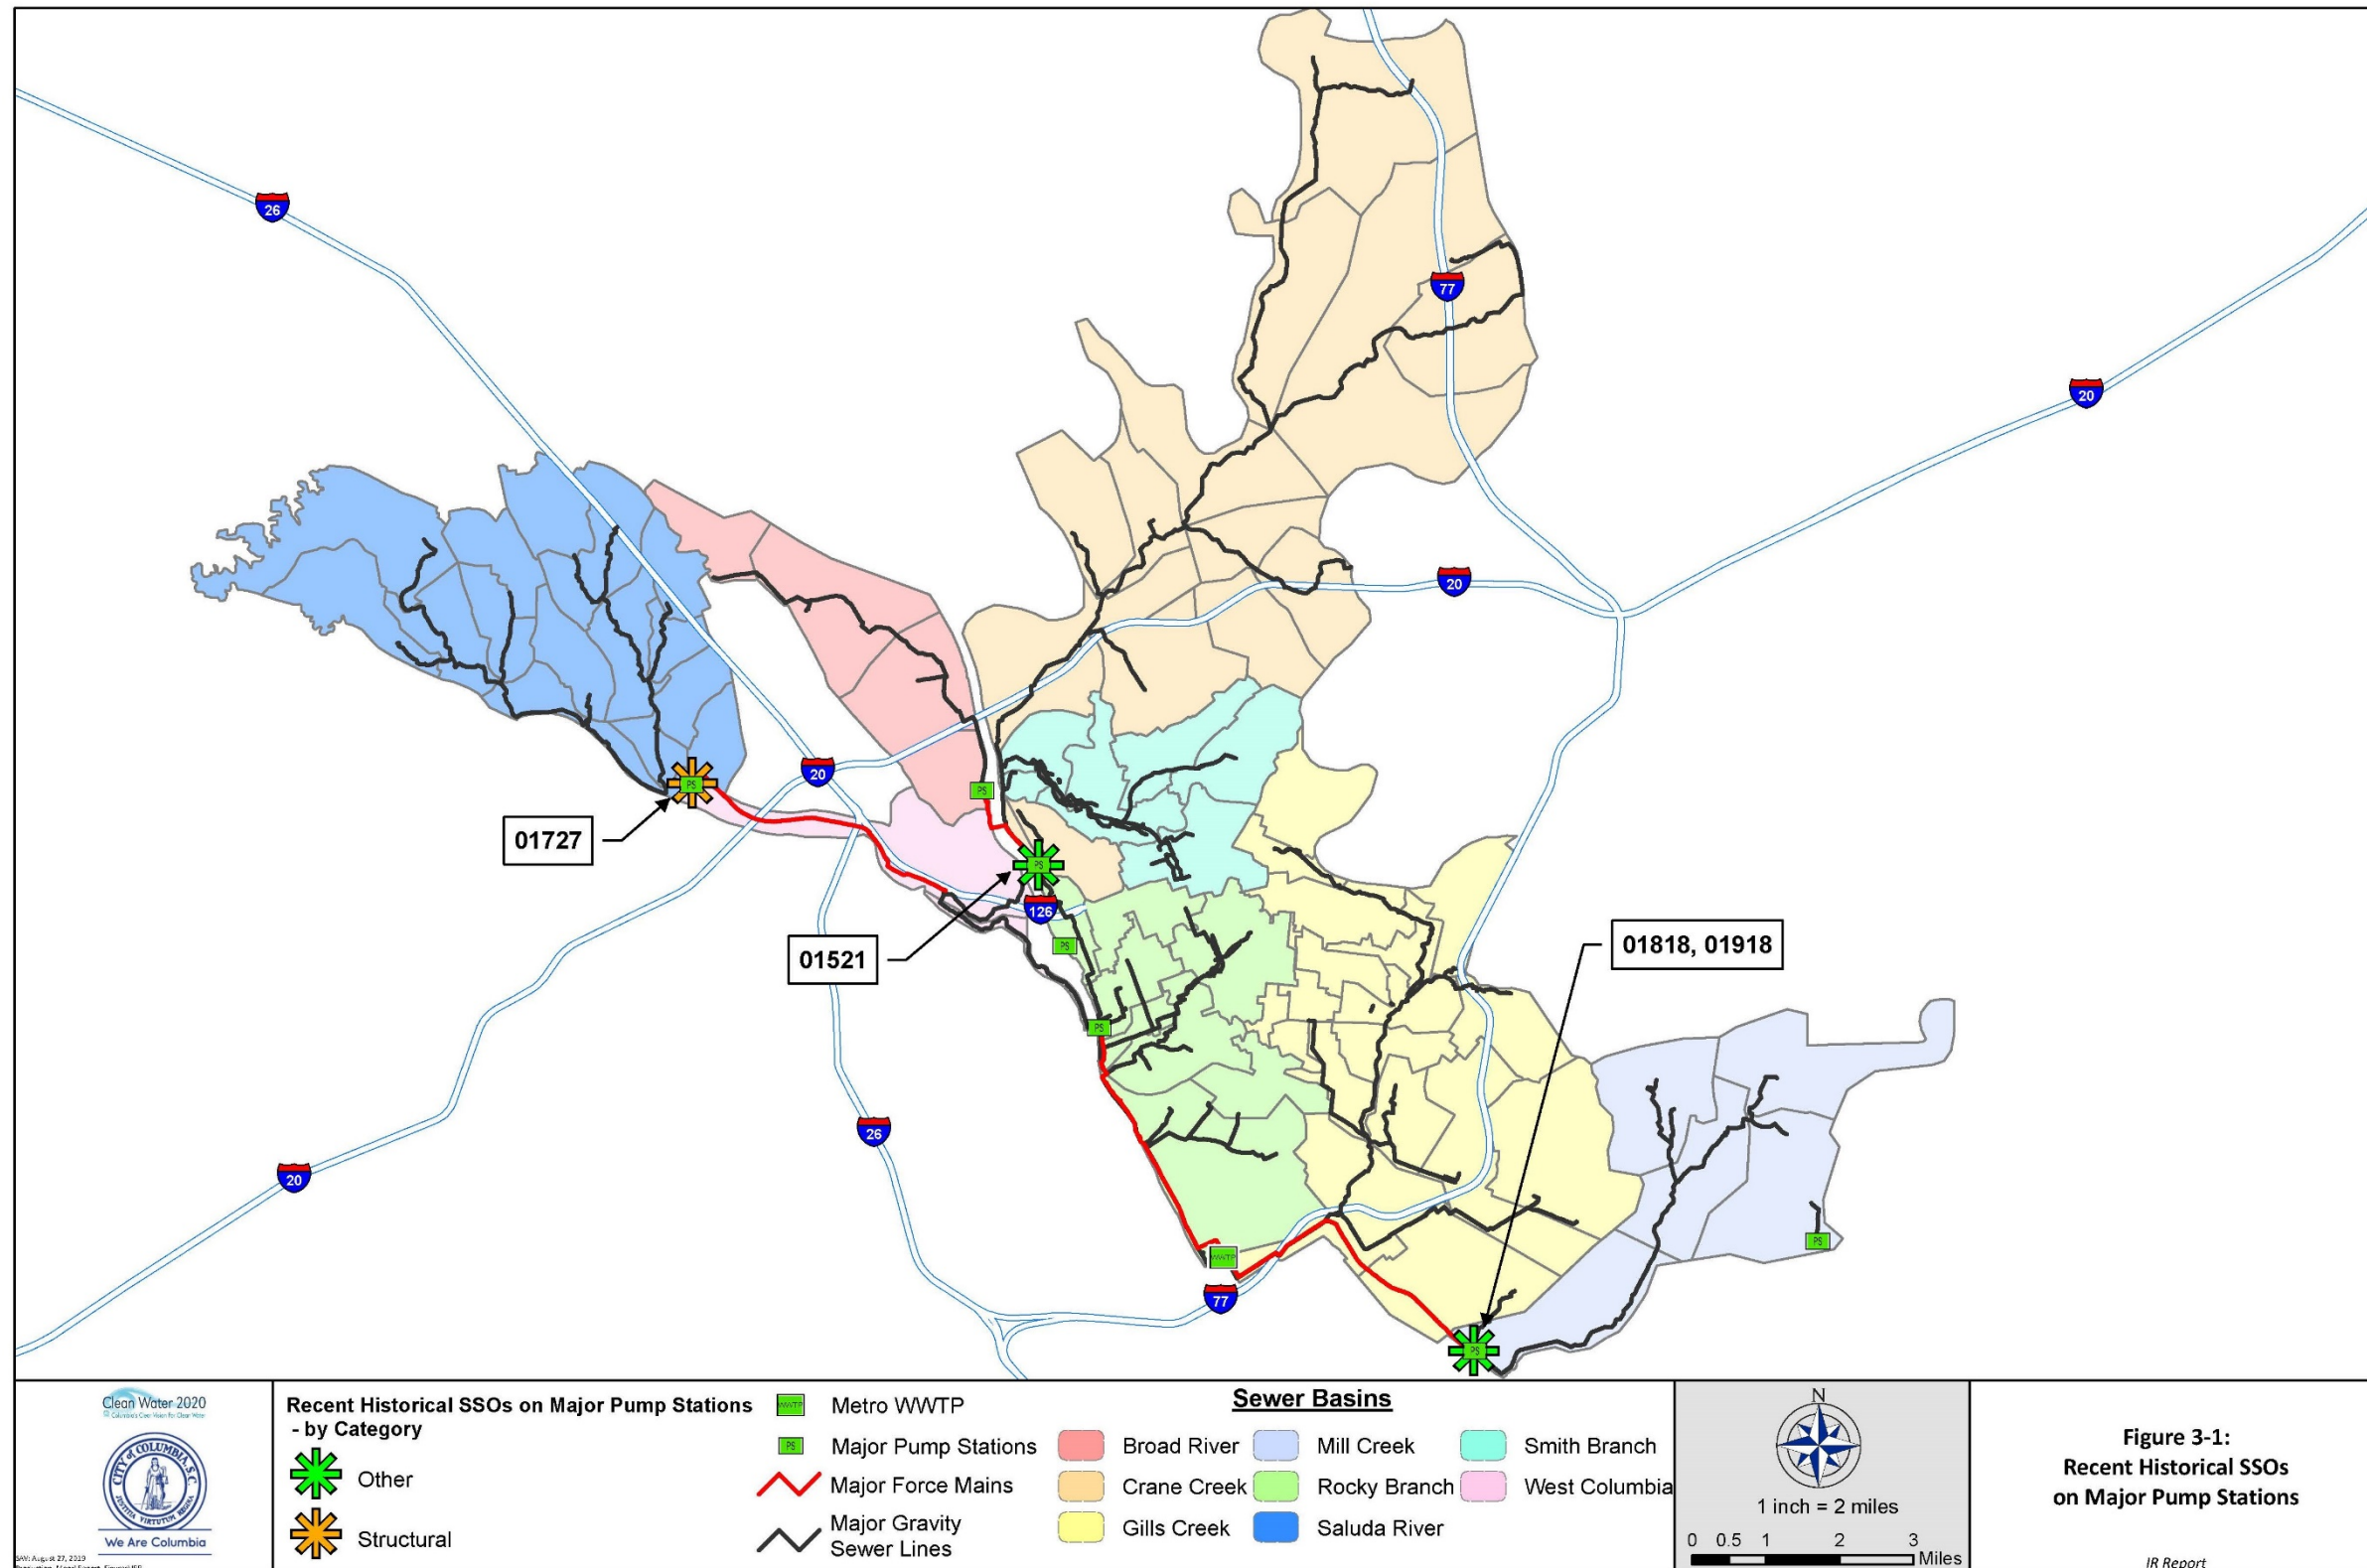
Figure 3-1 – Recent Historical SSOs on Major Pump Stations

- 1) Recent historical SSOs occurred from the Effective Date of the CD (May 21, 2014) through December 31, 2018.
- 2) SSO cause recorded at the time of the SSO investigation per the Wastewater Spill Response SOP.
- 3) SSO category is assigned for this evaluation based on the SSO cause. See Section 2.1 for category definitions.
- 4) Estimated SSO volume as listed on the SSO reports to DHEC. Volume is estimated per the Wastewater Spill Response SOP. For unobserved overflows where an estimated volume could not be calculated, the volume was reported as unknown.
