Clean Water 2020 Program

INFRASTRUCTURE REHABILITATION REPORT (IR Report)

August 2019

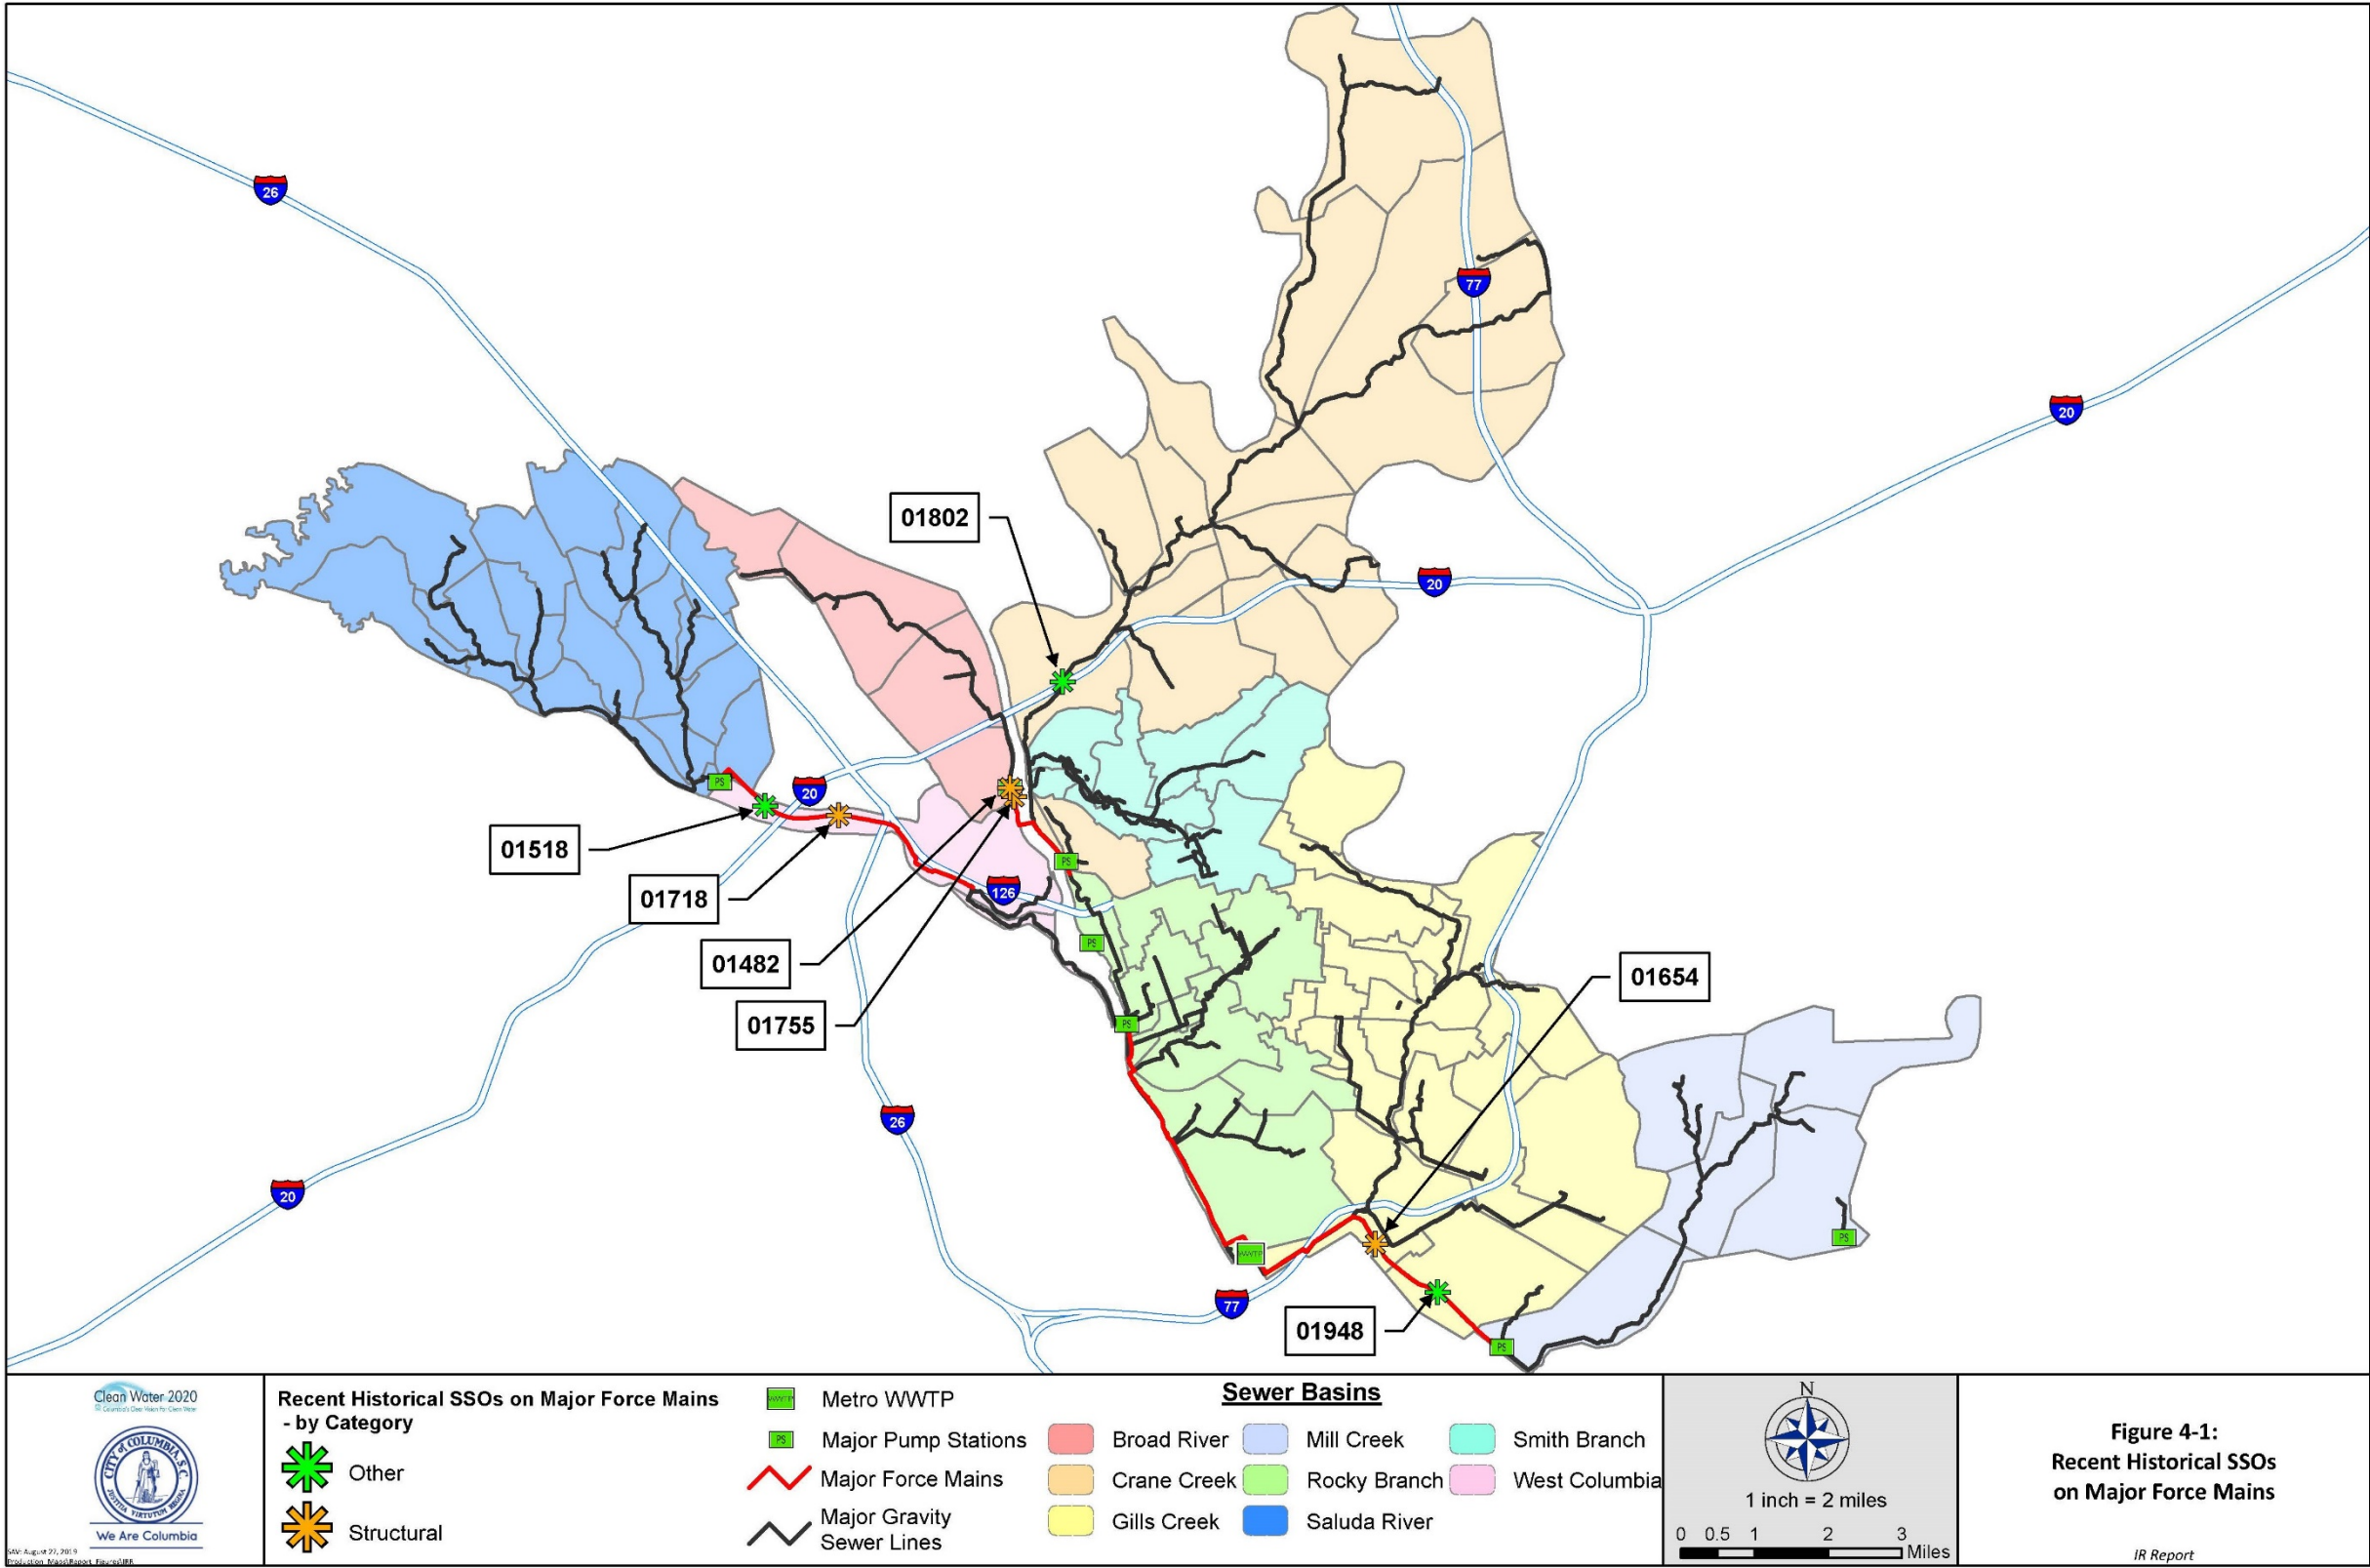
Figure 4-1 – Recent Historical SSOs on Major Force Mains

Recent historical SSOs on major Force Main segments are listed in **Table 4-1** and shown on **Figure 4-1**. None of the recent historical SSOs on major Force Mains are caused by severe natural conditions (see discussion in Section 2.1).

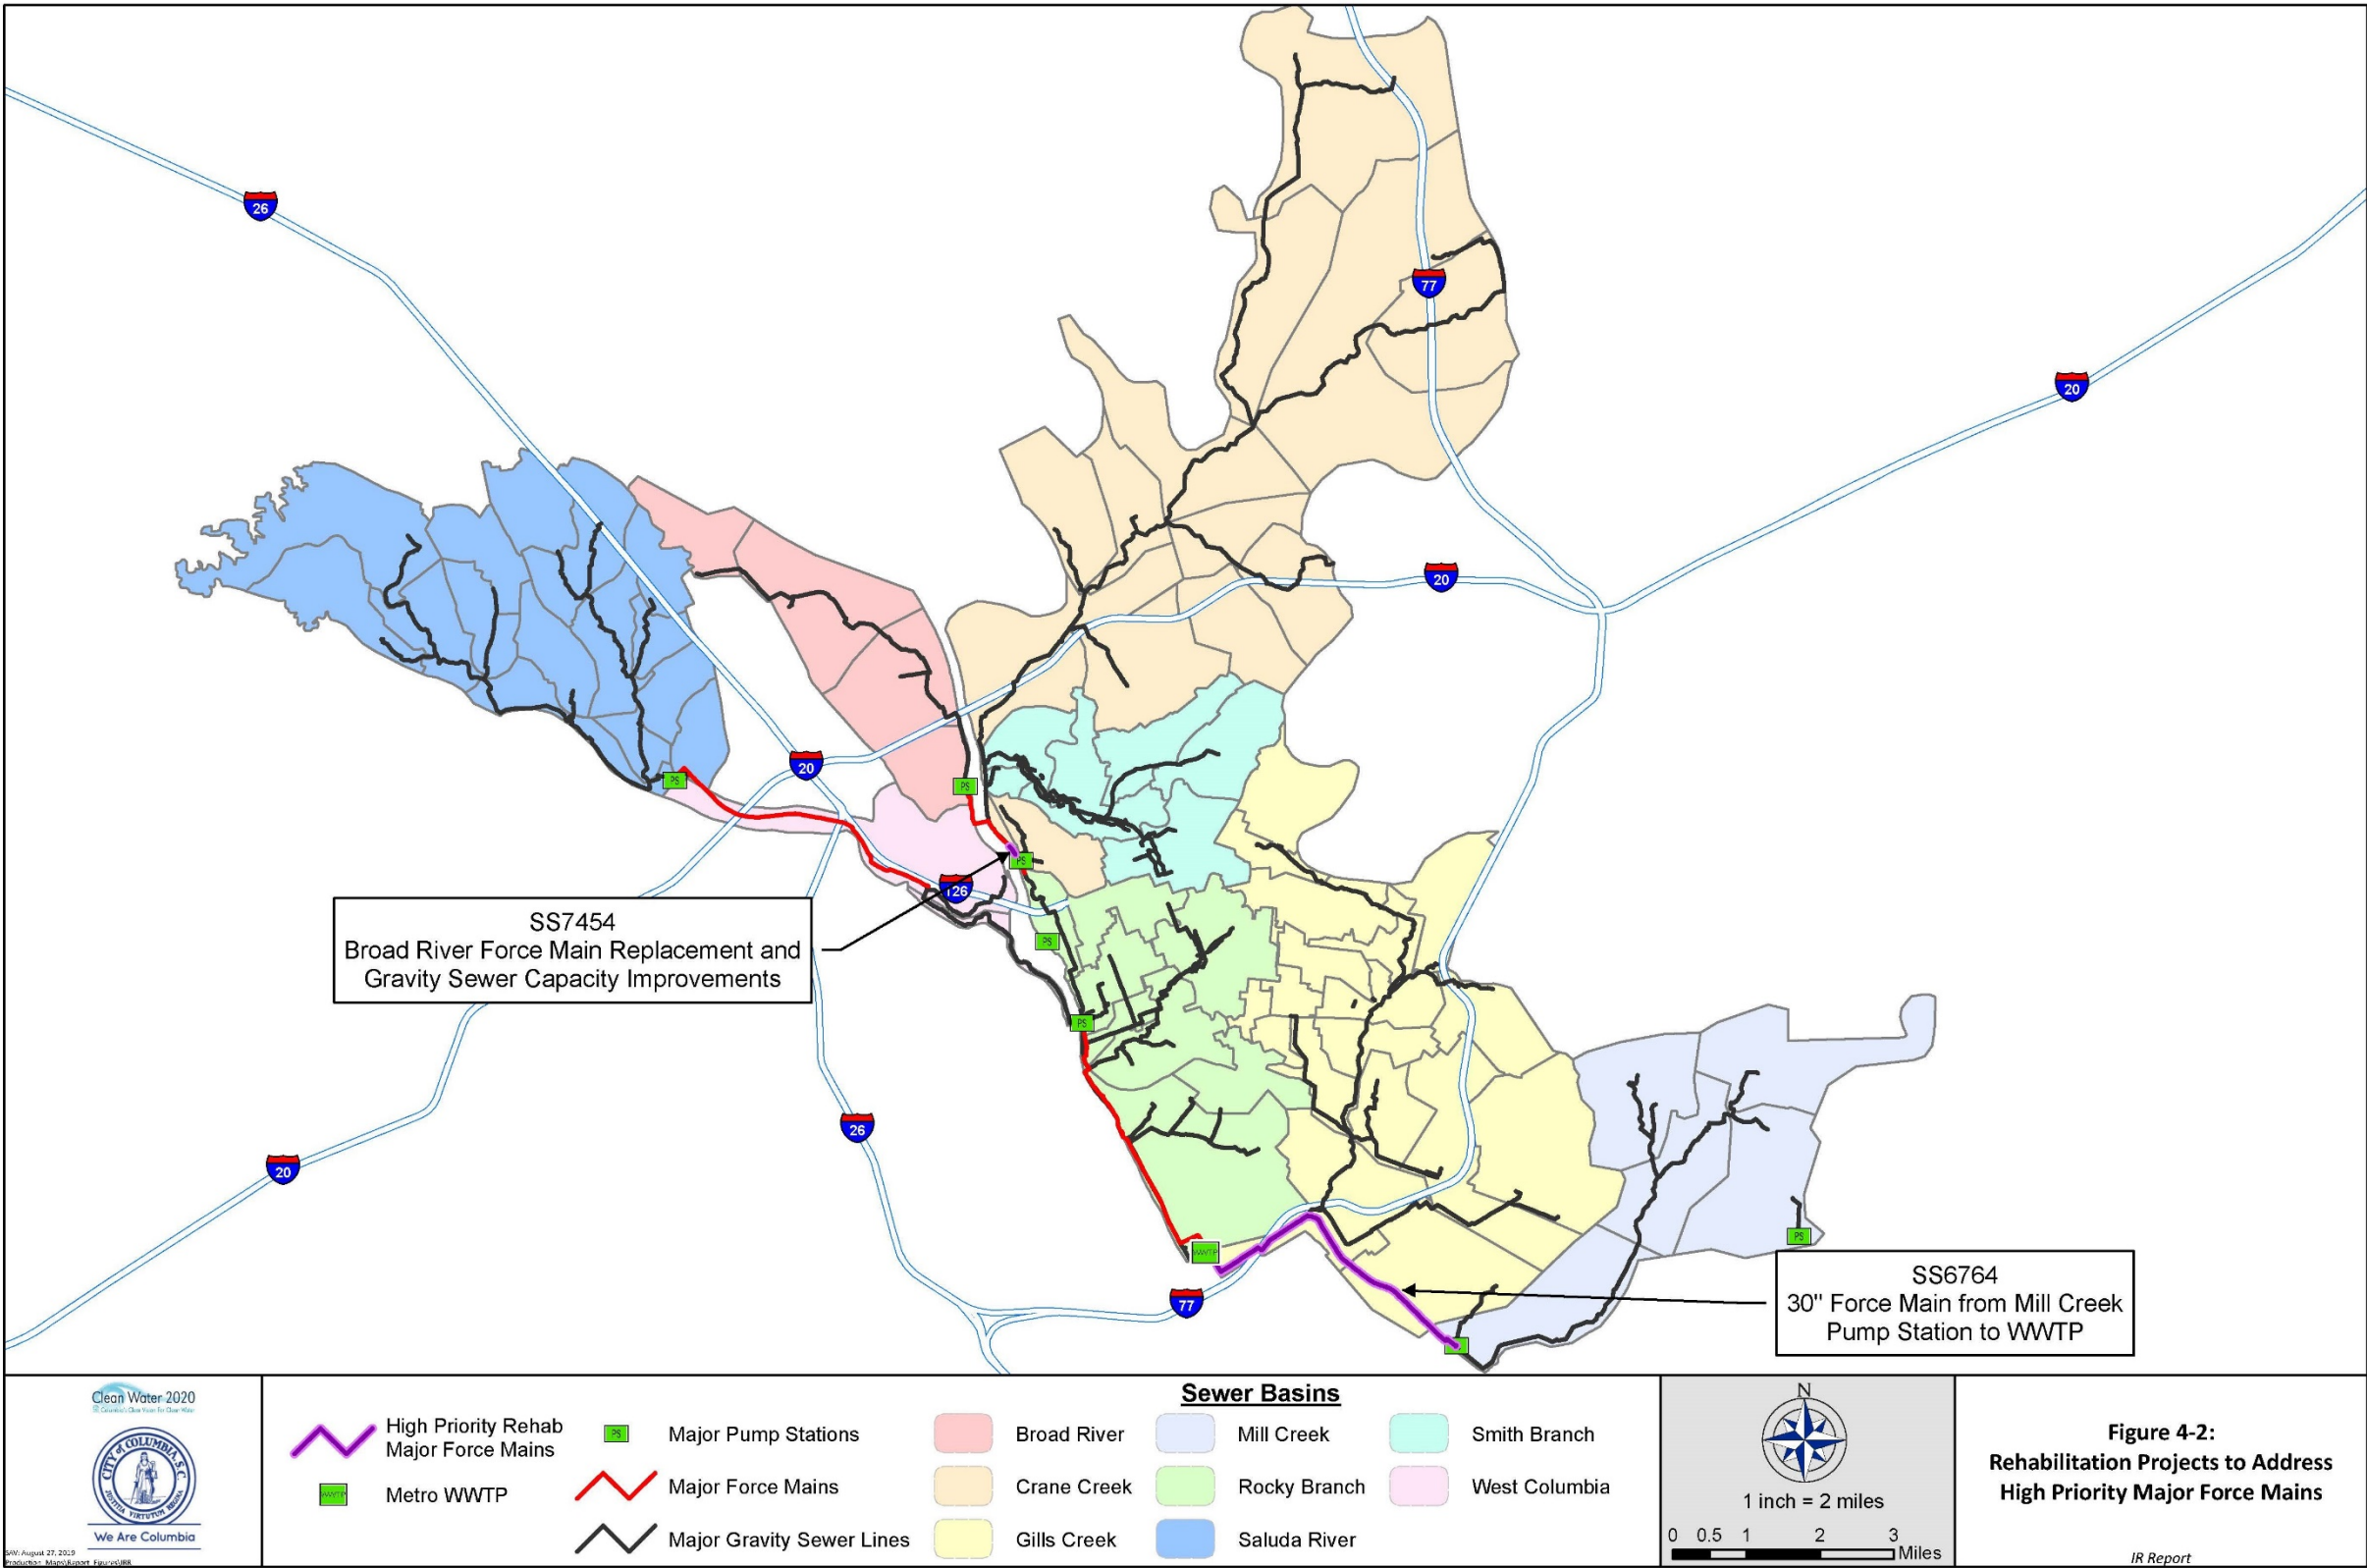
Figure 4-2 – Rehabilitation Projects to Address High Priority Major Force Mains

The projects listed in **Table 4-3**, with locations shown on **Figure 4-2** were identified to address capacity, condition, and other concerns on major Force Main segments that were identified as high priority from the CSAP desktop analysis.

Project Name/Description	Length (LF)
SS6764 30" Force Main from Mill Creek Pump Station to WWTP	24,400
SS7454 Broad River Force Main Replacement and Gravity Sewer Capacity Improvements	700

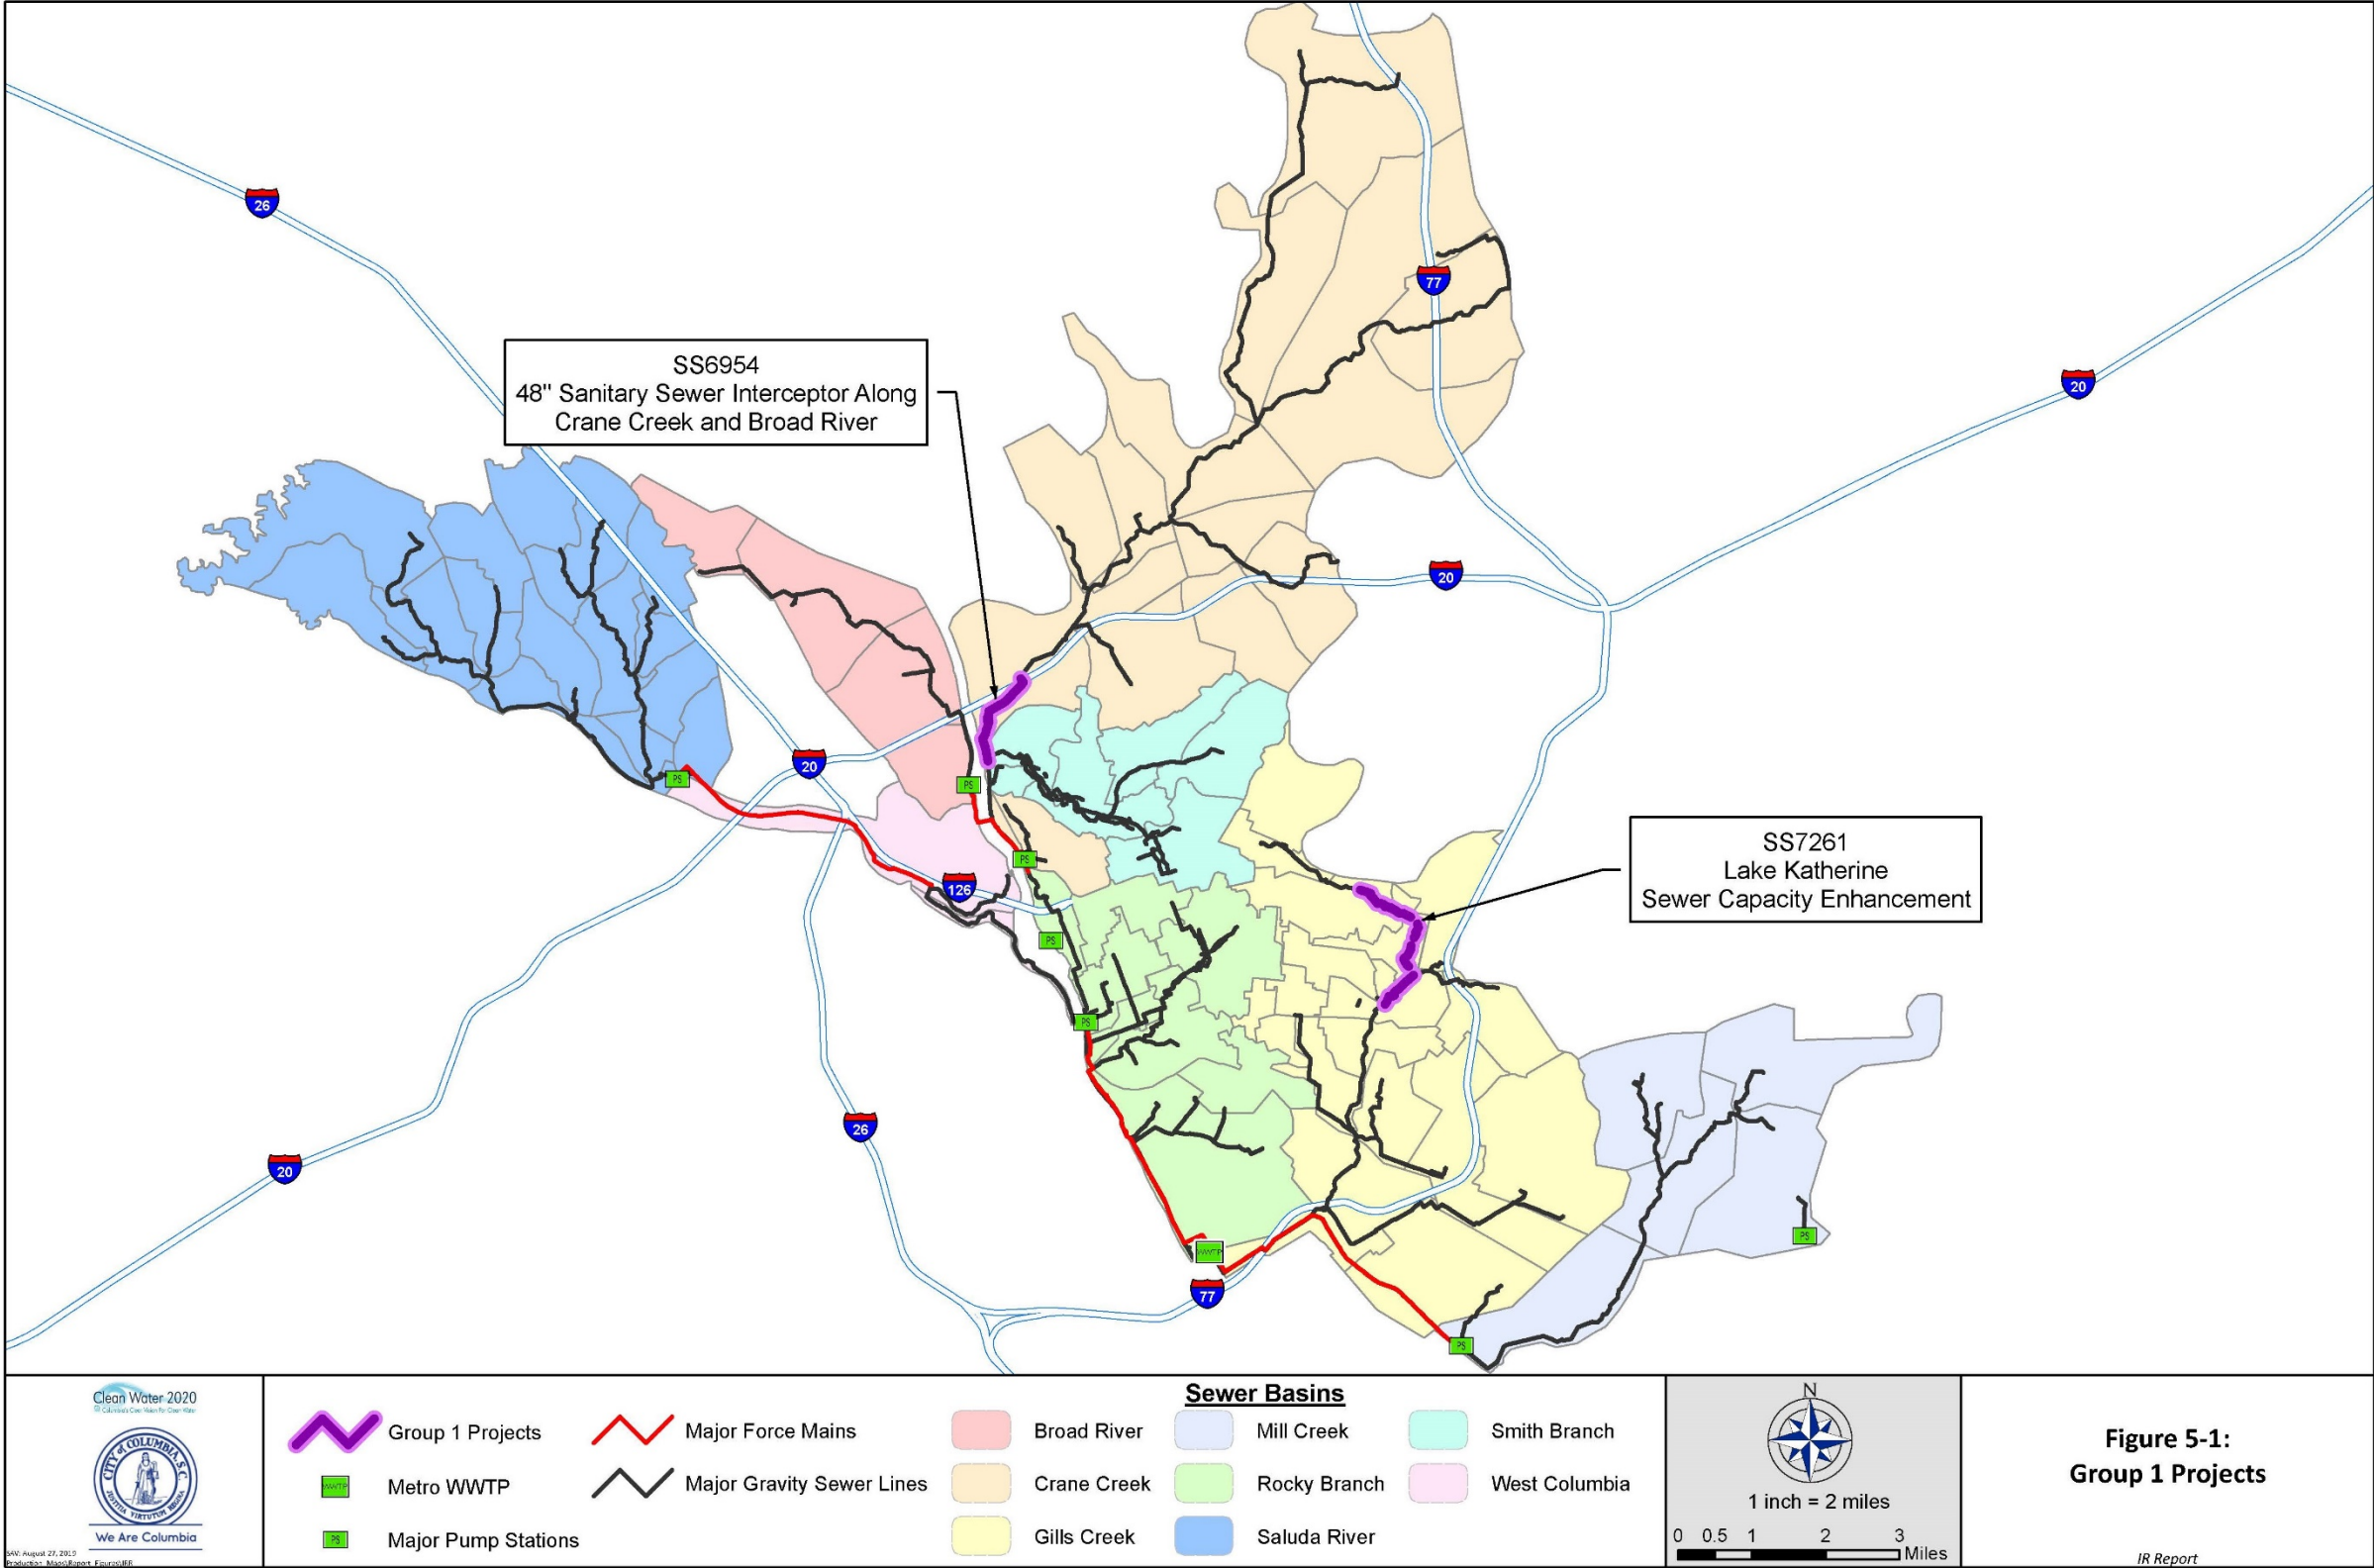
Figure 5-1 – Group 1 Projects

Project Name	Project Description	Recent Historical SSOs (Number of SSOs)	Volume (gallons)
SS6954 – 48" Sanitary Sewer Interceptor Along Crane Creek and Broad River	Approximately 8,000 LF of pipe capacity upgrades	17	4,191,000
SS7261 – Lake Katherine Sewer Capacity Enhancement	Approximately 13,000 LF of pipe capacity upgrades	12	157,000

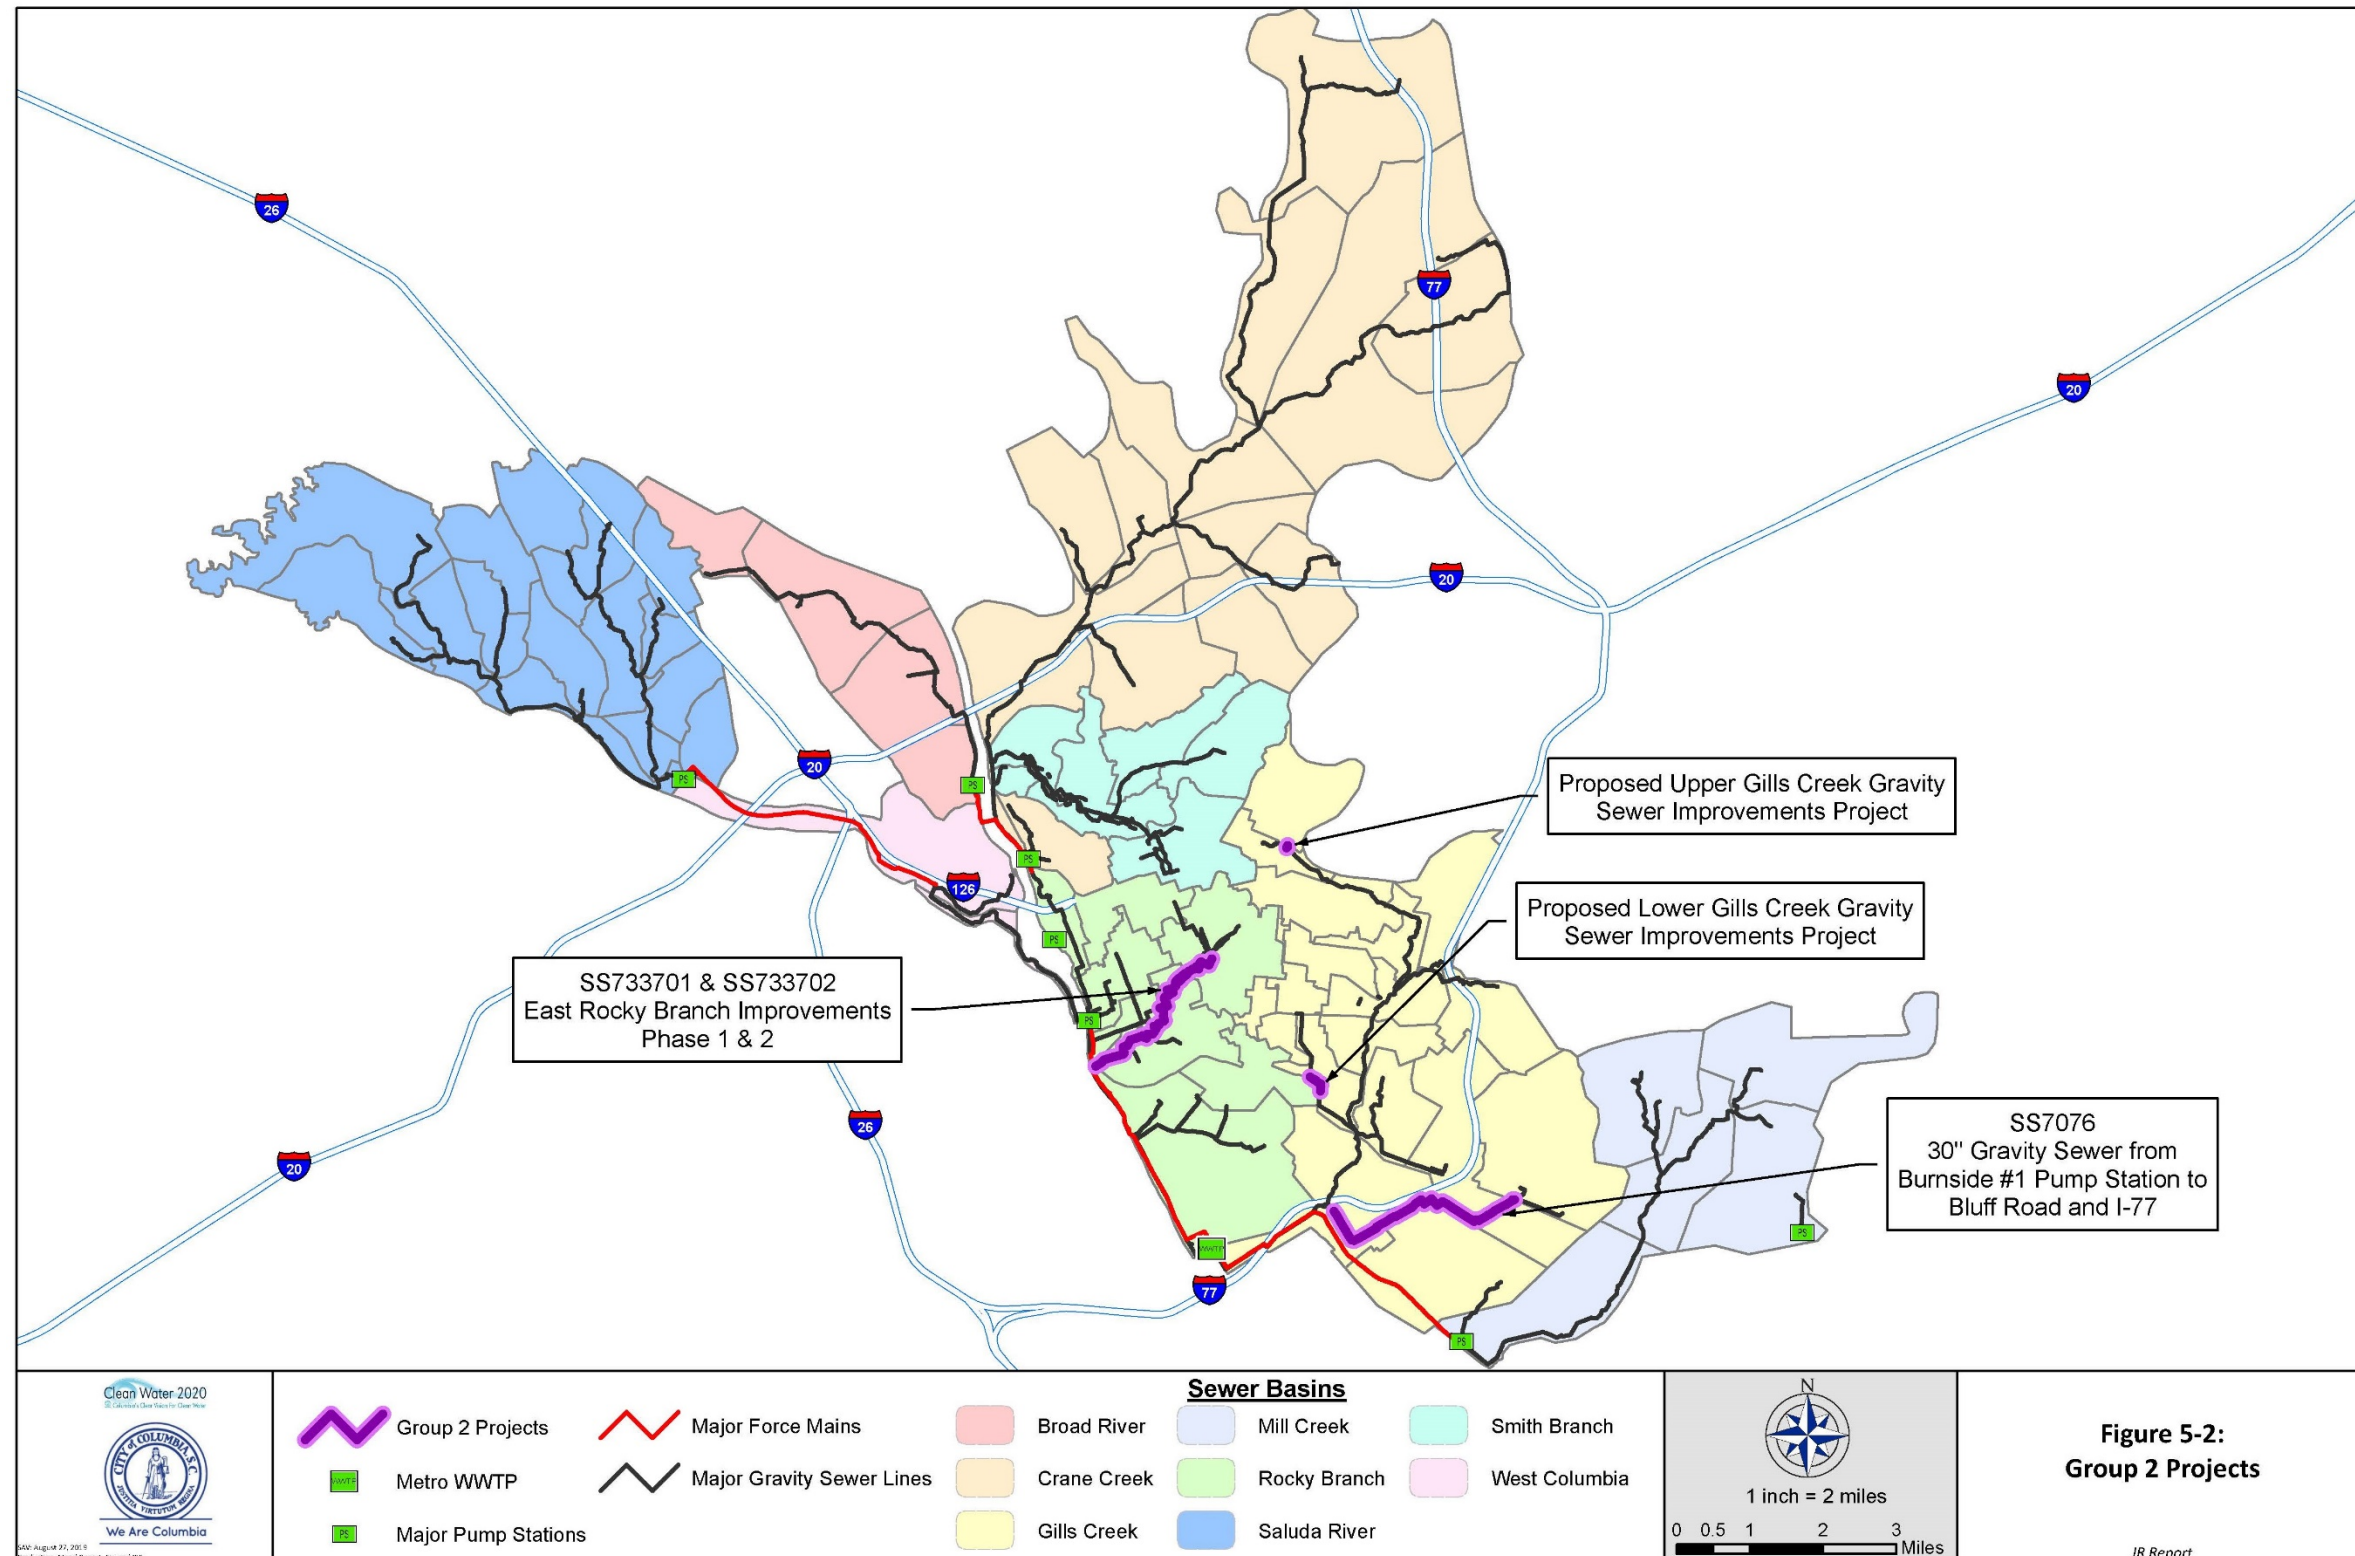
Figure 5-2 – Group 2 Projects

In accordance with the CD, Group 2 projects shall be completed no later than 5 years following EPA and DHEC approval of the IR Report. Group 2 projects address the remaining major components of the WCTS that have experienced a single recent historical SSO with root cause related to the capacity or poor condition of a Major Gravity Sewer Line, major manhole, Major Pump Station, or major Force Main segment from May 21, 2014 (the Effective Date of the CD) through December 31, 2018.

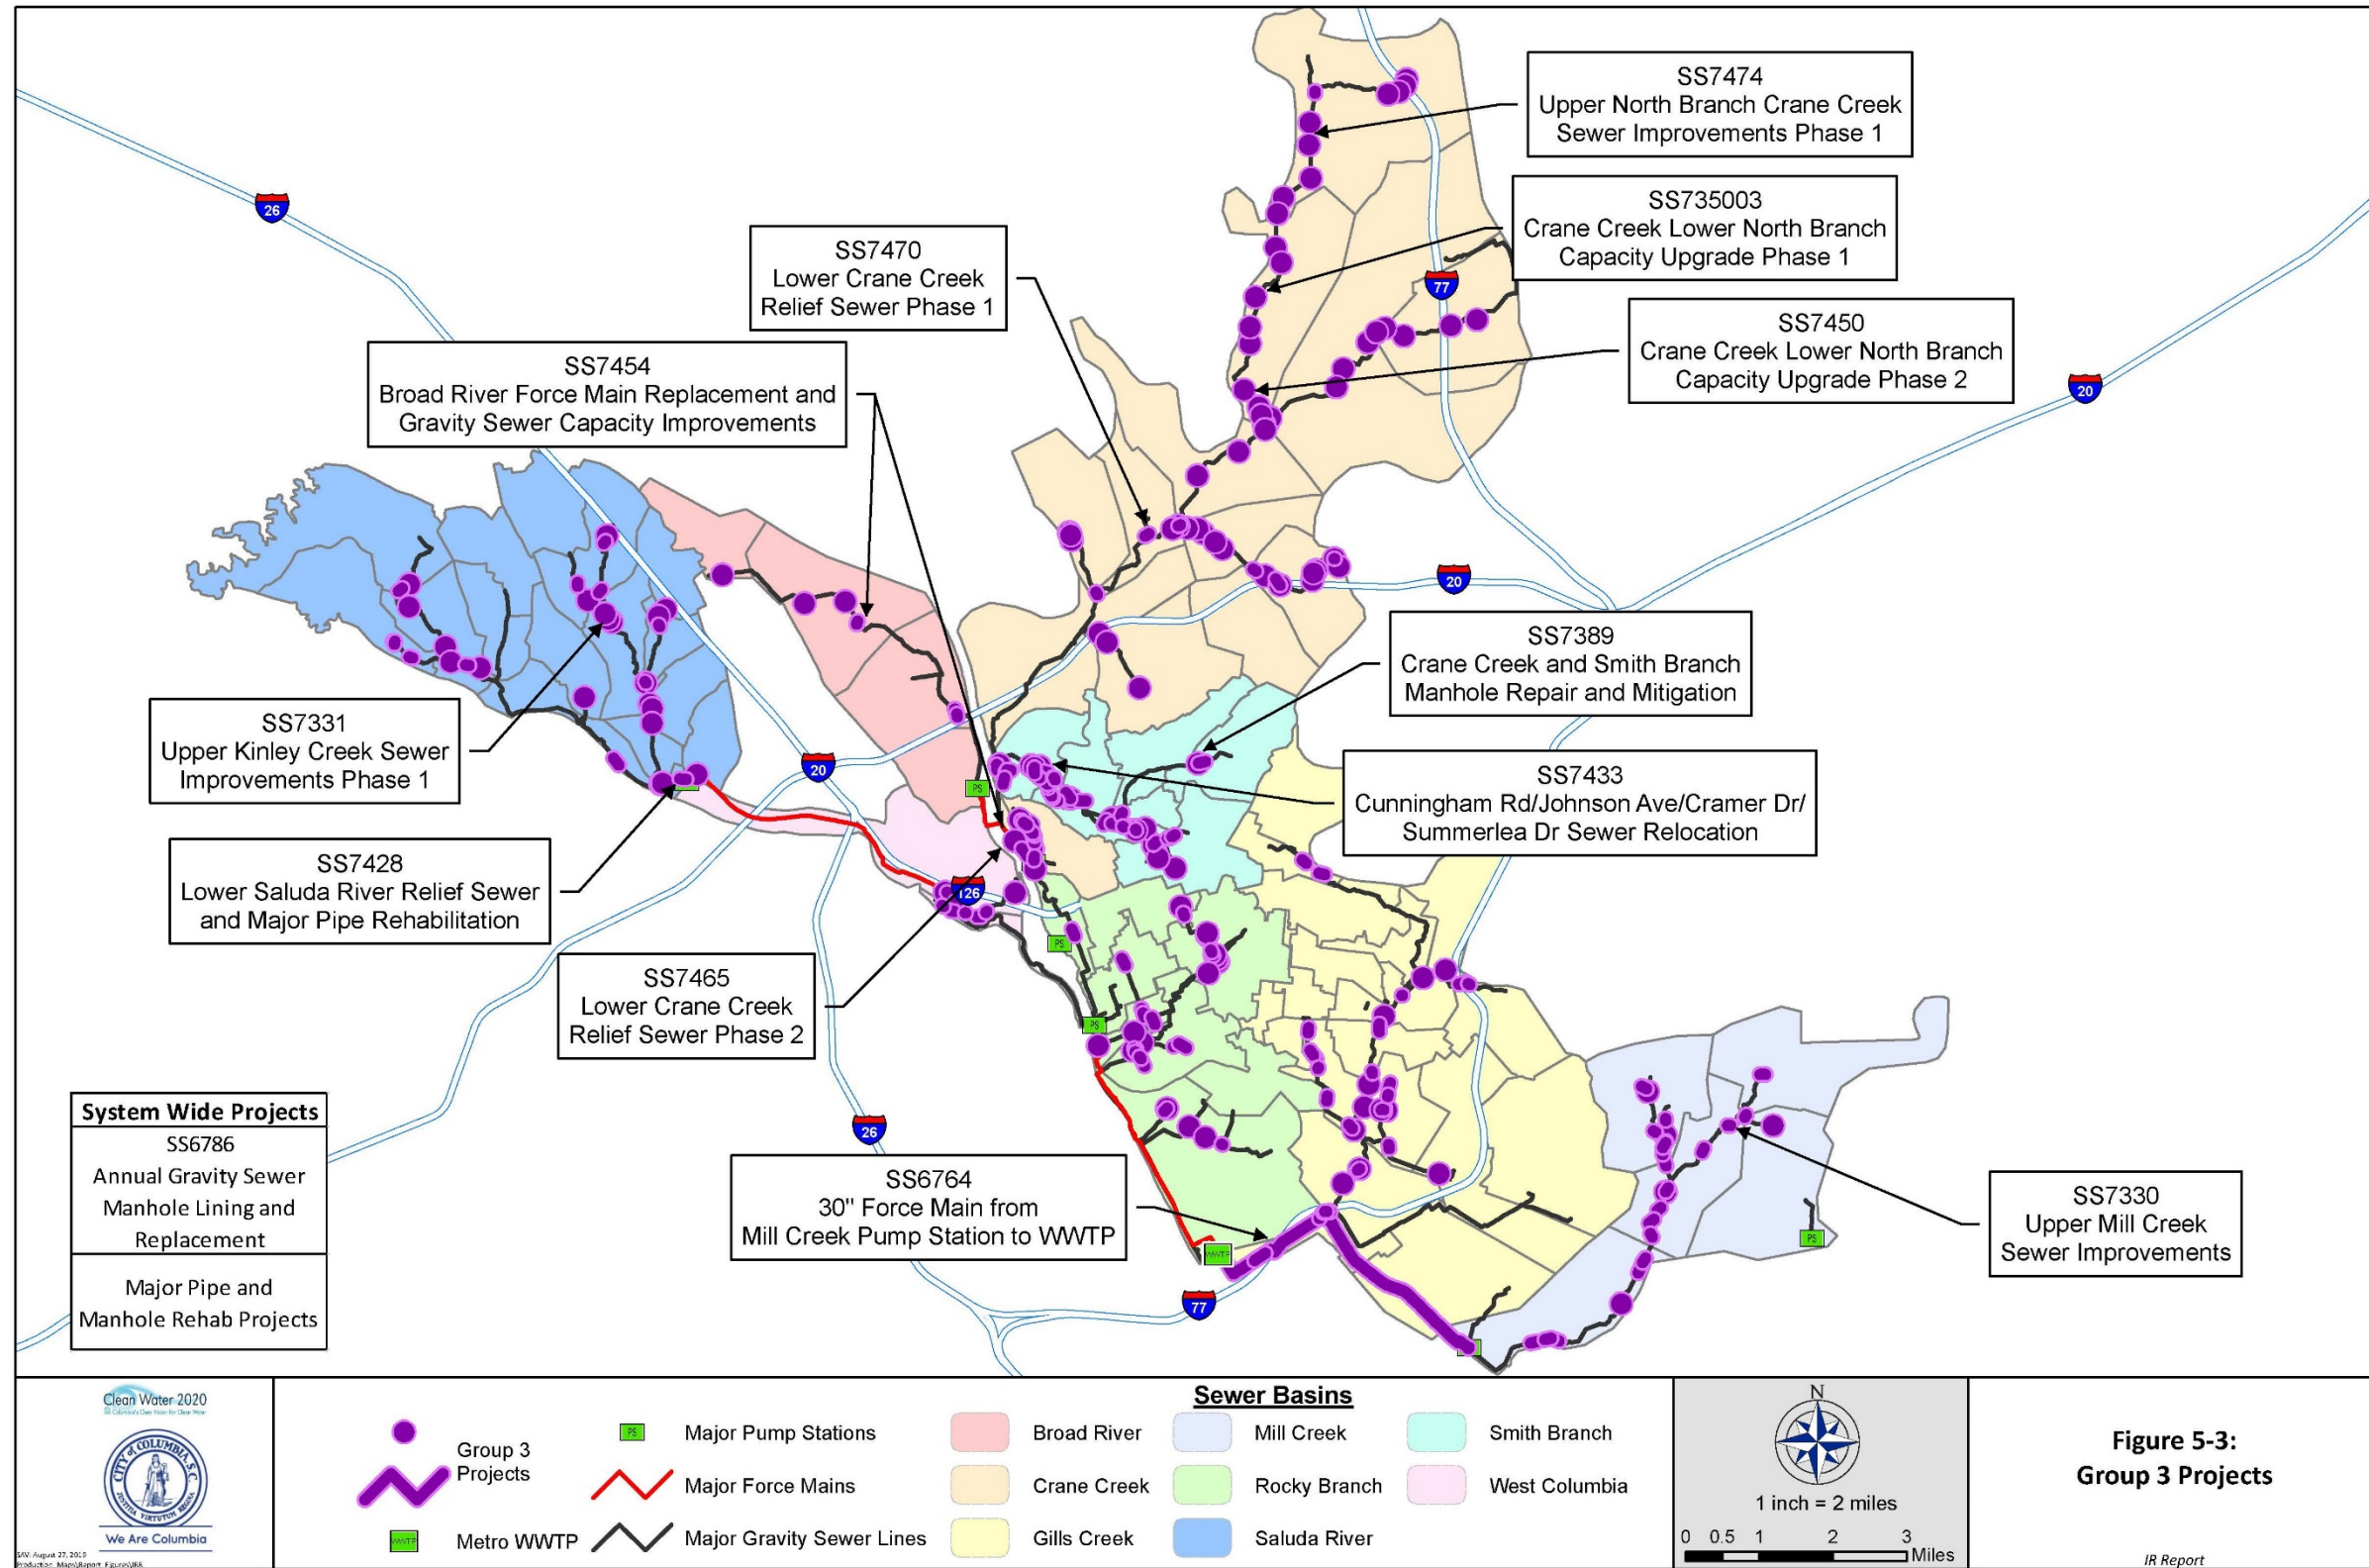
Figure 5-3 – Group 3 Projects

In accordance with the CD, Group 3 projects shall be completed no later than 7 years following EPA and DHEC approval of the IR Report. Group 3 projects address major components of the WCTS, identified through CSAP assessment, whose condition has not resulted in an SSO, but are high and low priority for rehabilitation based on condition and criticality as noted in Figure 2-3. These include projects to address Major Gravity Sewer Lines, major manholes, Major Pump Stations, or major Force Main segments that are highest priority for rehabilitation as defined in Sections 2.3, 3.3, and 4.3. **Table 5-4** includes a summary and description of the Group 3 projects that the City has undertaken or plans to undertake on major WCTS components. Group 3 projects are shown on **Figure 5-3**. As discussed more fully in Section 2.5.3, for Group 3 projects including other pipes within the project limits that are not high or low priority, only the prioritized pipe is required to be fixed on the schedule shown in Table 5-5. Once an asset is selected for rehabilitation, an engineering assessment will determine the method including the option of constructing a new asset (pipeline, manhole or pump station) or cleaning based on the noted defects.

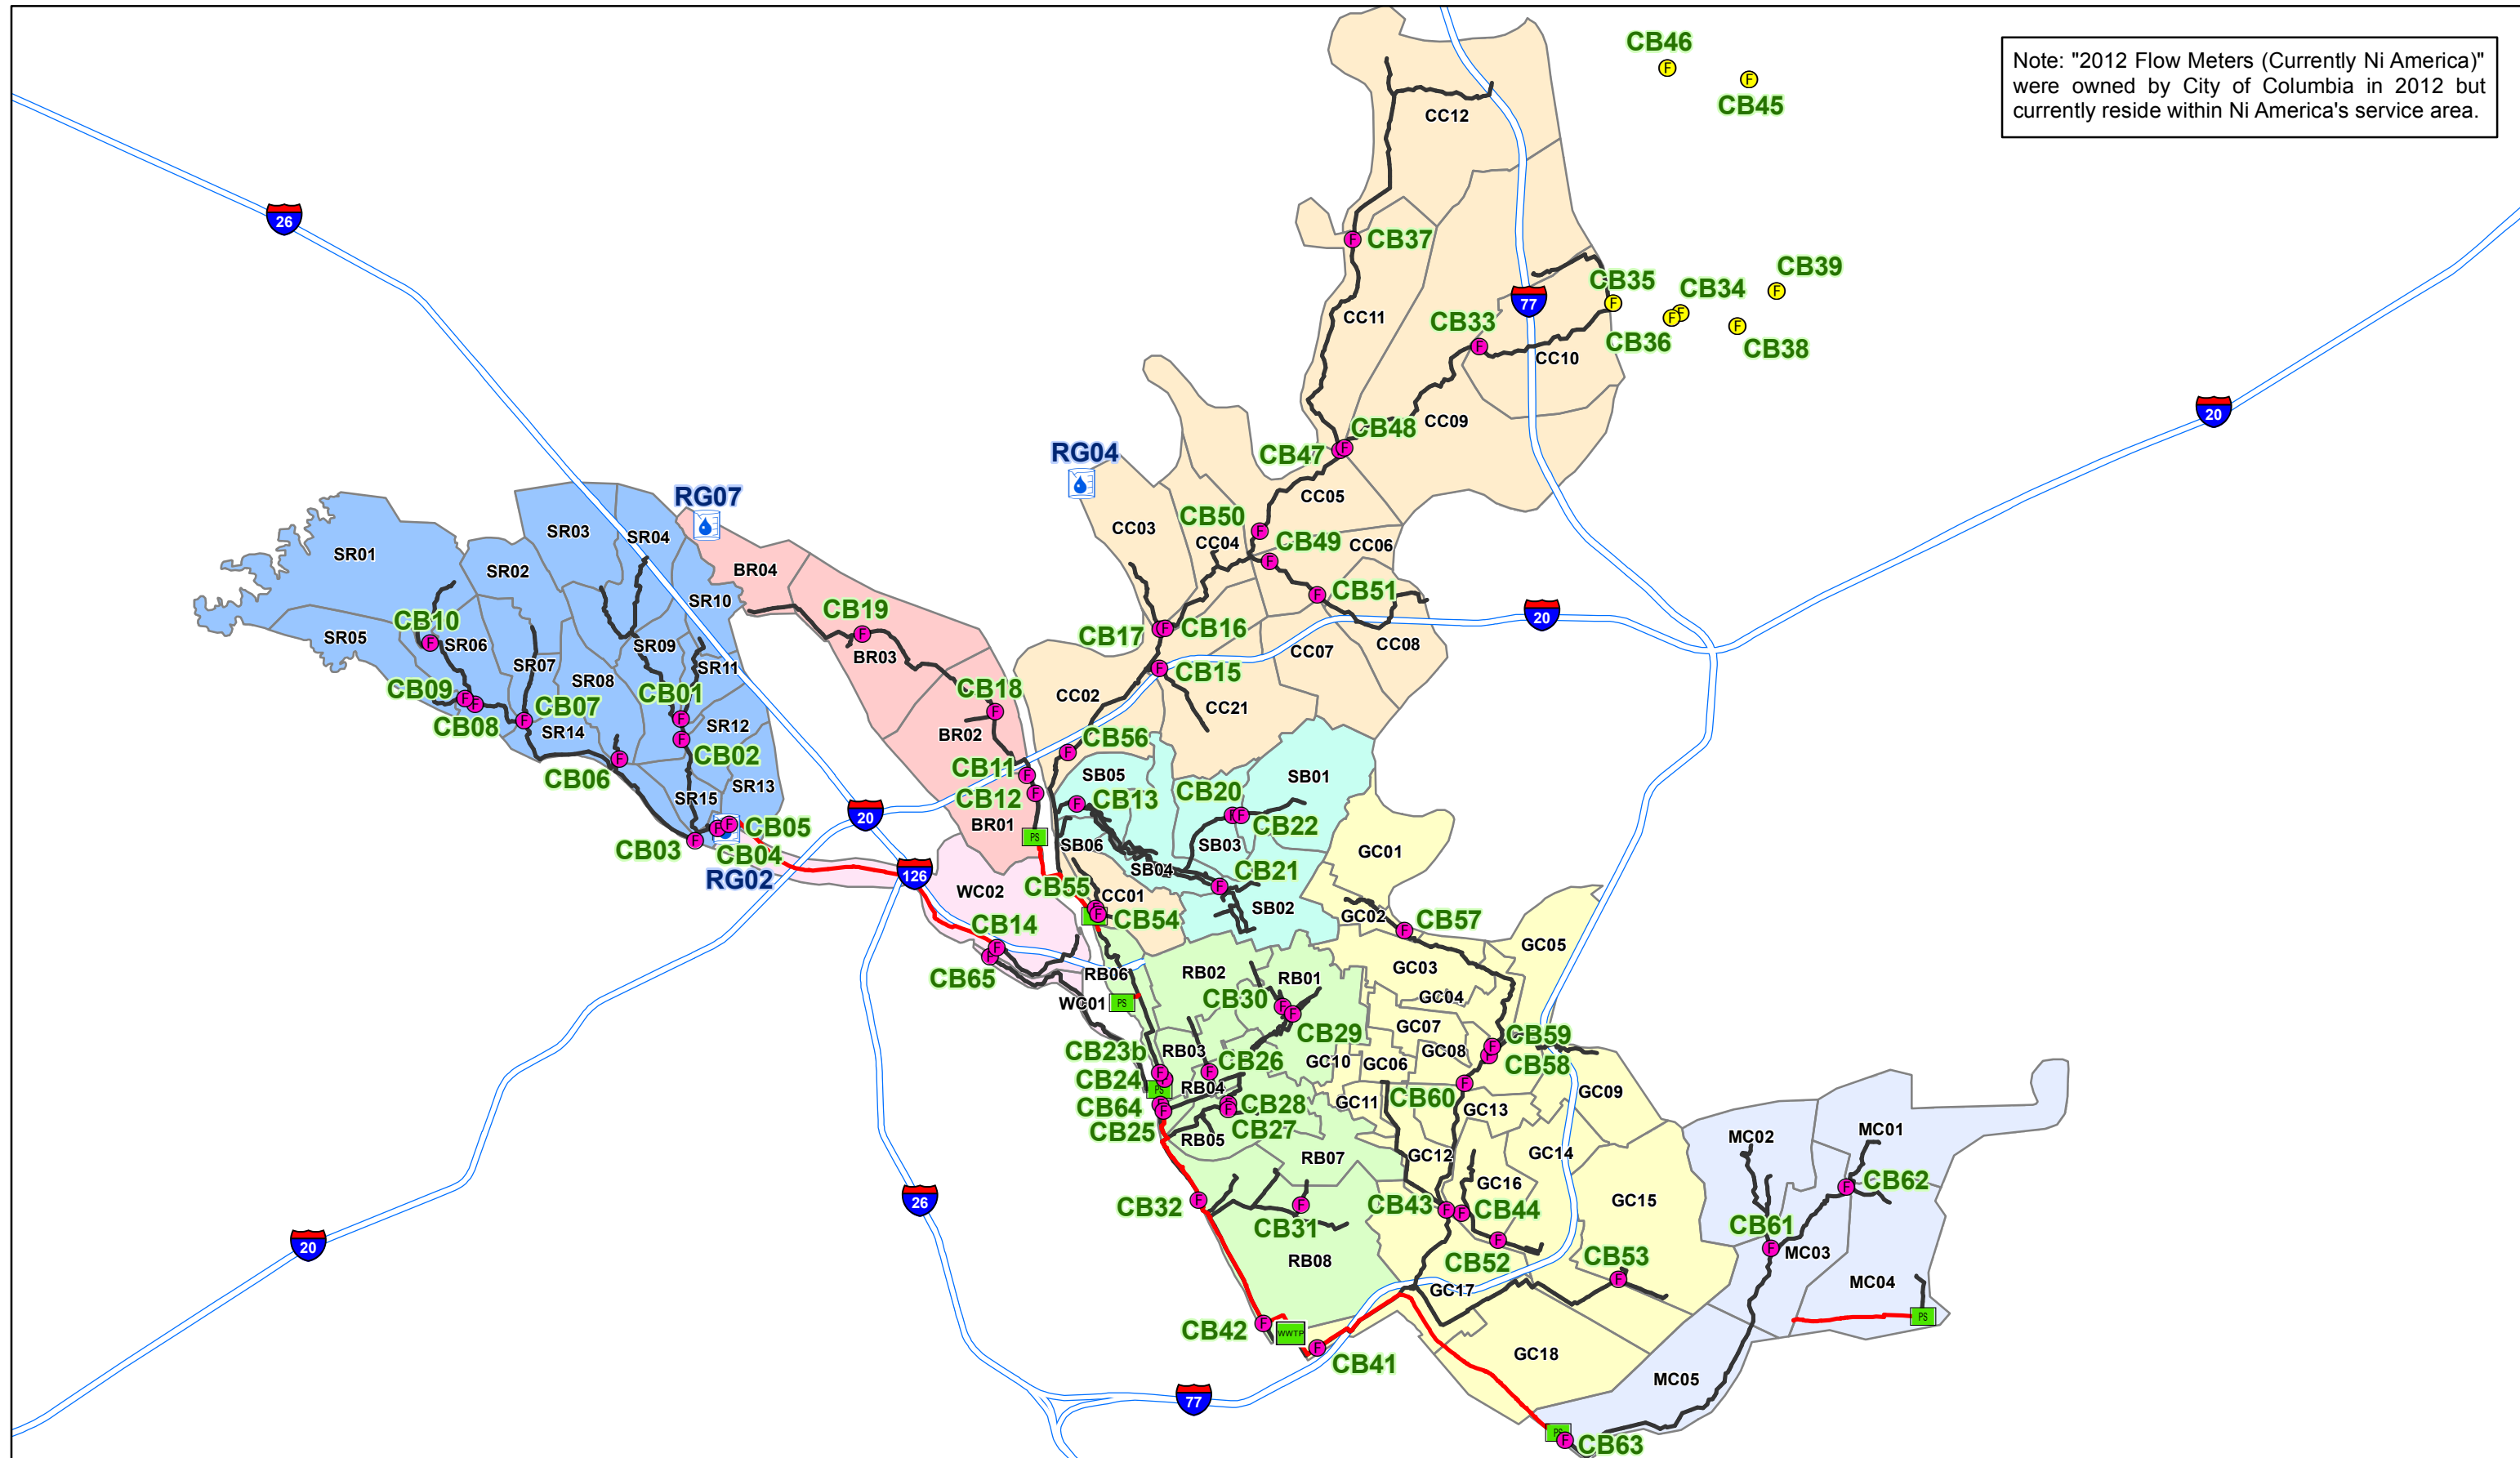
Figure A-2
2012 Temporary Flow Monitoring Location Map

Note: "2012 Flow Meters (Currently Ni America)" were owned by City of Columbia in 2012 but currently reside within Ni America's service area.

2012 Flow Meters (City of Columbia)		Metro WWTTP		Broad River		Mill Creek		Smith Branch
	2012 Flow Meters (Currently Ni America)		Major Pump Stations		Crane Creek		Rocky Branch		West Columbia
	2012 Rain Gauges		Major Force Mains		Gills Creek		Saluda River		
			Major Gravity Sewer Lines
