Clean Water 2020 Program

INFRASTRUCTURE REHABILITATION REPORT (IR Report)

August 2019

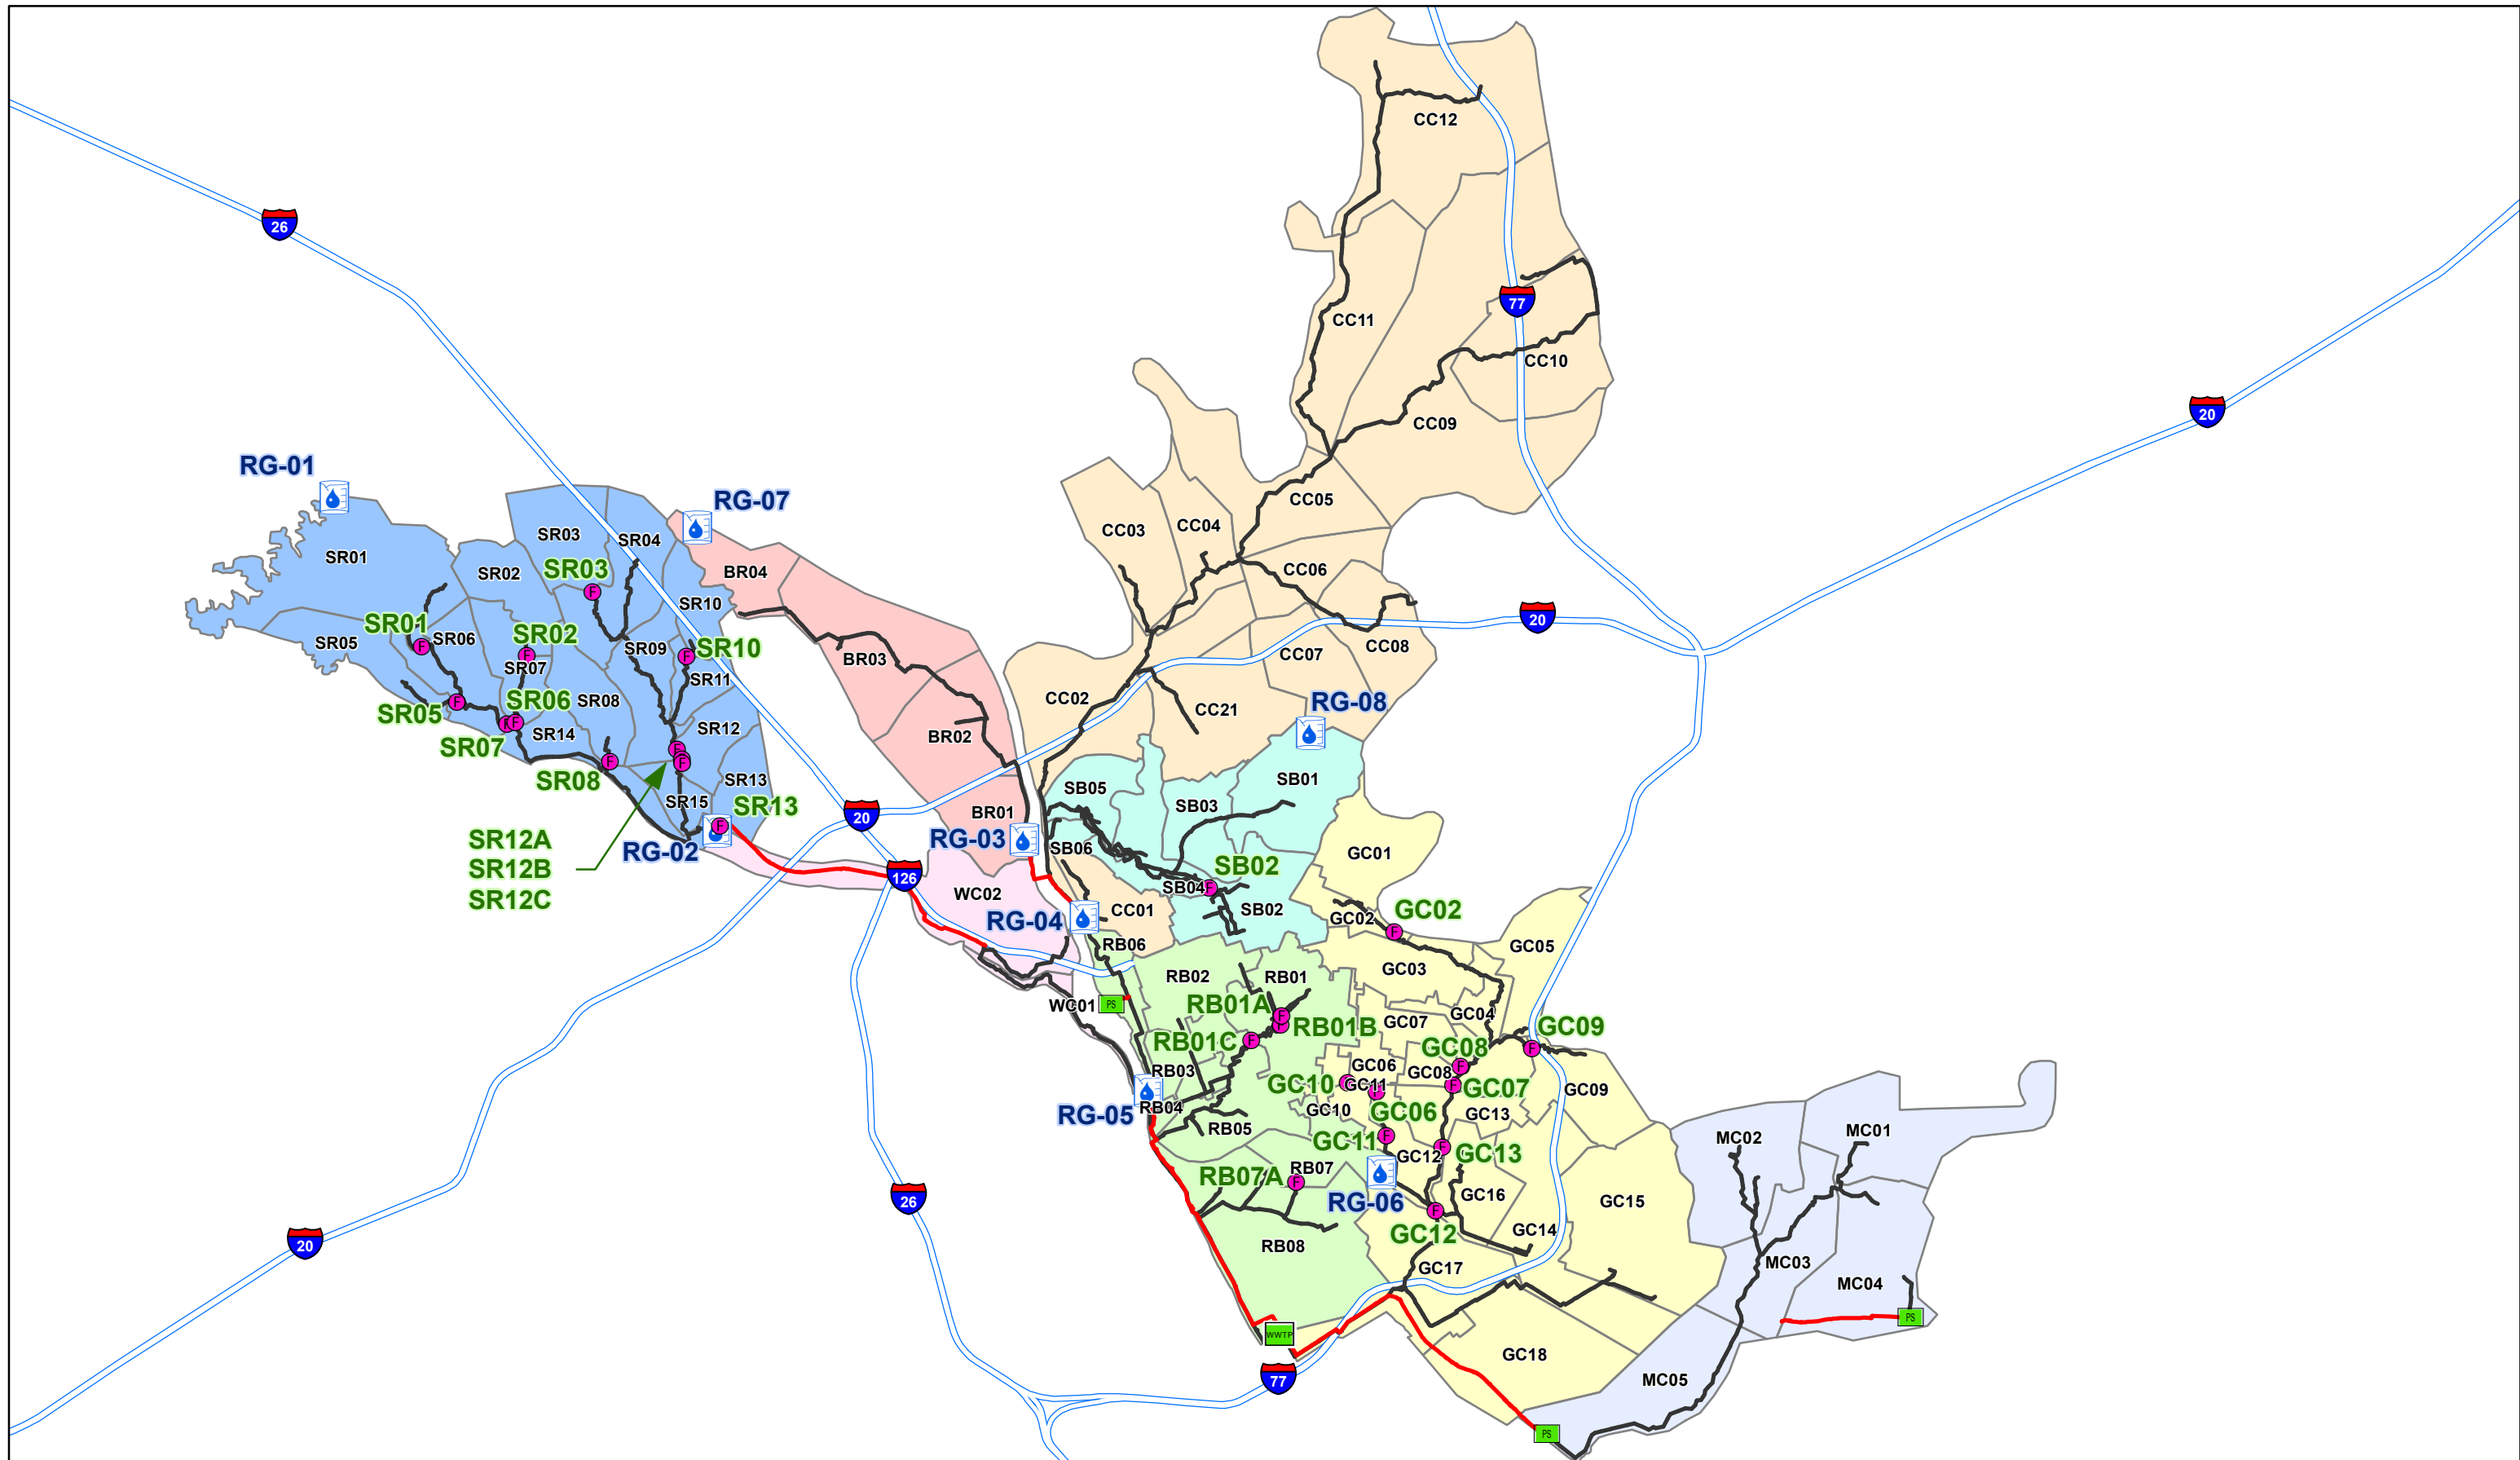
Figure A-3
2014 Temporary Flow Monitoring Location Map

Temp_FlowMeter_2014	Major Pump Stations	Broad River	Mill Creek	Smith Branch
Temp_RainGauge_2014	Major Force Mains	Crane Creek	Rocky Branch	West Columbia
Metro WWTP	Major Gravity Sewer Lines	Gills Creek	Saluda River

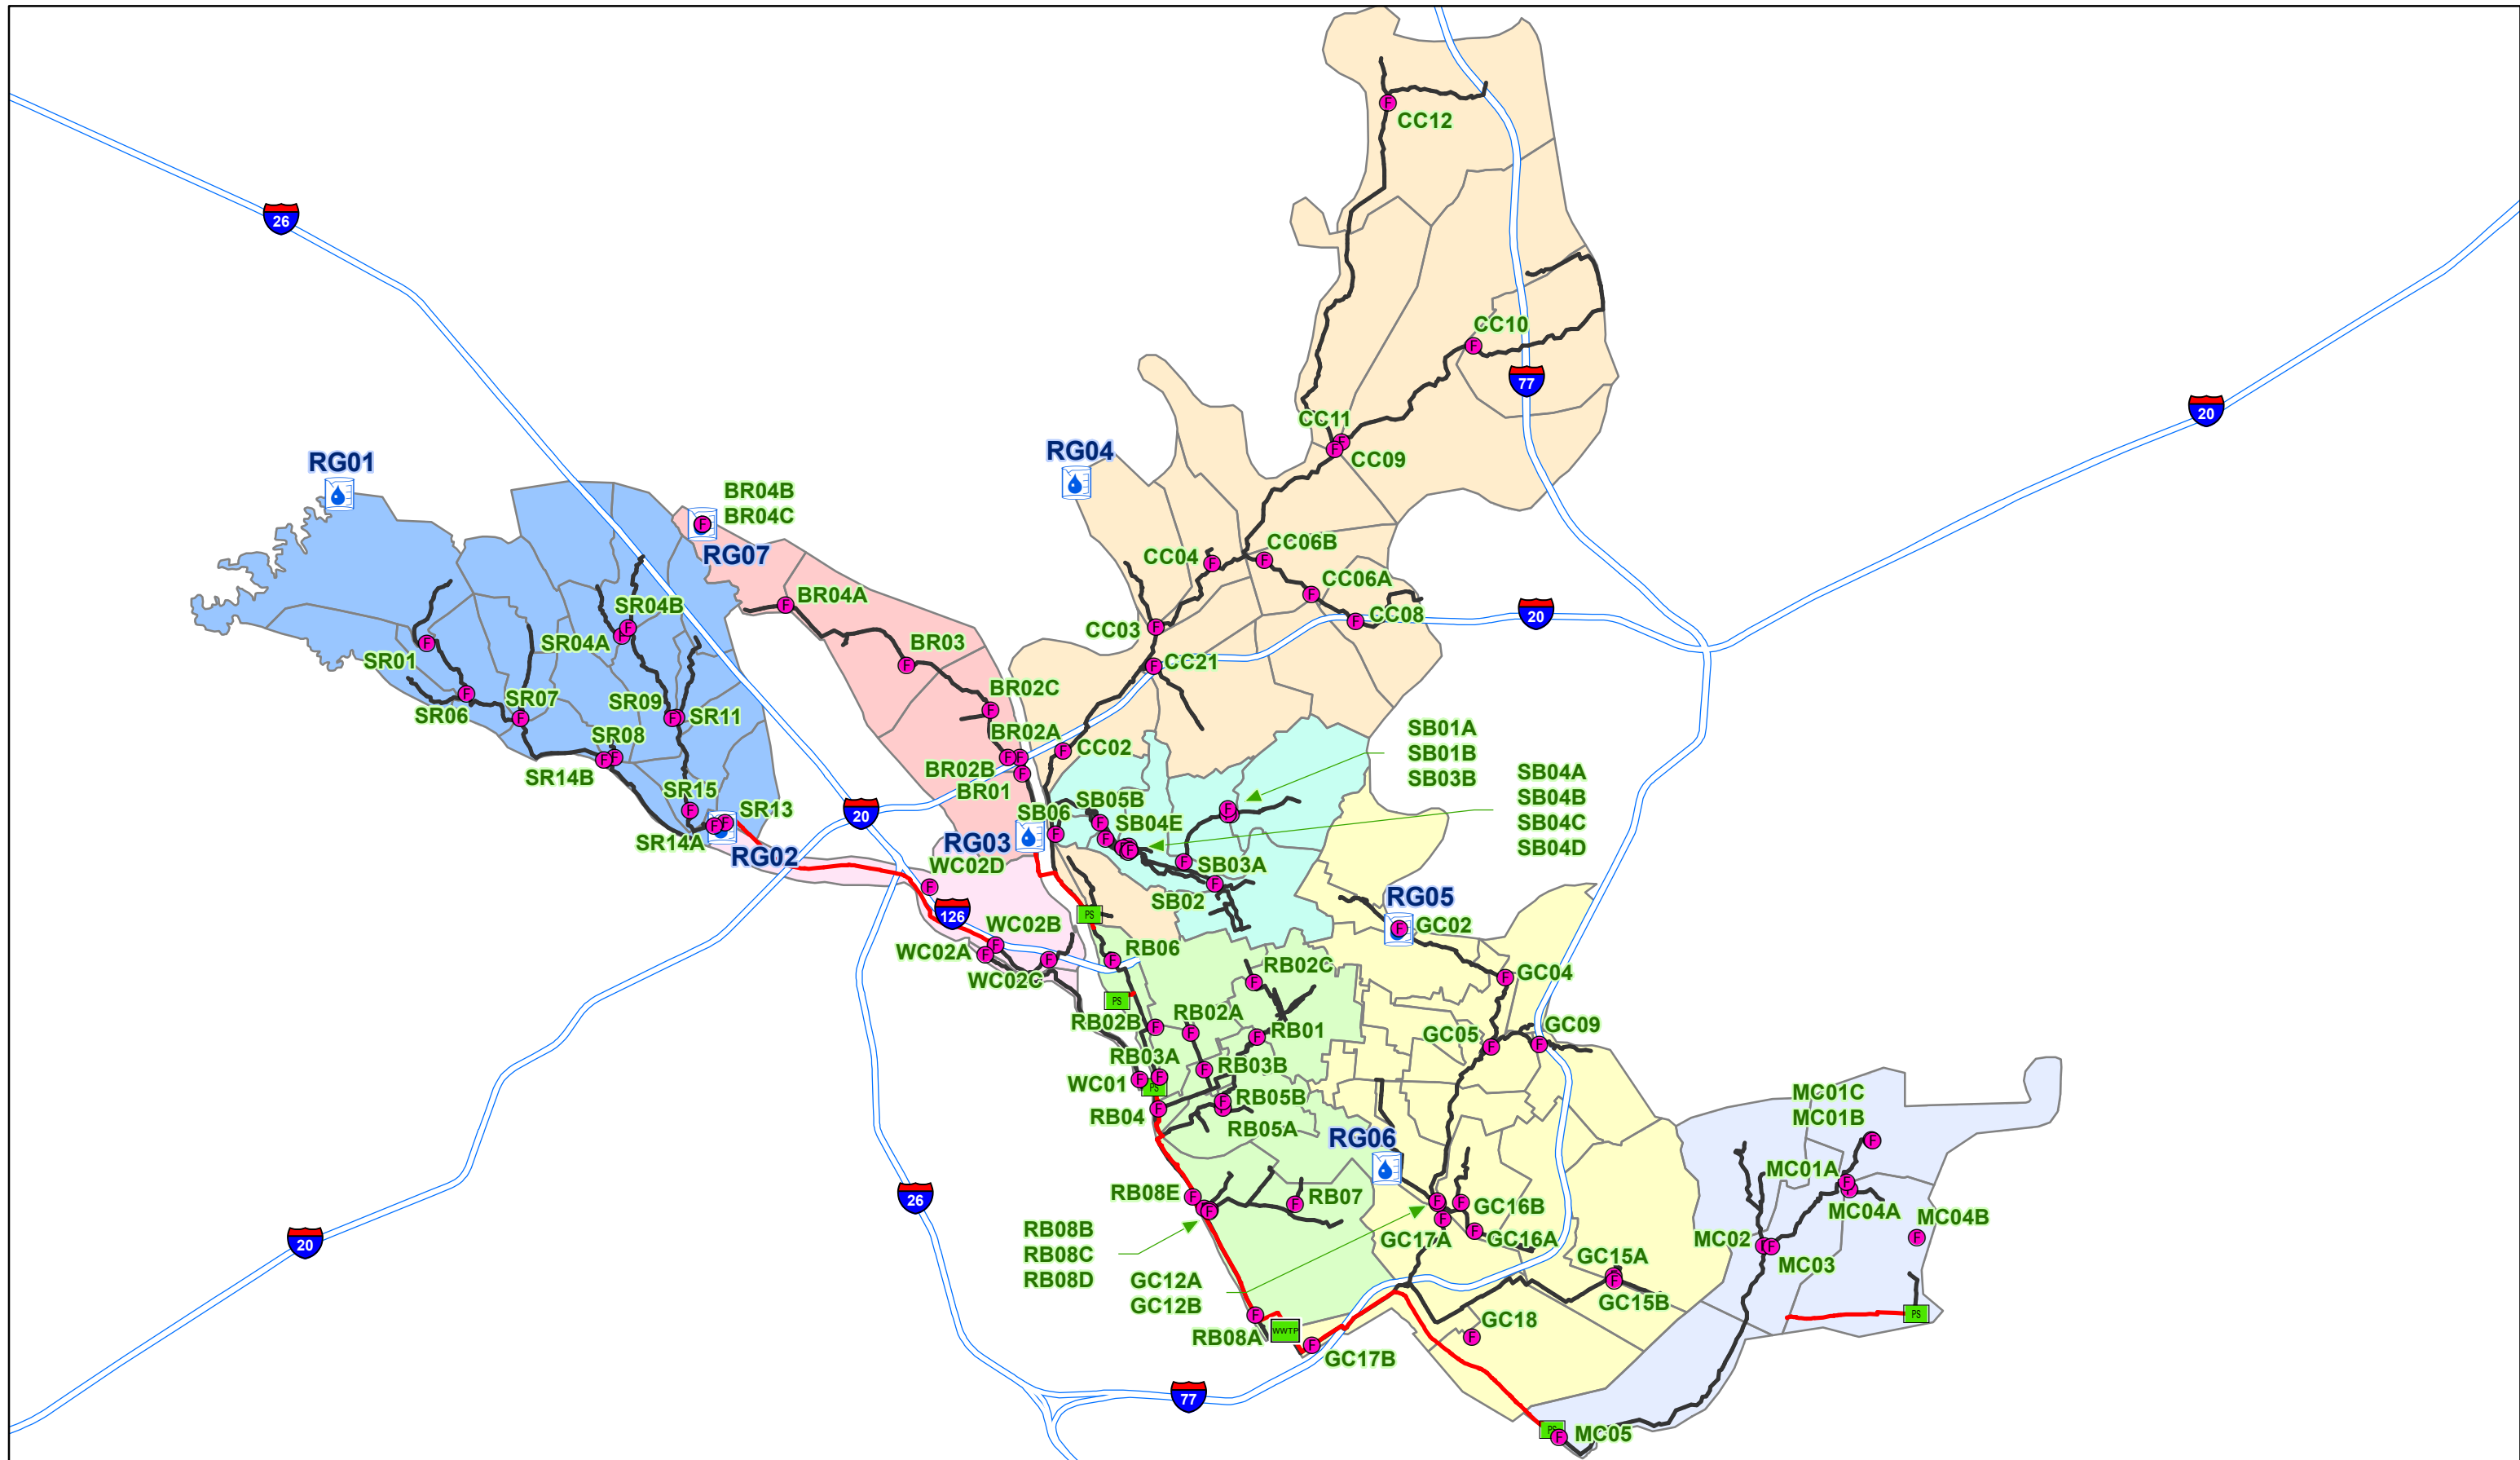
Figure A-4
2015 Temporary Flow Monitoring
Location Map

2015 Flow Meters		Major Pump Stations		Broad River		Mill Creek		Smith Branch
	2015 Flow Meters		Major Force Mains		Crane Creek		Rocky Branch		West Columbia
	Metro WWT		Major Gravity Sewer Lines		Gills Creek		Saluda River
