Rocky Branch Watershed Management Plan

# ROCKY BRANCH WATERSHED ASSESSMENT

McCormick Taylor Inc., supported by KCI Technologies, Inc., has been contracted by the City of Columbia, South Carolina to conduct an assessment of the Rocky Branch watershed to identify potential improvement opportunities to identify existing flooding and water quality conditions.

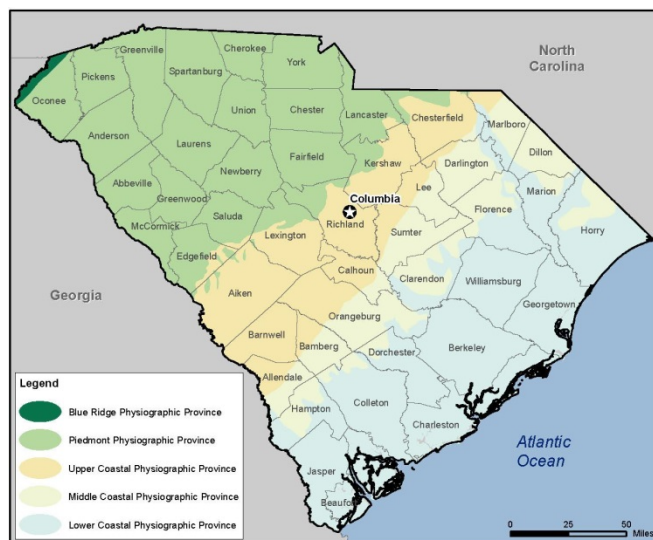
**Figure 3.2 Physiographic Provinces of SC**

The Rocky Branch watershed is located adjacent to the Congaree River and along the Fall Line, where the Coastal Plain adjoins the Piedmont province (**Figure 3.2**). The watershed is primarily characterized by the Cape Fear (Kcfe) and Peedee (Kpb) Formations of the inner Coastal Plain, formed during the upper Cretaceous. The Cape Fear formation consists of light-colored cross-bedded arkosic sand, gravel deposited in delta-dominated fluvial environments, and lenses of massive light-colored clay and kaolin with many local unconformities. The Peedee Formation consists of dark green or gray glauconitic and argillitic sand, many layers of which are calcareous (United States Department of Agriculture Soil Conservation Service, 1978).

The southwestern portion of the watershed consists of Tertiary sand, clay, or mud deposits (Td) that are likely Pliocene in age, as well as more recent alluvial sand and gravel along the Congaree River. A small portion in the northwest of the watershed is located within the Columbia granite Pluton (Cgcl) of the Piedmont.

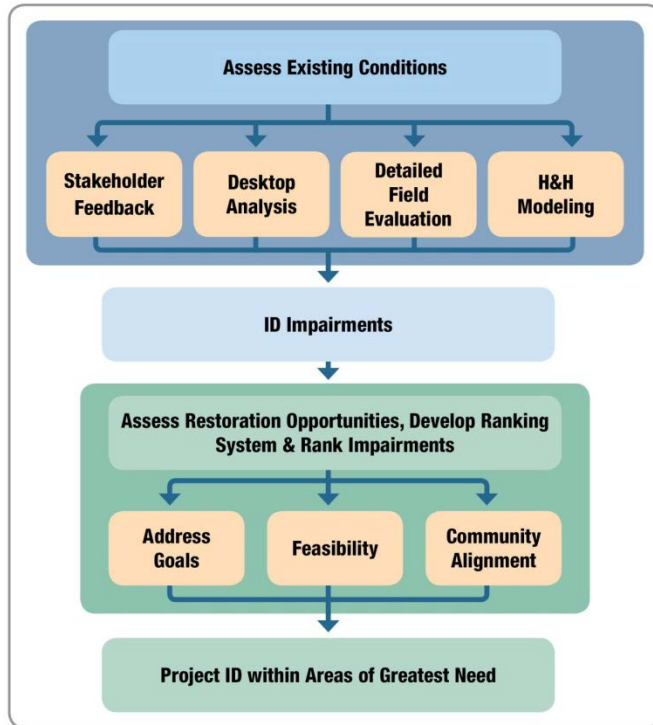
**Figure 4.1 Watershed Assessment Methodology**

A multi-faceted methodology was implemented (**Figure 4.1**), first by assessing the existing conditions of the watershed through desktop analysis of existing information as described above. Following desktop analysis and development of a general existing conditions overview, field efforts were initiated. This included conducting a field cruising effort for all open channel

subwatershed. Based on this ranking, Watershed Projects were identified in subwatersheds with the greatest impairment. This methodology is summarized in **Figure 4.1** and documented in detail below.

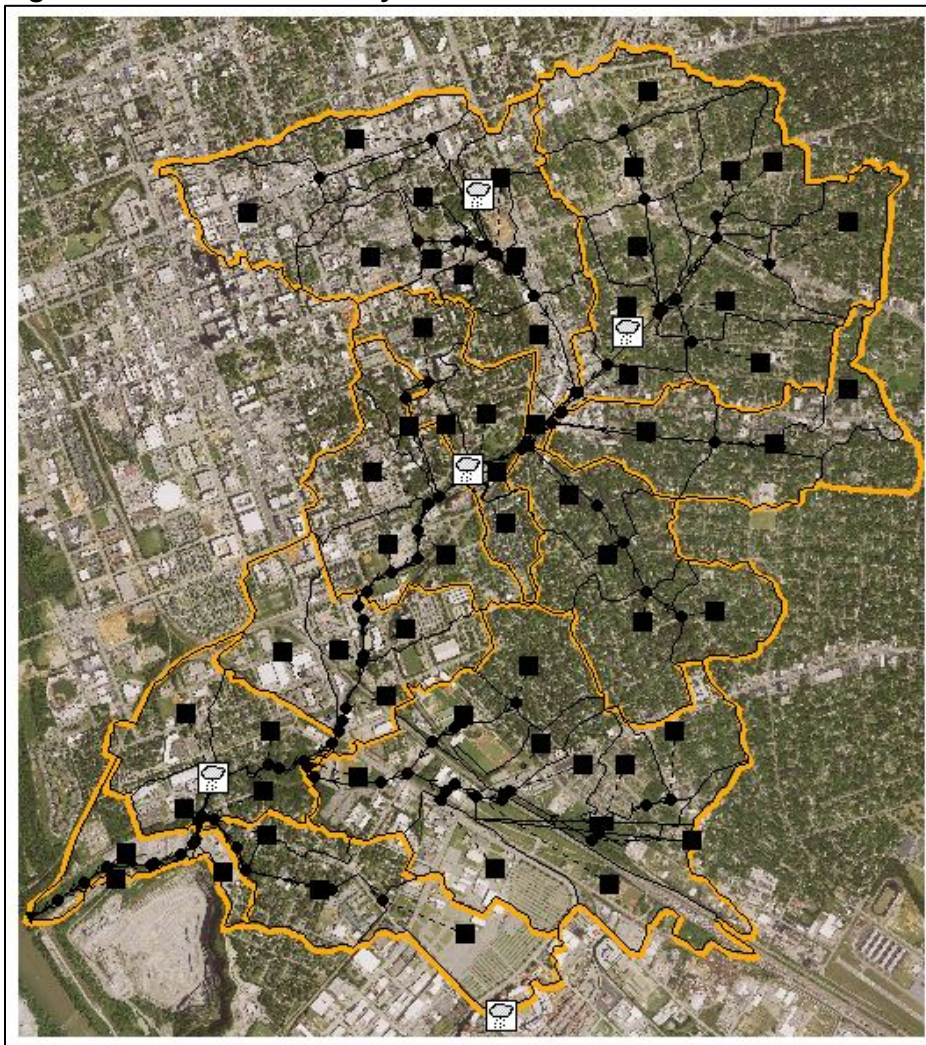
**Figure 4.3 SWMM Model Layout**

The Rocky Branch watershed has been previously divided into nine subwatersheds averaging a little less than 300 acres each. In order to model the Rocky Branch Watershed, the SWMM model was developed with 60 subcatchments ranging in size from 6.9 to 75.1 acres, with an average size of 44.2 acres. The subcatchments were created by further subdividing the subwatersheds based on topography and the storm drain system network. Available data from various sources, such as digital maps of impervious surfaces and the urban storm drain system, were incorporated in the model. The SWMM model layout is shown in **Figure 4.3**.

Spatially distributed rainfall-runoff modeling was conducted for the basin to quantify flood magnitudes and frequencies in different parts of the basin. The model was calibrated using the latest stream-flow data. Surface runoff was estimated using 5 gages at various points in the watershed. 15-minute or 5-minute rainfall data from a rain gage in close proximity to the subcatchment was used as the source of precipitation. Each subcatchment was assigned a specific rain gage. The rain gage locations and subcatchment boundaries are shown in **Figure 4.3**.

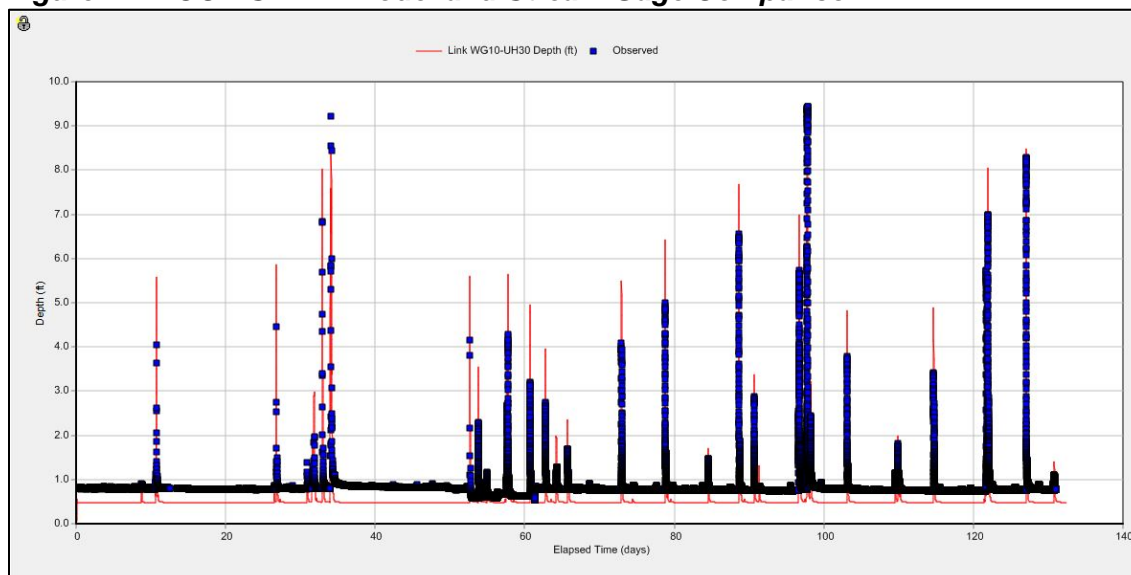
**Figure 4.4 ROCA SWMM Model and Stream Gage Comparison**

Stream gage data at three sites was used to help calibrate the SWMM Model. For each event modeled, water surface elevations were compared to gage data. The model subcatchment parameters were then adjusted so that the modeled depths attain a reasonable approximation to the elevations measured at the gage. Comparisons with historic events were also made to determine if the model represents roadway overtopping or flooding that actually occurred. The results of the SWMM Model compared to Stream Gages ROCA at Maxcy Gregg Park, the United States Geologic Survey (USGS) Whaley Street Gage, and Stream Gage ROCB are shown below (**Figures 4.4 to 4.6**).

The SWMM Model produced the most accurate peaks at the Rocky A (ROCA) gage. Further downstream, at the USGS Whaley Street Gage, the peaks from SWMM were lower than those from some higher intensity storms. At the Rocky B (ROCB) gage SWMM produced consistently higher peaks than what was measured. However, this was less important to the calibration because the purpose of the SWMM Model was not to predict peaks, but rather to estimate flows for use in HEC-RAS.

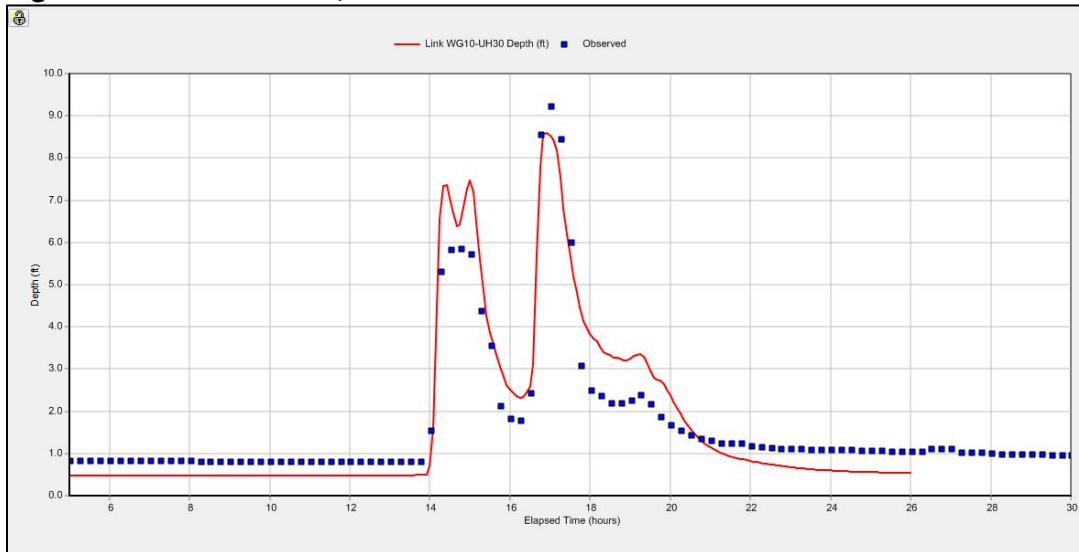
**Figure 4.7 ROCA June 3, 2015 Storm**

A storm that occurred on June 3, 2015 was also run in the HEC-RAS model, in order to check its output. This storm produced approximately 4.24 inches of rain in 6 hours, similar to the 25 year 6 hour National Oceanic and Atmospheric Administration (NOAA) event for this area. The results for this storm from SWMM are shown below at stream gages ROCA (**Figure 4.7**) and ROCB (**Figure 4.8**).

For the June 3, 2015 storm in HEC-RAS, the peak for the USGS Whaley St. Gage and the ROCB Gage are 180.19 and 142.14 feet North American Vertical Datum (NAVD), giving water depths of 12.79 and 10.87 feet when subtracted from the channel invert. The gages read from the permanent pool, so for the ROCB Gage, at Olympia Avenue where Rocky Branch has a permanent pool measured at approximately 133.6 feet NAVD deep, the HEC-RAS water surface corresponds to 8.5 feet of gage depth. This aligns well with the gage readings of 11.5 and 8.5 feet for these locations.

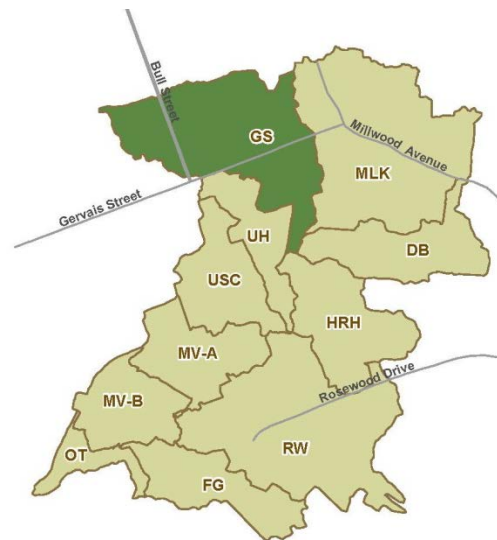
**Figure 6.2 Gregg Street Subwatershed**

- The Gregg Street (GS) subwatershed is the northwestern most subwatershed within the Rocky Branch watershed.
- The subwatershed's southernmost/downstream end falls between the UH and DB subwatersheds, north approximately 1 mile to Taylor Street, and west to approximately 200 feet east of Assembly Street.
- 404 acres or 0.63 square miles in drainage area
- Contains 0.34 miles of open stream channel, and 9.62 miles of mapped storm drain/pipe
- Dominant land use designations (**Figure 6.1, Table 6.1**):
  - Developed, High Intensity: 45%
  - Developed, Medium Intensity: 40%
- Impervious surface cover: 70%

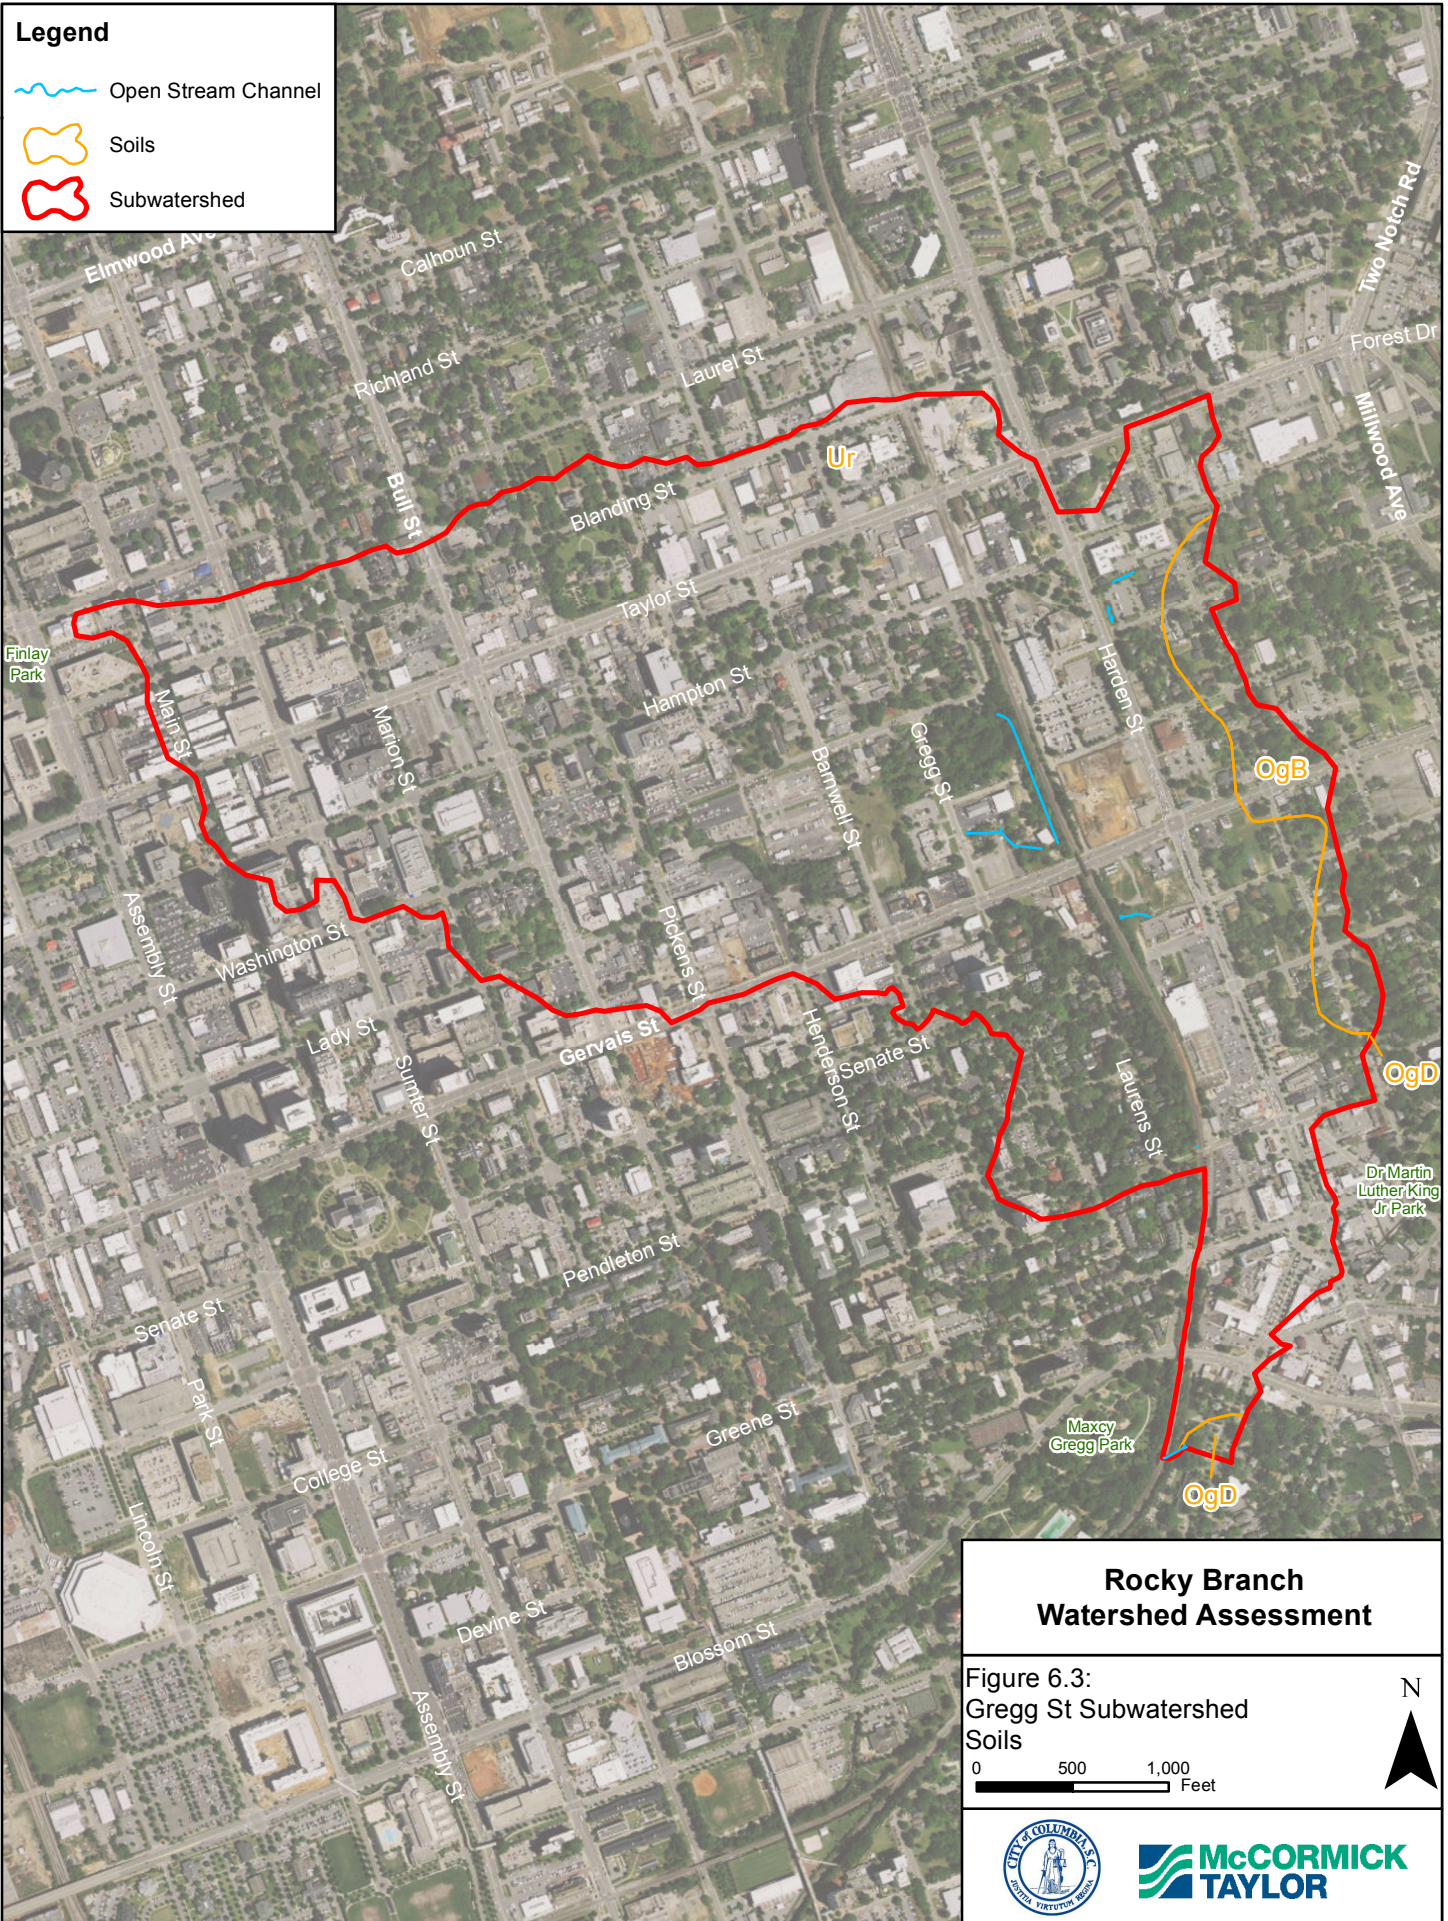
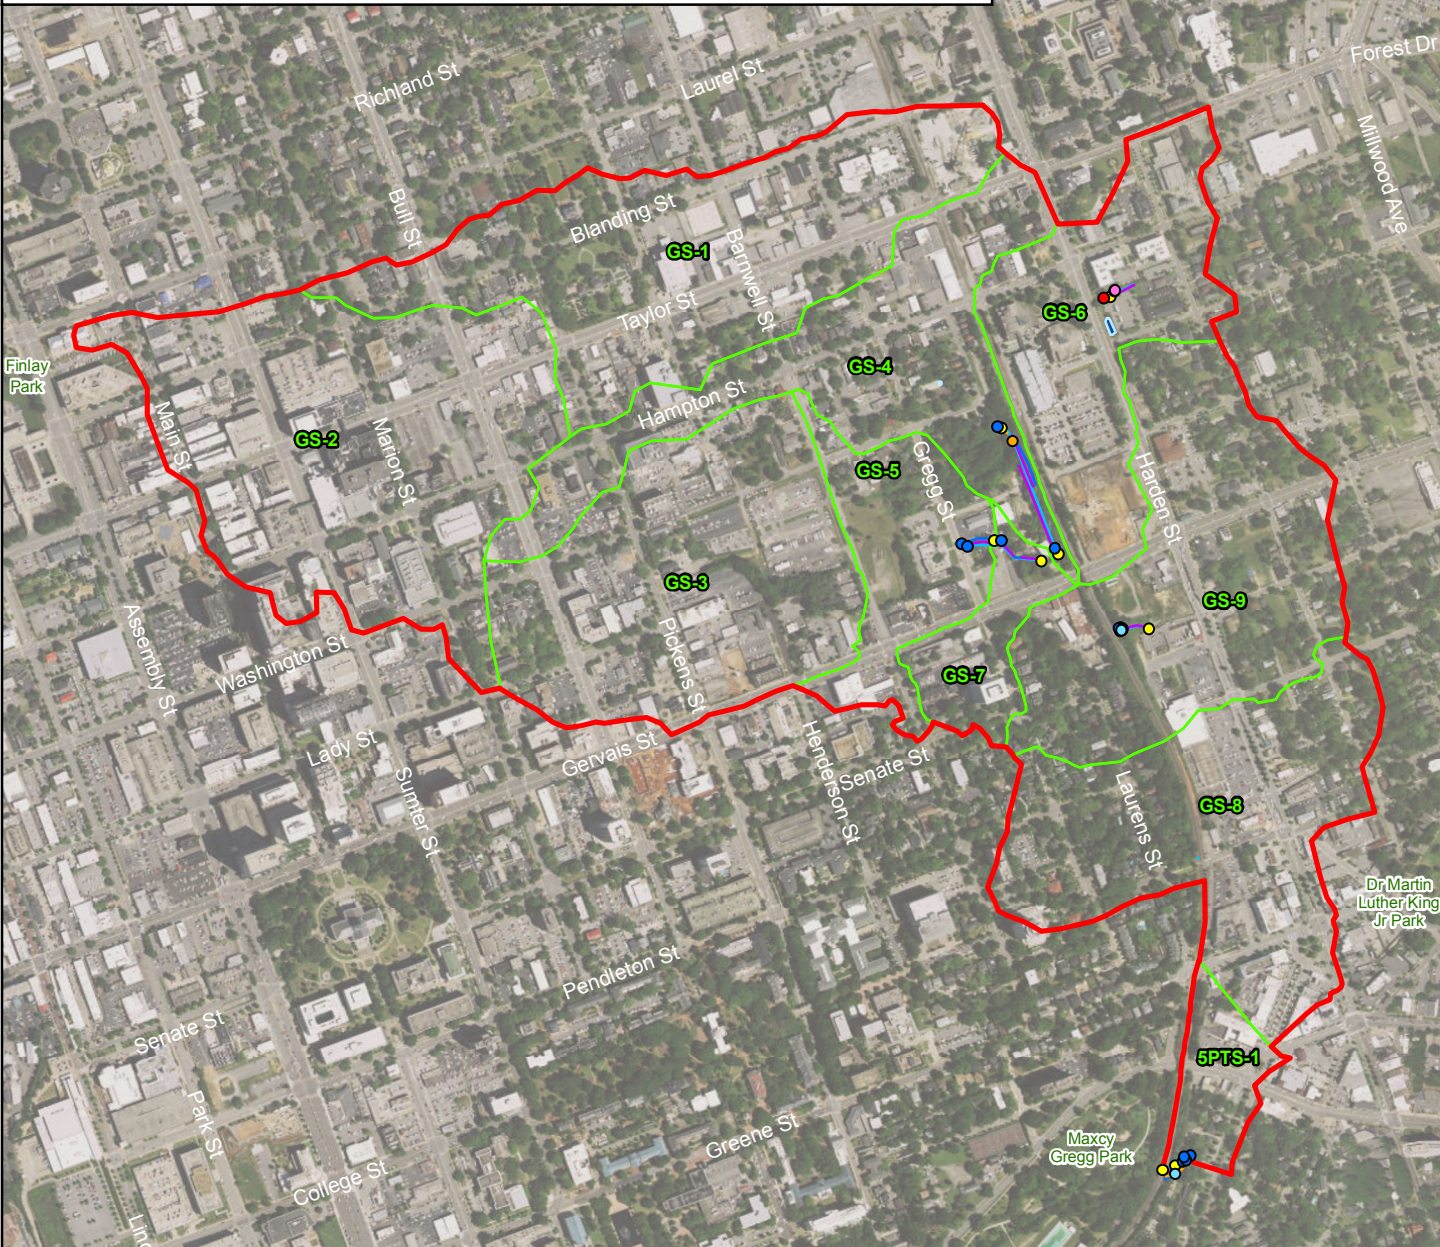
- Trash Dumping
- Pipe Outfall
- Near Stream Construction
- Possible Fish Barrier
- Exposed Pipe
- Bedrock
- Unmanaged Runoff
- Unusual Condition
- Open Stream Channel
- Erosion Site
- Channel Alteration
- Inadequate Forest Buffer
- SWM Facility
- SWMM Subcatchment
- Subwatershed

Existing Condition	Count
Exposed Pipes	5
Pipe Outfalls	13
Unmanaged Runoff	1
Unusual Condition	8
Trash Dumping	1
Possible Fish Barrier	0
Linear Feet	
Erosion Site	204
Channel Alteration	625
Inadequate Forest Buffer	2,580

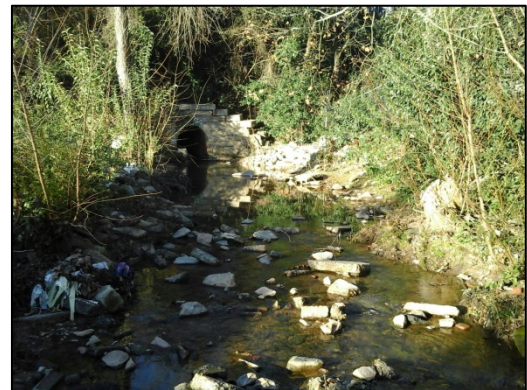
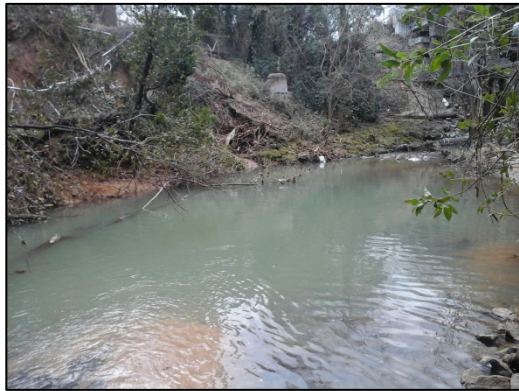
Another small segment of open stream channel is located south of the intersection of Gervais and Laurens Street. This stream segment receives all flow from previously described open channel. The stream originates from a stone block masonry arch emerging from underneath the railroad. Two 36-inch reinforced concrete pipes enter the channel from the left bank. A significant headcut has formed behind the pipes as a result of overland flow and concentrated runoff from Laurens Street and a parking lot adjacent to the stream. Two sanitary lines are exposed in the stream bed and one sanitary line runs along the right bank from a manhole stack into the railroad culvert. The 3 to 4-foot tall banks are vegetated with herbaceous cover and are stable. The channel substrate consists primarily of cobble, with some concrete and rubble from the banks slumped into the bed. The stream then flows into twin concrete pipes flanked by stone walls on either side.

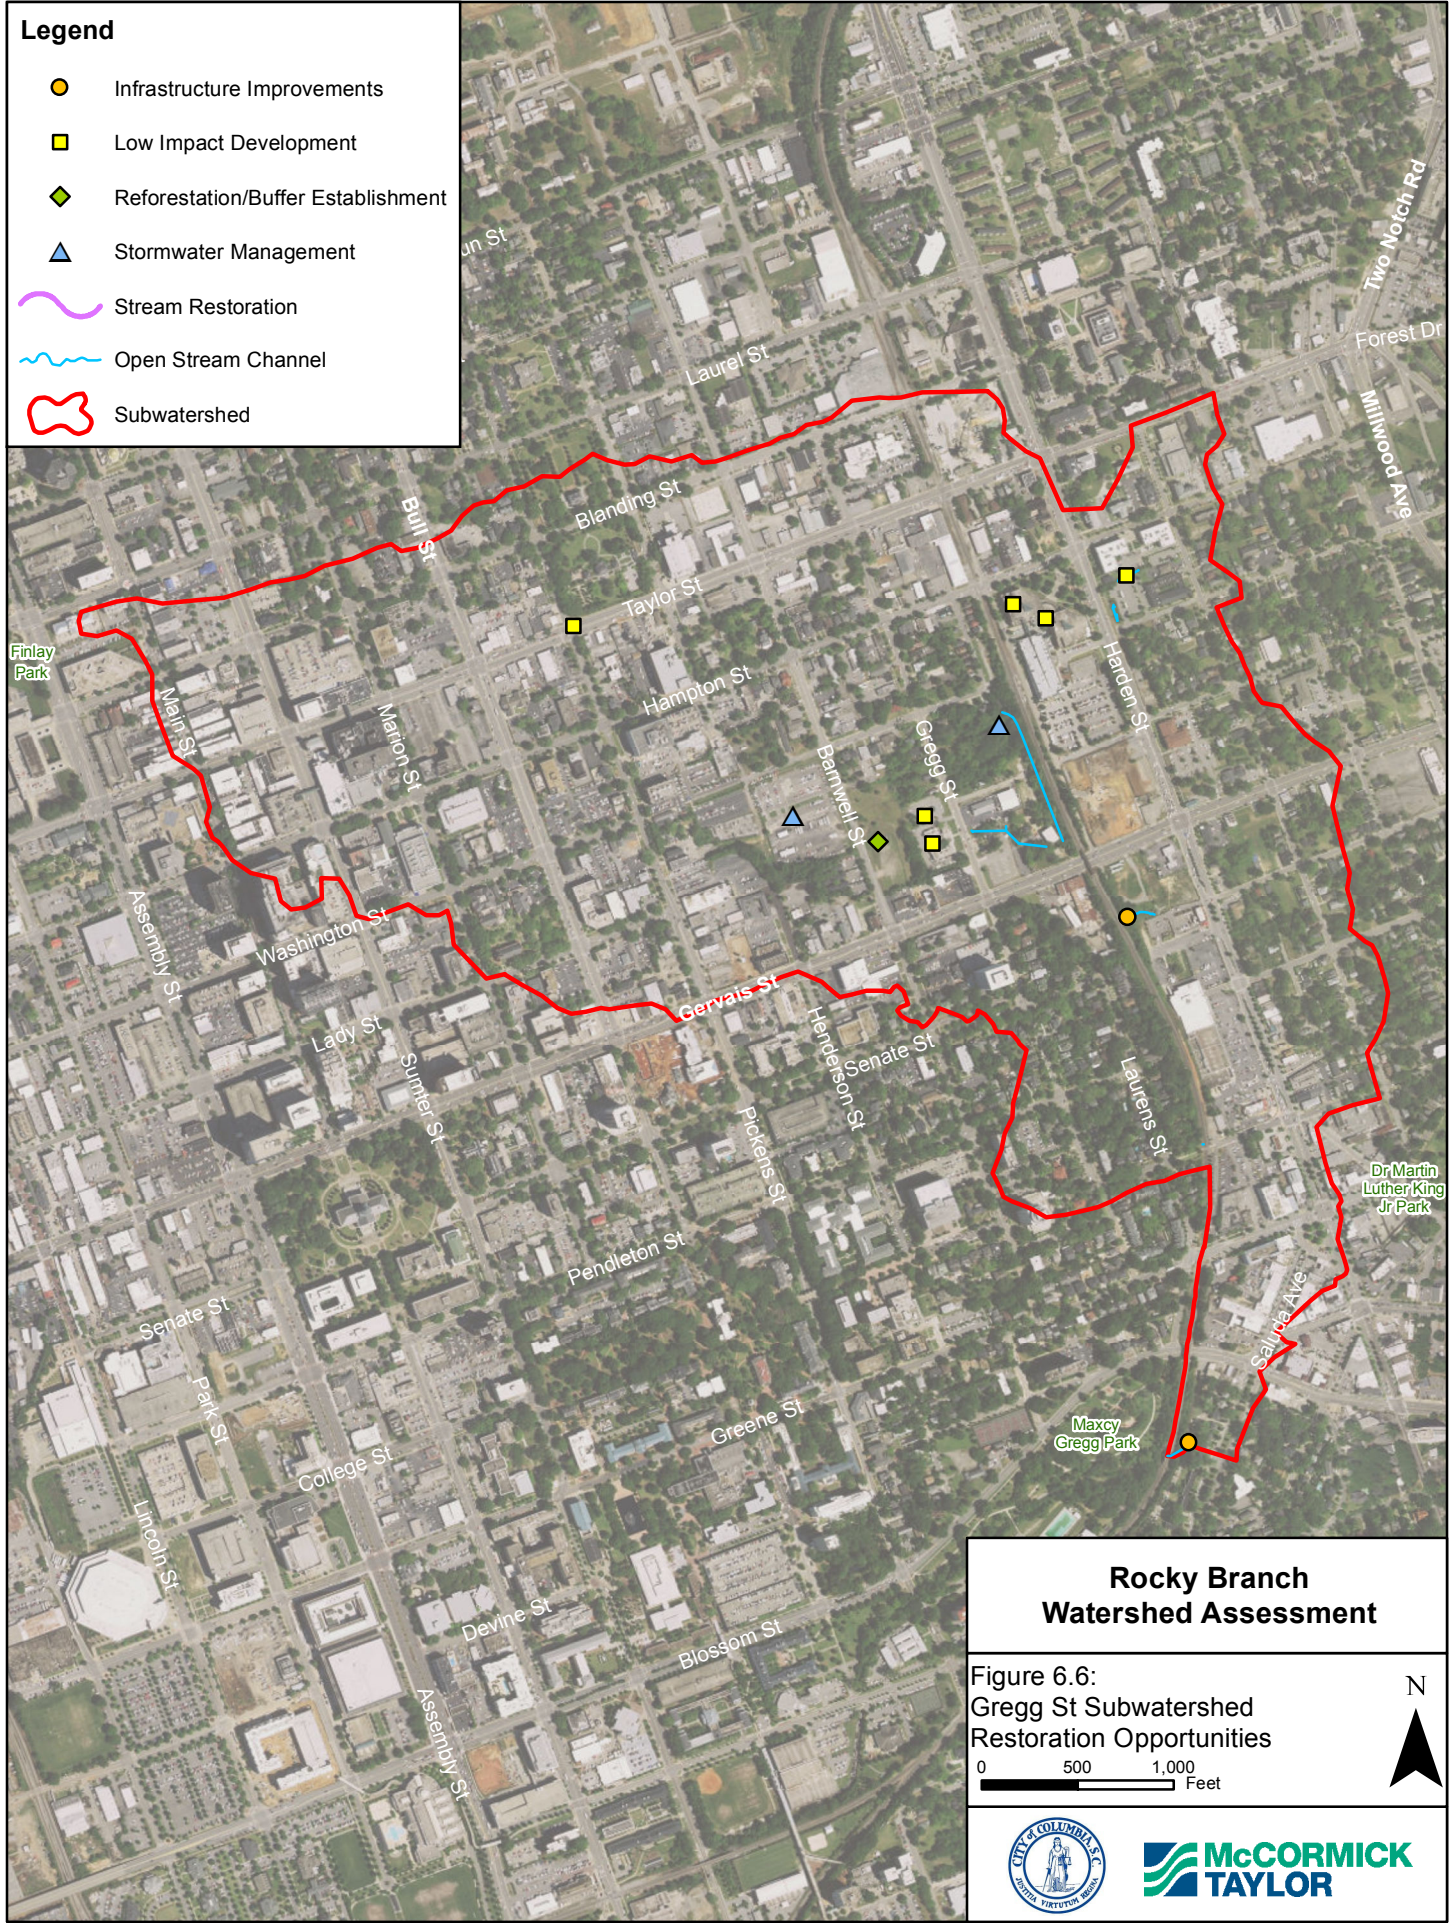
Figure 6.6:  
Gregg St Subwatershed  
Restoration Opportunities

The following projects or similar improvements may be considered to address conditions identified in the GS subwatershed. These projects are included in **Figure 6.6**.

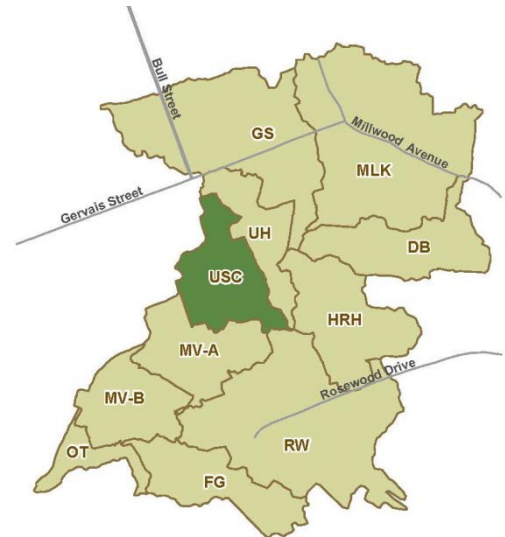
**Figure 6.7 University of South Carolina Subwatershed**

- The University of South Carolina Campus (USC) subwatershed is centrally located within the Rocky Branch watershed. USC is north of the MV-A subwatershed and northwest of the RW subwatershed.
- The subwatershed contains a large portion of the USC campus and portions of the Wales Garden neighborhood.
- 173 acres or 0.27 square miles in drainage area
- Contains 0.80 miles of open stream channel, and 8.17 miles of mapped storm drain/pipe
- Dominant land use designations (**Figure 6.1, Table 6.1**):
  - Developed, Medium Intensity: 55%
  - Developed, Low Intensity: 29%
- Impervious surface cover: 53%

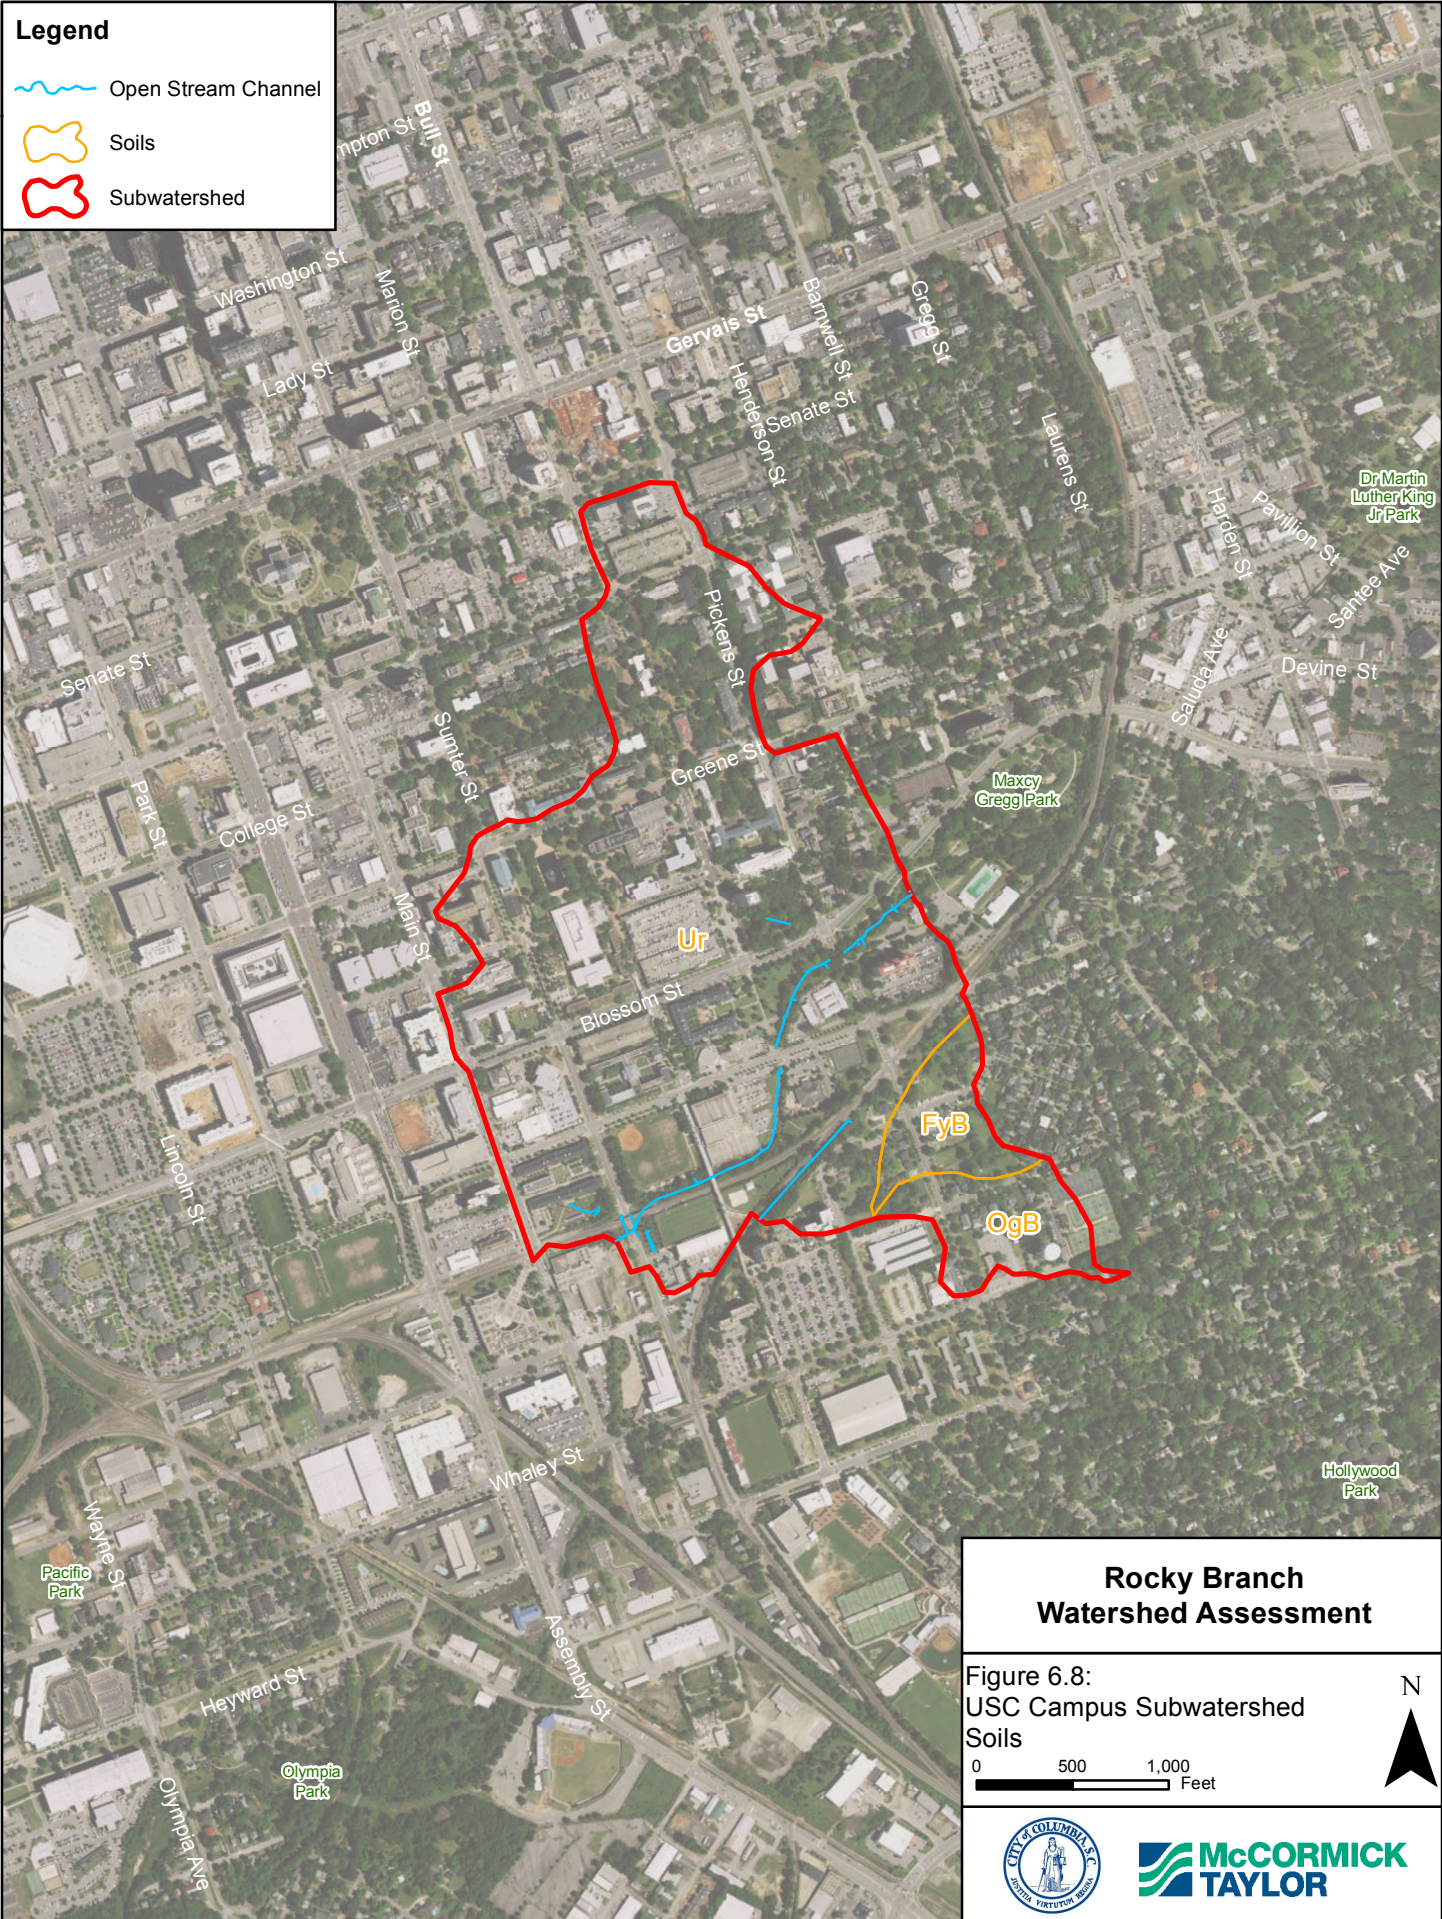
Figure 6.8:  
USC Campus Subwatershed  
Soils

**Soils:** Approximate soil type percentages within USC subwatershed include (refer to **Section 3.4** for soil descriptions and **Figure 6.8** for soil distributions):

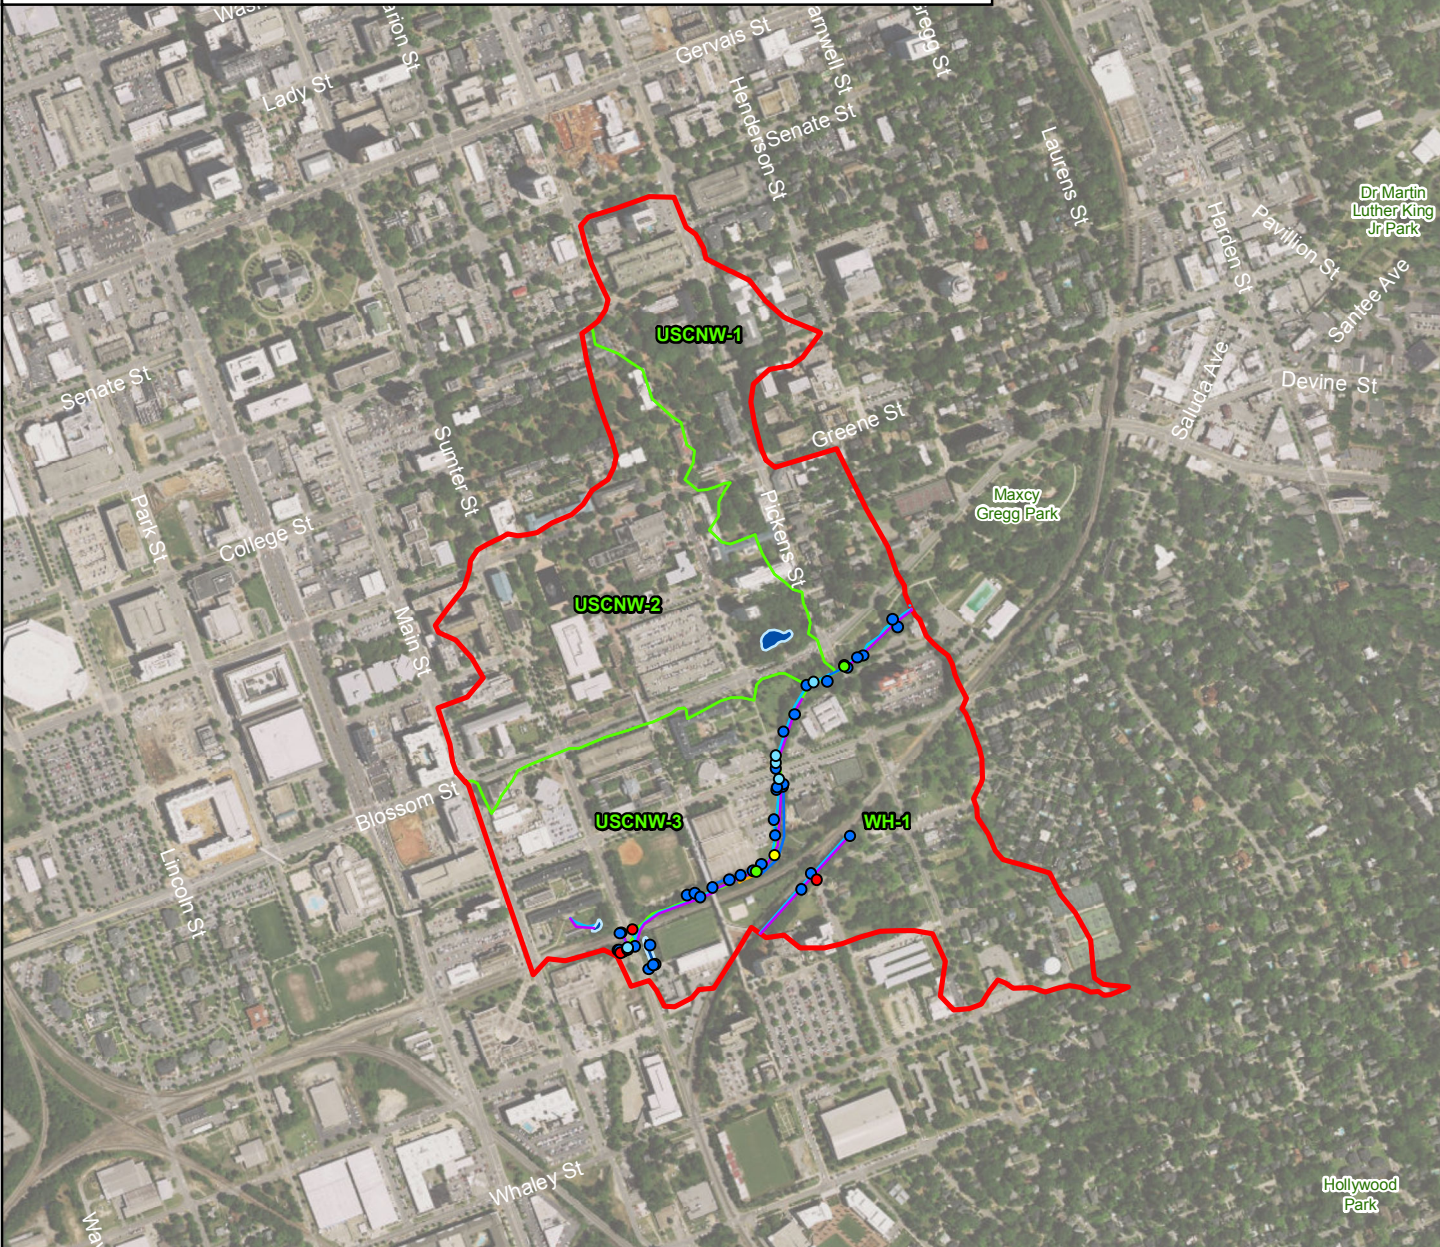
- Trash Dumping
- Pipe Outfall
- Near Stream Construction
- Possible Fish Barrier
- Exposed Pipe
- Bedrock
- Unmanaged Runoff
- Unusual Condition
- ~ Open Stream Channel
- Erosion Site
- Channel Alteration
- Inadequate Forest Buffer
- ☪ SWM Facility
- ☪ SWMM Subcatchment
- ☪ Subwatershed

Existing Condition	Count
Exposed Pipes	5
Pipe Outfalls	38
Unmanaged Runoff	4
Unusual Condition	2
Trash Dumping	0
Possible Fish Barrier	2
	<b>Linear Feet</b>
Erosion Site	98
Channel Alteration	983
Inadequate Forest Buffer	6,039

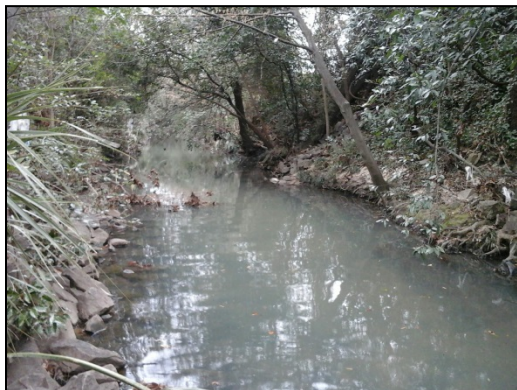
The upstream limit of open stream channel in the USC subwatershed is the Rocky Branch Mainstem within Maxcy Gregg Park. Stream banks are steep yet stable, with a thick layer of small trees and shrubs. Past riprap stabilization can be seen scattered along banks and in the stream bed. The channel substrate is primarily boulder and cobble material. The channel passes through a triple box culvert under Pickens Street and then continues downstream with similar channel conditions. This segment ends at the twin box culvert under Wheat Street.

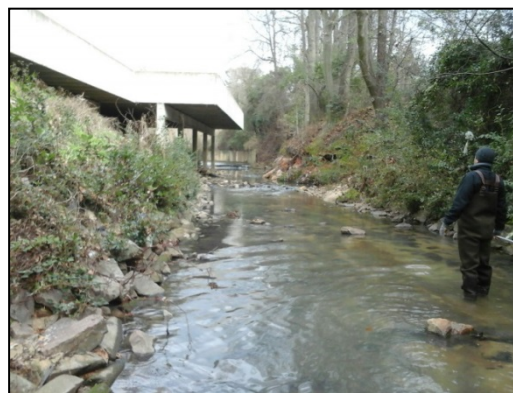
South (downstream) of Wheat Street, the entire stream channel has been straightened and converted to a flat bottom concrete bed and vertical concrete banks. The concrete channel ends 500 feet downstream of Wheat Street. The channel bed is downcut into a large scour pool at the downstream limit of the concrete channel and the left bank is also highly unstable in this location. The channel is highly confined through this reach with the Solomon Blatt Physical Education Center and athletic fields along the right bank and the railroad embankment along the steep left bank. A balcony from the Physical Education Center overhangs the stream channel with pier supports within the active bed. The channel substrate is mostly coarse, with some fine deposition in the pools and some coarse mid-channel bars. The stream takes an abrupt turn at Sumter Street, through a road culvert identified as being in severe condition. This area acts as a pinch point and is modeled to produce a backwater condition at a 2-year storm event. The mainstem channel downstream of Sumter Street has concrete bed and banks that extend to the subwatershed boundary.

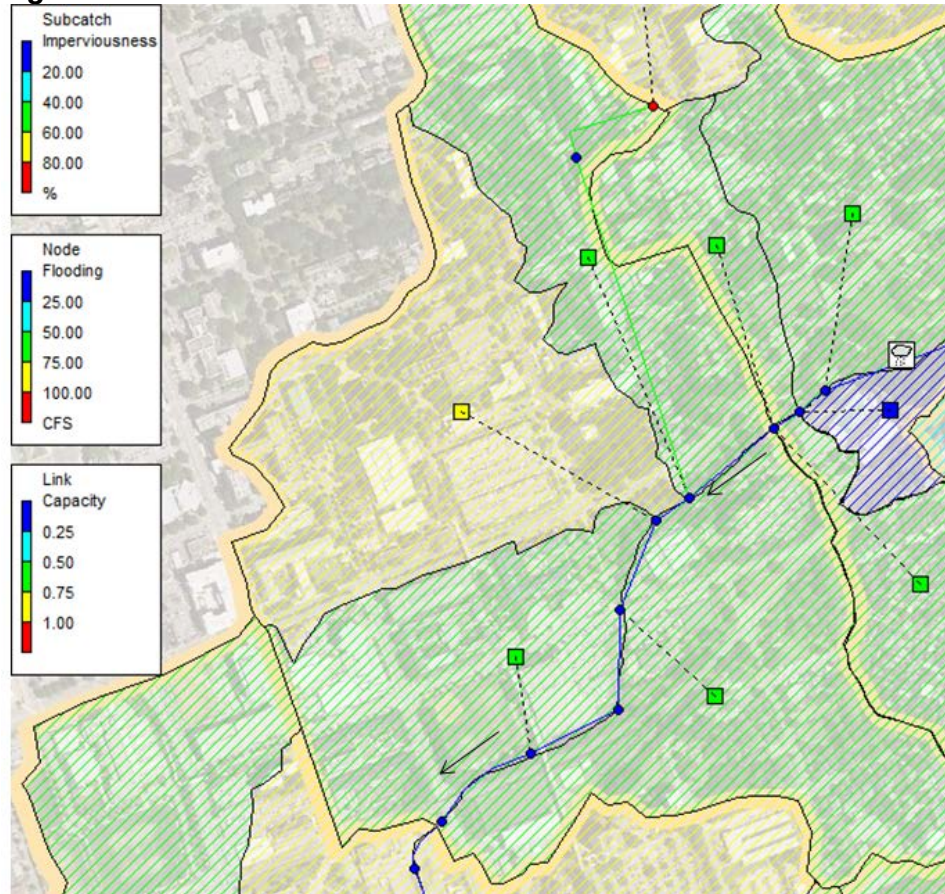
**Figure 6.10 USC SWMM Model**

The USC subwatershed consists of four subcatchments in SWMM, all of them connecting directly to Rocky Branch. In this subwatershed, most of the hydraulic improvements recommended are along the Rocky Branch channel itself.
