Rocky Branch Watershed Management Plan

# ROCKY BRANCH WATERSHED ASSESSMENT

McCormick Taylor Inc., supported by KCI Technologies, Inc., has been contracted by the City of Columbia, South Carolina to conduct an assessment of the Rocky Branch watershed to identify potential improvement opportunities to identify existing flooding and water quality conditions.

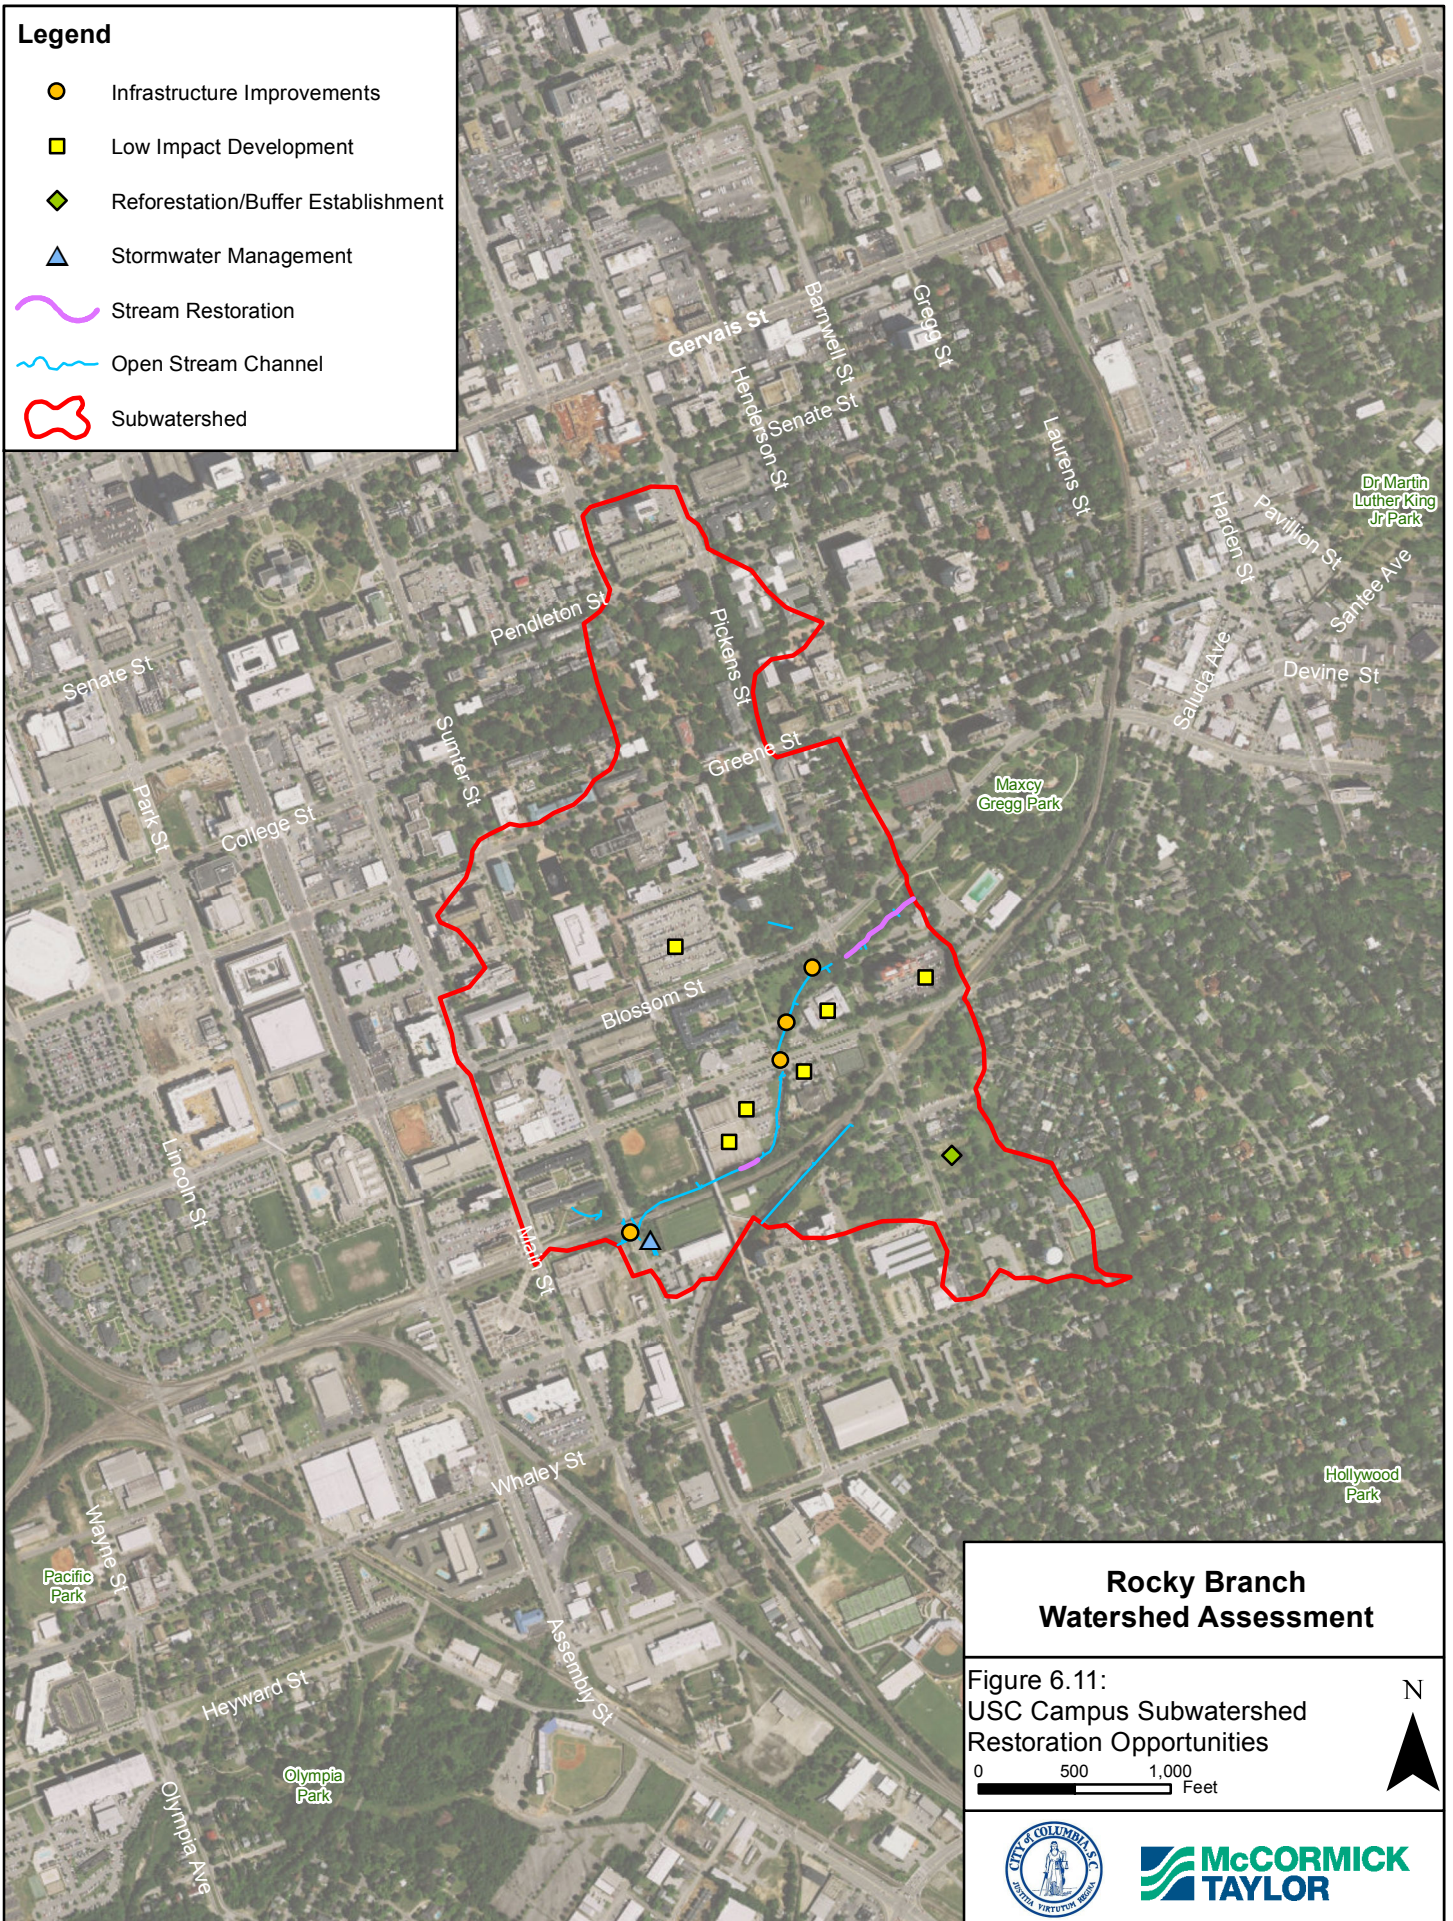
The following projects or similar improvements may be considered to address conditions identified in the USC subwatershed. These projects are included in **Figure 6.11**.

- Opportunities for infiltration and storage should be investigated here to reduce peaks downstream.
  - Retrofit the SWM pond at the USC Dance Facility Building, expand the footprint and convert to a shallow marsh

- At Maxcy Gregg Park and northeast of Catawba and Pickens Streets, and Rice and Pickens Streets, add tree plantings where feasible.
- Bevel the top and sides at the entrance to the Wheat Street culvert over Rocky Branch to reduce entrance losses into the culvert. This structure is modeled to produce a backwater in existing conditions during a 2-year storm event.

- Modify the bridge at Pickens Street over Rocky Branch to remove the existing barriers and to create a beveled entrance in order to improve routing through the structure. Currently it is creating a backwater in existing conditions during a 2-year storm event.

- Restore the eroded outfall discharging into the stream behind the ROTC building
- Stabilize the stream bank behind the Solomon Blatt building
- Relocate the utility pipes away from the culvert at Sumter Street over Rocky Branch. This structure is modeled to produce a backwater condition at a 2-year storm event, and removing these pipes would provide greater capacity.

- Repair undercut sanitary line in stream bed within Maxcy Gregg Park, downstream of Pickens Street
- Addition of imperviousness is not recommended for this watershed without storage for excess runoff

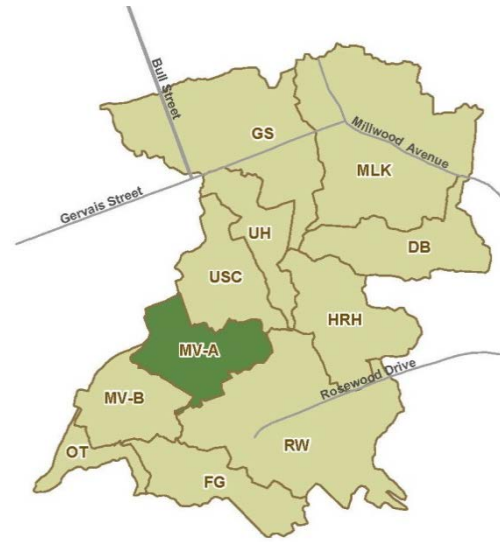
**Figure 6.12 Mill Villages A Subwatershed**

- The Mill Villages A (MV-A) subwatershed is located to the north of the MV-B subwatershed and to the west of the RW subwatershed.
- Within the subwatershed are portions of the USC campus, Olympia-Granby, and Wales Garden neighborhoods.
- 174 acres or 0.27 square miles in drainage area
- Contains 0.98 miles of open stream channel, and 5.0 miles of mapped storm drain/pipe
- Dominant land use designations (**Figure 6.1, Table 6.1**):
  - Developed, Medium Intensity: 58%
  - Developed, High Intensity: 25%
  - Developed, Low Intensity: 16%
- Impervious surface cover: 54%

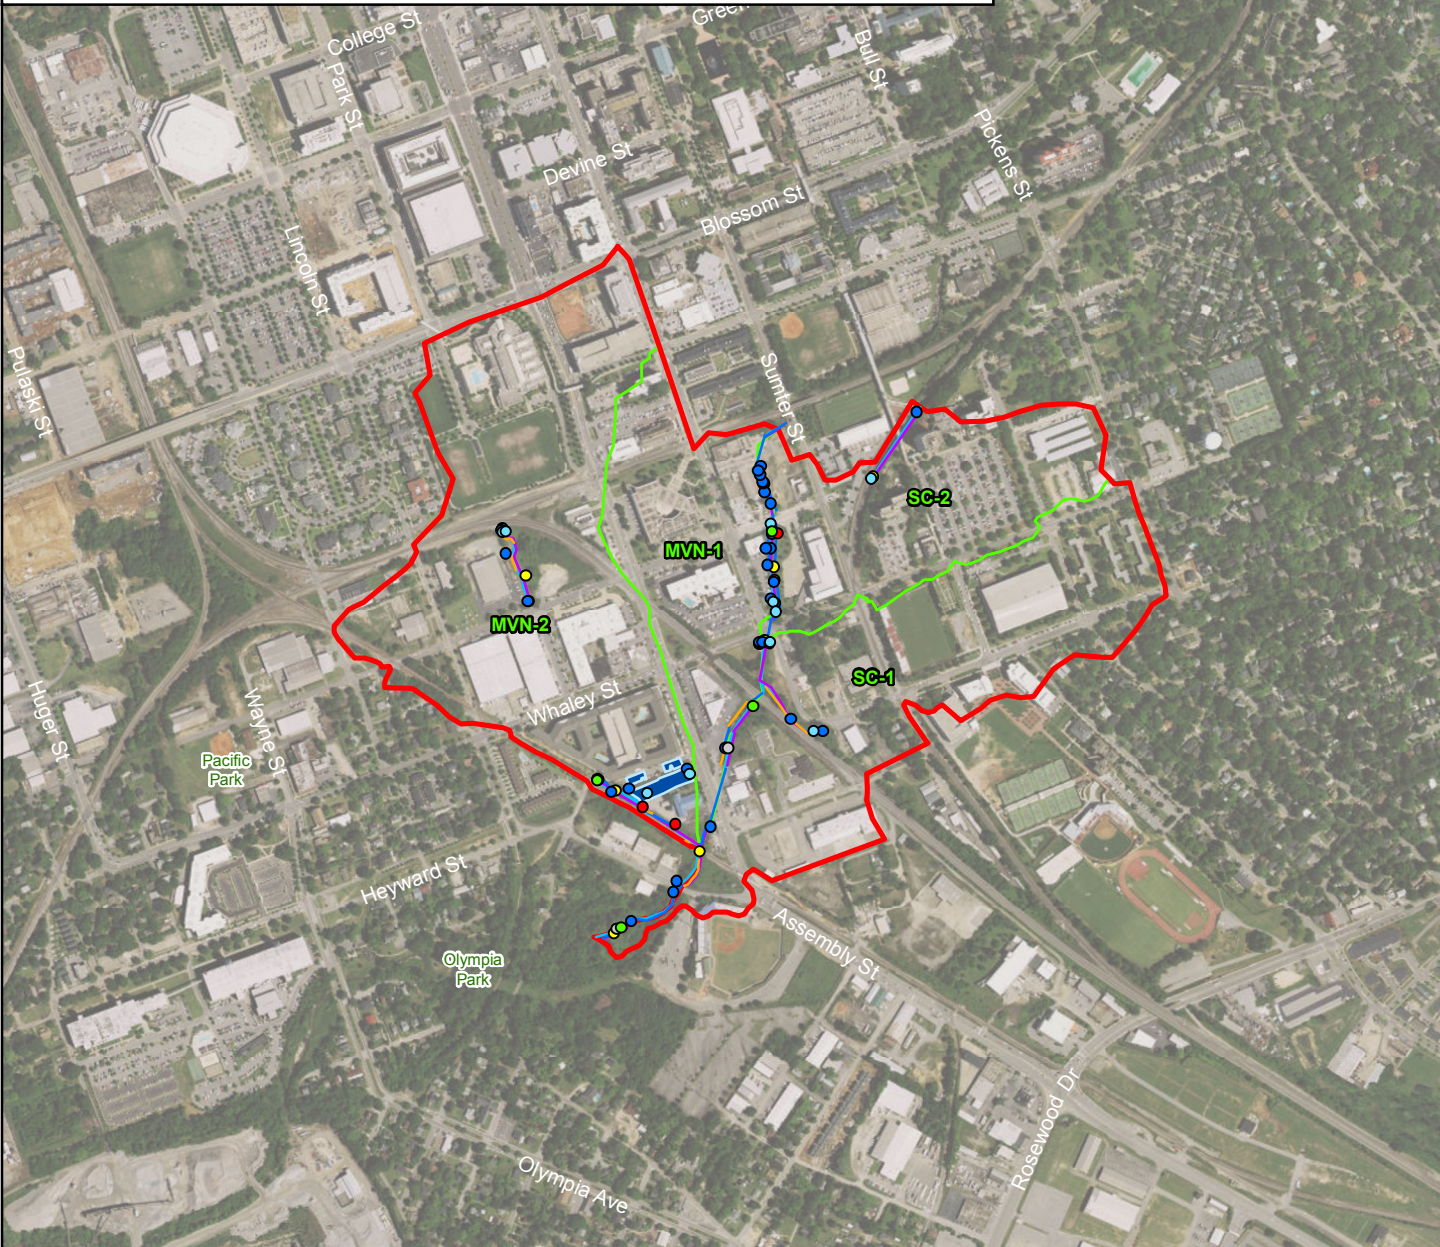
Figure 6.14:  
Mill Villages A Subwatershed  
Existing Conditions

Existing Condition	Count
Exposed Pipes	5
Pipe Outfalls	13
Unmanaged Runoff	1
Unusual Condition	8
Trash Dumping	1
Possible Fish Barrier	0
	<b>Linear Feet</b>
Erosion Site	204
Channel Alteration	625
Inadequate Forest Buffer	2,580

**Figure 6.14** highlights existing conditions that were either captured during the stream cruising effort or developed using GIS data.

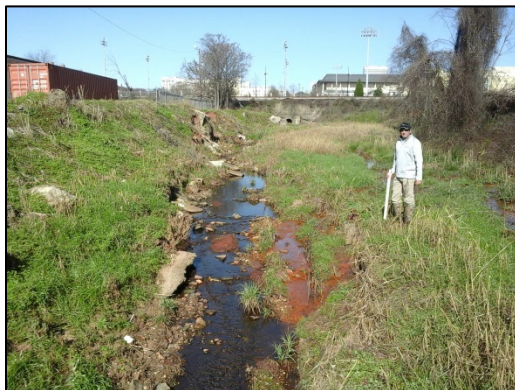
A small open channel segment is located north of the Catawba Street and Park Street intersection, adjacent to the Richland Industrial building. The left floodplain is saturated and likely a wetland. The upstream end of this segment begins with two outfalls emerging from the railroad embankment. Approximately 20% of the banks are eroded, occurring on alternating banks along the outside of bends. The channel substrate is mostly gravel, with some sand and cobble.

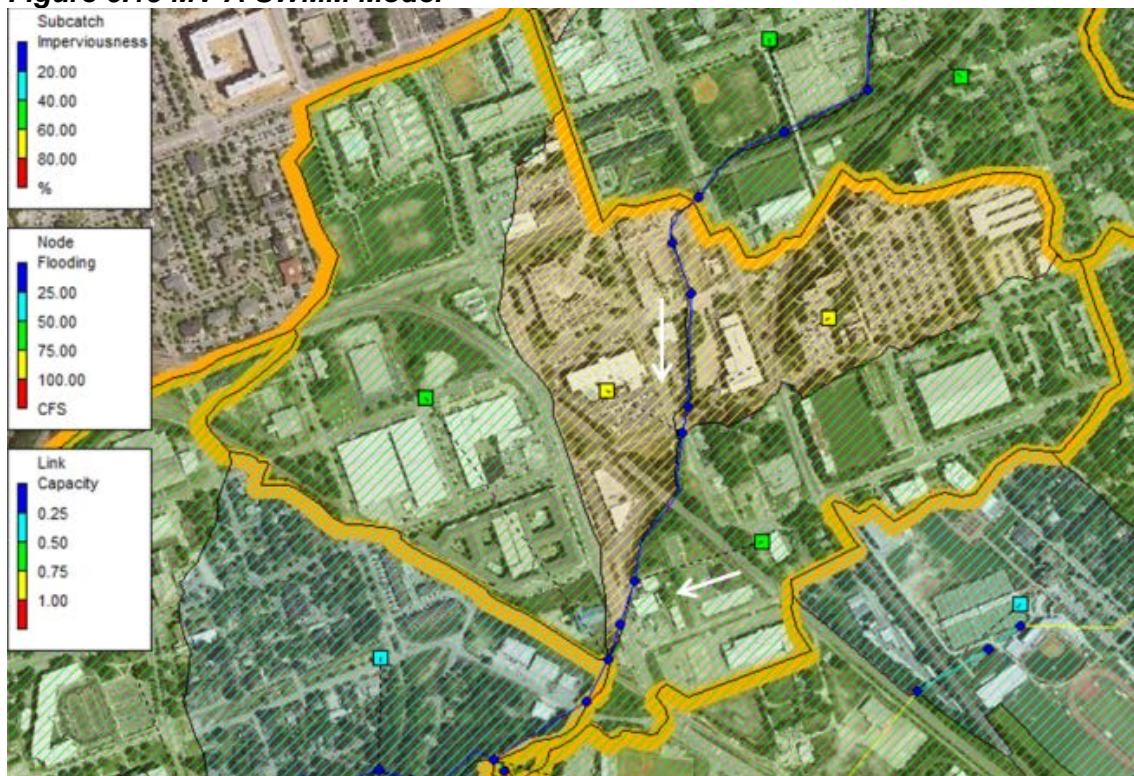
**Figure 6.15 MV-A SWMM Model**

This subwatershed is modeled as four subcatchments in SWMM. The flows from these subcatchments are linked directly to Rocky Branch. The model does not indicate any flooding occurring in the subcatchments as a result of overburdened drainage pipes.

The MV-A subwatershed lies to the south of the USC area and has the second highest value of impervious surface at 54%. The MV-A subwatershed is only 175 acres, but the SWMM model predicts for a 2-year storm event that the area will produce 11.4 million gallons of runoff, which is the fourth highest in the watershed. The discharge per acre for a 2-year storm event is modeled at 5.7 peak cfs/acre, putting it at the third highest amount within Rocky Branch, and 8,675 cubic feet/acre, which is fourth highest among the subwatersheds. As a result, the MV-A subwatershed received a higher subwatershed runoff ranking.

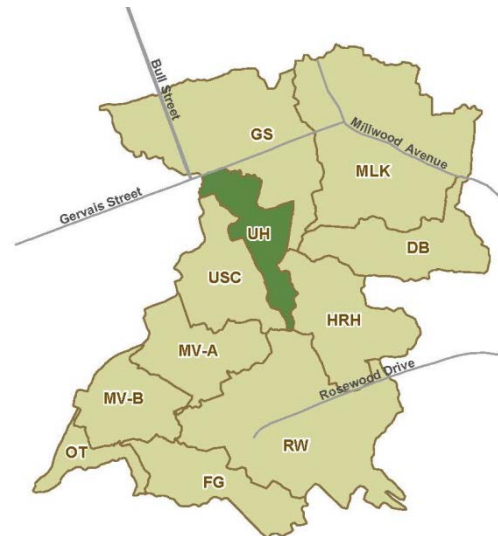
**Figure 6.17 University Hill Subwatershed**

- The University Hill (UH) subwatershed is centrally located within the Rocky Branch watershed. The USC subwatershed is to the southwest of the UH subwatershed and the RW subwatershed is to the south.
- This subwatershed is the second smallest within the watershed and is situated to the northeast of the USC campus, with Gervais Street at the northwest boundary and Enoree Avenue to the southeast.
- 125 acres or 0.20 square miles in drainage area
- Contains 0.25 miles of open stream channel, and 4.44 miles of mapped storm drain/pipe
- Land use designations (**Figure 6.1, Table 6.1**):
  - Developed, Medium Intensity: 55%
  - Developed, Low Intensity: 28%
- Impervious surface cover: 54%

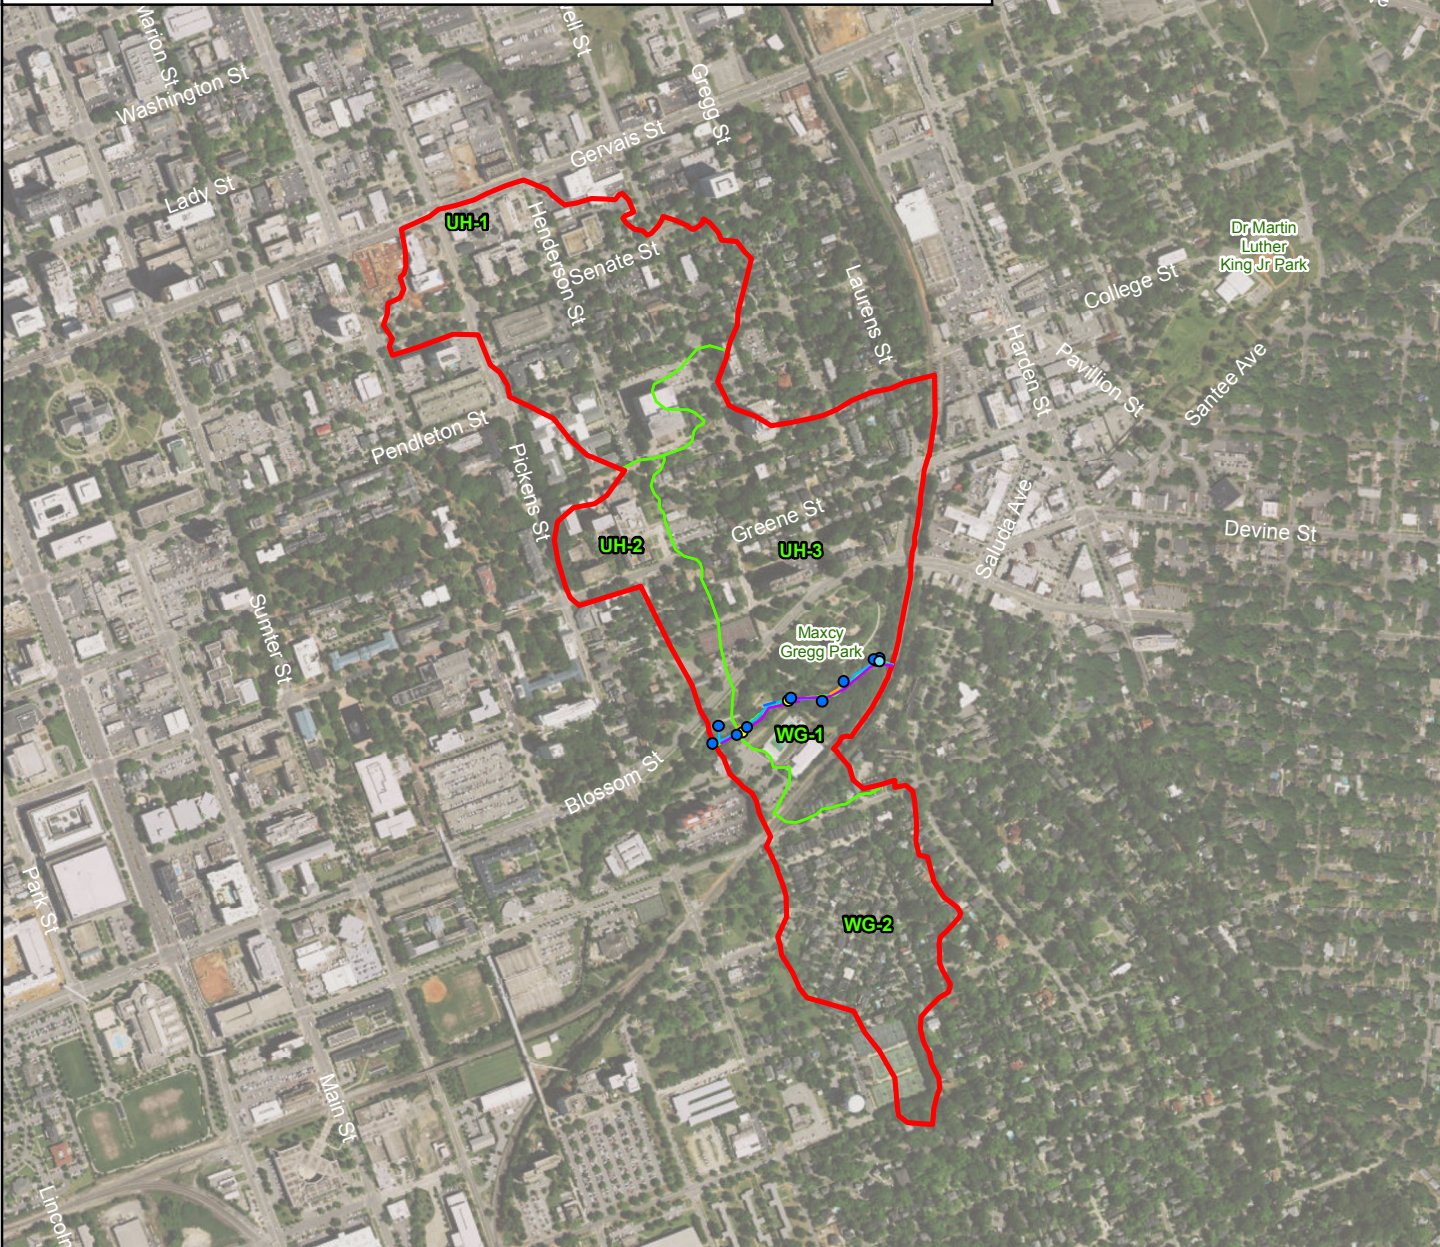
Figure 6.19:  
University Hill Subwatershed  
Existing Conditions

Existing Condition	Count
Exposed Pipes	1
Pipe Outfalls	9
Unmanaged Runoff	0
Unusual Condition	3
Trash Dumping	0
Possible Fish Barrier	0
	<b>Linear Feet</b>
Erosion Site	173
Channel Alteration	59
Inadequate Forest Buffer	1,501

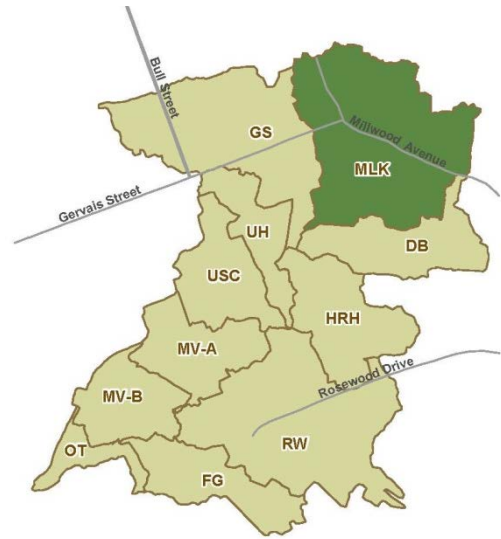
**Figure 6.22 Martin Luther King Jr. Subwatershed**

- The Martin Luther King JR. (MLK) subwatershed is the northeastern most, and largest, subwatershed within the Rocky Branch watershed.
- MLK’s downstream end falls between the GS and DB subwatersheds, extends north approximately 1 mile to slightly north of Forest Drive. The Gervais Street, Millwood Avenue intersection is at the northwest.
- 503 acres or 0.79 square miles in drainage area
- Contains 0.35 miles of open stream channel, and 11.61 miles of mapped storm drain/pipe
- Dominant land use designations (**Figure 6.1, Table 6.1**):
  - Developed, Low Intensity: 46%
  - Developed, Medium Intensity: 34%
  - Developed, Open Space: 12%
- Impervious surface cover: 47%

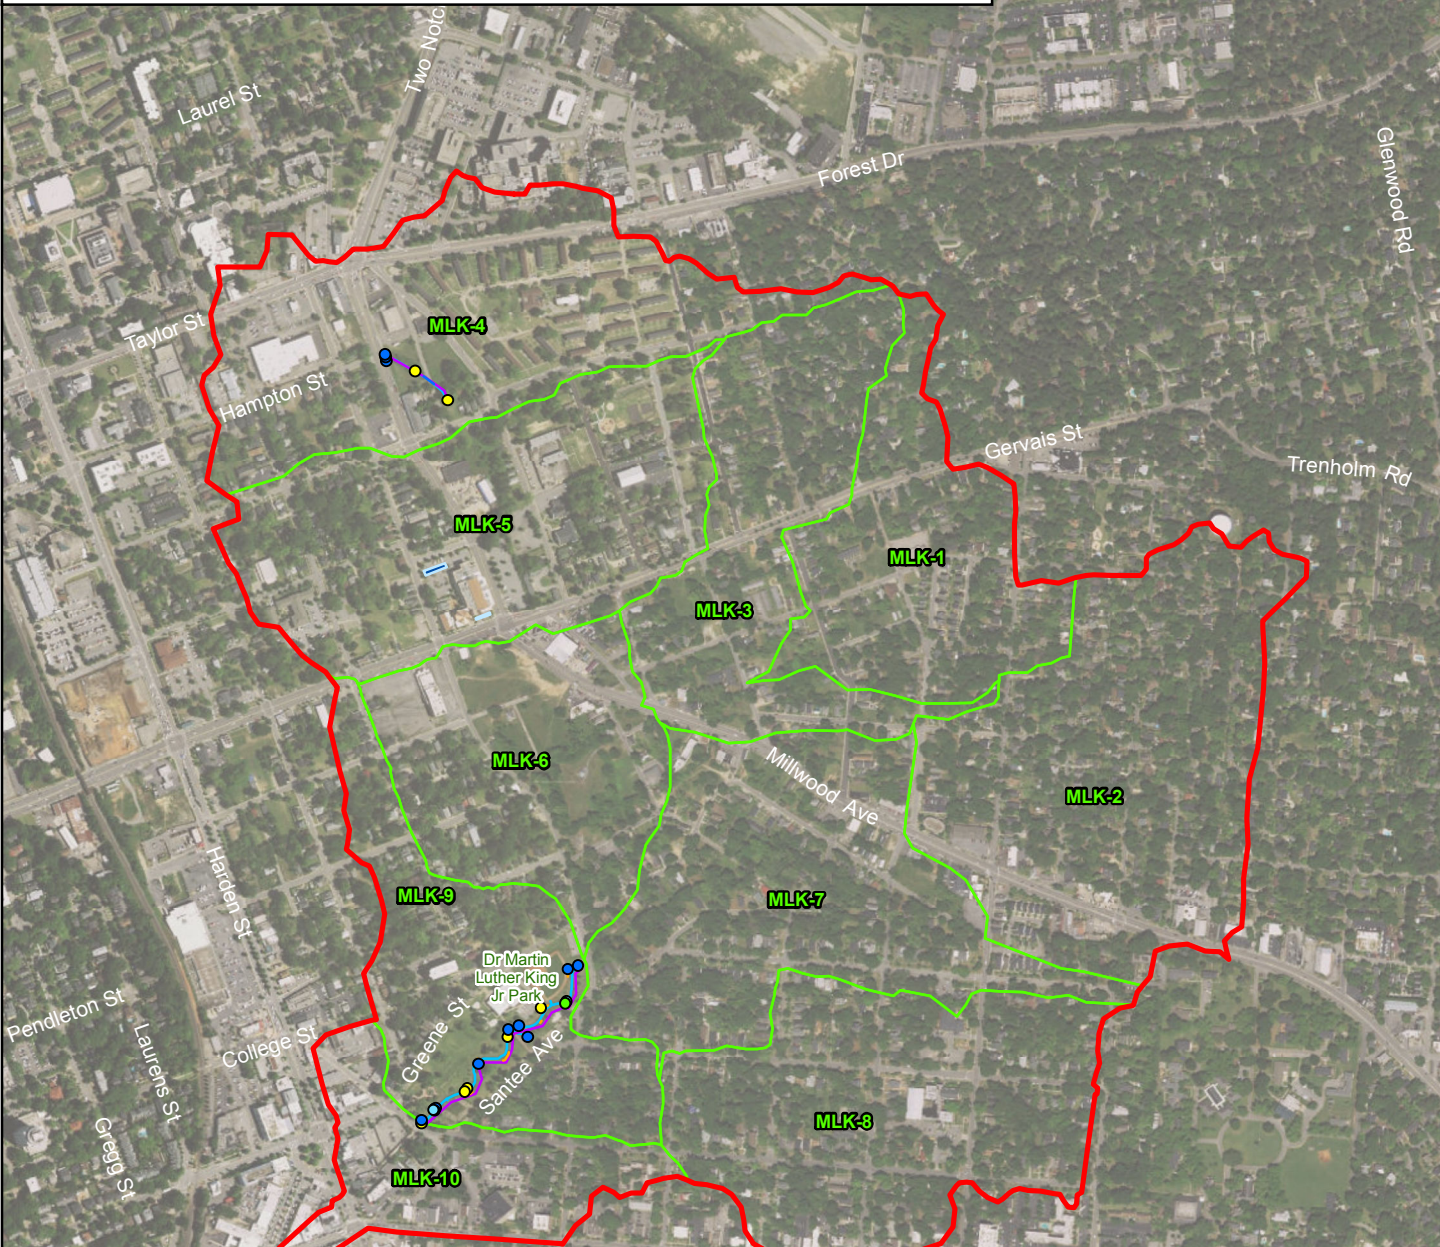
Existing Condition	Count
Exposed Pipes	2
Pipe Outfalls	13
Unmanaged Runoff	0
Unusual Condition	7
Trash Dumping	0
Possible Fish Barrier	1
Linear Feet	
Erosion Site	274
Channel Alteration	88
Inadequate Forest Buffer	3,491

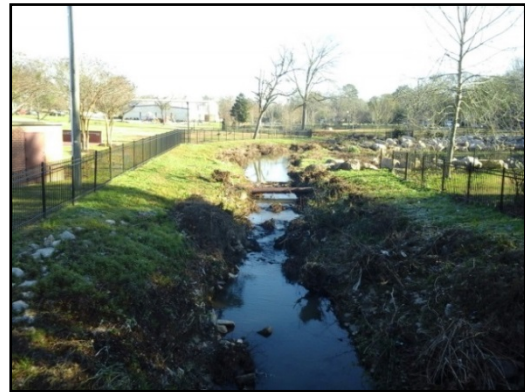
The second open channel segment in this subwatershed begins at the northeastern edge of MLK Park, where the stream emerges from underneath Heidt Street. The open channel section within MLK Park was recently restored using natural channel design and stabilization techniques. The entire stream corridor within the park is fenced in. Grade controls including large boulders across the bed and bank stabilization are present throughout this segment. Isolated areas of erosion are located along the outsides of bends, resulting in sediment sloughing off of the 6 to 7-foot banks and portions of the park fence falling down the eroding slopes. Adjacent to Heidt Street, an exposed 18-inch sanitary pipe was observed crossing the stream. A cross vane structure is located immediately downstream of this pipe crossing. Erosion was observed along the left bank caused by the channel flanking the structure. A beaver dam located downstream of the park pedestrian bridge has altered the restored channel by causing localized backwater conditions. Further downstream, another exposed sanitary pipe was observed, and is spanning above base flow. The stream then enters a culvert beneath Pavilion Avenue and is piped through the Five Points neighborhood, eventually emerging in the southern portion of the Gregg Street subwatershed.

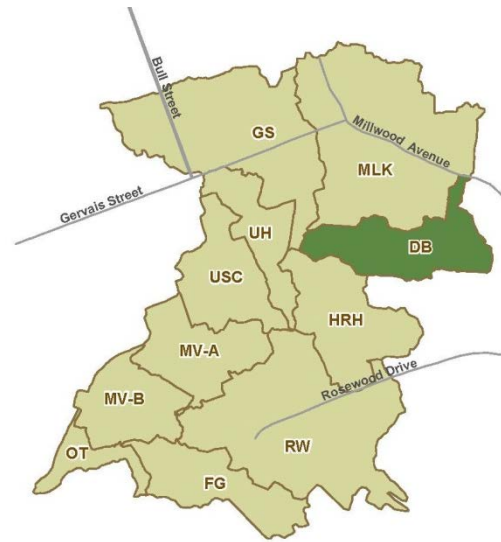
**Figure 6.27 Devine Blossom Subwatershed**

- The Devine Blossom (DB) subwatershed is located directly north of the HRH subwatershed
- This subwatershed encompasses the northwest portion of the Shandon neighborhood from Wilmot Avenue to its northernmost point at Millwood Avenue (US-378). The east-west boundaries are from Sims Avenue to Saluda Avenue.
- 165 acres or 0.26 square miles in drainage area
- Contains no open stream channel, and 3.40 miles of mapped storm drain/pipe
- Dominant land use designations (**Figure 6.1, Table 6.1**):
  - Developed, Medium Intensity: 36%
  - Developed Low Intensity: 34%
  - Developed, Open Space: 18%
- Impervious surface cover: 47%

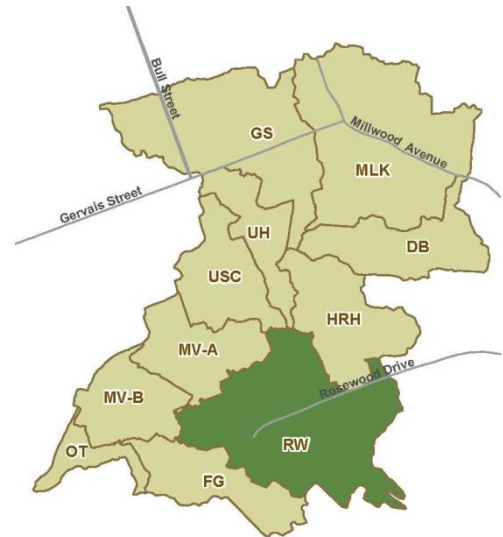
**Figure 6.32 Rosewood Subwatershed**

- The Rosewood (RW) subwatershed is located to the southeast and is the second largest subwatershed within the Rocky Branch watershed.
- The subwatershed encompasses Capital City Stadium and the USC sports facilities complex. Rosewood Drive intersects the northern boundary along with portions of the Wales Garden and the Hollywood-Rose Hill neighborhoods.
- 489 acres or 0.76 square miles in drainage area
- Contains 1.48 miles of open stream channel, and 5.81 miles of mapped storm drain/pipe
- Dominant land use designations (**Figure 6.1, Table 6.1**):
  - Developed, Medium Intensity: 40%
  - Developed, Low Intensity: 34%
  - Developed, High Intensity: 14%
- Impervious surface cover: 41%

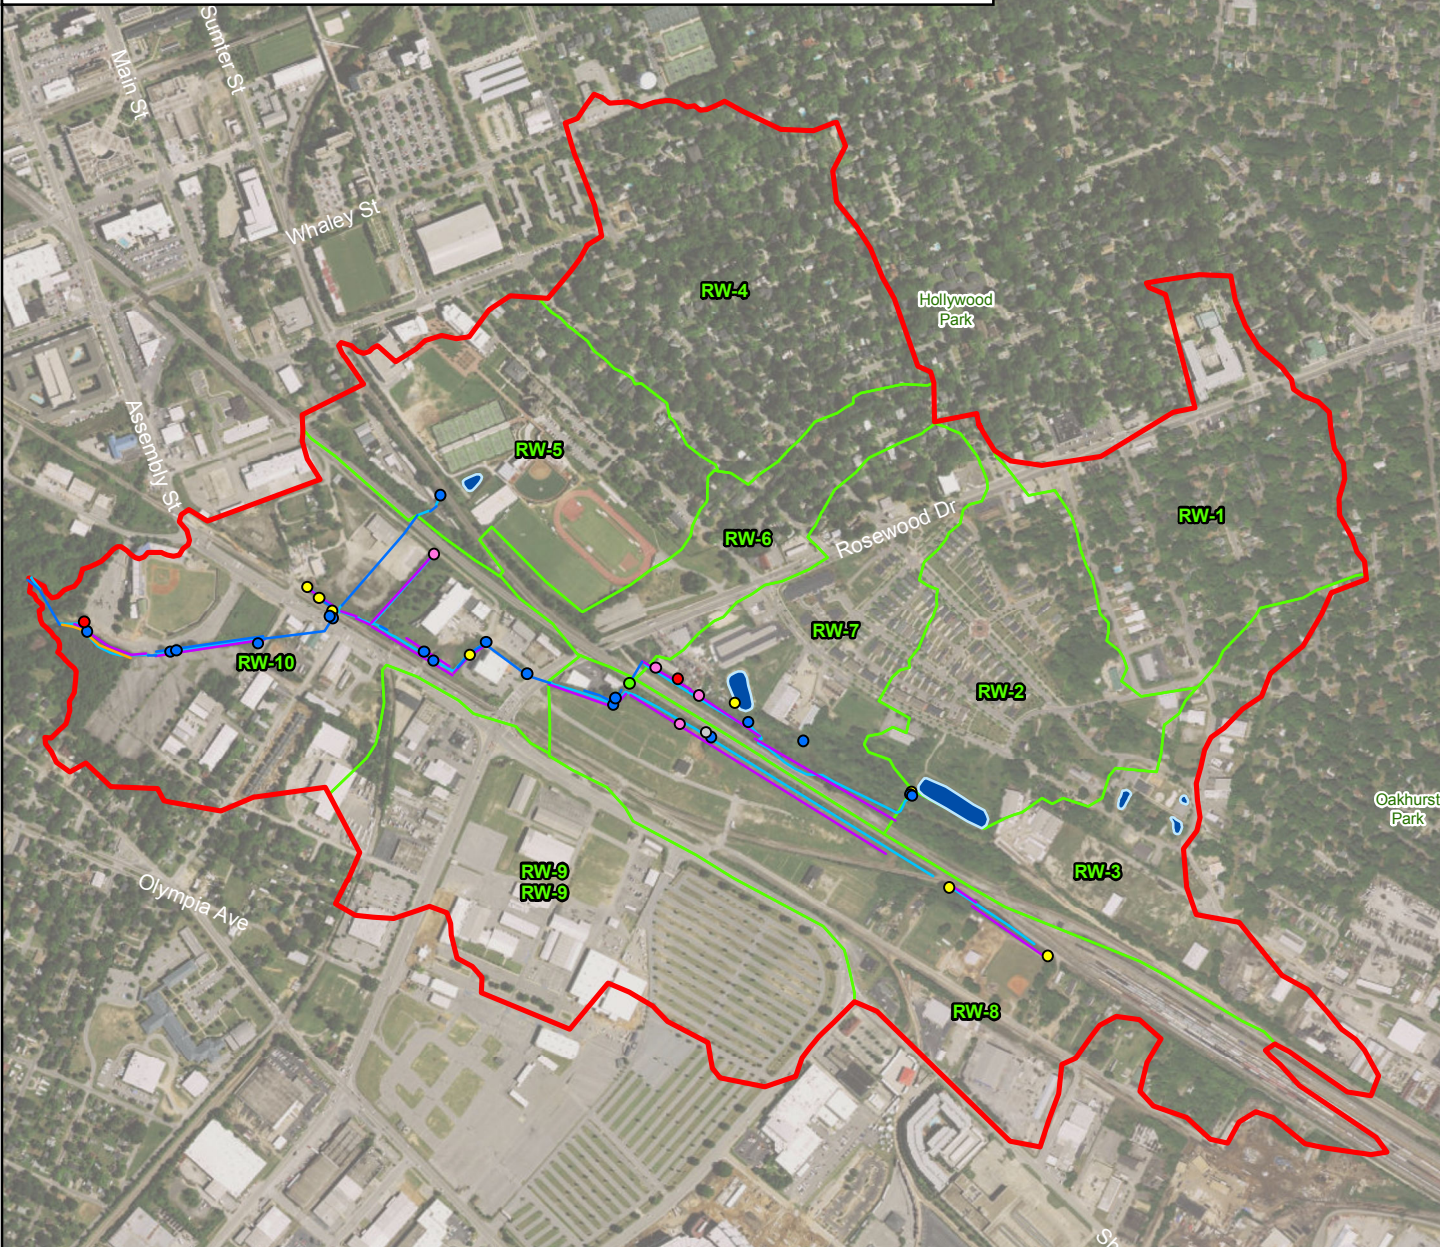
Existing Condition	Count
Exposed Pipes	5
Pipe Outfalls	13
Unmanaged Runoff	1
Unusual Condition	8
Trash Dumping	1
Possible Fish Barrier	0
Linear Feet	
Erosion Site	204
Channel Alteration	625
Inadequate Forest Buffer	2,580

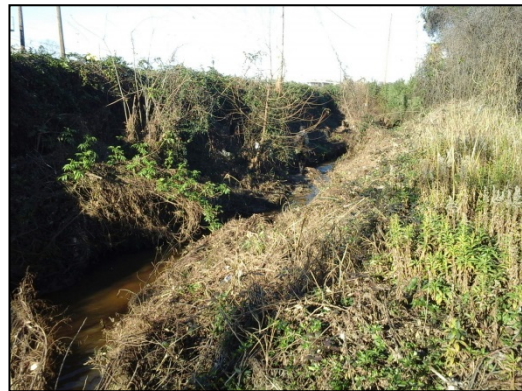
The stream is channelized between roads and businesses in the central region of the watershed. At the upstream end, near Rosewood Avenue, the channel runs between two parking lots; the left bank is defined by a 5-foot tall stone wall stabilizing the edge of the parking lot. The channel then turns to the right, running parallel to the railroad along South Assembly Street. The channel is narrow and pinched between a 5-foot tall railroad embankment on the left and a more gradual slope to a business on the right. The stream passes through two culverts under abandoned road crossings in this segment. A small channel originating from a wetland seep draining from the right bank converges with the main channel downstream of the abandoned road crossings. Two smaller tributaries converge with the main channel before the receiving channel passes underneath South Assembly Street.

The culvert that traverses beneath the railroad north of the Assembly Street and Virginia Street intersection was considered to be in severe condition. The culvert is showing signs of significant degradation with active scouring around and behind the right pipe and heavy debris blocks the left pipe. The pipes have separated at terminal section joints. Soil slumping around these pipes is a severe threat to the railroad embankment that crosses this culvert.

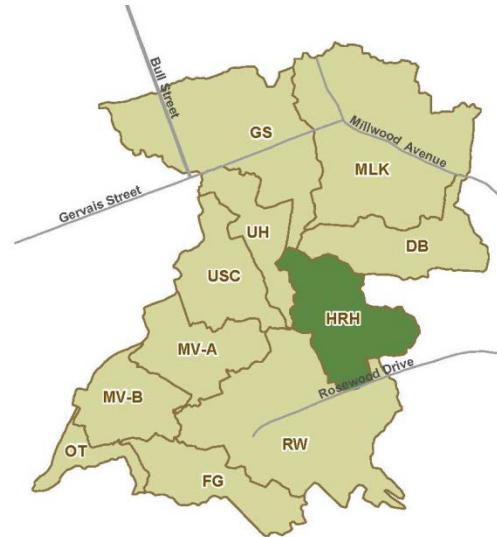
**Figure 6.37 Hollywood-Rose Hill Subwatershed**

- The Hollywood-Rose Hill (HRH) subwatershed is centrally located on east side of the Rocky Branch watershed. The UH subwatershed is to the west and the RW subwatershed is to the south of HRH.
- This subwatershed is north of Rosewood Drive and the Hollywood-Rosewood, Wales Garden, and Shandon neighborhoods are located within it.
- 221 acres or 0.35 square miles in drainage area
- Contains no open stream channel and approximately 4.14 miles of mapped storm drain/pipe
- Dominant land use designations (**Figure 6.1, Table 6.1**):
  - Developed, Low Intensity: 58%
  - Developed, Open Space: 33%
- Impervious surface cover: 40%

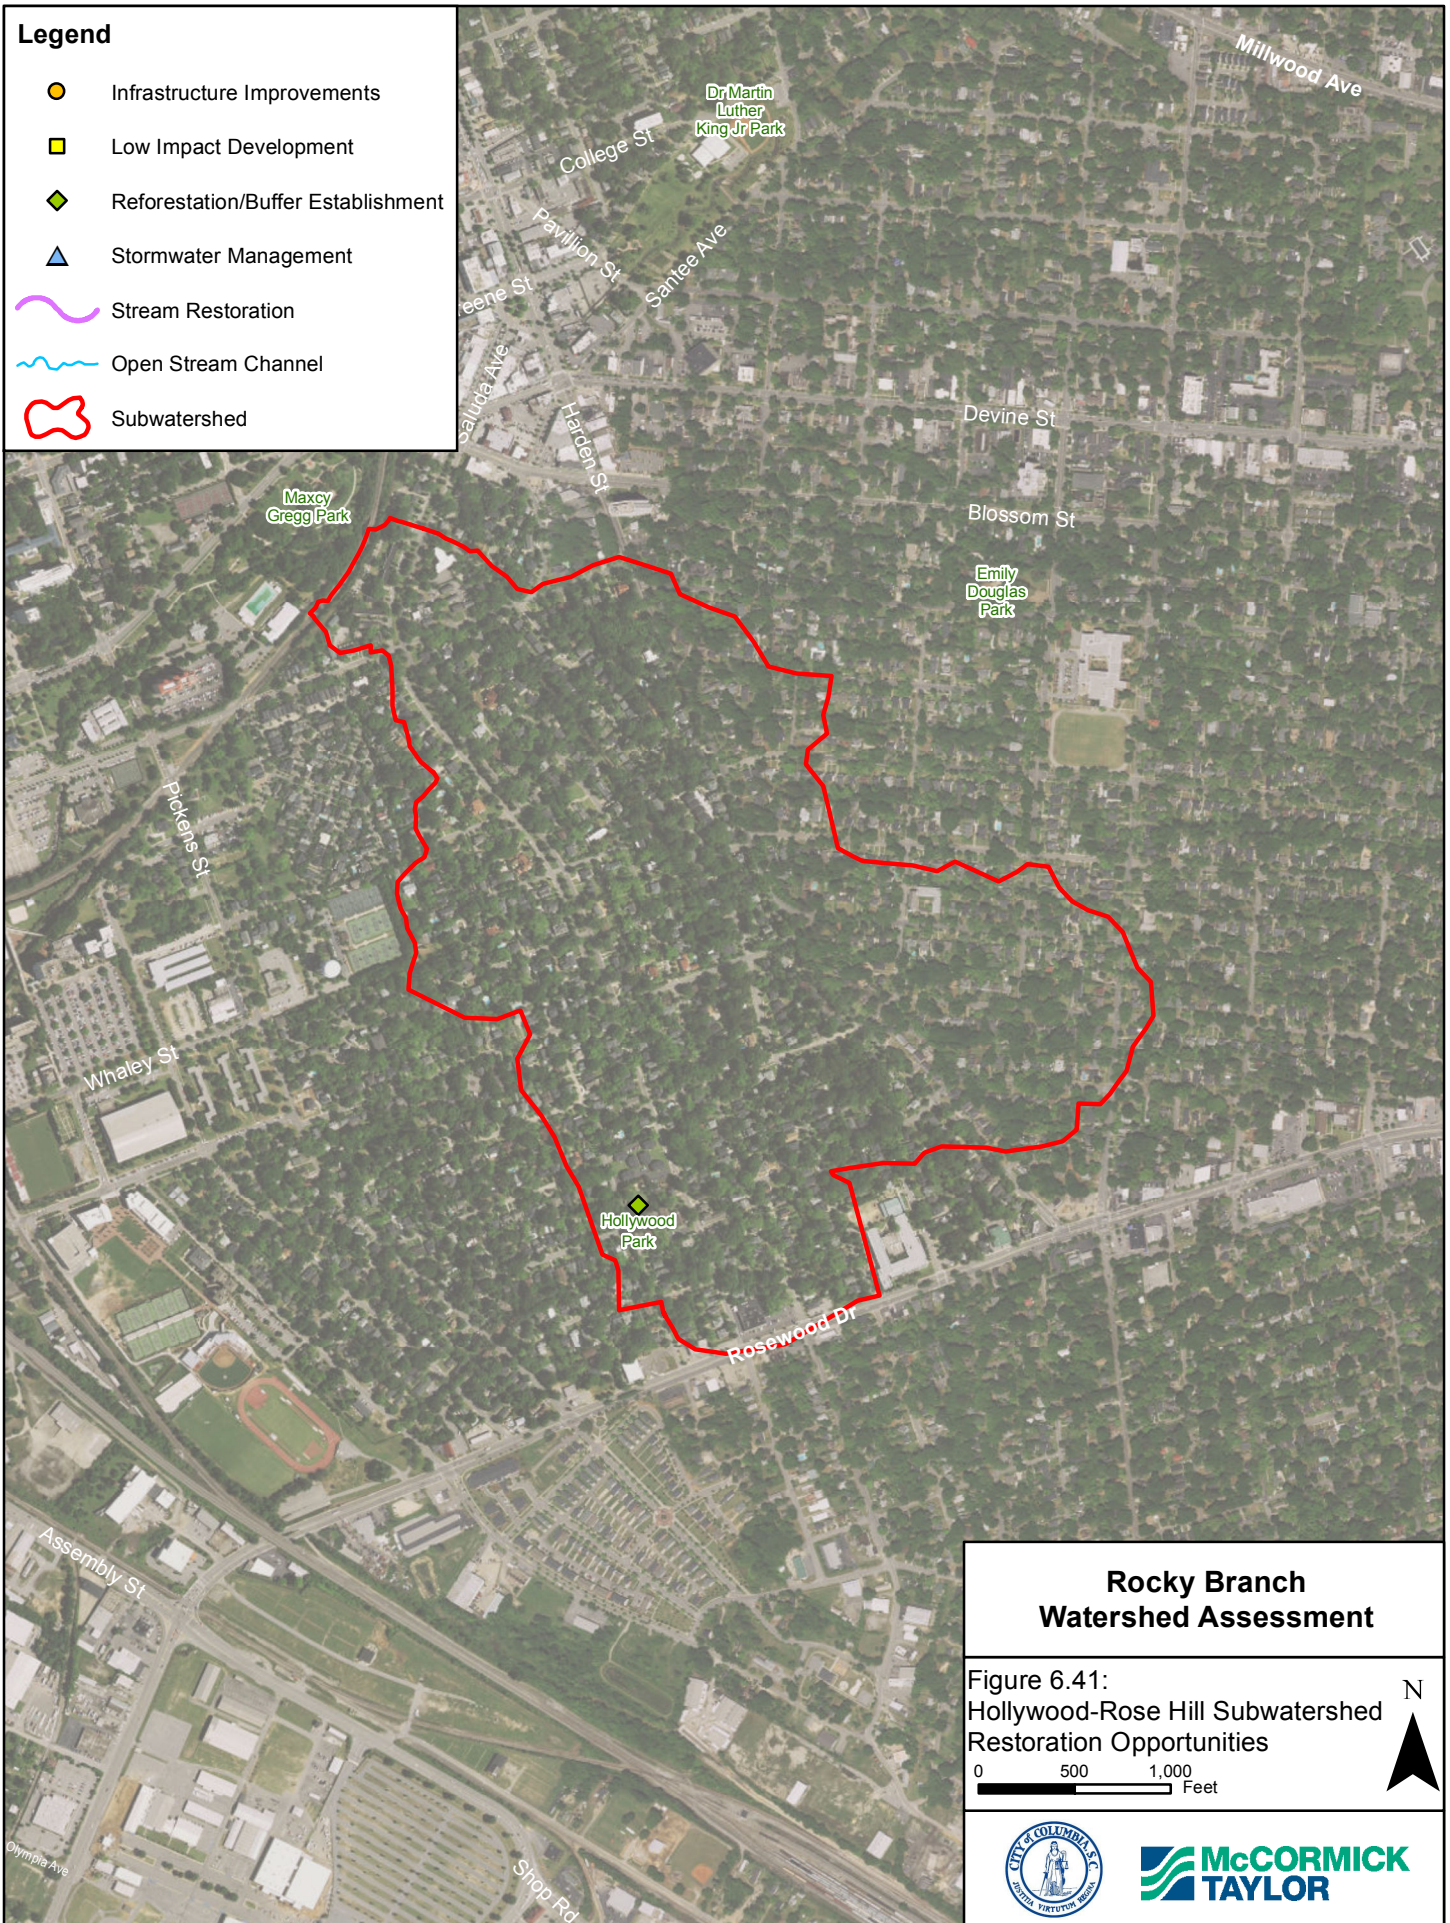
Figure 6.41:  
Hollywood-Rose Hill Subwatershed  
Restoration Opportunities

The following projects or similar improvements may be considered to address conditions identified in the HRH subwatershed. These projects are included in **Figure 6.41**.

- Opportunities for infiltration and storage should be investigated here to reduce runoff and peaks downstream
  - Apply green streets template to reduce runoff from Hollywood-Rose Hill neighborhood
  - Add tree plantings to Hollywood Park where feasible
- Addition of imperviousness is not recommended for this watershed without storage for excess runoff.

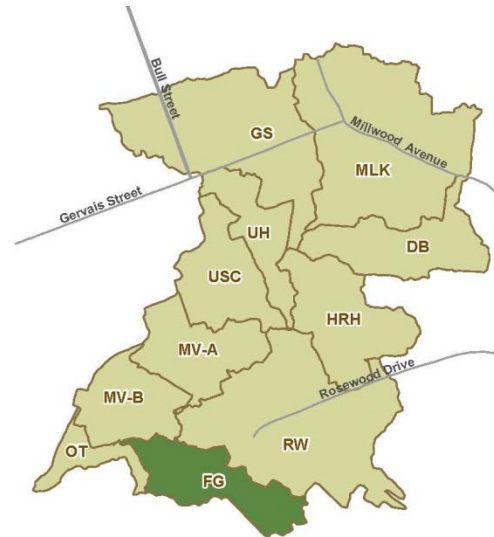
**Figure 6.42 Fairgrounds Subwatershed**

- Fairgrounds (FG) is the southernmost subwatershed within the Rocky Branch watershed
- This subwatershed spans from the Vulcan Materials mine northwest/downstream to the Williams-Brice Stadium to the southeast
- 171 acres or 0.27 square miles in drainage area
- Contains 0.04 miles of open stream channel, and 0.93 miles of mapped stream drain/pipe
- Dominant land use designations (**Figure 6.1, Table 6.1**):
  - Developed, Medium Intensity: 41%
  - Developed, Low Intensity: 38%
  - Developed, High Intensity: 19%
- Impervious surface cover: 46%

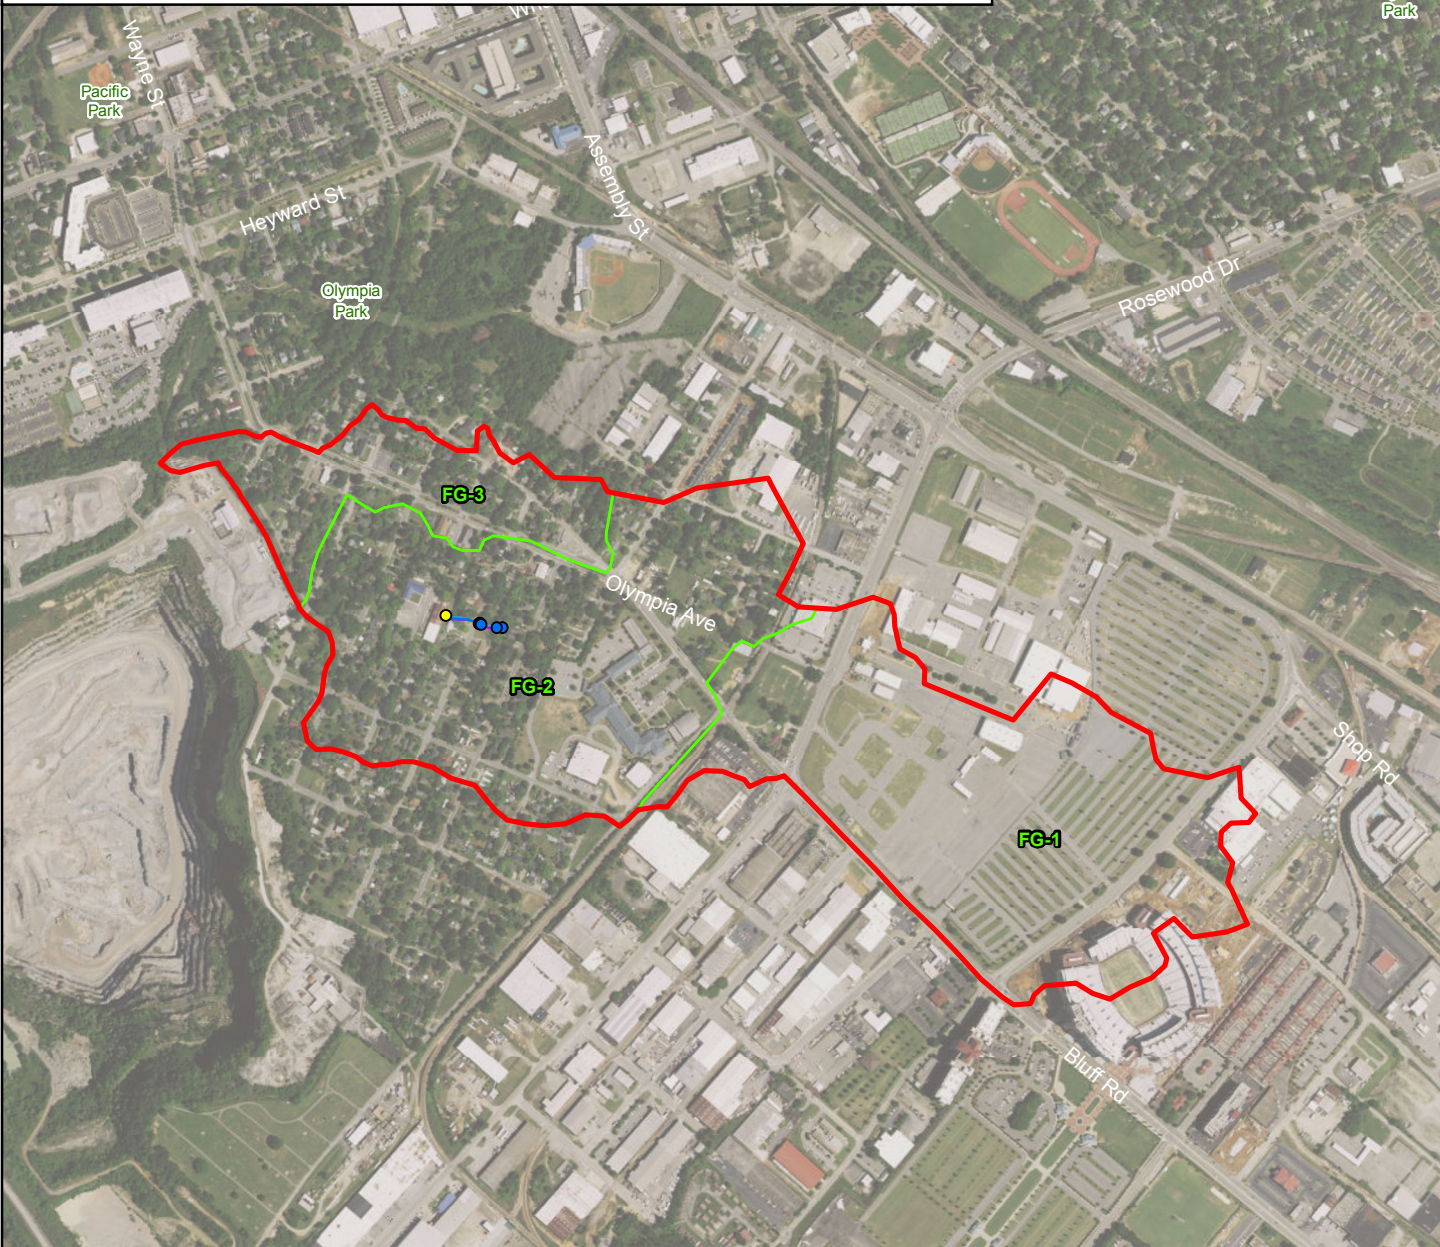
Figure 6.44:  
Fairgrounds Subwatershed  
Existing Conditions

Existing Condition	Count
Exposed Pipes	0
Pipe Outfalls	4
Unmanaged Runoff	0
Unusual Condition	2
Trash Dumping	0
Possible Fish Barrier	0
Erosion Site	0
Channel Alteration	174
Inadequate Forest Buffer	336

**Figure 6.44** highlights existing conditions that were either captured during the stream cruising effort or developed using GIS data.

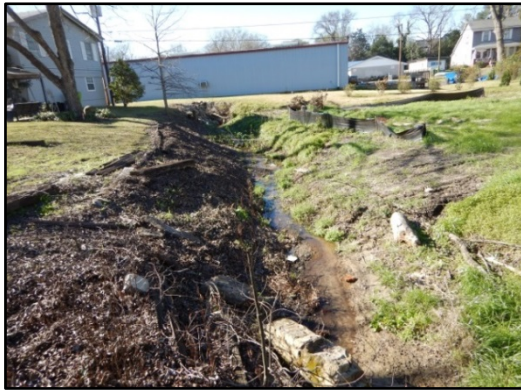
There is minimal open channel length in the FG subwatershed. There is one short section that flows underneath Ohio Street, between Whitney Street and Olympia Avenue. The stream is channelized, located between private properties, and has low, stable banks. The channel bed lacks feature diversity and the substrate includes mostly sand and silt.

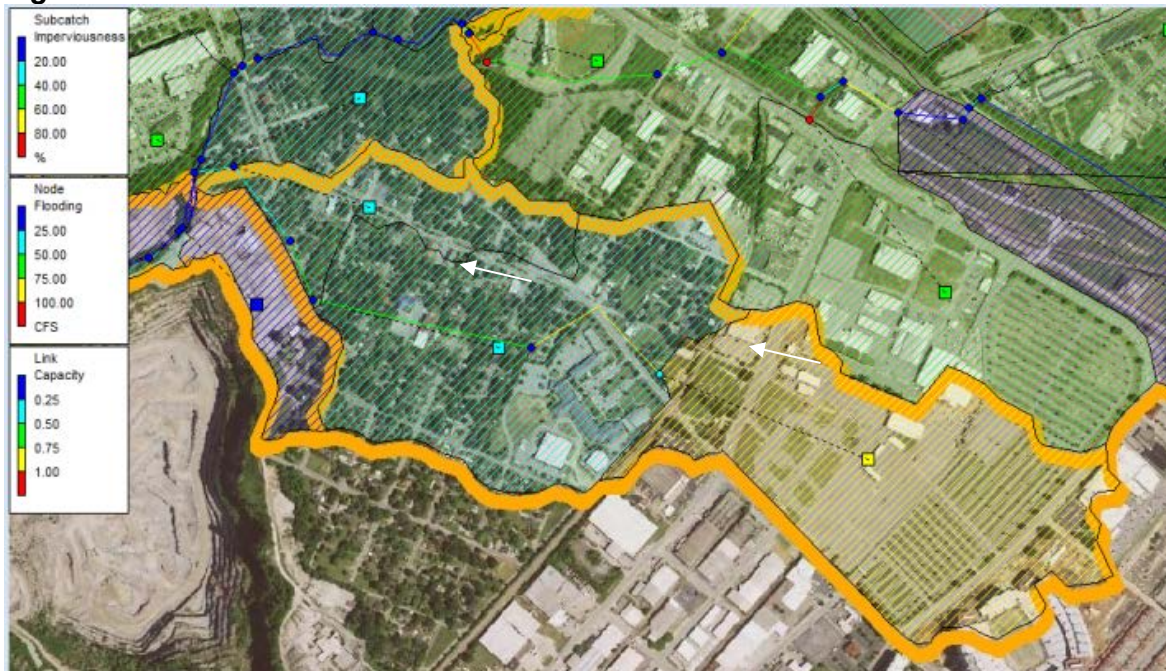
**Figure 6.45 FG SWMM Model**

The SWMM modeling of existing conditions showed that the FG subwatershed has a simulated 2.8 peak cfs/acre for a typical 2-year storm event, which is the lowest amount for the Rocky Branch Watershed. The 171-acre subwatershed is modeled to create approximately 7.7 million gallons of runoff during the 2-year event, which is also on the lower end for the watershed, and 6,029 cubic feet/acre, which is mid-range for the watershed. The FG subwatershed is approximately 46% impervious, which is just above the average value for the watershed. The lower slopes in this subwatershed likely contribute to less peak discharge being modeled during storm events.

The FG subwatershed consists of 3 modeled subcatchments. Most of the drainage flows from east to west through a 60 inch RCP. Even though this RCP was determined to outfall into the Vulcan Materials mine, it was modeled as if it is attached to Rocky Branch in order to simulate flows. The line is very close to capacity during the 2-year event, and flooding begins to occur at this point based on the model. The western portion of this subwatershed does not flood until the 10-year event at existing culvert capacities.
