Rocky Branch Watershed Management Plan

# ROCKY BRANCH WATERSHED ASSESSMENT

McCormick Taylor Inc., supported by KCI Technologies, Inc., has been contracted by the City of Columbia, South Carolina to conduct an assessment of the Rocky Branch watershed to identify potential improvement opportunities to identify existing flooding and water quality conditions.

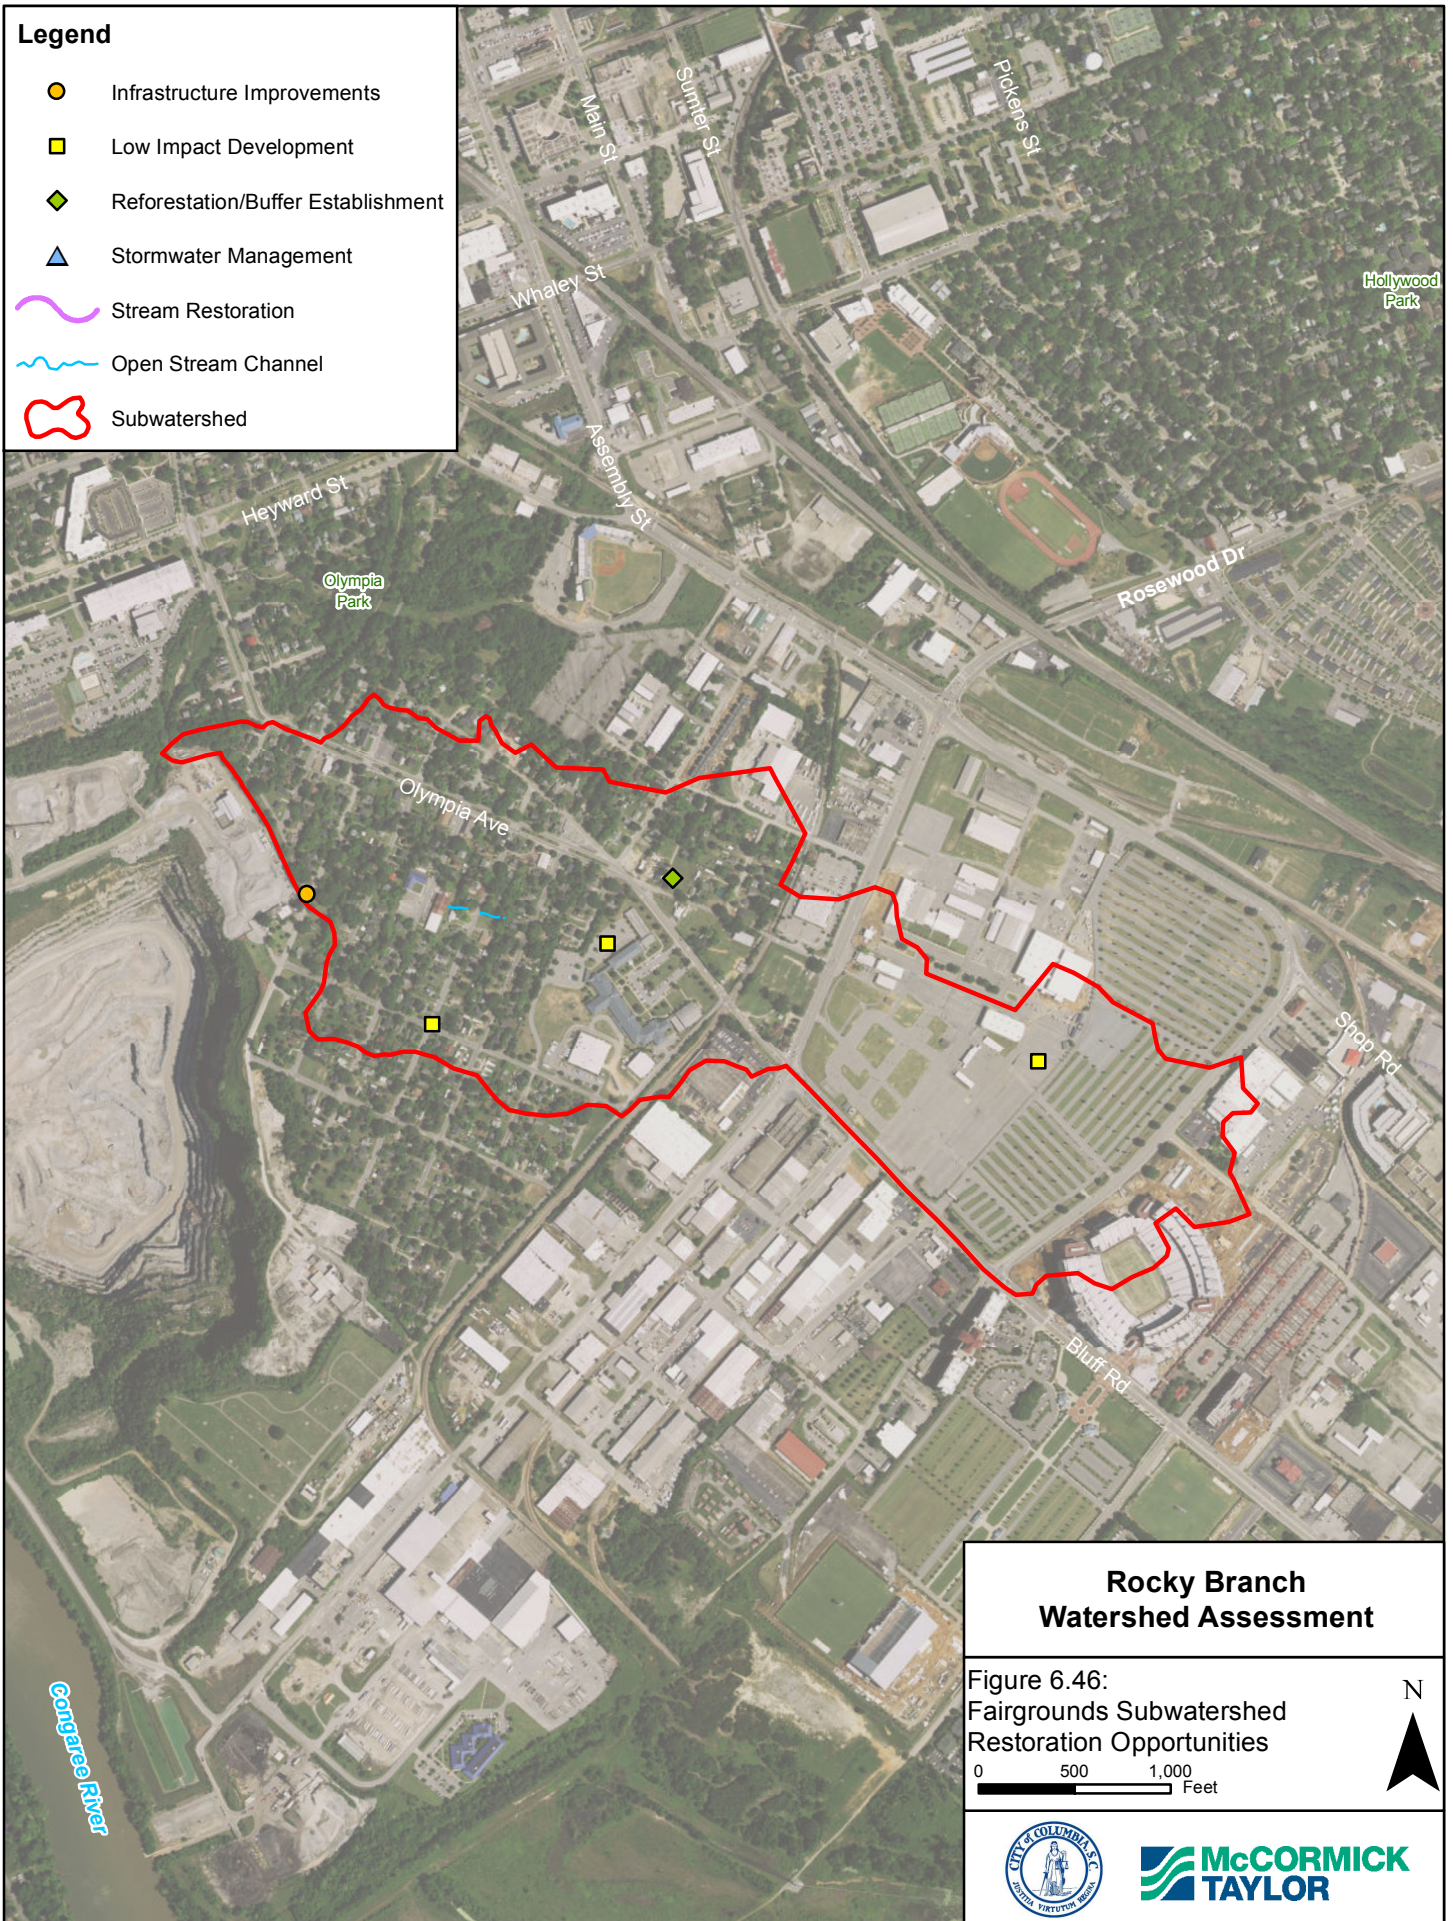
Figure 6.46:  
Fairgrounds Subwatershed  
Restoration Opportunities

The following projects or similar improvements may be considered to address conditions identified in the FG subwatershed. These projects are included in **Figure 6.46**.

- Opportunities for infiltration and storage should be investigated here to reduce runoff and peaks downstream.
  - Apply green streets template to reduce runoff from Olympia-Granby neighborhood.
  - Plant trees where feasible in the lot east of Hastings Street and north of Olympia Avenue.
- Field reconnaissance suggests that a large portion of this basin drains into the Vulcan Materials mine through a 60 inch RCP on Georgia Street. The City of Columbia should work with Vulcan to reroute this drainage down Delaware Street. This would also help with flooding problems locally.

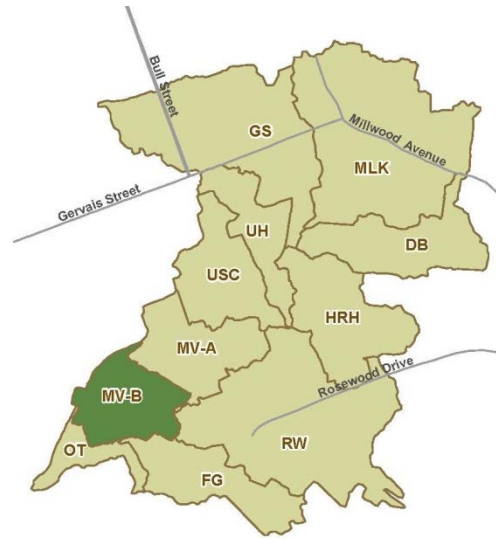
**Figure 6.47 Mill Villages B Subwatershed**

- The Mill Villages B (MV-B) subwatershed is located directly to the northeast of the Outlet (OT) subwatershed.
- The subwatershed extends from Pacific Park at the western end to the Capital City Stadium at the eastern/upstream edge, and to the Vulcan Materials mine to the south/downstream.
- 154 acres or 0.24 square miles in drainage area
- Contains 0.74 miles of open stream channel, and 1.57 miles of mapped storm drain/pipe
- Dominant land use designations (**Figure 6.1, Table 6.1**):
  - Developed, Medium Intensity: 44%
  - Developed, Low Intensity: 34%
- Impervious surface cover: 40%

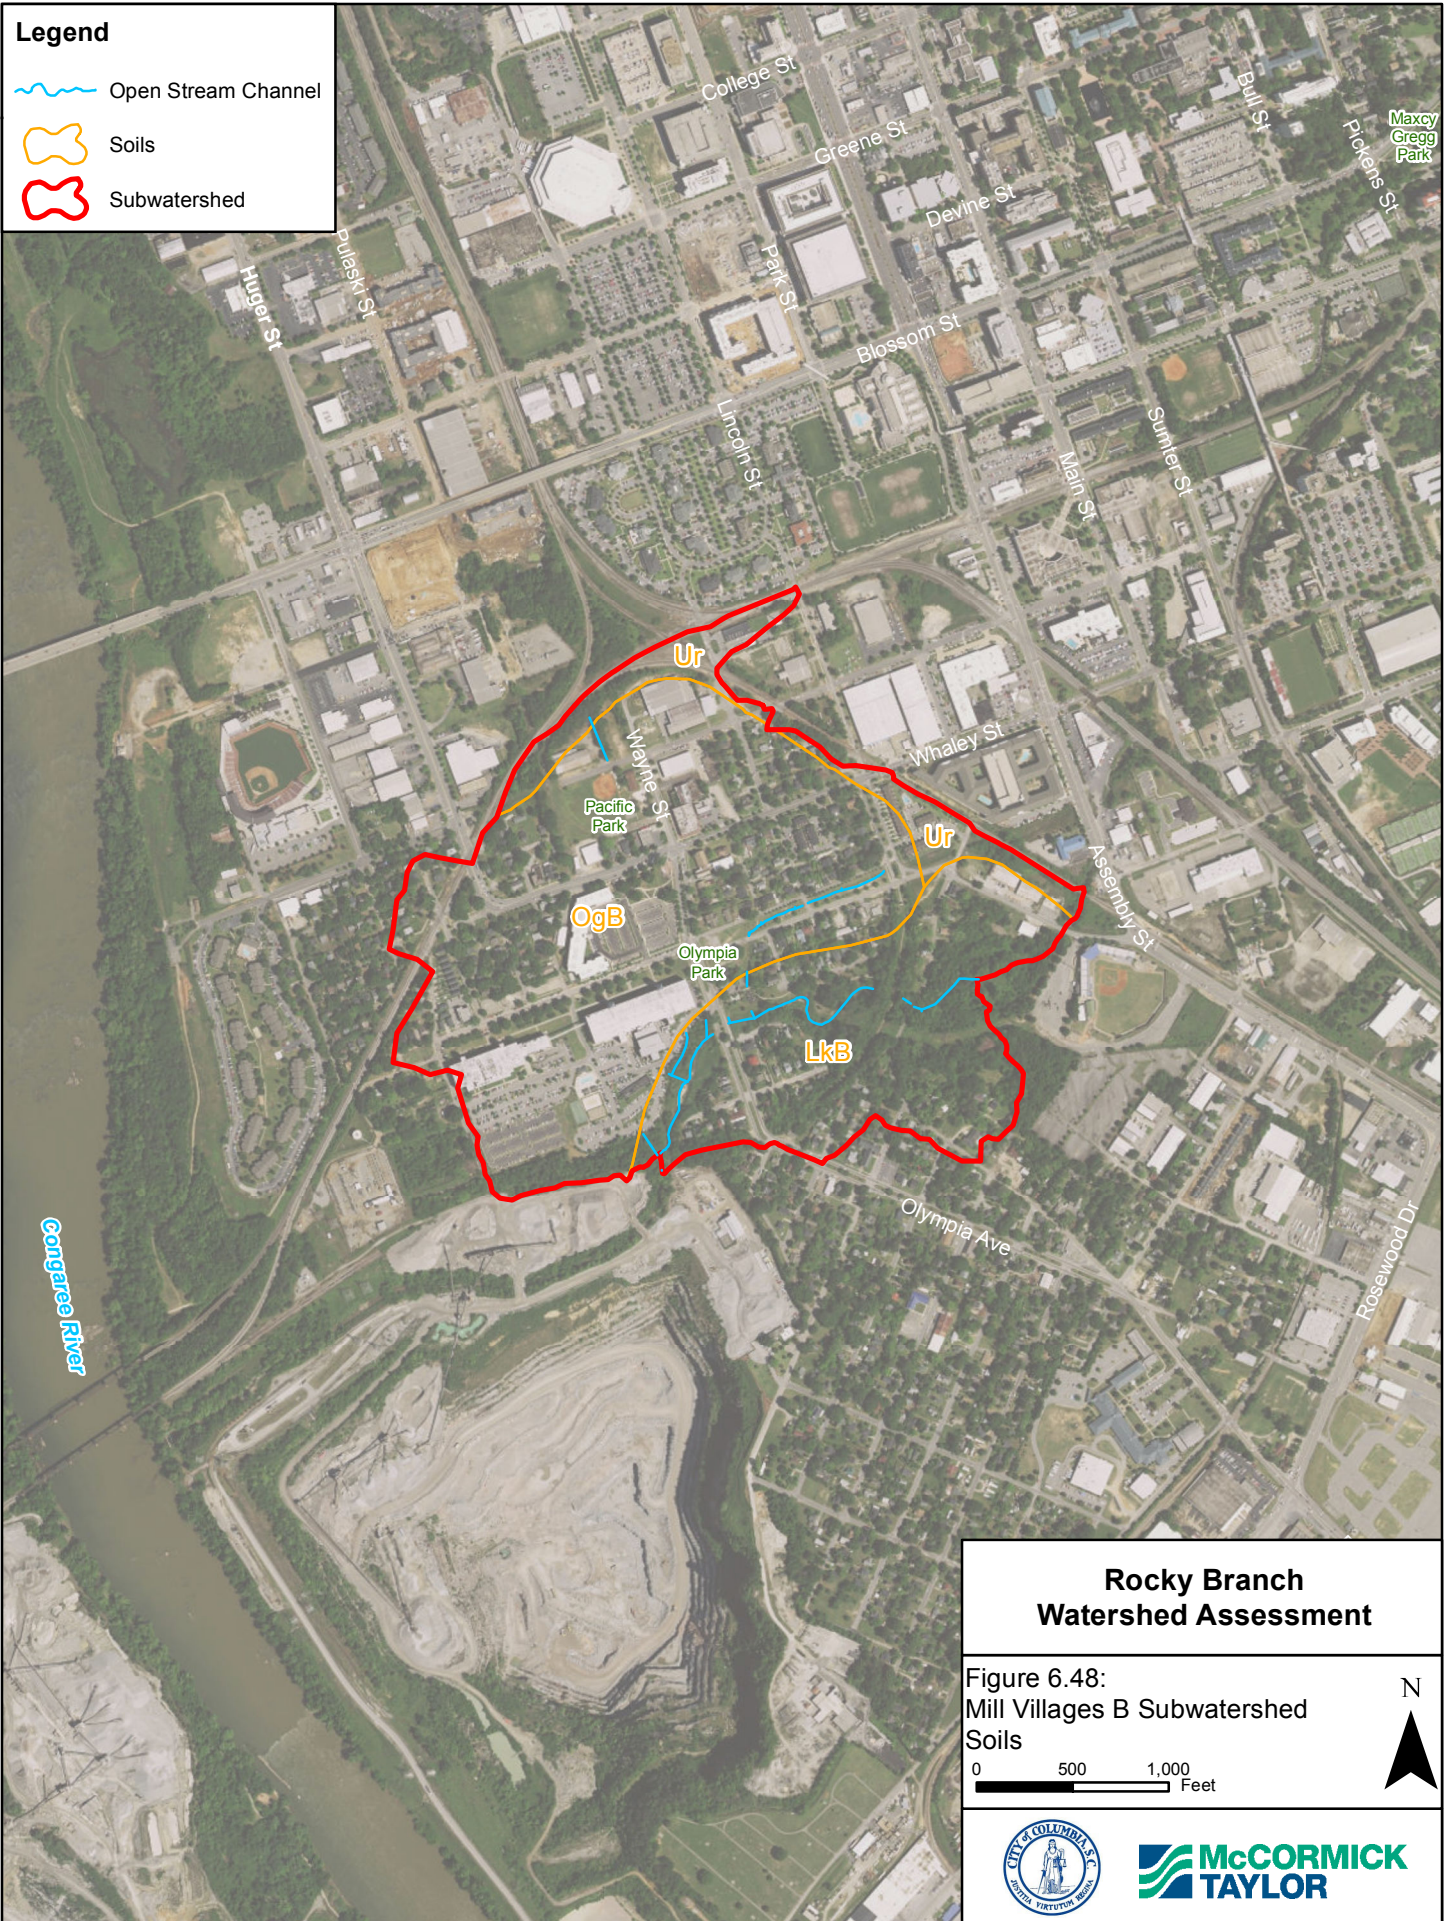
Figure 6.48:  
Mill Villages B Subwatershed  
Soils

**Soils:** Approximate soil type percentages within MV-B subwatershed include (refer to **Section 3.4** for soil descriptions and **Figure 6.48** for soil distributions):

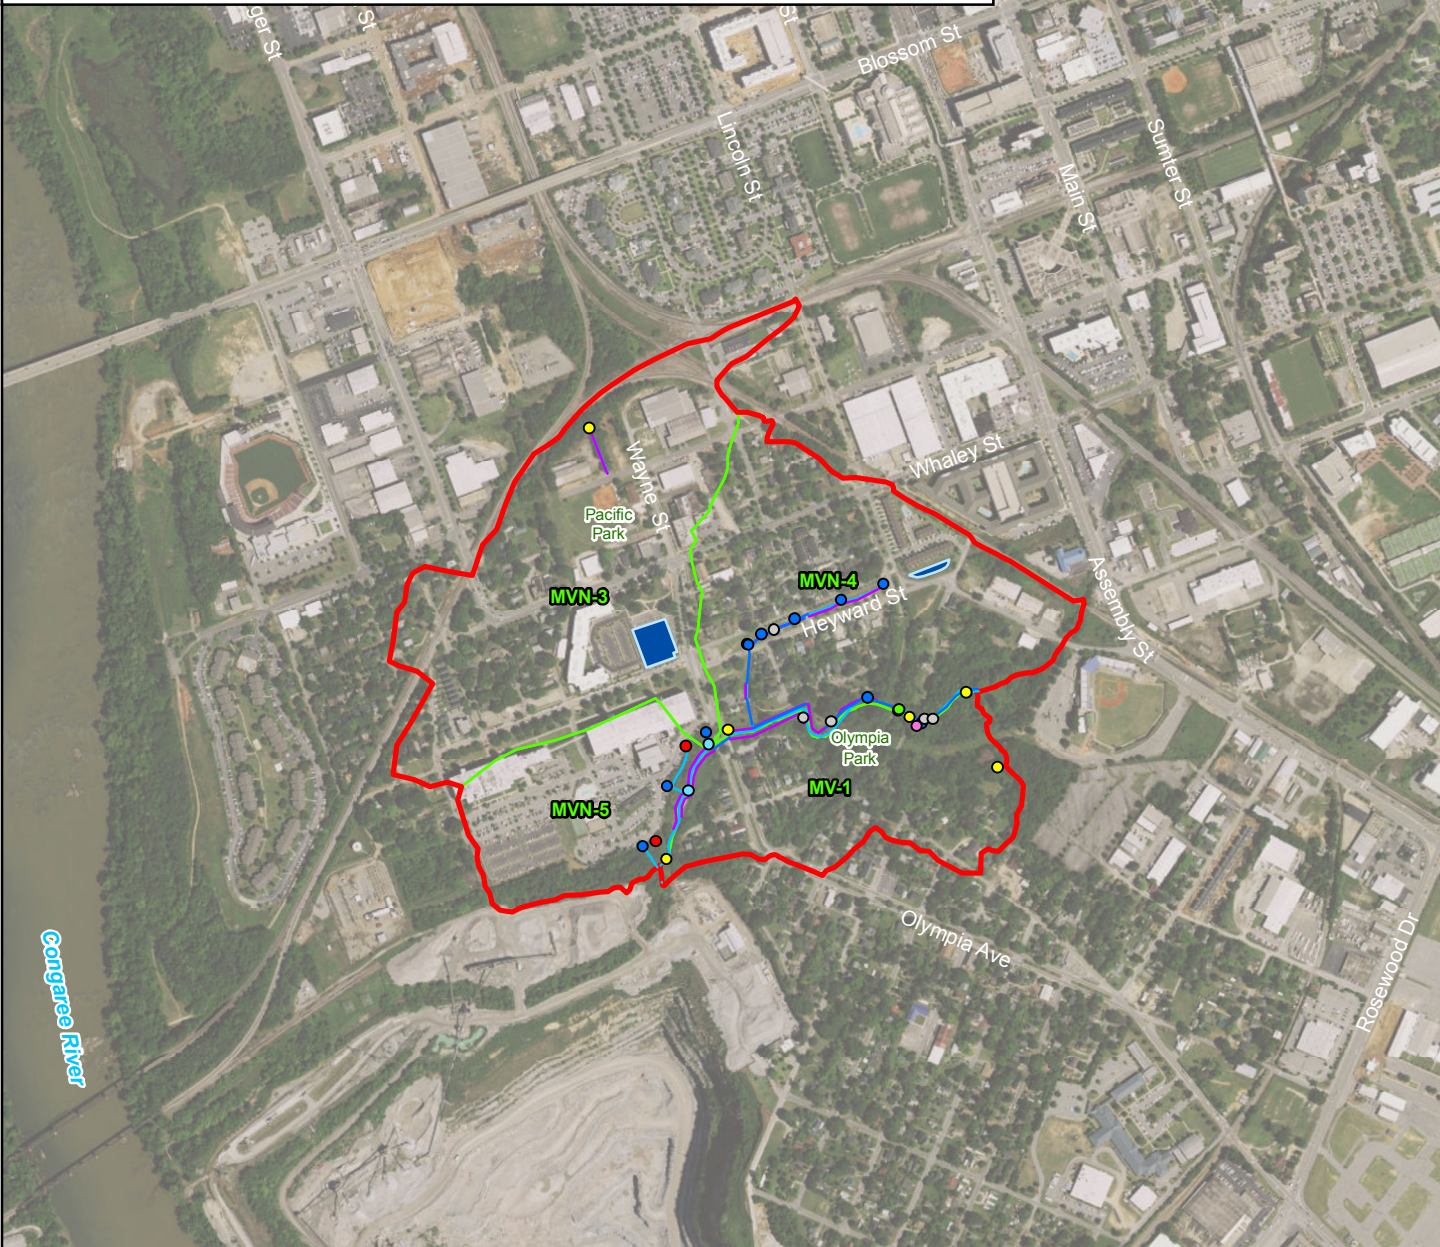
Figure 6.49:  
Mill Villages B Subwatershed  
Existing Conditions

Existing Condition	Count
Exposed Pipes	5
Pipe Outfalls	13
Unmanaged Runoff	1
Unusual Condition	8
Trash Dumping	1
Possible Fish Barrier	0
Linear Feet	
Erosion Site	204
Channel Alteration	625
Inadequate Forest Buffer	2,580

**Figure 6.49** highlights existing conditions that were either captured during a field effort or developed using GIS data.

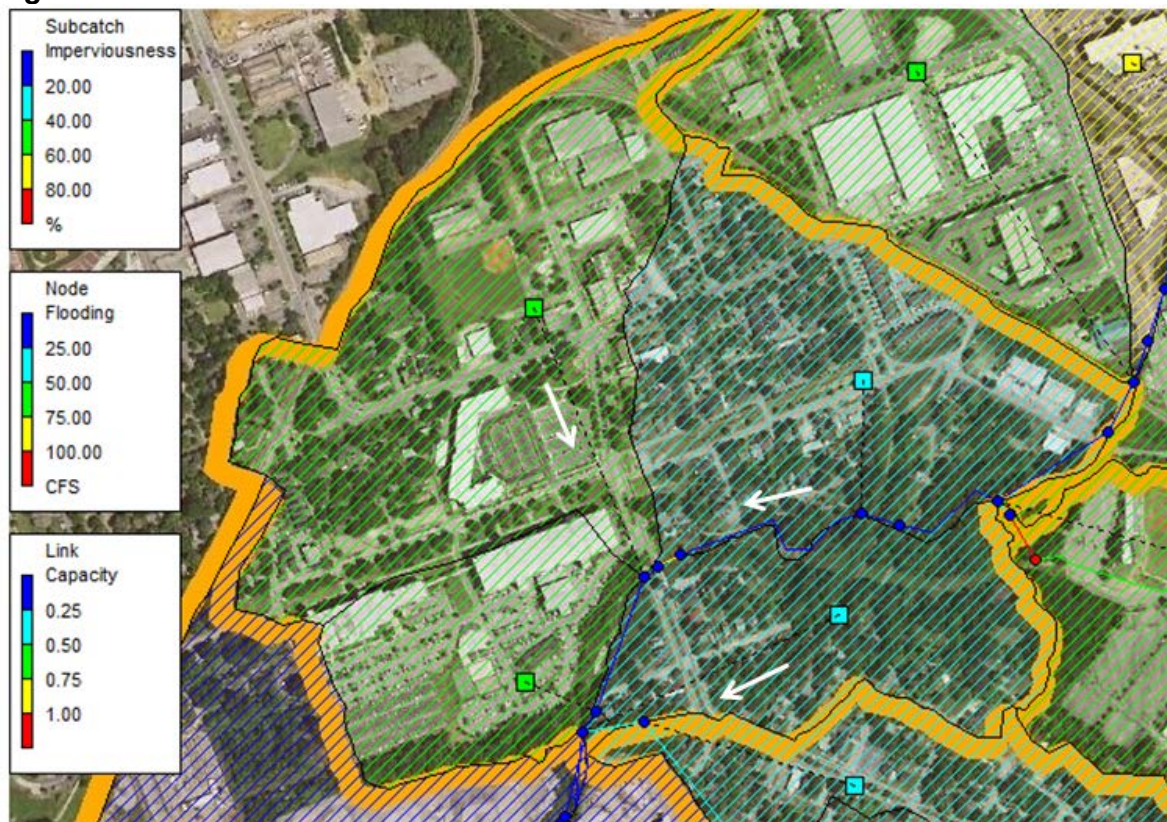
**Figure 6.50 MV-B SWMM Model**

The MV-B subwatershed is adjacent and to the south of MV-A. MV-B has almost 15% less impervious surface than its northern counterpart and the second lowest impervious value for the watershed. With its smaller size of 154 acres, the MV-B subwatershed is modeled with SWMM to produce only 6.1 million gallons of runoff for a 2-year storm event, the tenth lowest amount for the watershed. The runoff per area is also low at 5,283 cubic feet/acre. The discharge per acre for the 2-year event is in the mid-range at 4.3 peak cfs/acre. Due to these attributes, the MV-B subwatershed received the second lowest subwatershed runoff ranking.

The MV-B subwatershed was modeled as four subcatchments in SWMM. The flows from these subcatchments are linked directly to Rocky Branch, so the model does not indicate any flooding is occurring in the subcatchments as a result of overburdened drainage pipes. Portions of this subwatershed are within the 10-year floodplain for Rocky Branch.

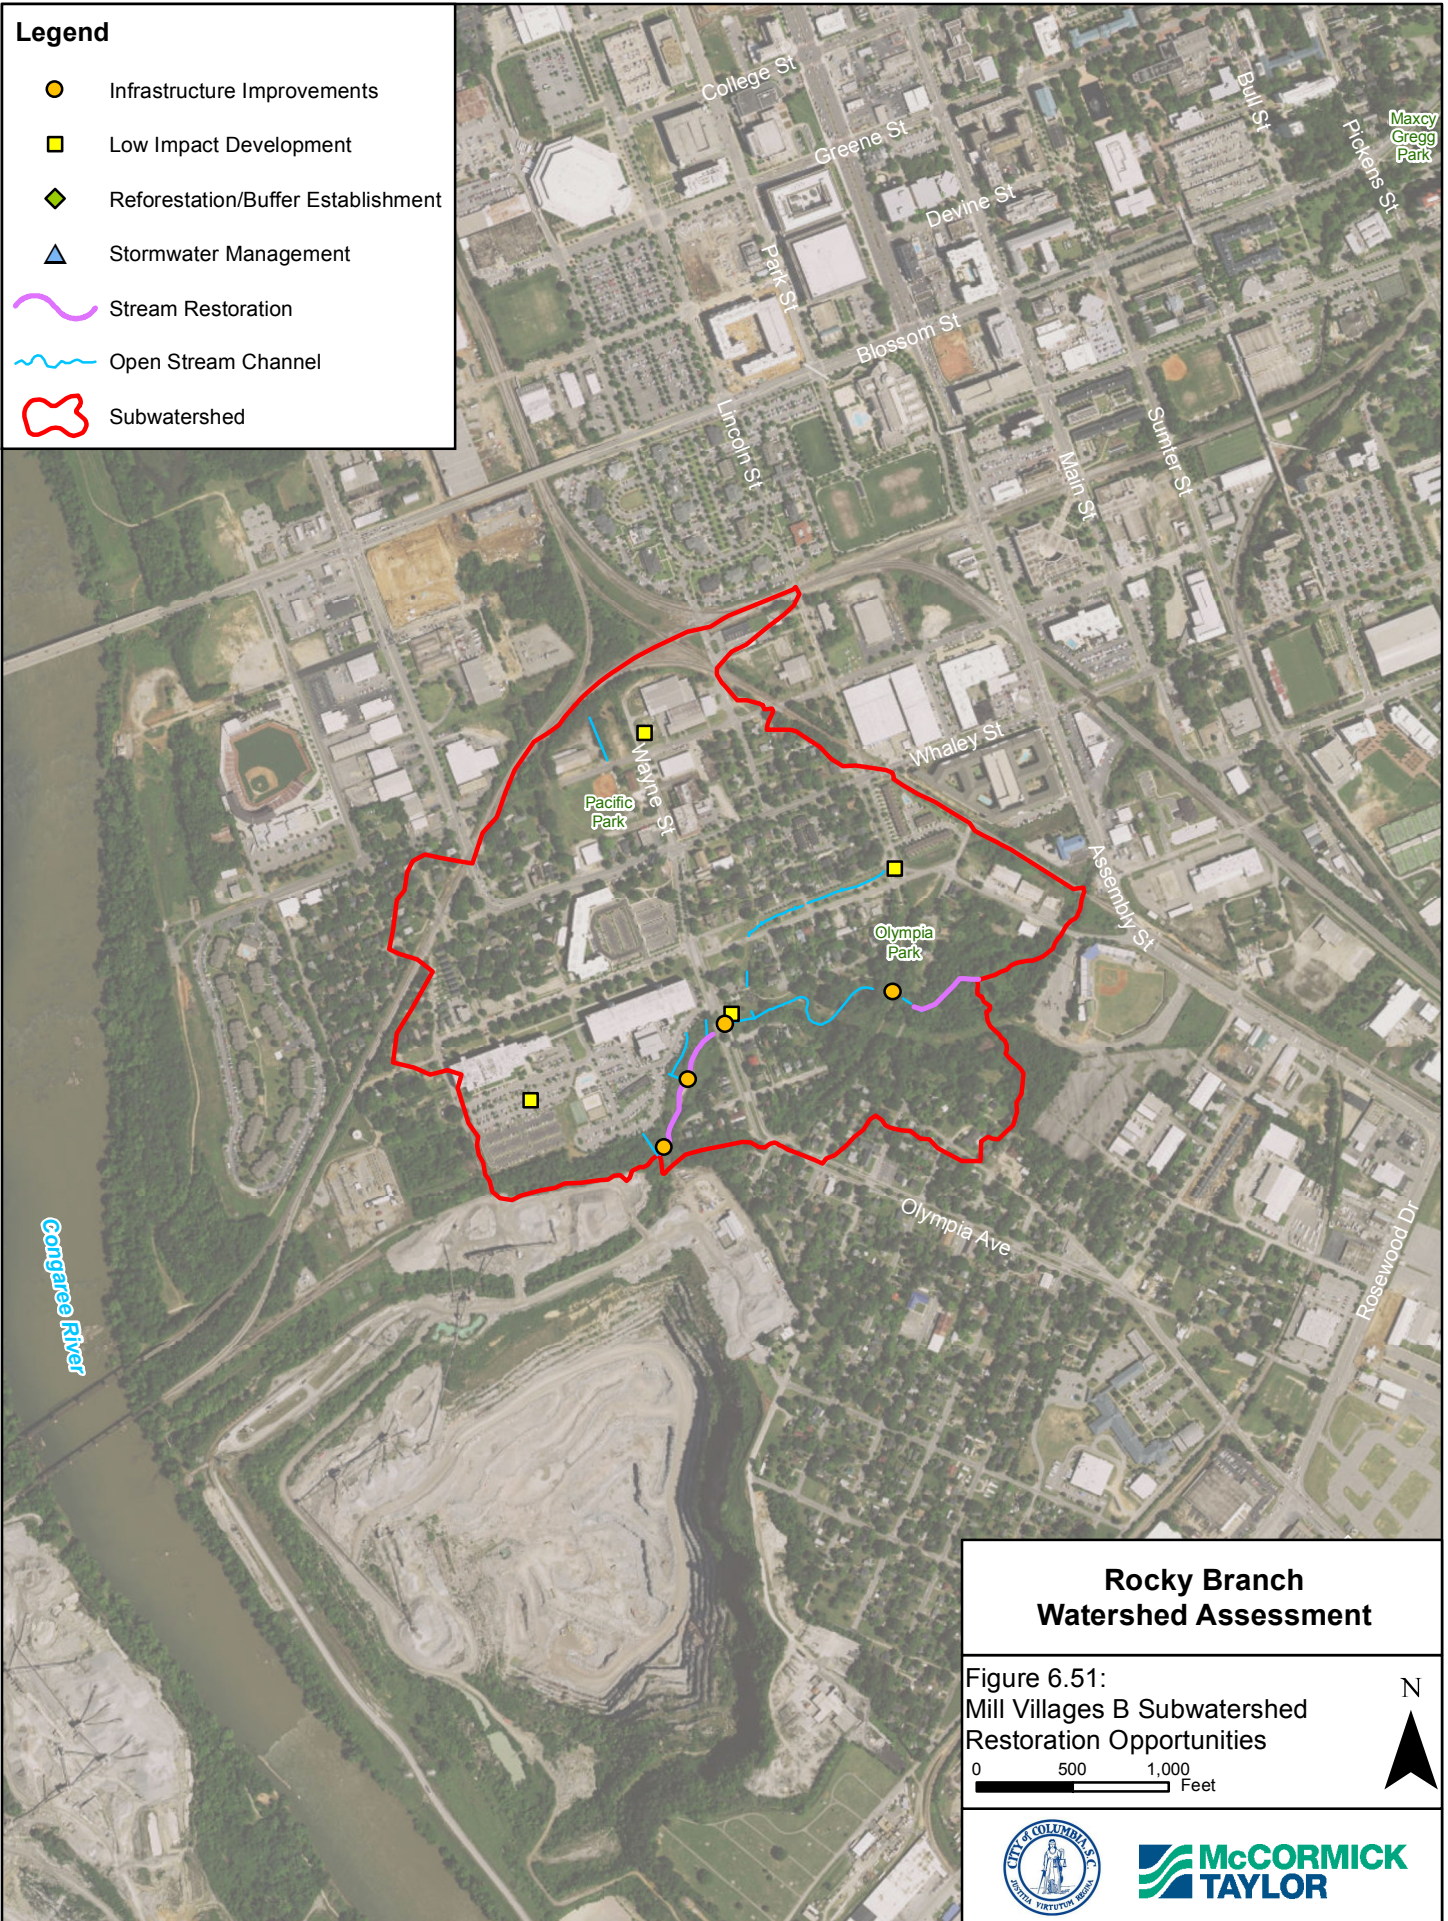
Figure 6.51:  
Mill Villages B Subwatershed  
Restoration Opportunities

The following projects or similar improvements may be considered to address conditions identified in the MV-B subwatershed. These projects are included in **Figure 6.51**.

- Opportunities for infiltration and storage should be investigated here to reduce runoff and peaks downstream.
  - Install a bioretention area or sand filter to the Granby Mills Student Housing, Olympia Park, Catawba and Wayne Streets, and the median of Heyward and Lincoln Streets.

- Remove the former railroad bridge downstream of Olympia Avenue and restore the channel to a natural condition.
- Replace the sanitary line that crosses the channel west of Olympia Avenue.

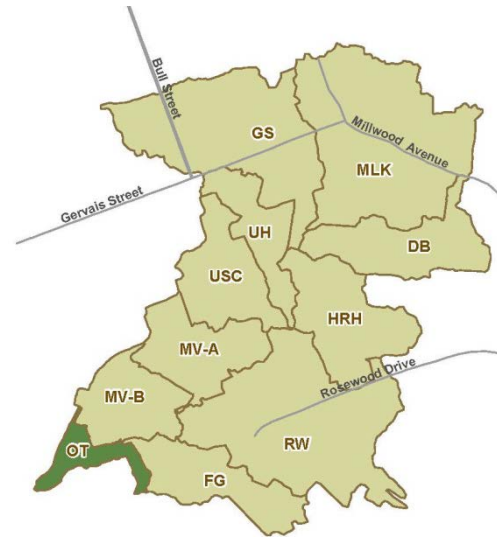
**Figure 6.52 Outlet Subwatershed**

- Outlet (OT) subwatershed is the southwestern most subwatershed within the Rocky Branch watershed and includes the confluence with the Congaree River
- Situated to the north and northeast of the Vulcan Materials mine
- 63 acres or 0.10 square miles in drainage area
- Contains 0.62 miles of open stream channel, and 0.01 miles of mapped storm drain/pipe
- Dominant land use designations (**Figure 6.1, Table 6.1**):
  - Barren Land: 42%
  - Developed, Low Intensity: 25%
  - Developed, Medium Intensity: 13%
- Impervious surface cover: 11%

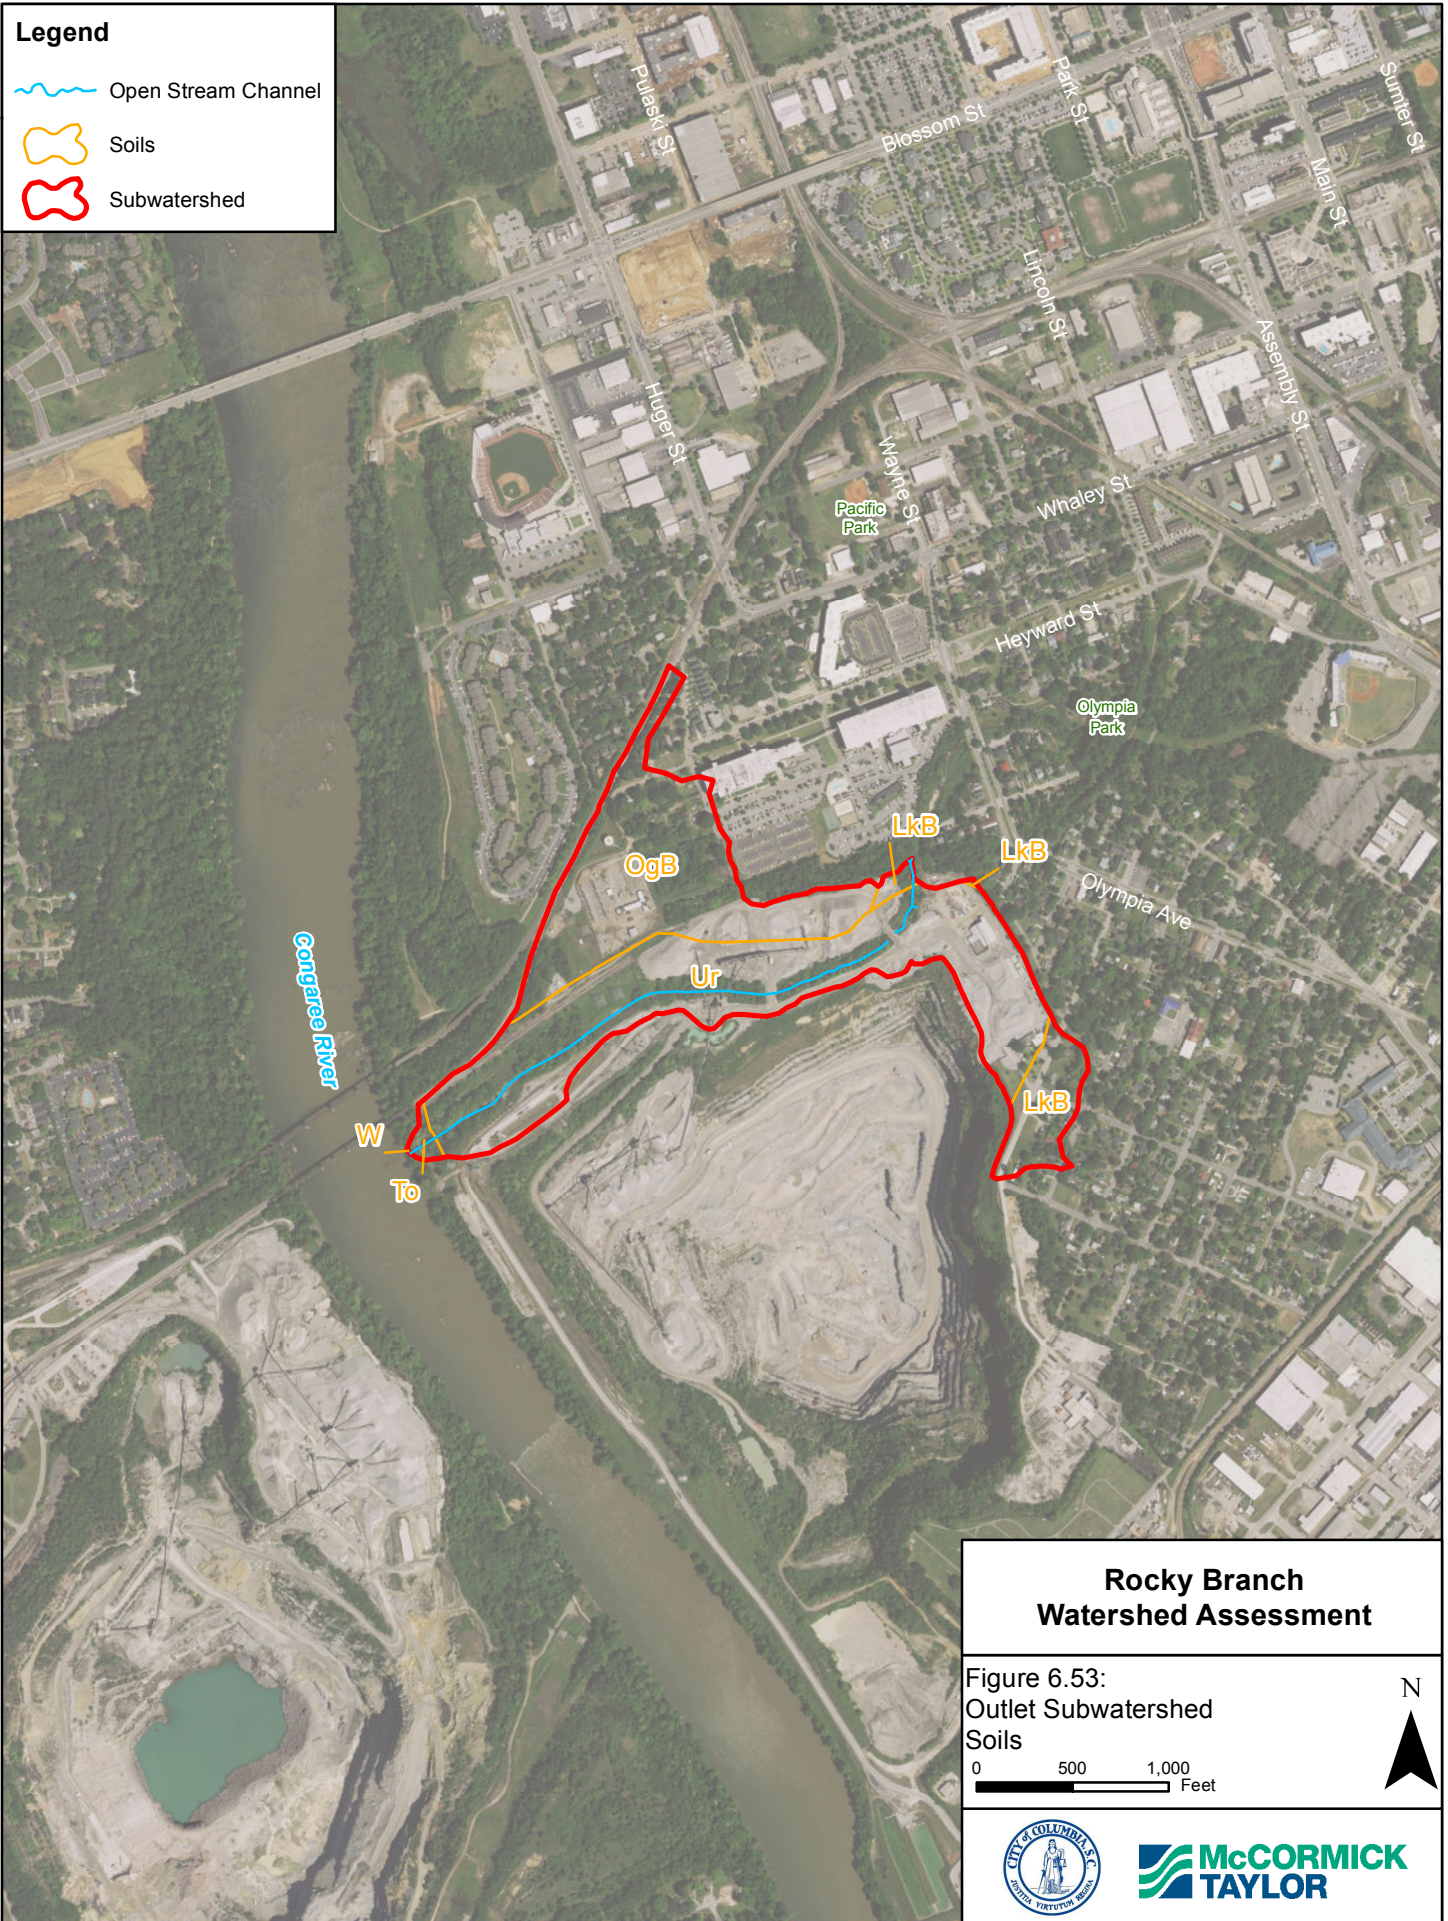
Figure 6.53:  
Outlet Subwatershed  
Soils

**Soils:** Approximate soil type percentages within OT subwatershed include (refer to **Section 3.4** for soil descriptions and **Figure 6.53** for soil distributions):

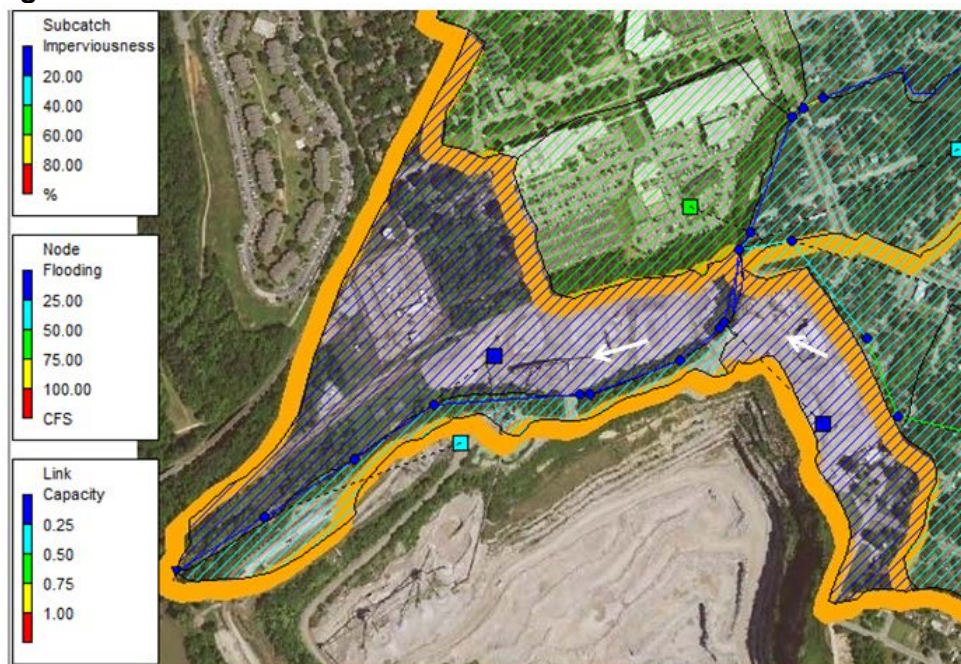
**Figure 6.55 OT SWMM Model**

The OT subwatershed is unique in that it occupies the very downstream limit of the watershed and is comprised of only 63 acres. With 11% impervious surface, the OT subwatershed is the lowest within the watershed. As a result, the values from the SWMM model for a 2-year event also place the OT subwatershed in the lower end: the subwatershed is modeled to produce 3.3 peak cfs/acre, the lowest overall in the watershed, and 1.1 million gallons of runoff, the second smallest amount in the watershed. The runoff per area is also modeled as the smallest value in the watershed at 2,387 cubic feet/acre. These existing conditions give the OT subwatershed the highest (least impaired) runoff ranking in the watershed and indicate that has the lowest relative need of hydraulic improvement in the Watershed.

The OT subwatershed was modeled as three subcatchments in SWMM. The flows from these subcatchments are linked directly to the Rocky Branch mainstem. Most of the OT subwatershed is within the Vulcan Materials mine.

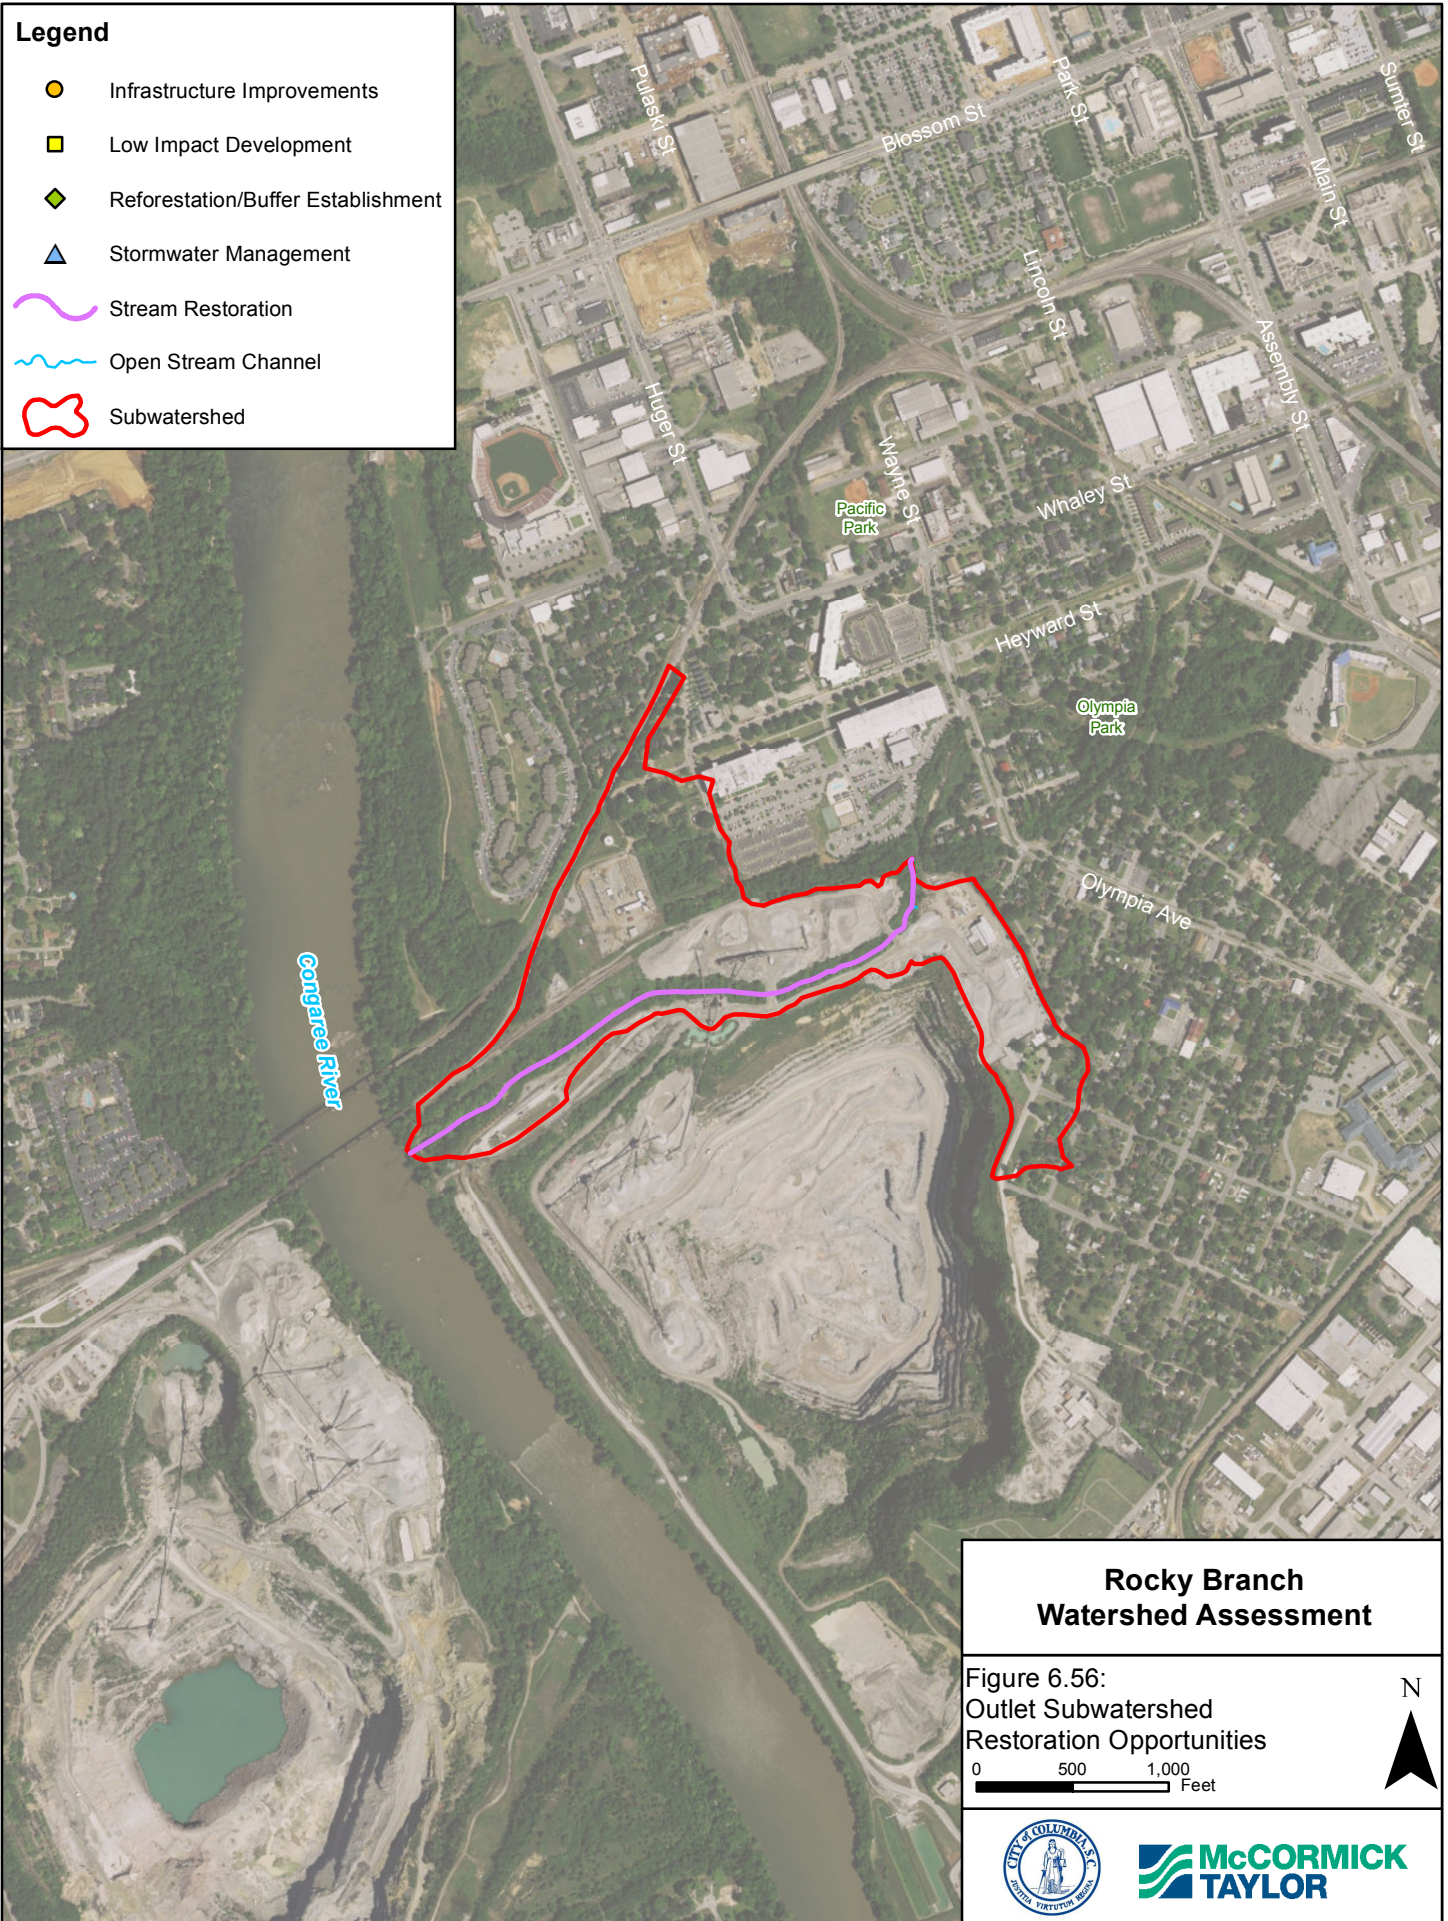
Figure 6.56:  
Outlet Subwatershed  
Restoration Opportunities

The following projects or similar improvements may be considered to address conditions identified in the OT subwatershed. These projects are included in **Figure 6.56**.
