Rocky Branch Watershed Management Plan

# ROCKY BRANCH WATERSHED ASSESSMENT

McCormick Taylor Inc., supported by KCI Technologies, Inc., has been contracted by the City of Columbia, South Carolina to conduct an assessment of the Rocky Branch watershed to identify potential improvement opportunities to identify existing flooding and water quality conditions.

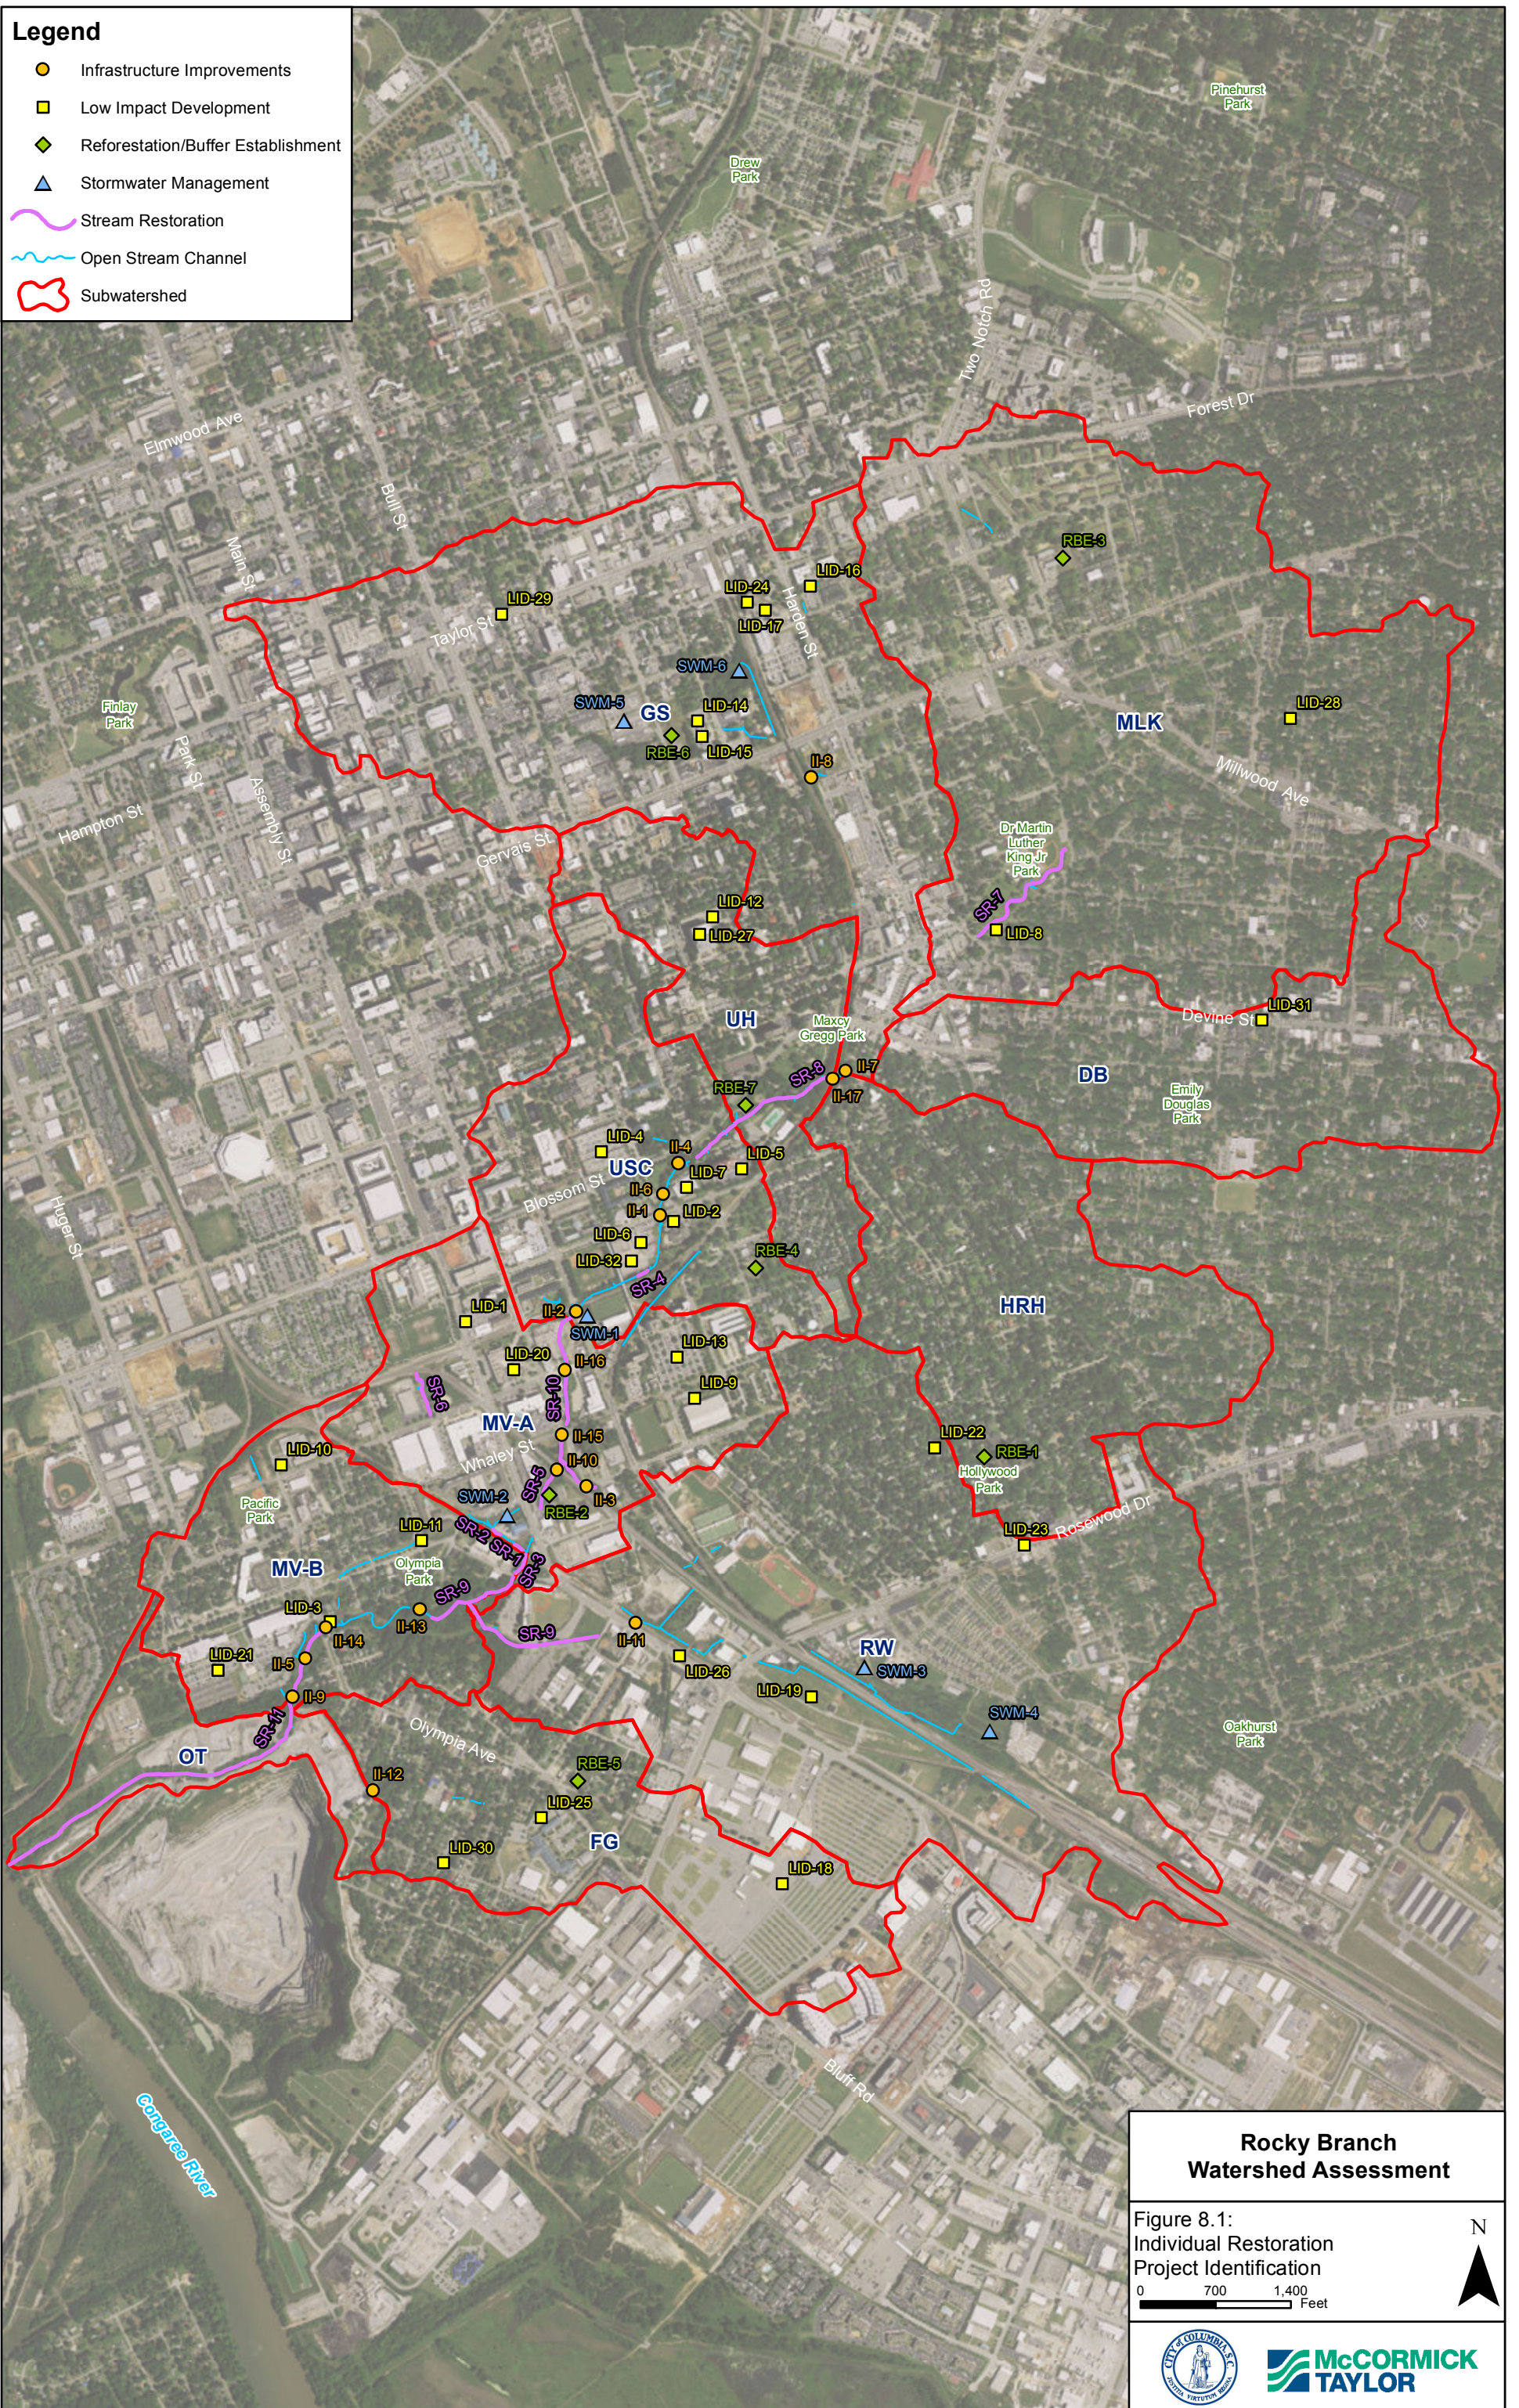
Figure 8.1:  
Individual Restoration  
Project Identification

**Legend**

- Infrastructure Improvements
- Low Impact Development
- ◆ Reforestation/Buffer Establishment
- ▲ Stormwater Management
- ~ Stream Restoration
- ~ Open Stream Channel
- Subwatershed

Through integration of the in-field assessment efforts, SWMM modeling results, and watershed goals established by the stakeholders, 73 Watershed Projects have been identified within the Rocky Branch Watershed (**Figure 8.1**). **Table 8.1** (Individual Project Identification and Description) summarizes the results of the subwatershed prioritization and associated project identification. The prioritization ranking for the subwatersheds is directly related to the results of the hydraulic modeling which revealed the subwatersheds of Gregg Street and USC were most in need of rehabilitation. Within each subwatershed, projects were evaluated on acres of impervious treated, available open space, property ownership, potential conflicts, ease of construction, and cost.

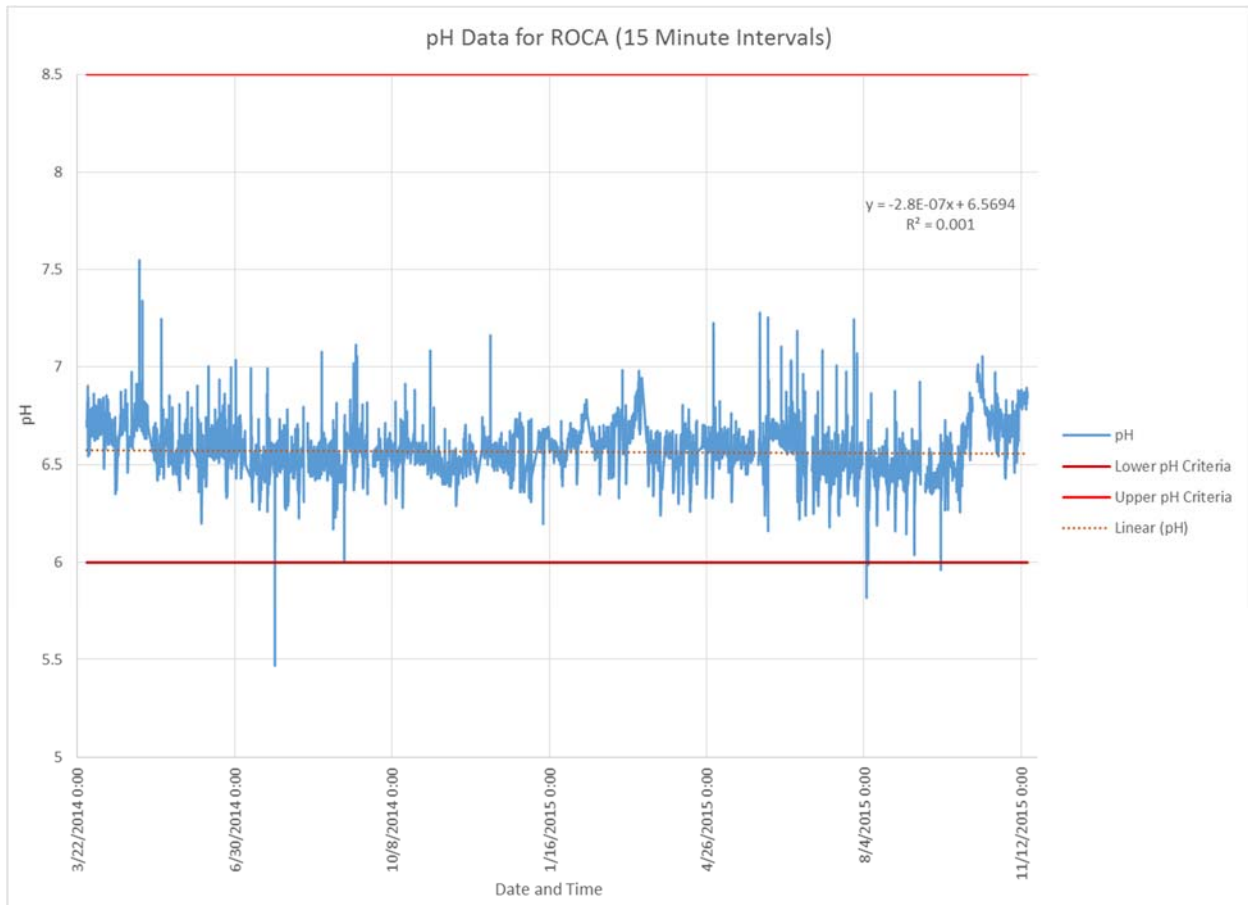
A linear regression analysis was performed for 15-minute interval pH data from ROCA. The results of the linear regression analysis show a slight negative slope (-2.8209E-07), which was significant at the  $p < 0.01$  level ( $p < 0.001$ ). This indicates that the likelihood of this decreasing pH relationship occurring by chance is very small. The negative slope of the line indicates that pH values are decreasing very slightly throughout this dataset. This rate of change is so small that changes in observed pH values would happen over several tens of thousands of measurements. If this relationship holds true with data collected over additional time periods, it would take over a year for a realized 0.01 decrease in pH value.

Monthly average pH and seasonal average pH were calculated for this site to investigate patterns and seasonality in the data. This created 21 monthly averages and seven seasonal averages. No patterns exist in monthly average nor seasonal average pH.

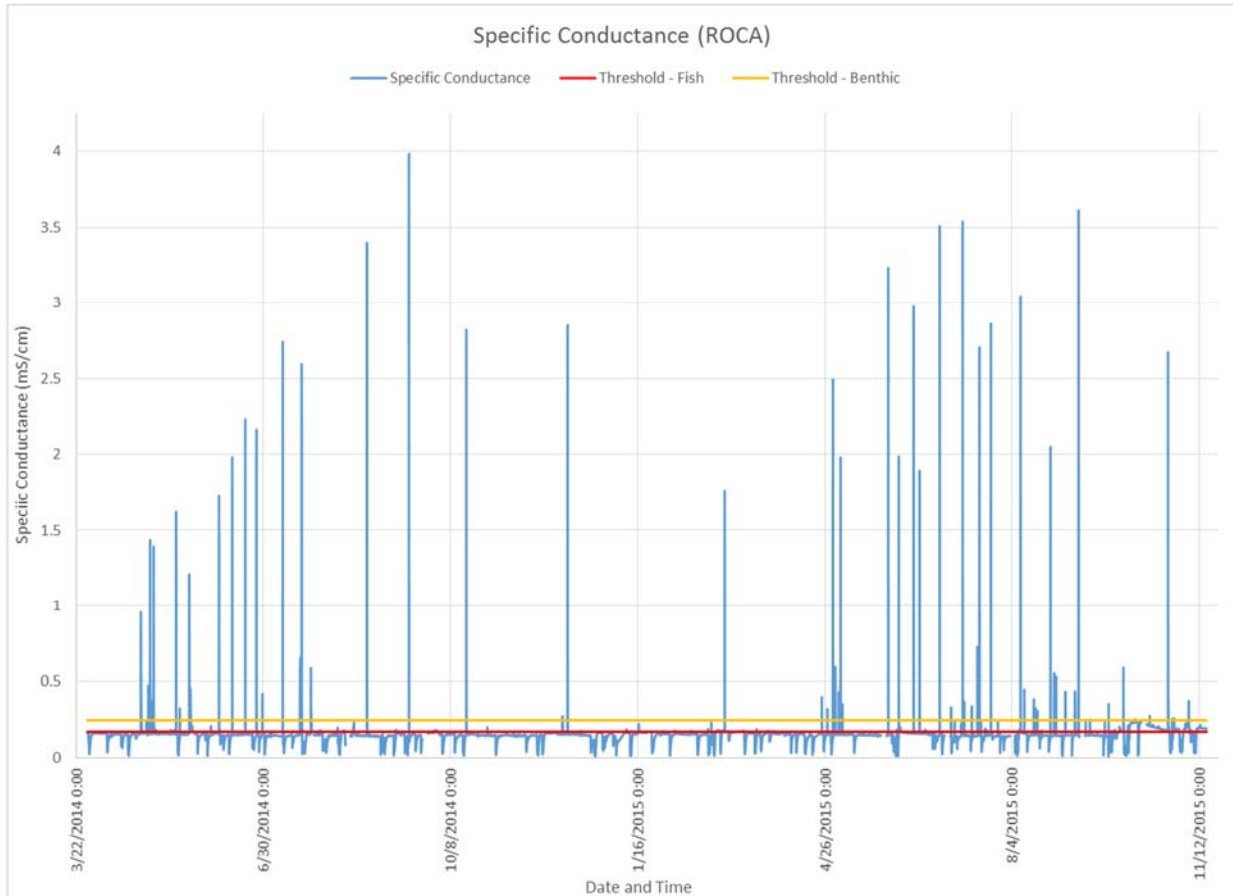
Site ROCA had higher maximum observed specific conductance values than ROCB, but a much lower percentage of values above the possible biological assemblage impairment thresholds. At ROCA, almost

without exception, the highest specific conductivity events were observed with concomitant spikes in turbidity.

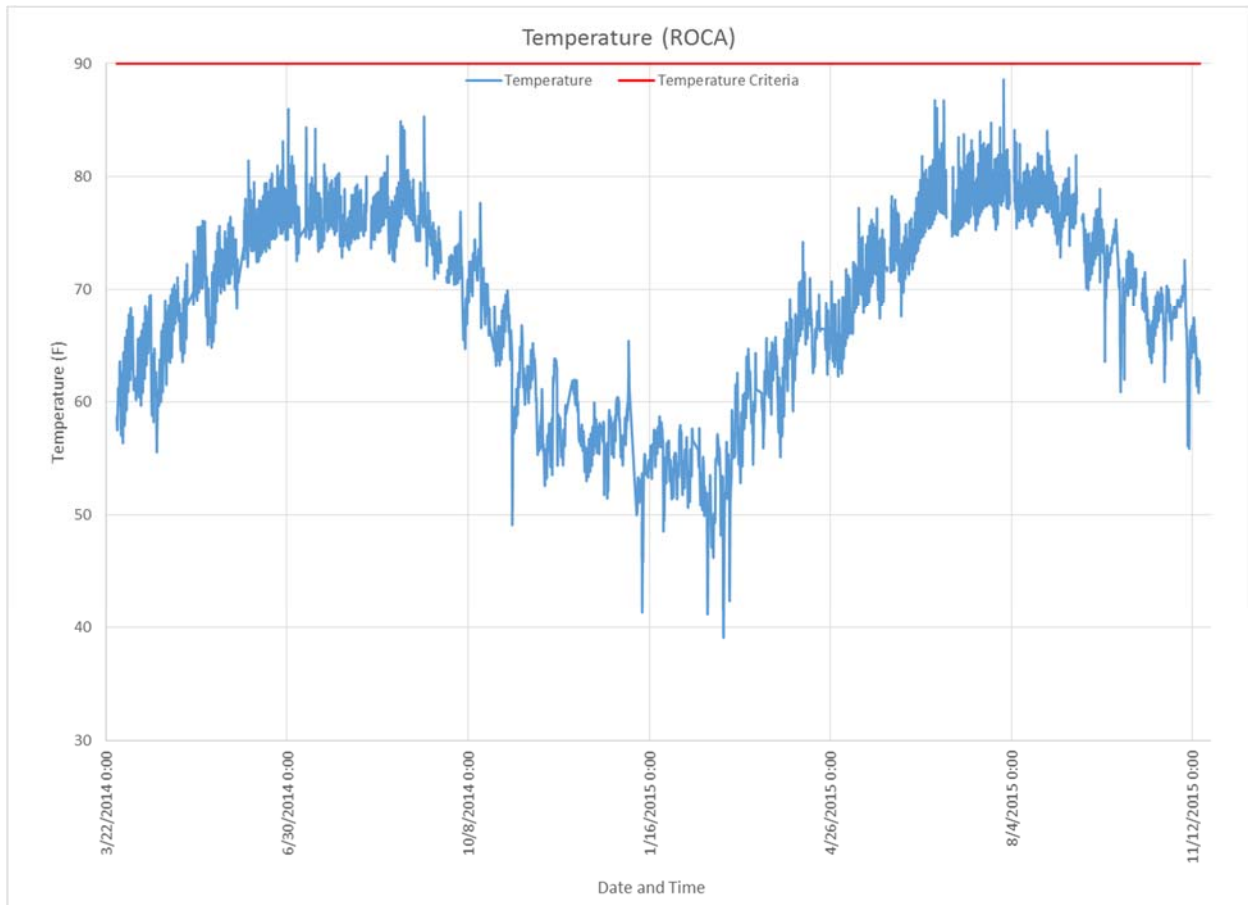
The water quality criteria for temperature of 90.0° F was not exceeded at ROCA. All temperature measurements were well below 90.0° F.

As expected, there is a seasonal and diurnal pattern to water temperature in Rocky Branch. The highest measured water temperatures occurred during the summer time. Summer is the time of the year with the highest air temperatures, and the greatest amount of solar radiation. These factors help warm water throughout the day. The highest temperatures measured each day were in the afternoon. Afternoon is usually the period of time with the highest air temperature, and sunlight has been warming the water and stream substrates throughout the day.

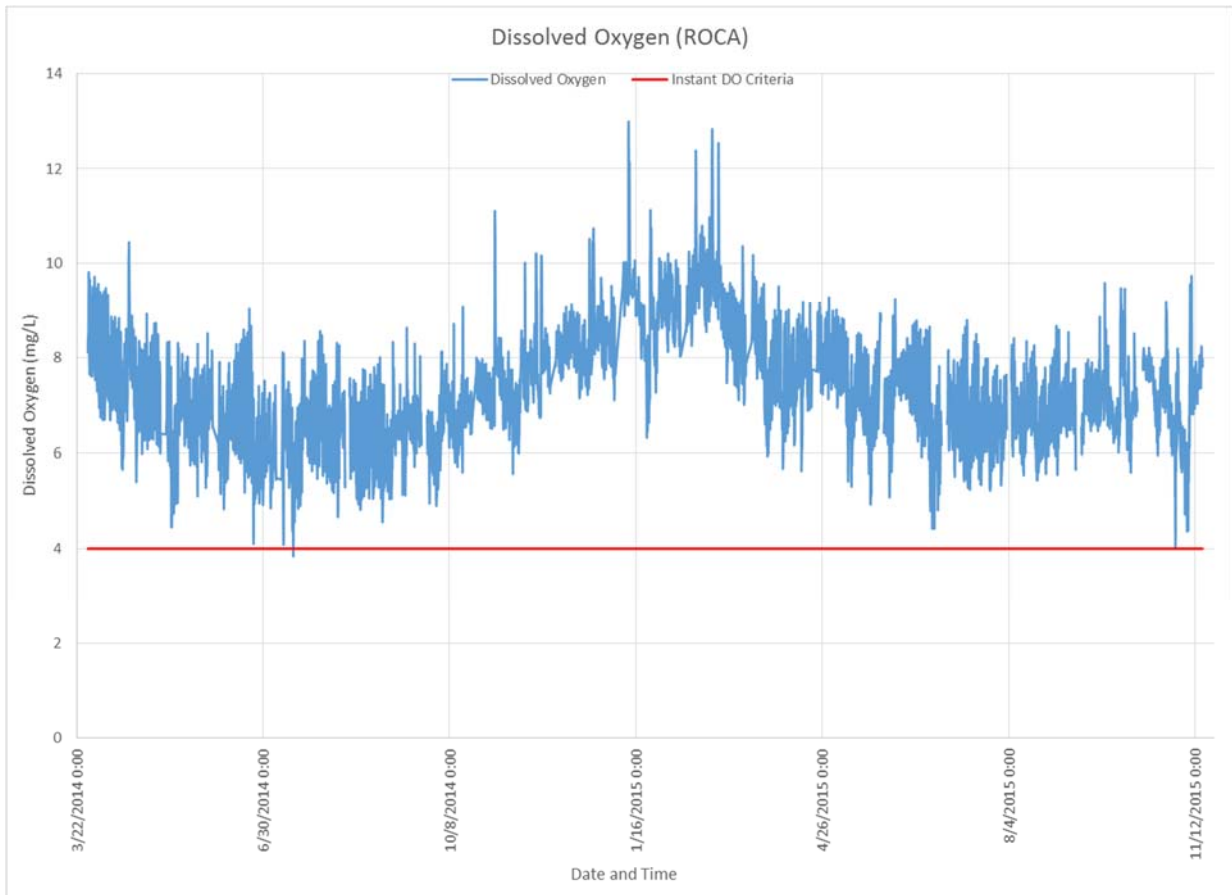
Water quality sonde data from site ROCA show that the instantaneous water quality standard for dissolved oxygen of 4.0 mg/L was violated 0.01% of the time (4 out of 52,929 records) over the period of record. Over the same period of time, the water quality standard for daily average dissolved oxygen of 5.0 mg/L was violated 0.00% of the time (0 out of 555 days). The instantaneous criteria violations happened over a 45-minute period on July 16<sup>th</sup>, 2014 from 05:15 to 06:00. July 16<sup>th</sup>, 2014 also had the lowest observed daily average dissolved oxygen concentration of 5.28 mg/L.

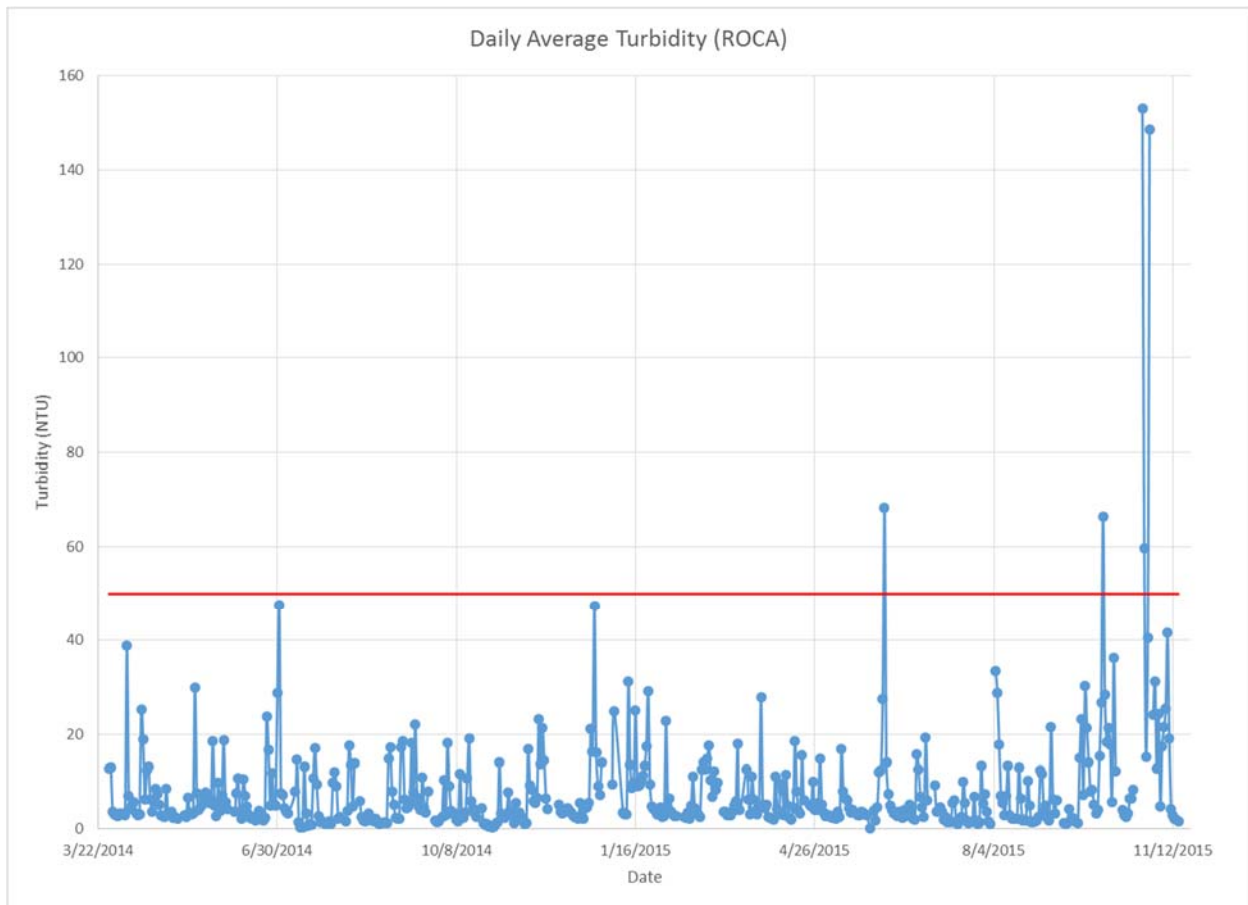
Results of turbidity data from the water quality sonde at ROCA show that the turbidity water quality standard of 50.0 NTU was exceeded 1.27% of the time (644 records out of a total 50,609 records).

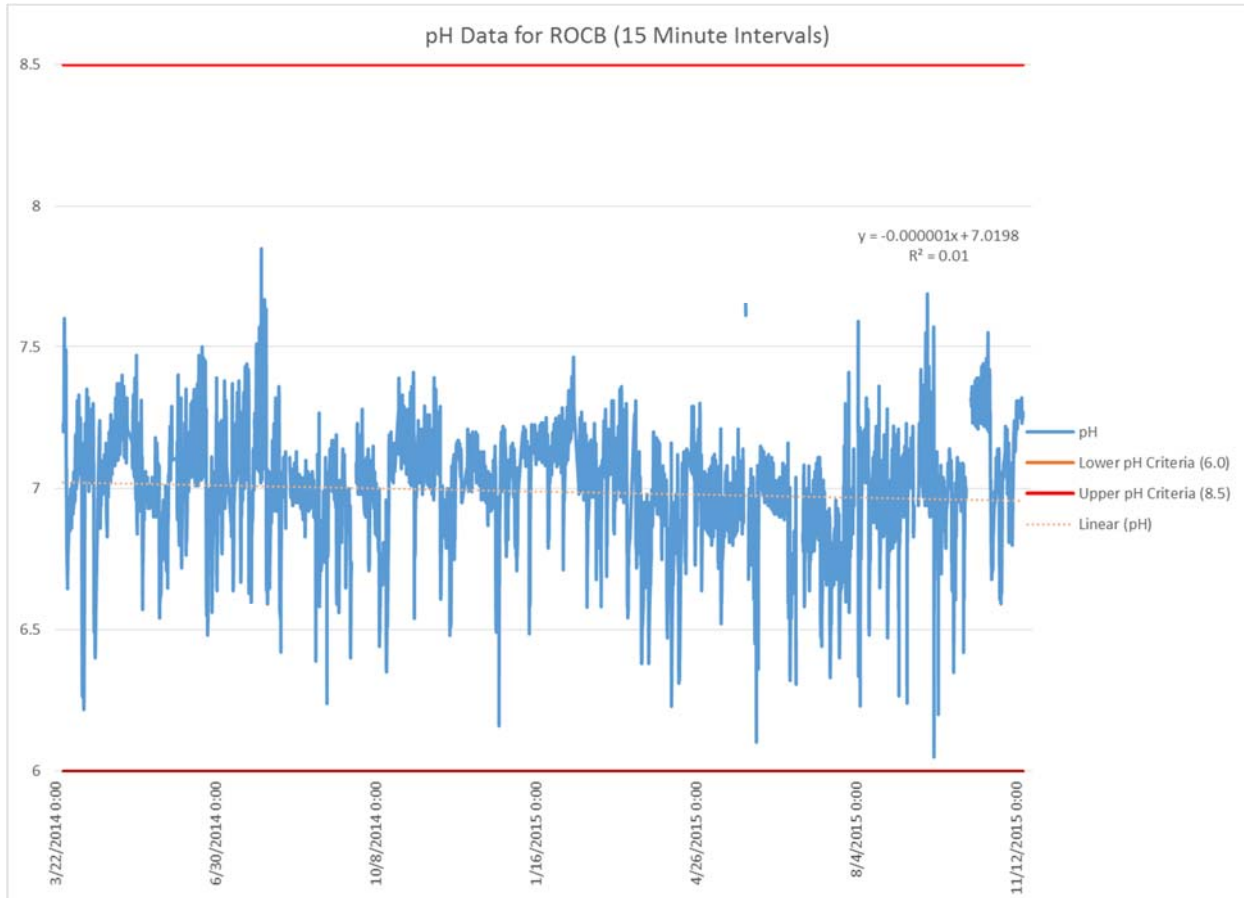
A linear regression analysis was performed for 15-minute interval pH data. The results of the linear regression analysis show a slight negative slope ( $-1.166E-06$ ), which was significant at the  $p < 0.01$  level ( $p < 0.001$ ). This indicates that the likelihood of this decreasing pH relationship occurring by chance is very small. The negative slope of the line indicates that pH values are decreasing very slightly throughout this dataset. This rate of change is so small that changes in observed pH values would happen over several tens of thousands of measurements. If this relationship holds true with data collected over additional time periods, it would take over a year for a realized 0.01 decrease in pH value.

Monthly average pH and seasonal average pH were calculated for this site to investigate patterns and seasonality in the data. This created 21 monthly averages and seven seasonal averages. No patterns are evident in monthly average nor seasonal average pH.

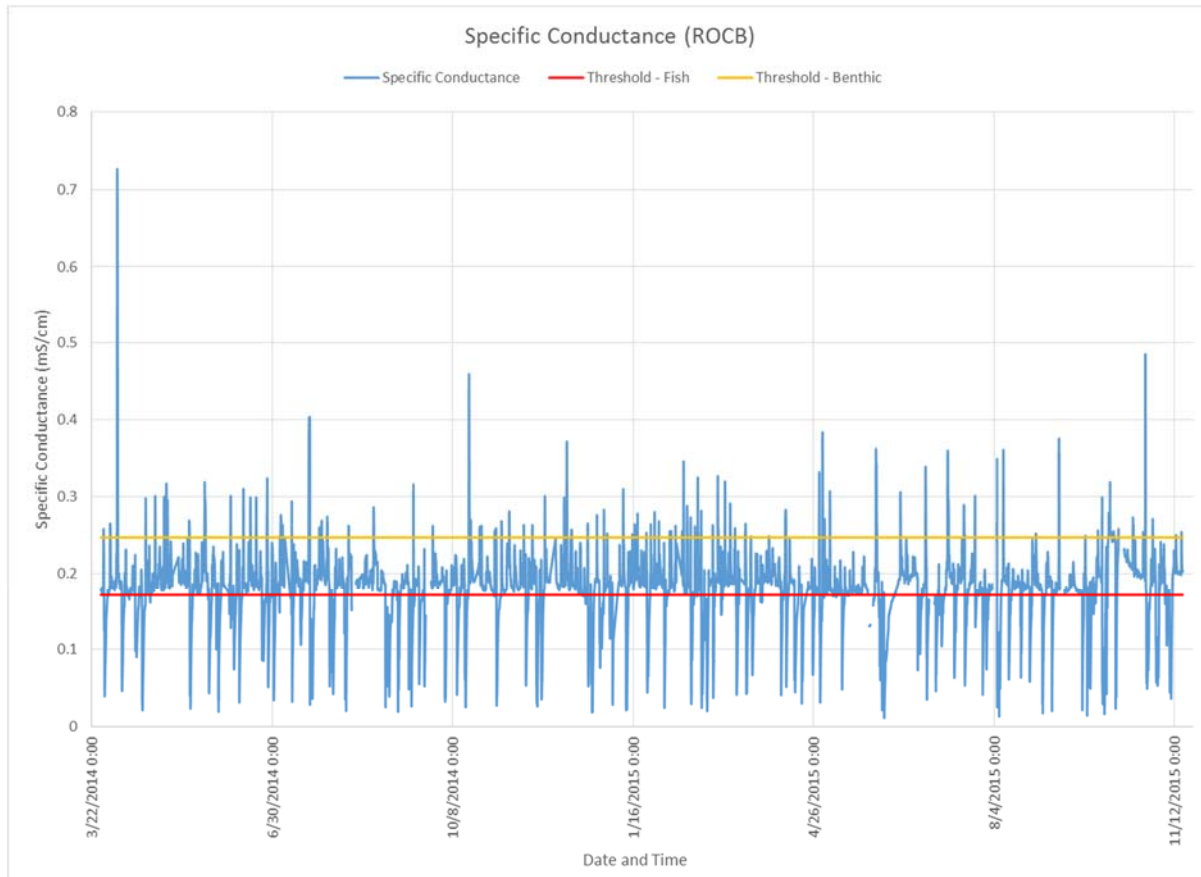
Site ROCB had lower maximum observed specific conductance values than ROCA, but had a higher percentage of values above the possible biological assemblage impairment thresholds. These data suggest that site ROCB has a chronic specific conductivity condition that may limit the ecological health of this portion of Rocky Branch.

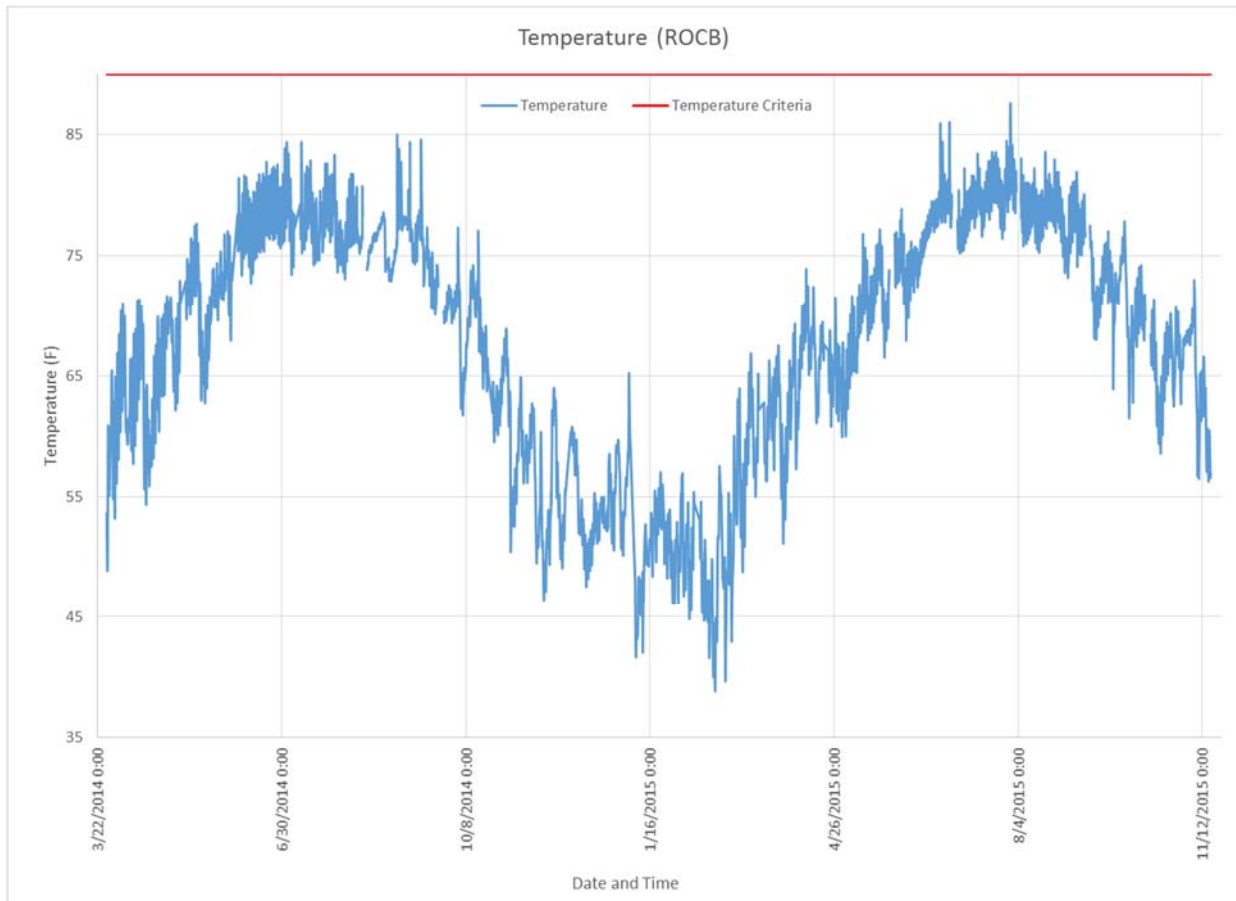
The water quality criteria for temperature of 90.0° F was not exceeded at ROCB. All temperature measurements were well below 90.0° F.

As expected, there is a seasonal and diurnal pattern to water temperature in Rocky Branch. The highest measured water temperatures occurred during the summer time. Summer is the time of the year with the highest air temperatures, and the greatest amount of solar radiation. These factors help warm water throughout the day. The highest temperatures measured each day were in the afternoon. Afternoon is usually the period of time with the highest air temperature, and sunlight has been warming the water and stream substrates throughout the day.

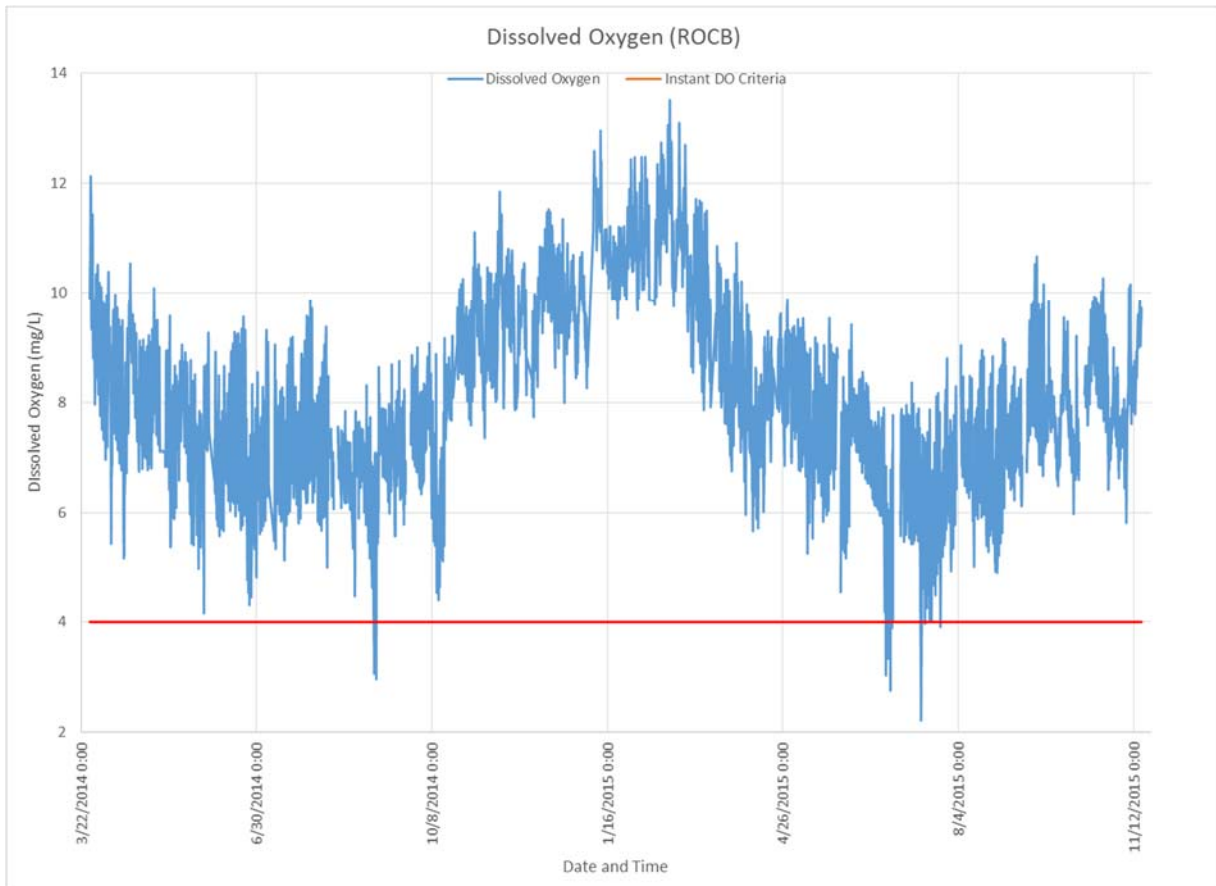
Water quality sonde data from site ROCB show that the instantaneous water quality standard for dissolved oxygen of 4.0 mg/L was violated 0.26% of the time (138 out of 53,138 records) over the period of record. Over the same period of time, the water quality standard for daily average dissolved oxygen of 5.0 mg/L was violated 0.89% of the time (5 out of 559 days). The daily criteria violations happened over a 4-day period from June 23<sup>rd</sup> through June 26<sup>th</sup>, 2015, and during July 13<sup>th</sup>, 2015.

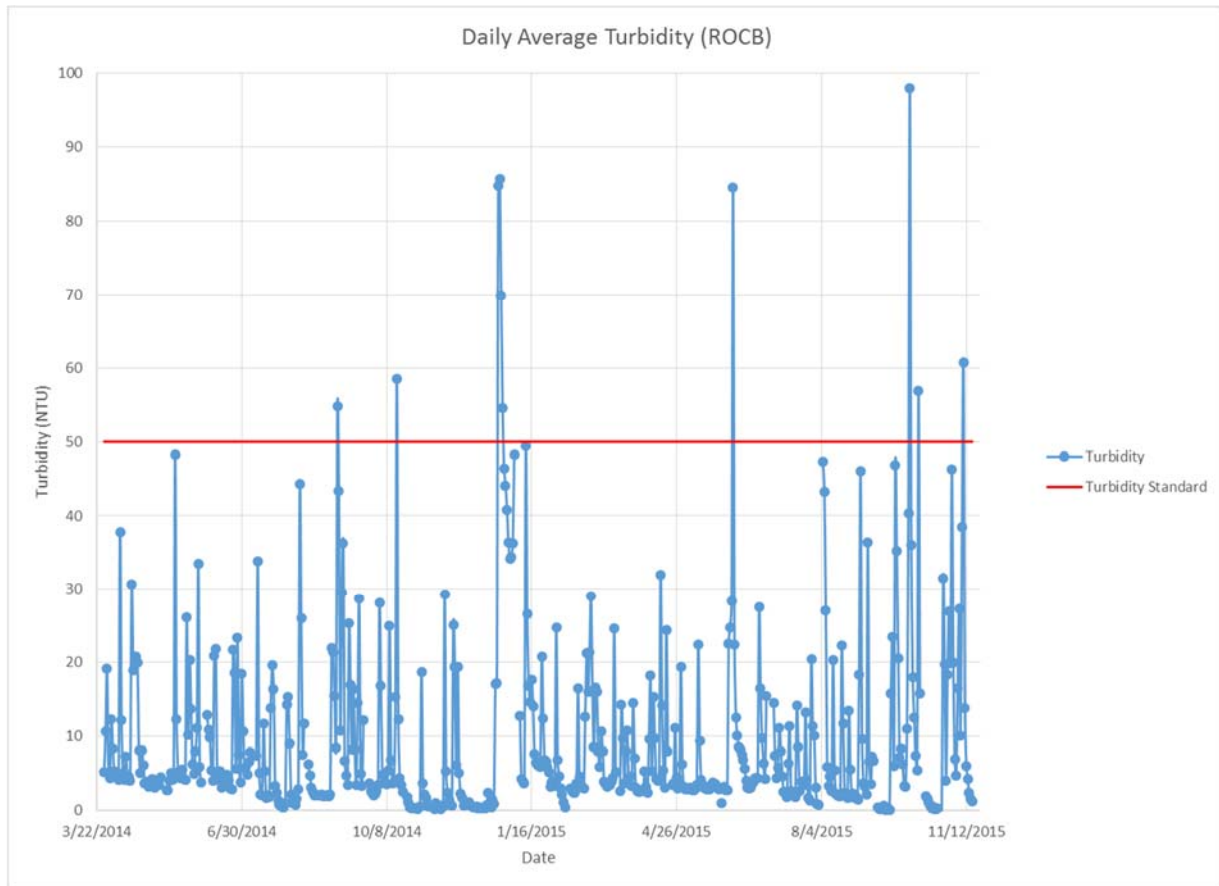
Water quality sonde data from site ROCB show that water quality standard for turbidity of 50 NTU was violated 3.58% of the time (1894 out of 52,836 records) over the period of record.

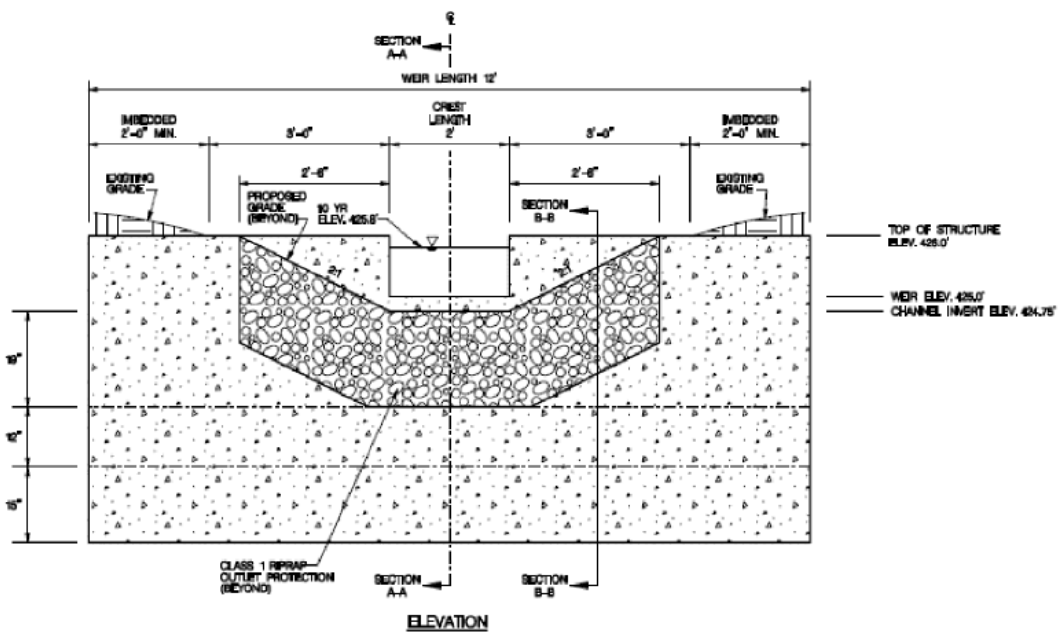
Stormwater Management Retrofit Cross Section

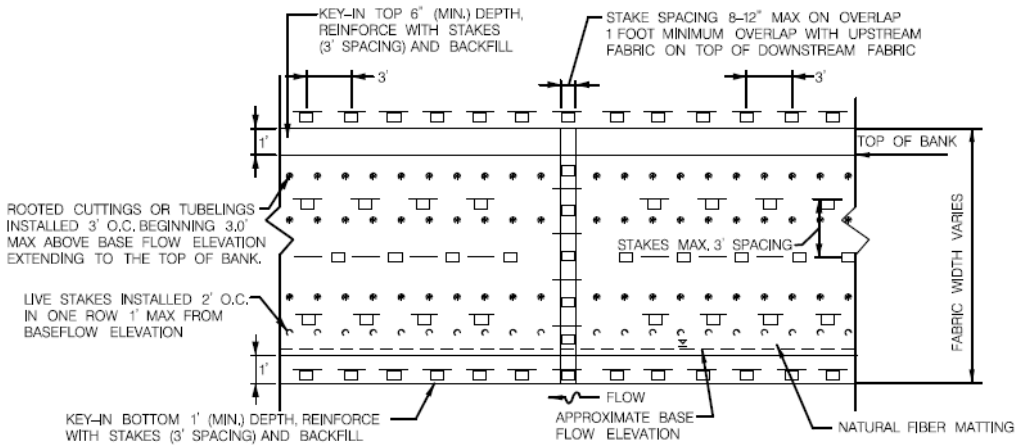
**NATURAL FIBER MATTING – PLAN VIEW**

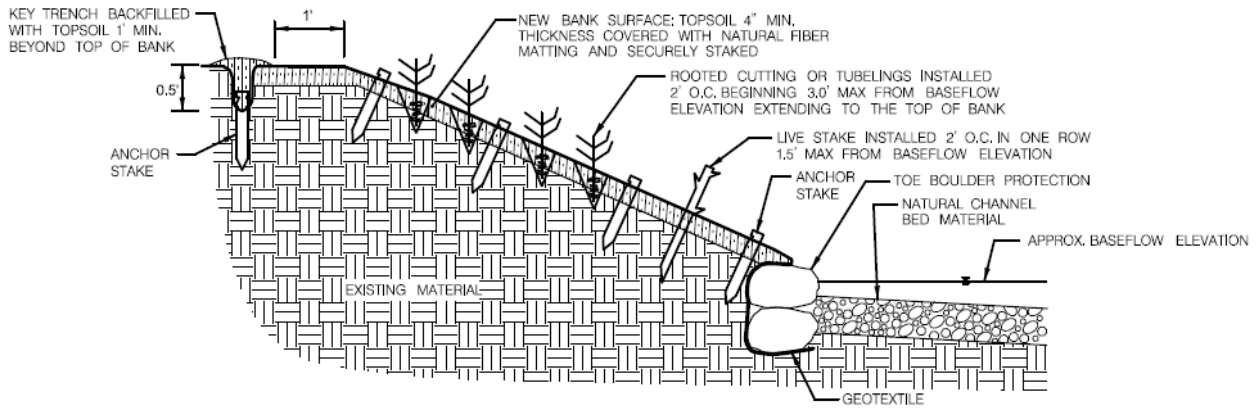
**TOE BOULDER PROTECTION TYPICAL**

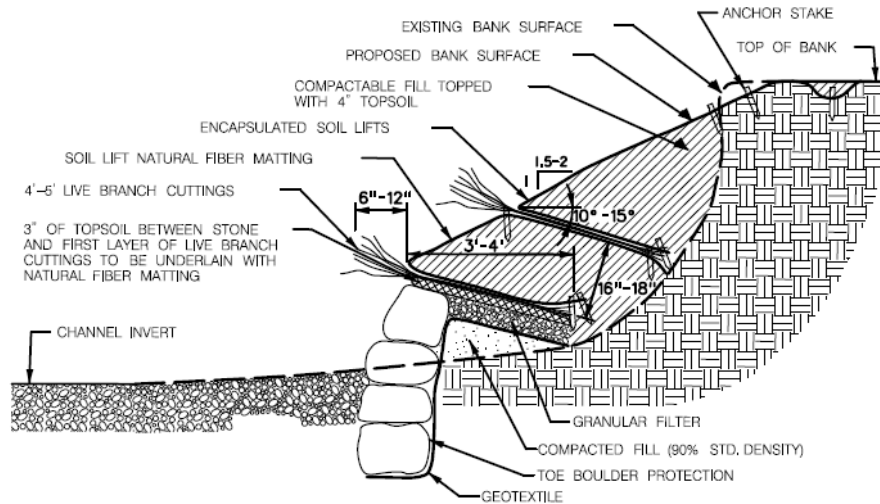
**TOE BOULDER PROTECTION WITH BRANCH LAYERING TYPICAL**

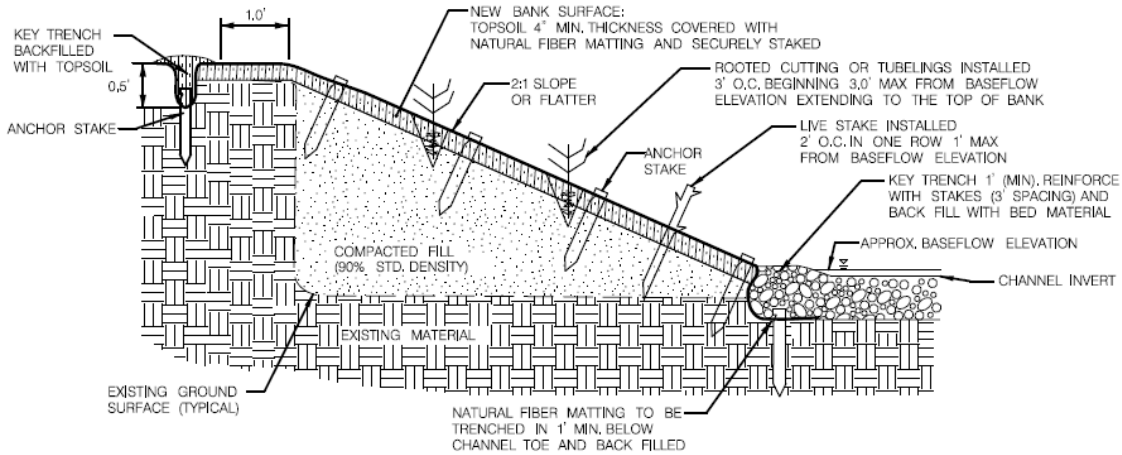
**TYPICAL STREAMBANK STABILIZATION IN FILL**  
NOT TO SCALE

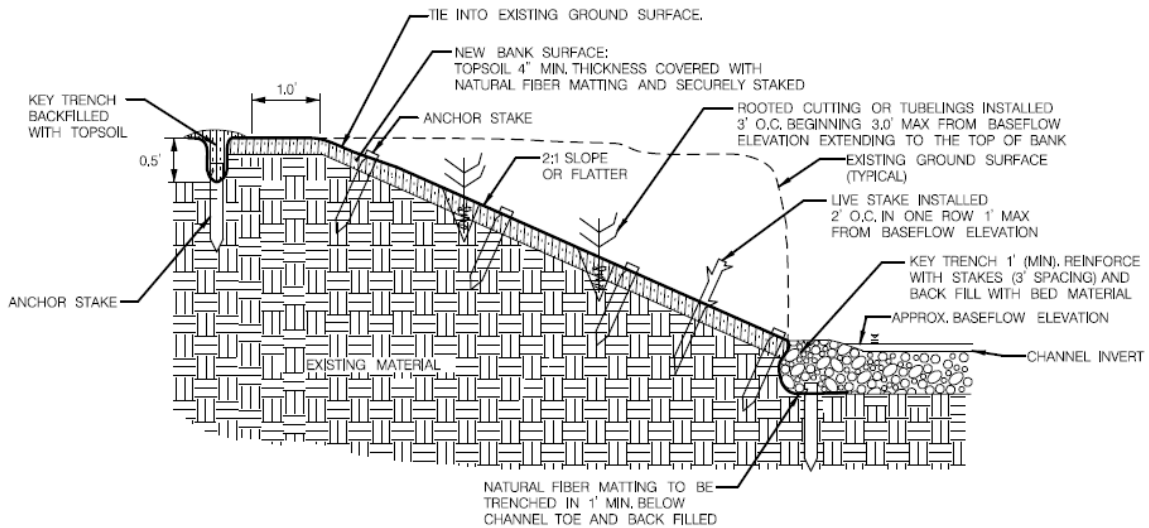
**TYPICAL STREAMBANK STABILIZATION IN CUT**  
NOT TO SCALE

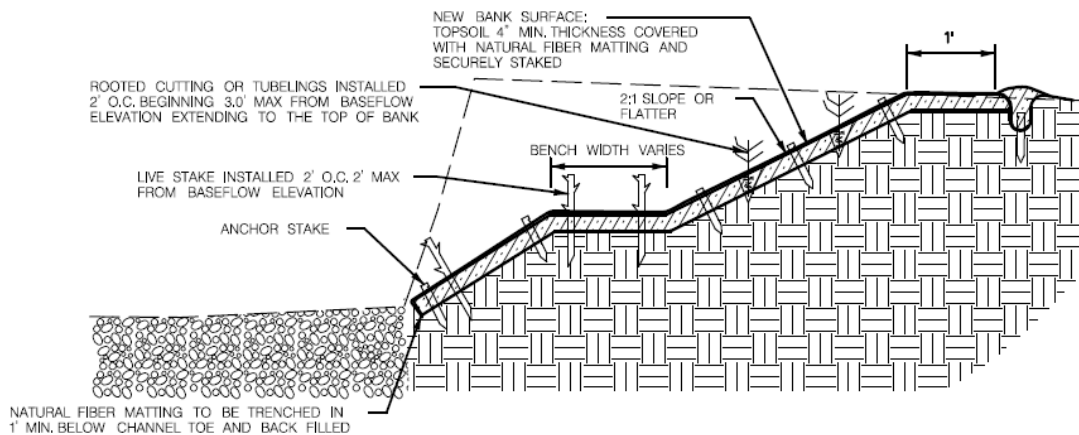
**TYPICAL STREAMBANK STABILIZATION WITH FLOODPLAIN BENCH**  
NOT TO SCALE

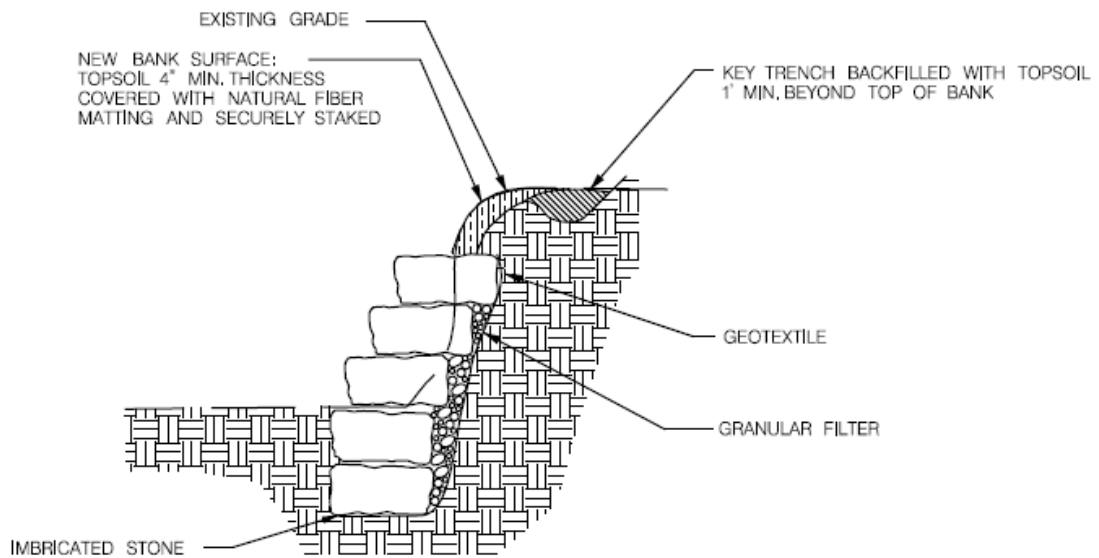
IMBRICATED STONE WALL CHANNEL PROTECTION-SECTION VIEW

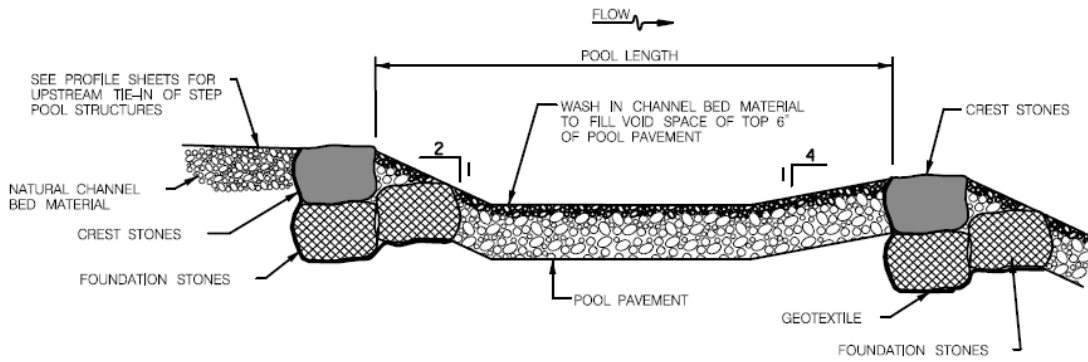
TYPICAL PROFILE THROUGH STEP-POOL

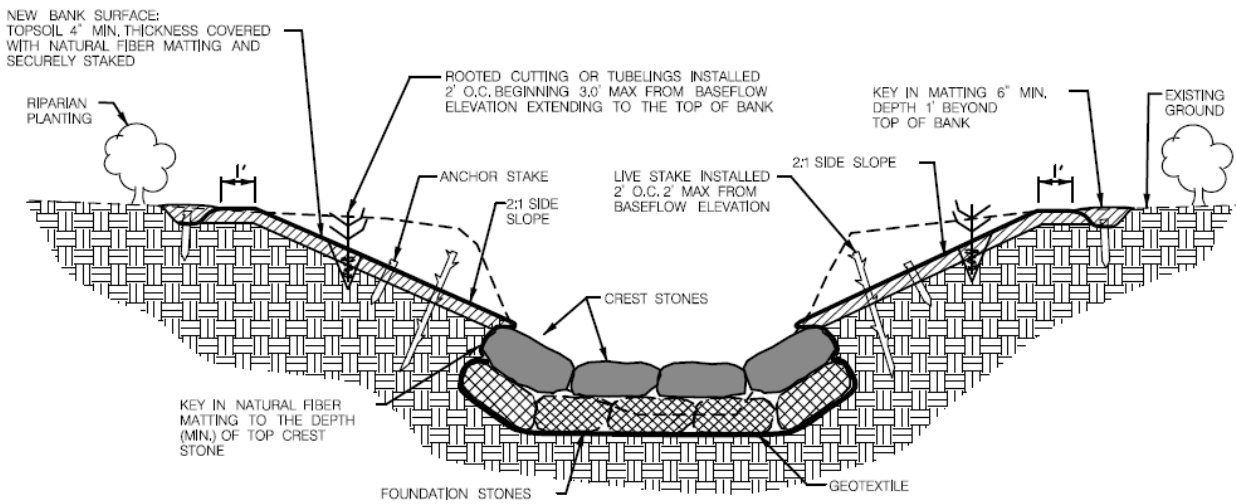
TYPICAL CROSS SECTION OF STEP-POOL CREST

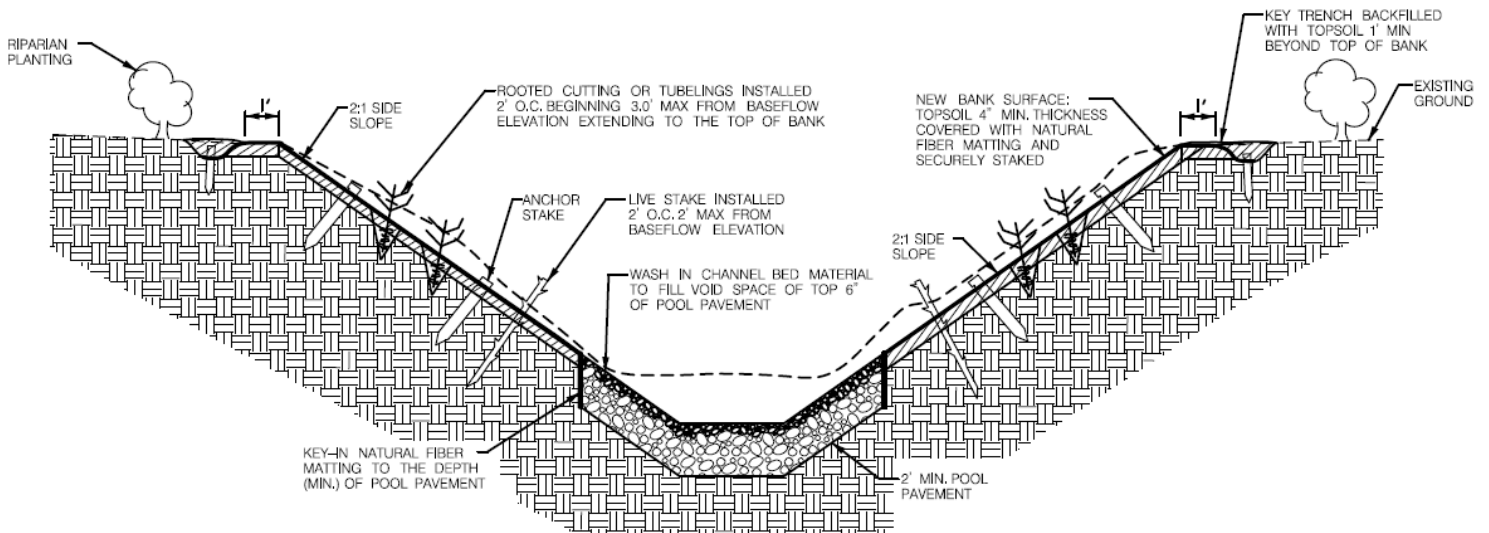
TYPICAL CROSS SECTION OF STEP-POOL POOL
