Rocky Branch Watershed Management Plan

# ROCKY BRANCH WATERSHED ASSESSMENT

McCormick Taylor Inc., supported by KCI Technologies, Inc., has been contracted by the City of Columbia, South Carolina to conduct an assessment of the Rocky Branch watershed to identify potential improvement opportunities to identify existing flooding and water quality conditions.

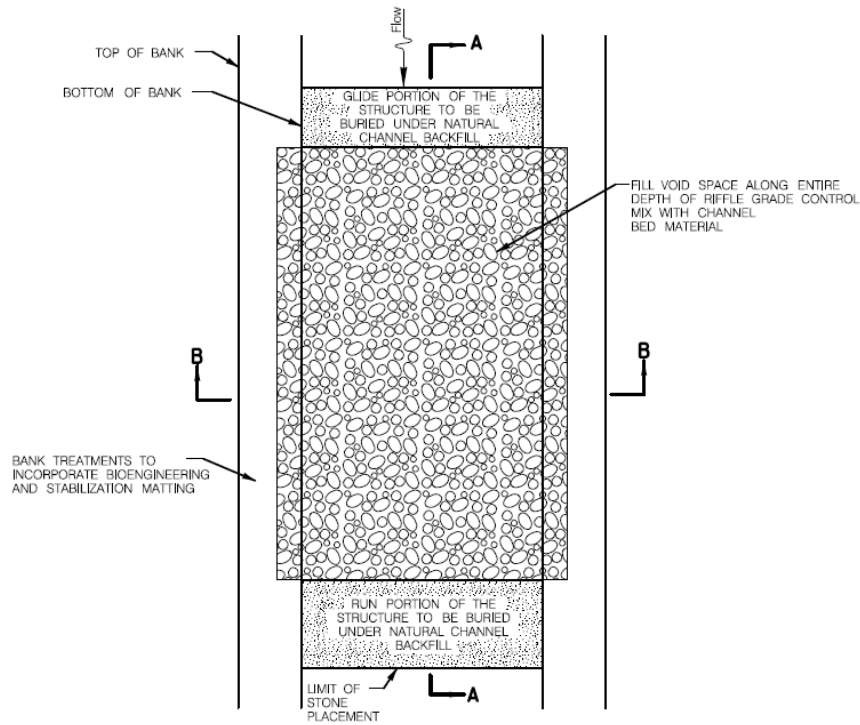
PLAN VIEW TYPICAL  
RIFFLE GRADE CONTROL  
NOT TO SCALE

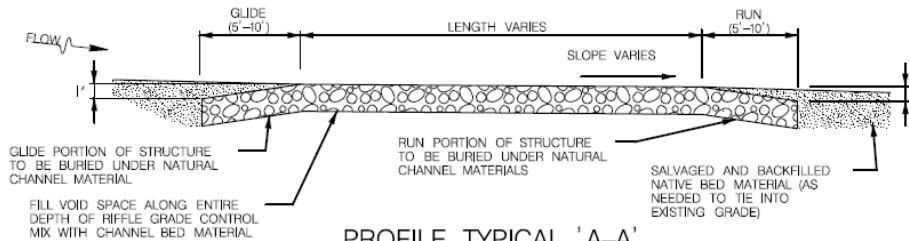
PROFILE TYPICAL 'A-A'  
RIFFLE GRADE CONTROL  
NOT TO SCALE

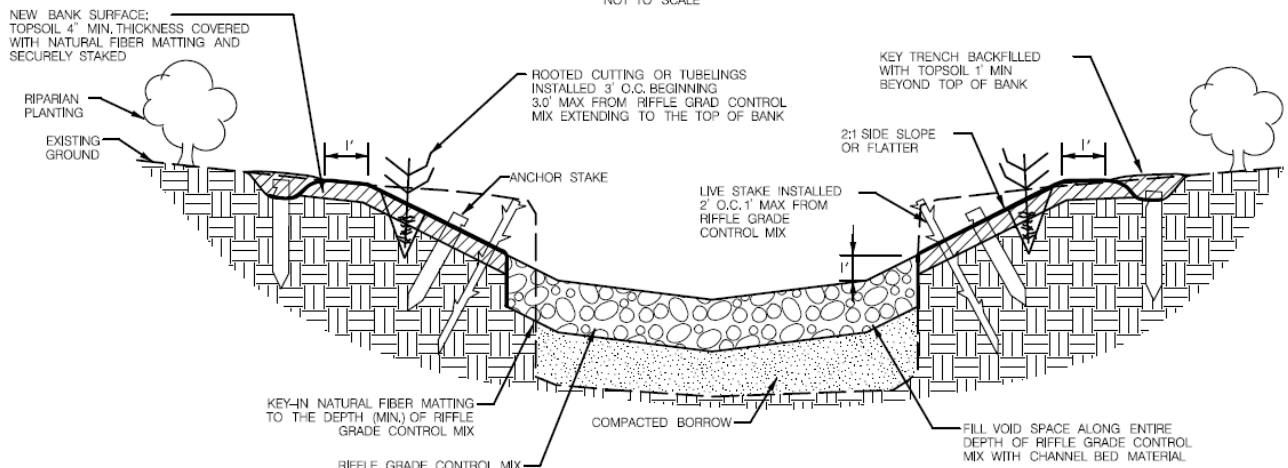
CROSS SECTION TYPICAL 'B-B'  
RIFFLE GRADE CONTROL  
NOT TO SCALE

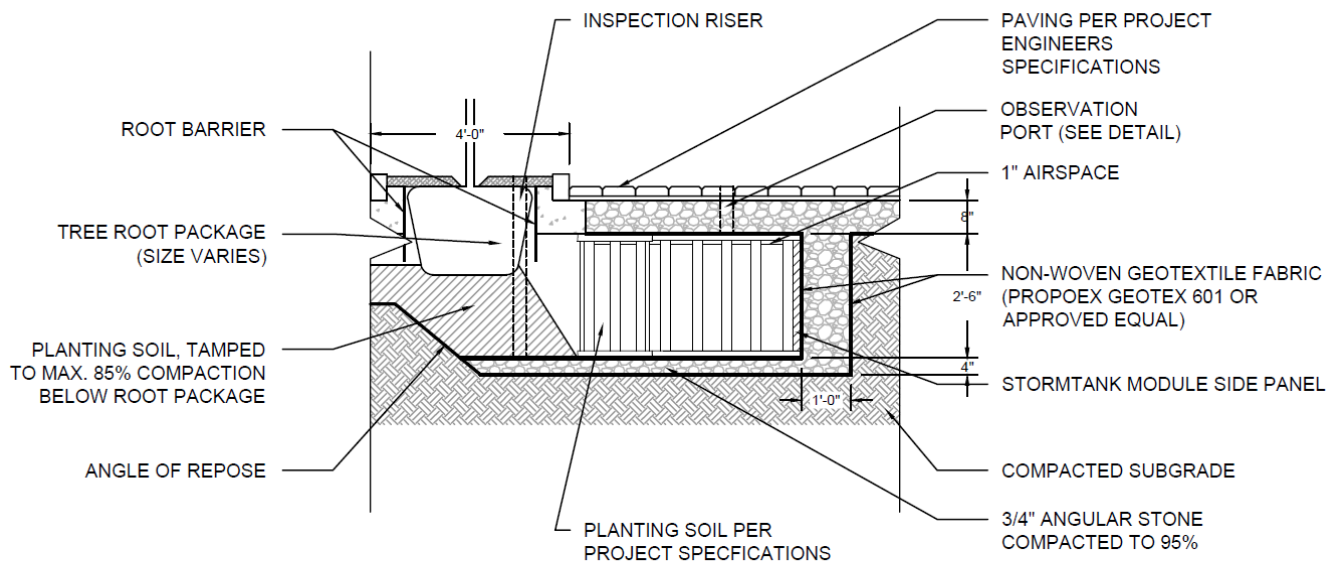
## Boulevard Approach Tree Boxes

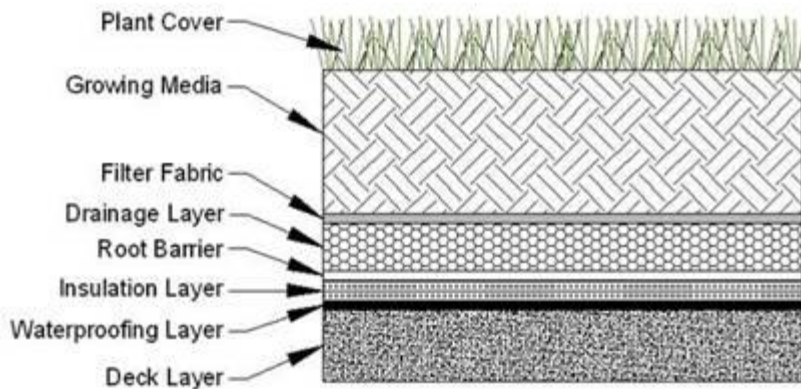
## Green Roof System

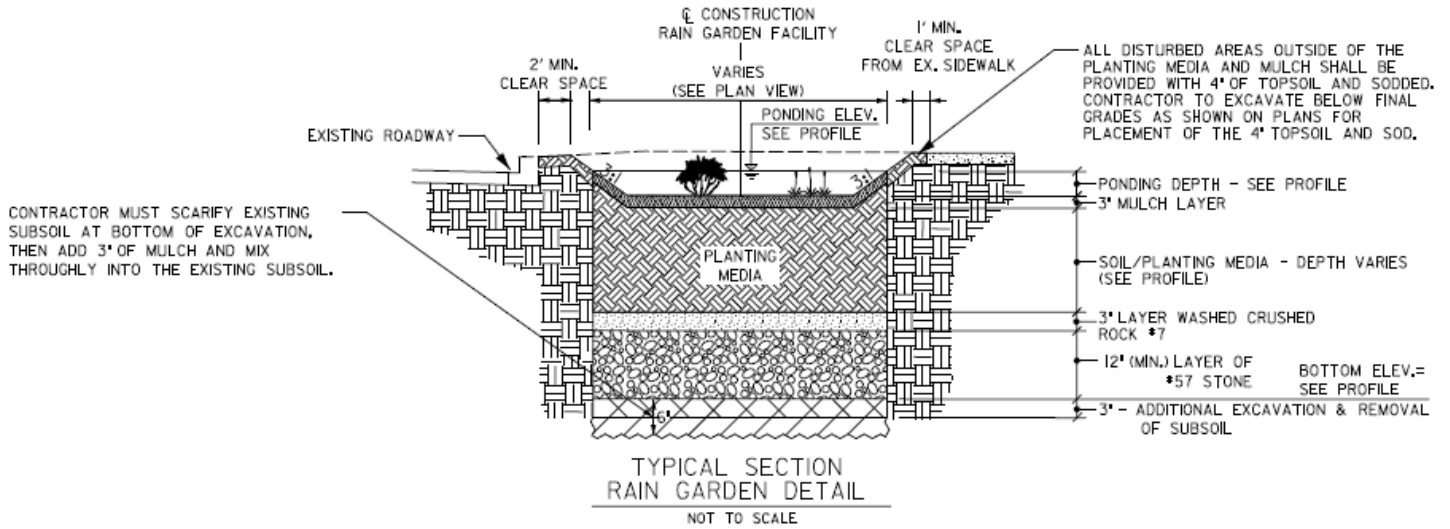
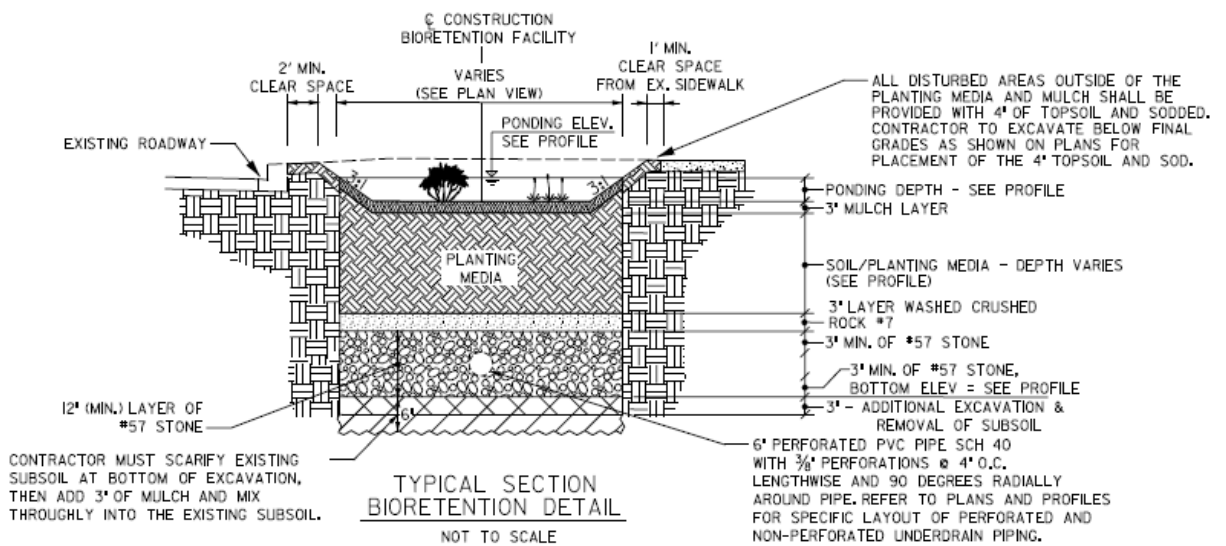
# LID Treatments: Rain Gardens and Bioretention Areas,

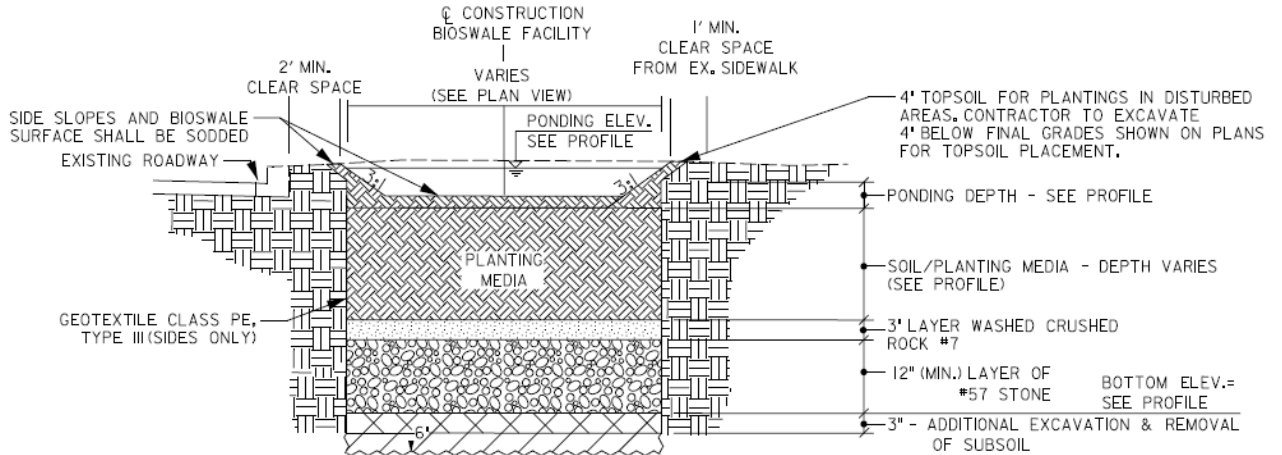
TYPICAL SECTION  
BIOSWALE DETAIL  
NOT TO SCALE

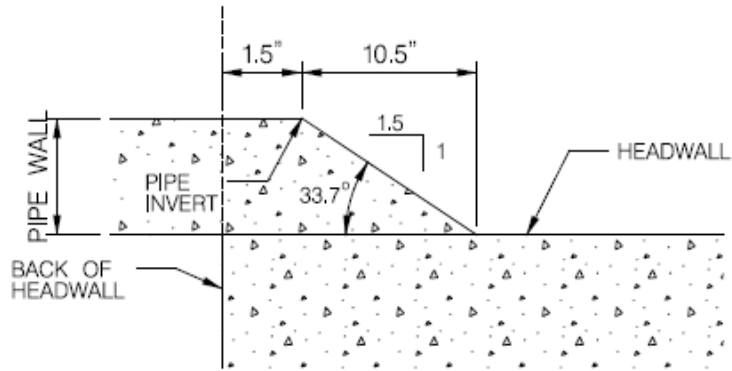
## 1.5:1 INLET BEVEL

CONSTRUCT A 1.5:1 BEVEL AROUND ENTIRE CIRCUMFERENCE OF THE CULVERT.

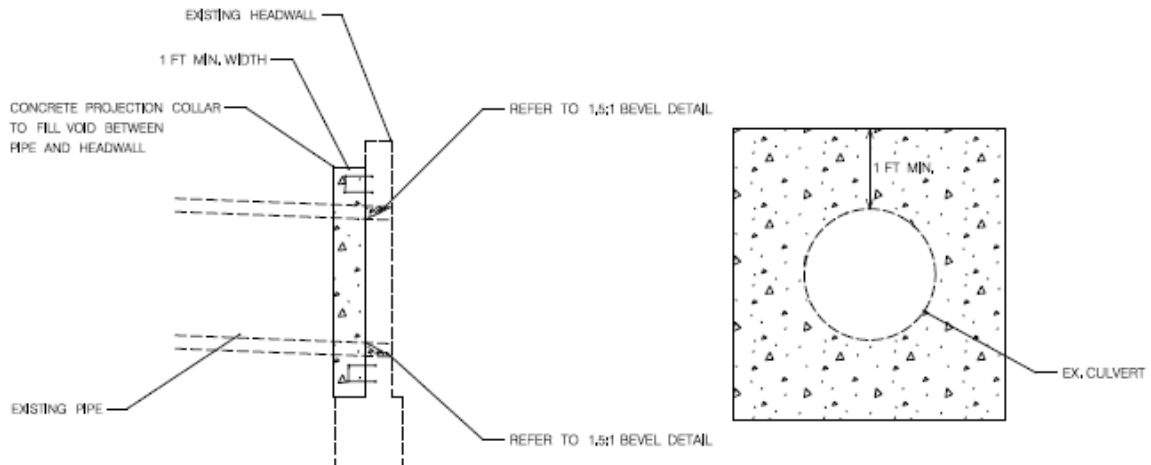
## CONCRETE PIPE COLLAR

CAST 1 FOOT THICK CONCRETE COLLAR TO HEADWALL WITH 4 U-SHAPED REBARS

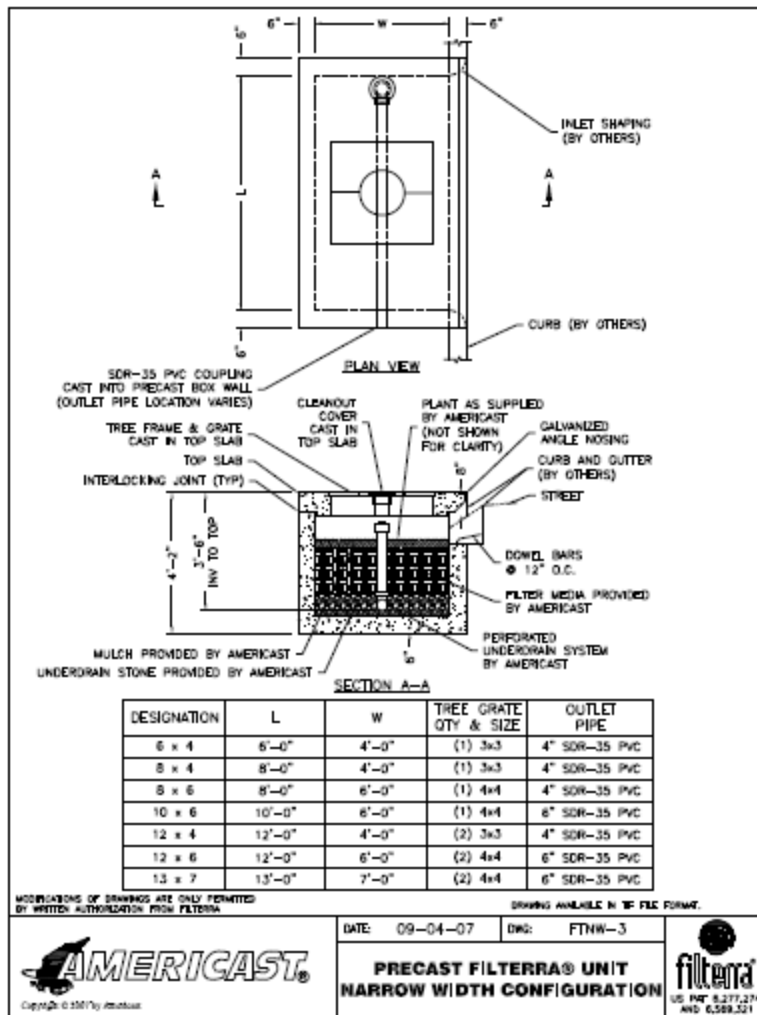
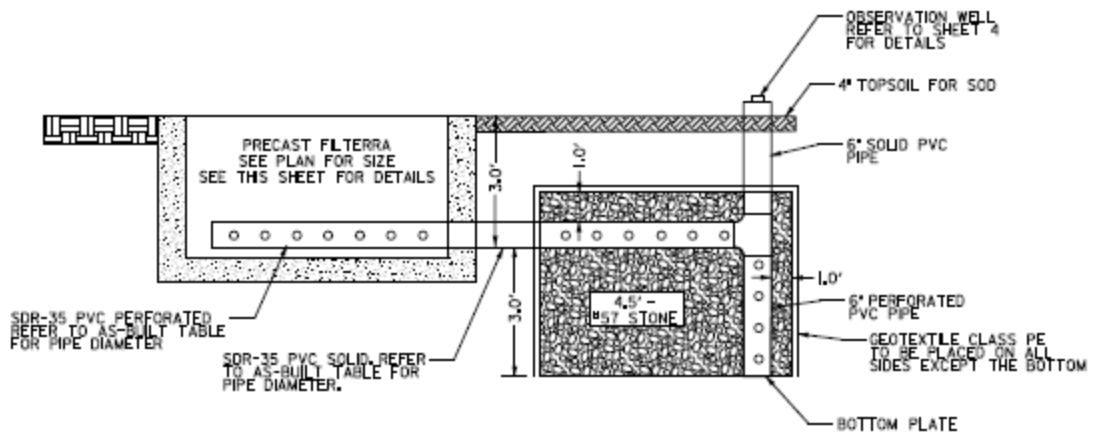
TYPICAL FILTERRA AND STONE TRENCH DETAIL

# LID Treatments: Infiltration

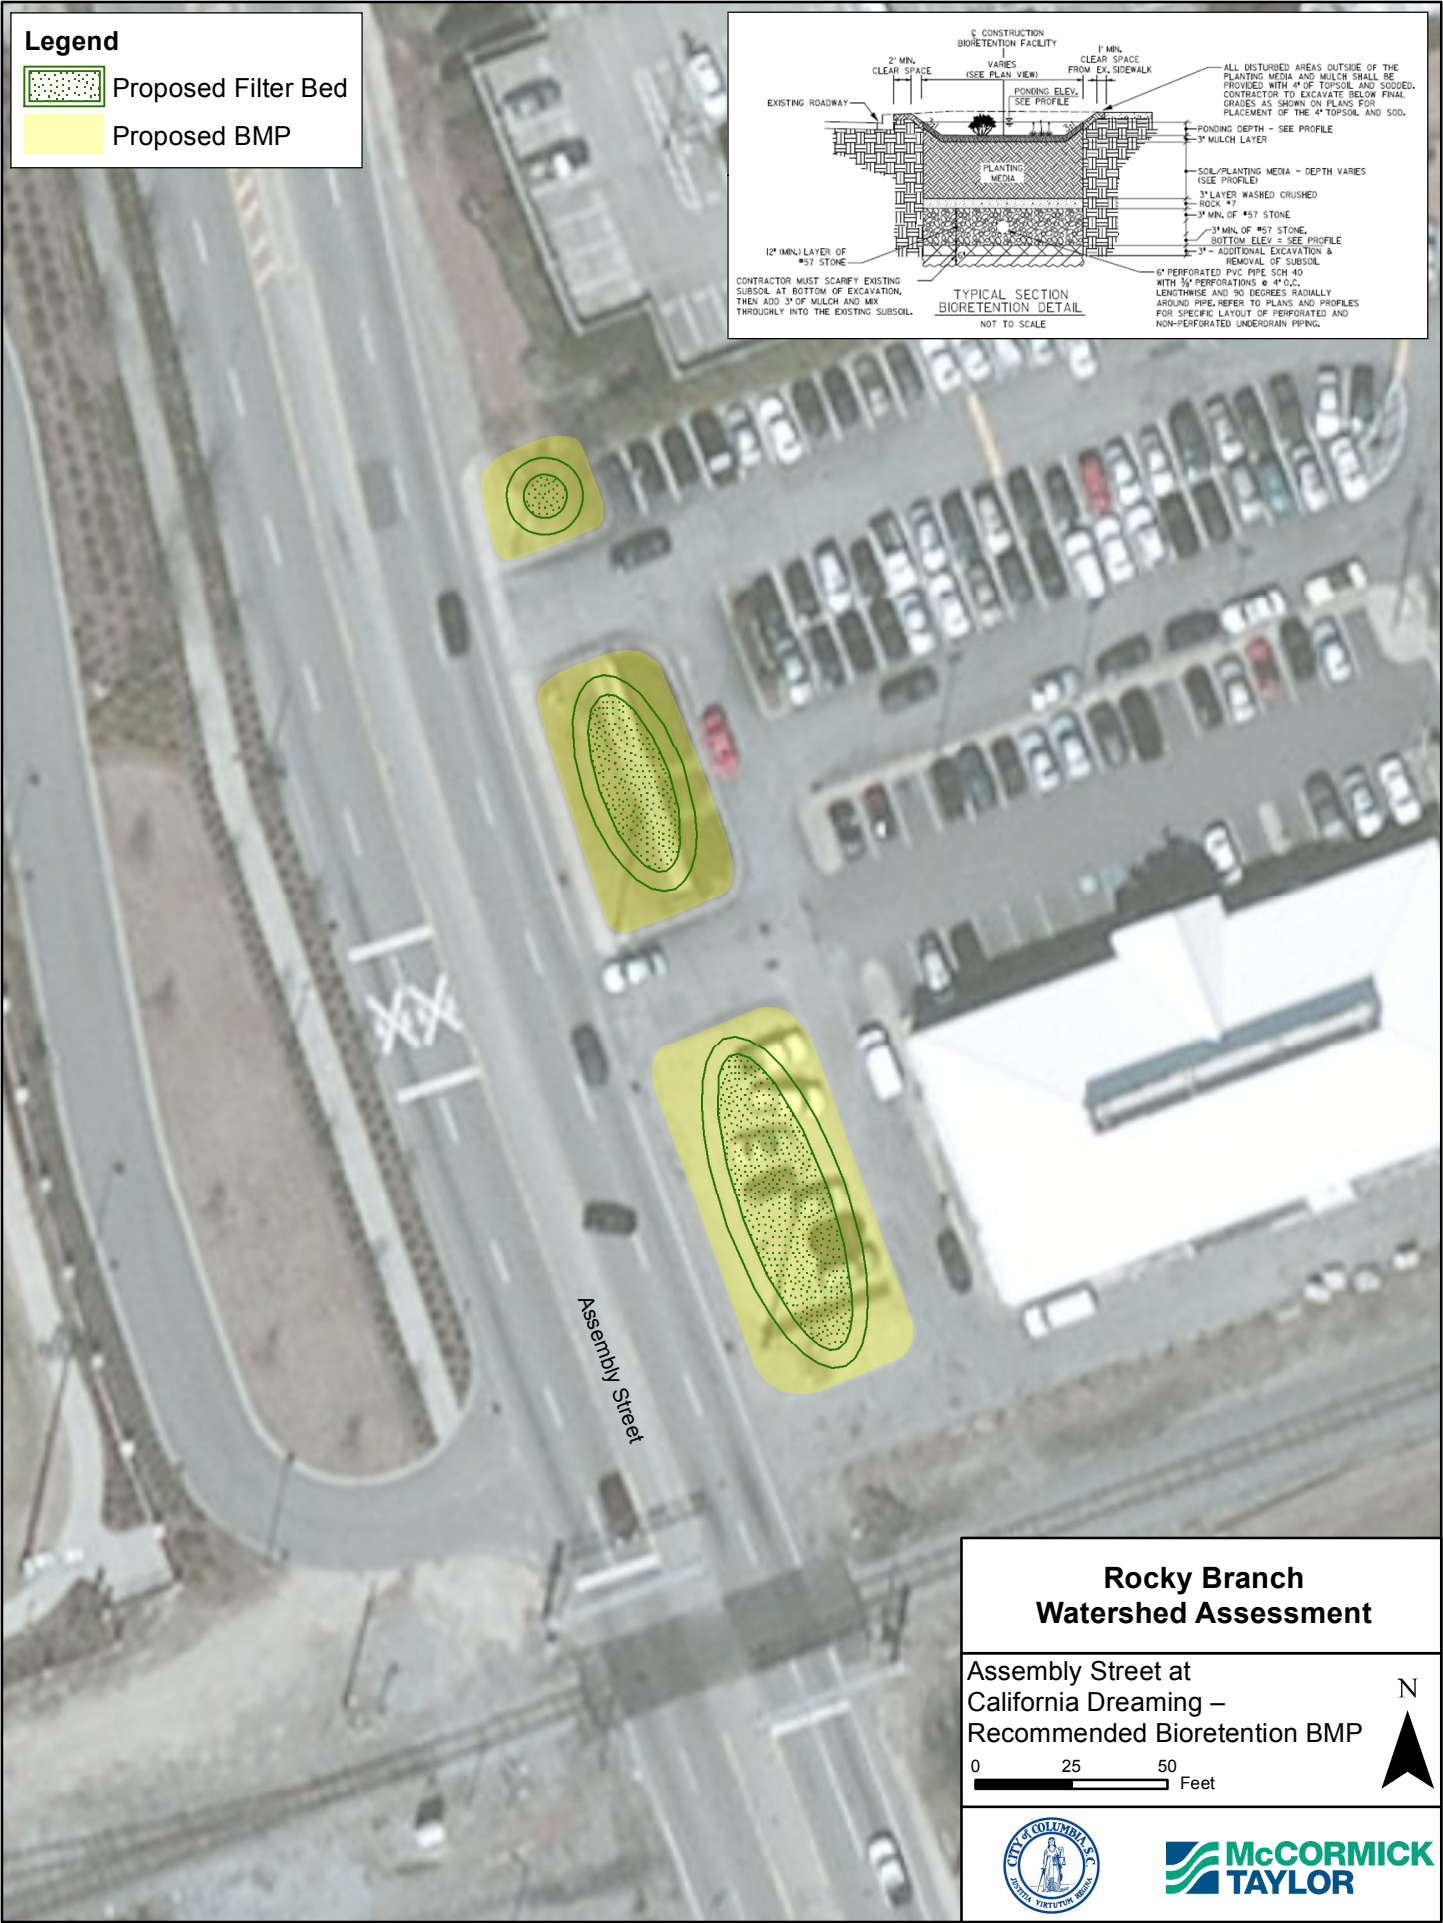
Assembly Street at  
California Dreaming –  
Recommended Bioretention BMP

**Rocky Branch  
Watershed Assessment**

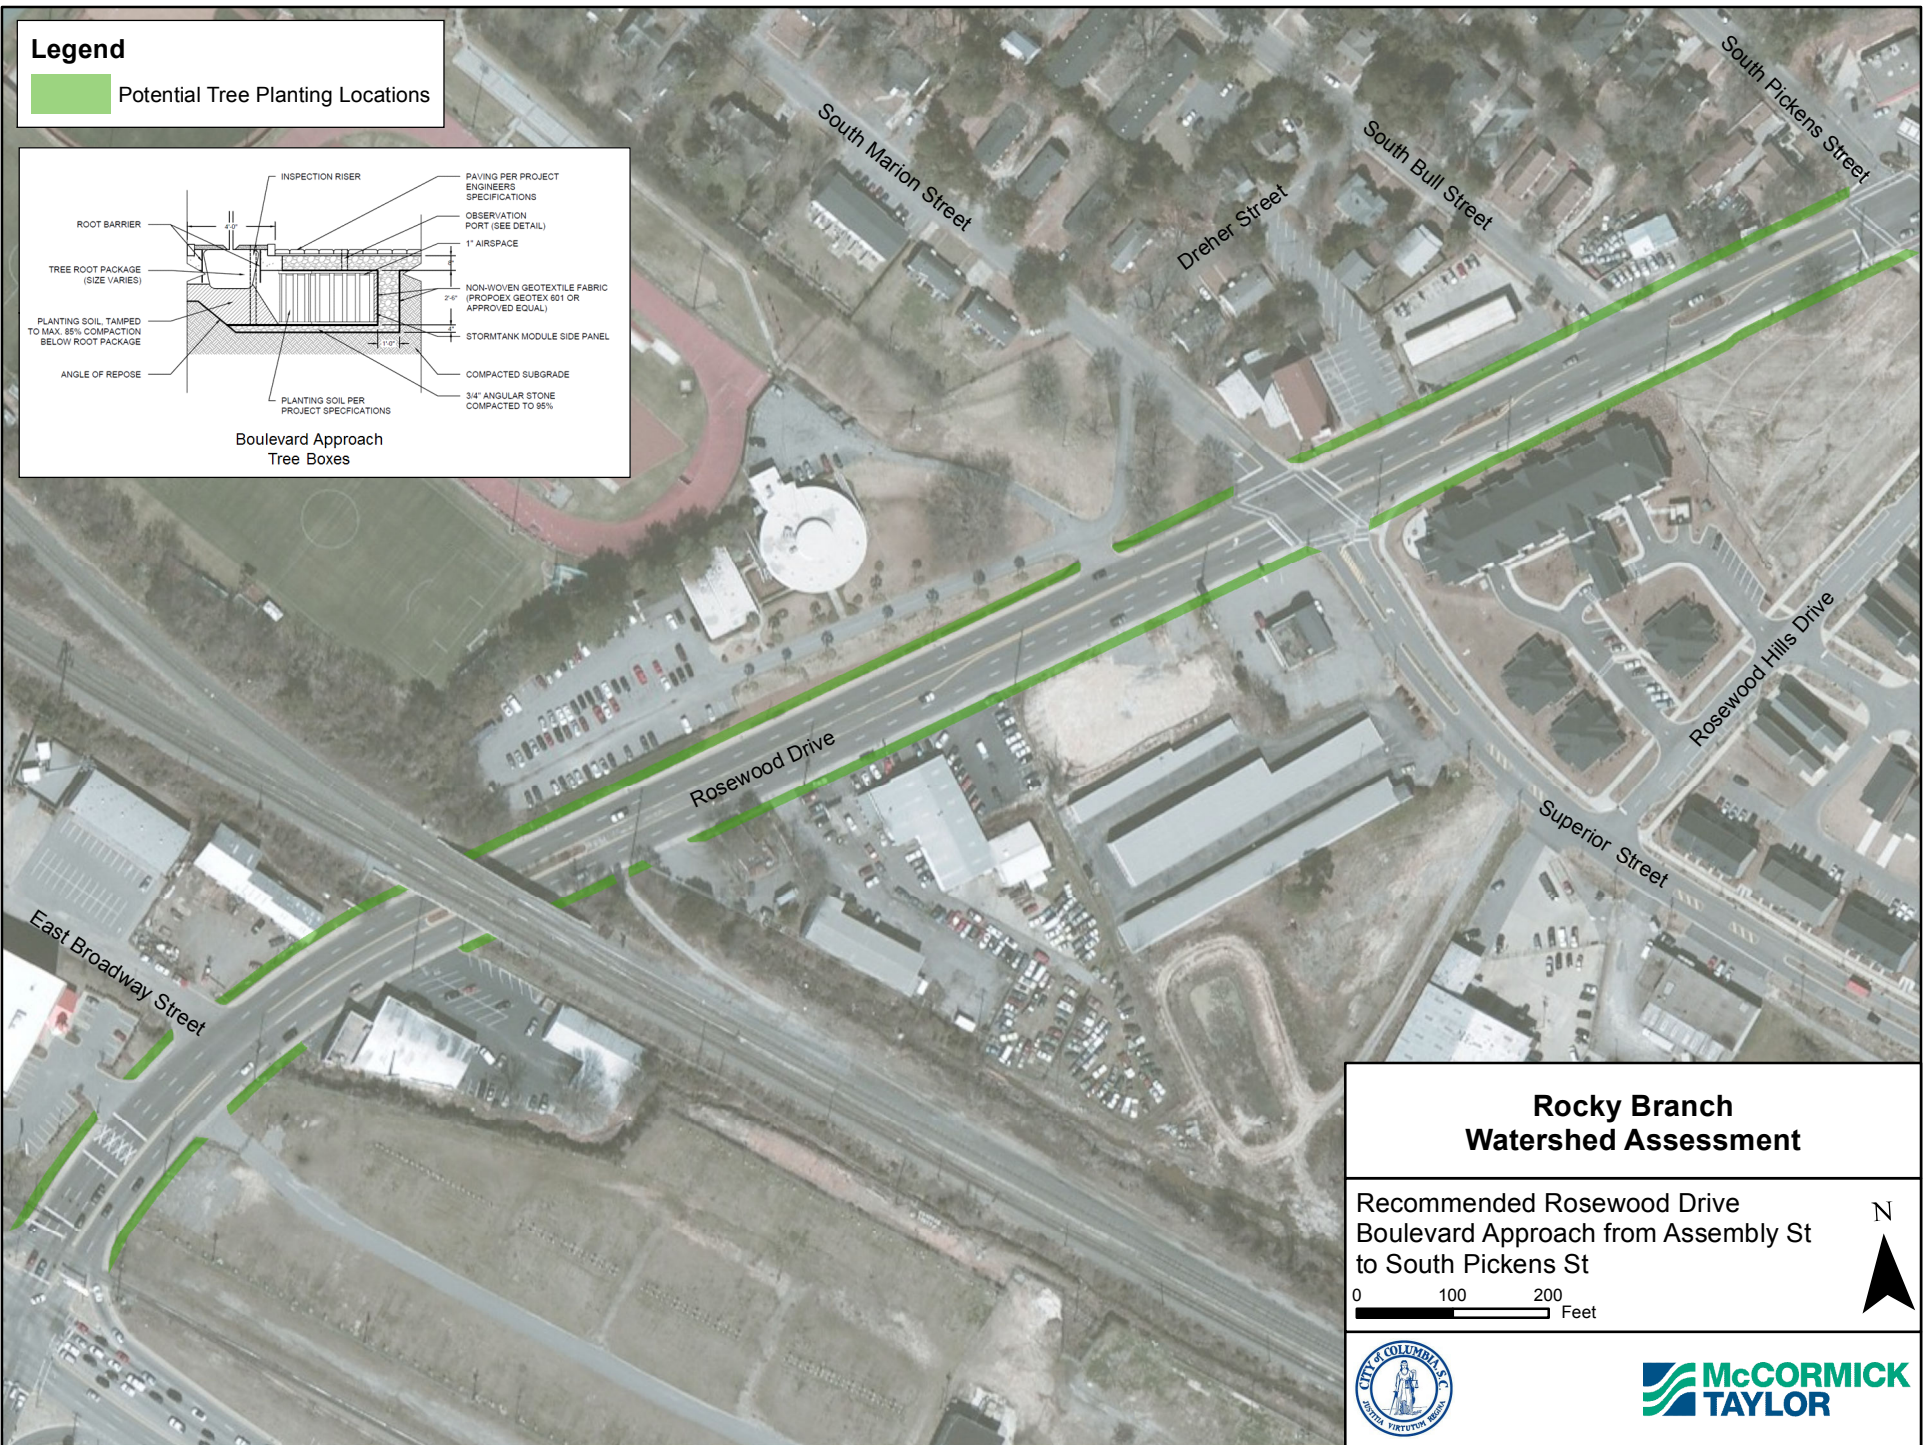
Recommended Rosewood Drive Boulevard Approach from Assembly St to South Pickens St

## Rocky Branch Watershed Assessment

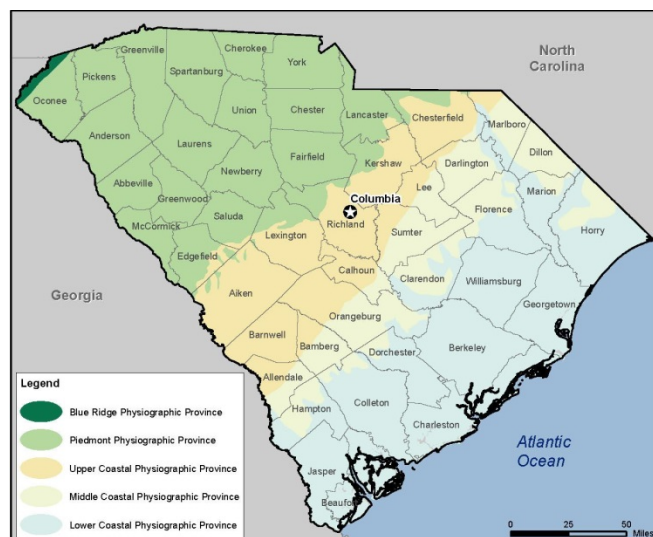
**Figure 3.2 Physiographic Provinces of SC**

The Smith Branch Watershed is located where the Coastal Plain adjoins the Piedmont province (known as the Fall Line), as shown in **Figure 3.2**. The majority of the watershed exists within the Congaree Sand Hills, which corresponds approximately to the Cape Fear formation of the Upper Cretaceous (Kcfe). The Cape Fear formation consists primarily of light-colored cross-bedded arkosic sand, gravel deposited in delta-dominated fluvial and restricted environments, and lenses of massive light-colored clay and kaolin with many local unconformities (United States Department of Agriculture Soil Conservation Service, 1978).

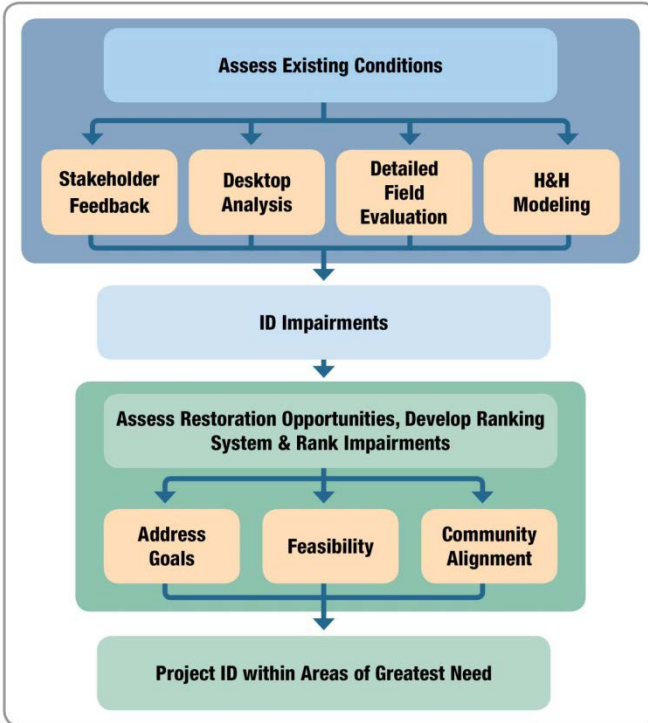
**Figure 4.1 Watershed Assessment Methodology**

A multi-faceted methodology was implemented (**Figure 4.1**), first by assessing the existing conditions of the watershed through desktop analysis of existing information as described above.

Once subwatershed breaks were established, several evaluations were conducted both in the field, through visual inspection, and using GIS data to further evaluate the individual subwatersheds. Following these evaluations, preliminary data review pointed to the high level of urbanization and associated flooding as the primary issues within the watershed. Considering the level of urbanization and complexity of the drainage network, the Storm Water Management Model (SWMM) was used to evaluate and eventually rank each subwatershed. Based on this ranking, Watershed Projects were identified in all subwatersheds with a focus in the subwatersheds with the greatest impairment. This methodology is summarized in **Figure 4.1** and described in detail below.

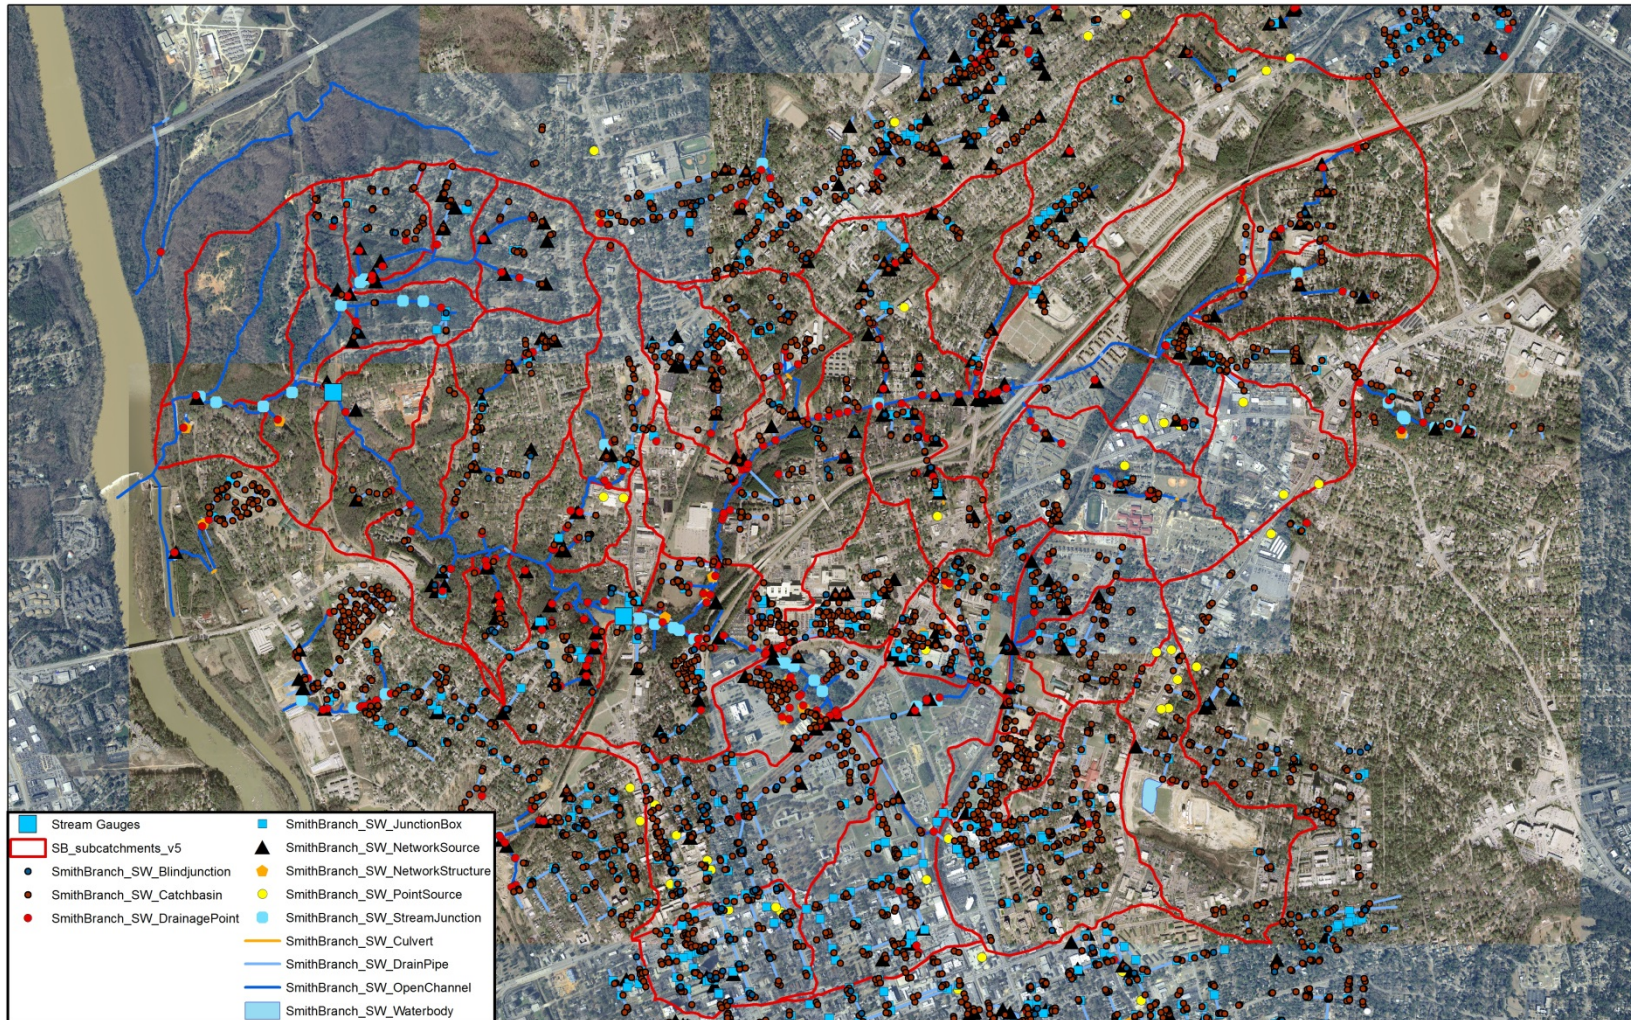
Figure 4.3 GIS Storm Drains, Nodes, and Links

The node and conduit data from GIS for the Smith Branch Watershed are shown in **Figure 4.3**.

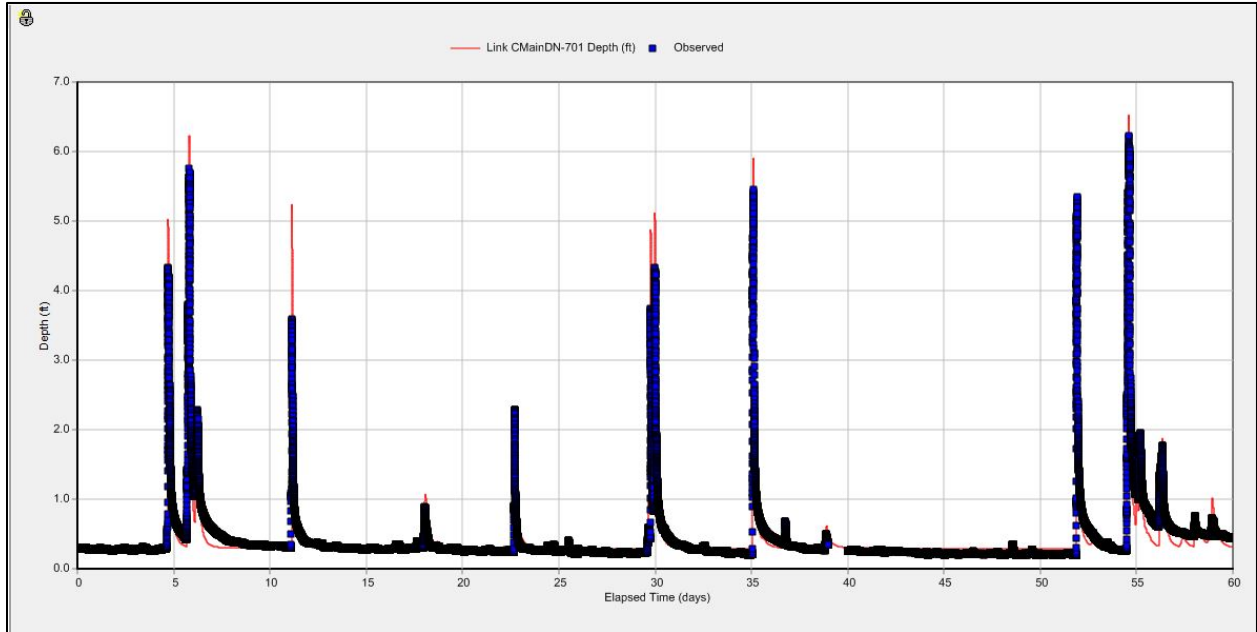
**Figure 4.5 Smith Branch Gage A (Main St)**

also made to determine if the model represents roadway overtopping or flooding that actually occurred. The results of the SWMM Model were compared to depths from the Stream Gage A at Earlewood Park and at Stream Gage B at the Clement Road Crossing. Flows from the USGS Gage just above Clement Street were also used in the calibrations. The time period from August 1, 2015 to October 1, 2015 was used for calibration. The gages were out of commission for over a week after a storm on October 2, 2015. The calibration results are shown in **Figures 4.5, 4.6, and 4.7.**

The SWMM Model produced reasonably accurate peaks at both depth gages. At the USGS Gage, near the Smith Branch Gage A location, the flows were created from a well-established rating curve, and compared to the flows from SWMM at this location. The purpose of the SWMM Model was not to predict peaks, but rather to estimate flows for use in HEC-RAS; however both peaks and flows were reasonably well-represented by the SWMM Model. Unlike the SWMM Model, the HEC-RAS model contains bridge, culvert and utility crossings. Once the SWMM Model calibration was completed, the 2, 10, 25, 50 100 and 500-year design storms were simulated through the SWMM Model, each as a single event. This produced flows along Smith Branch that were input into the HEC-RAS model at the specified river stations.

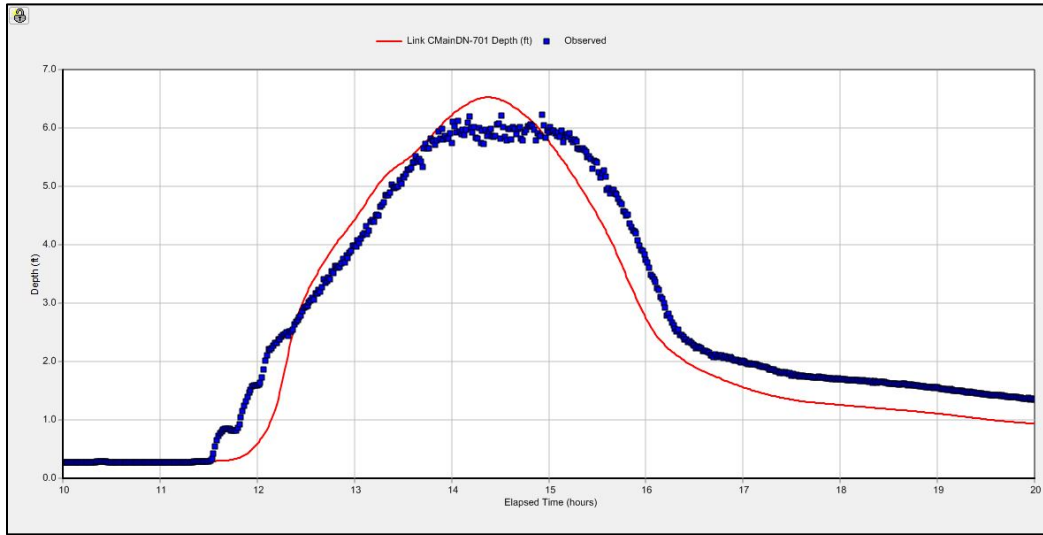
**Figure 4.8 September 25, 2015 Storm at Smith Branch A (Main St.)**

A storm that occurred on September 25, 2015 produced approximately 3.52 inches of rain in 6 hours, similar to the 10-year, 6-hour National Oceanic and Atmospheric Administration (NOAA) event for this area. The storm was also run in the HEC-RAS model to compare its output. Flows from the September 25, 2015 Storm, when run in HEC-RAS, produced a depth of 8.97 feet at the approximate location of the USGS Gage. Data from the Smith Branch B Gage in this area shows a slightly lower depth of 8.5 feet. The results from SWMM for this same storm are shown in **Figures 4.8** and **4.9** at Stream Gages A and B, respectively.

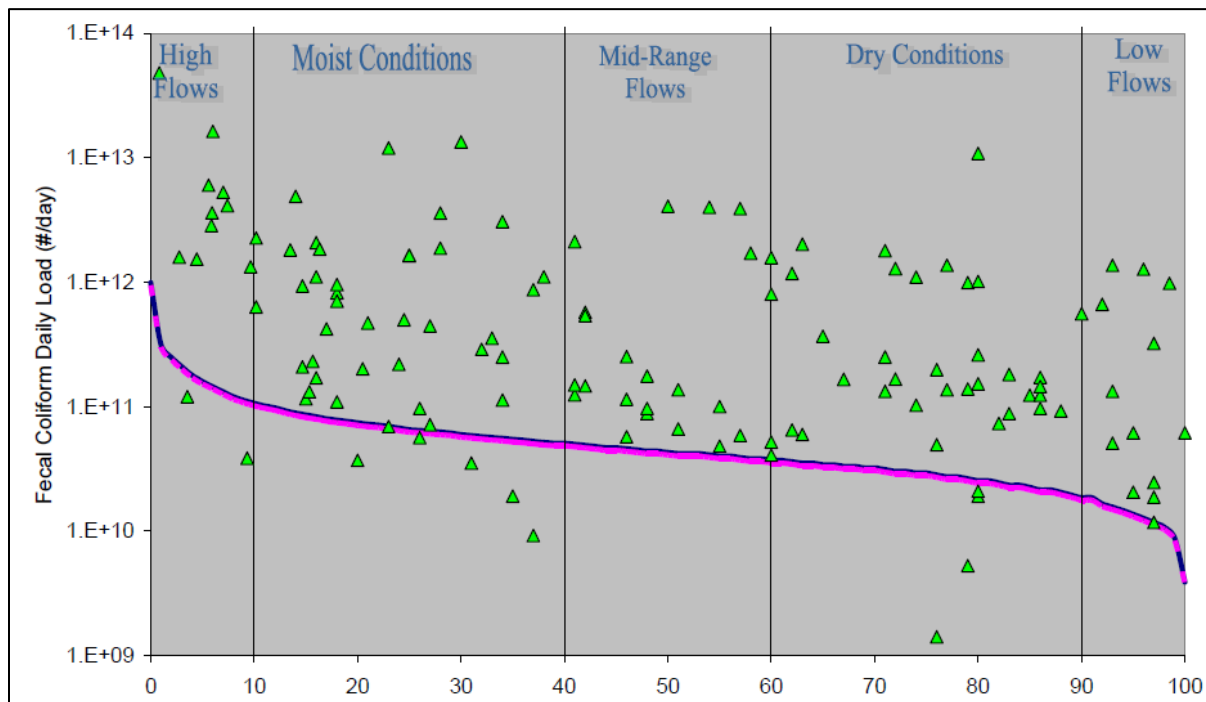
**Figure 4.11 Fecal Coliform Load Duration Curve 1990-2000, Station B-280 (Smith Branch)**

Samples for 32, or 89% of the 36 water samples collected at Station B-280 from January 1998 through December 2000 exceeded the fecal coliform WQS of 400 cfu/100 ml. There is no active NPDES-permitted wastewater discharge plants (WWTP) discharging fecal coliform in this watershed. There were no SSO's reported within this watershed. There are an estimated 612 on-site waste disposal (OSWD) systems within this watershed resulting in 17.1 OSWD systems per 100 acres. The sources of fecal coliform contributing to nonsupport of primary contact recreation most probably include a combination of MS4 point sources, failing OSWD systems, leaking sewers, pets, and wildlife.

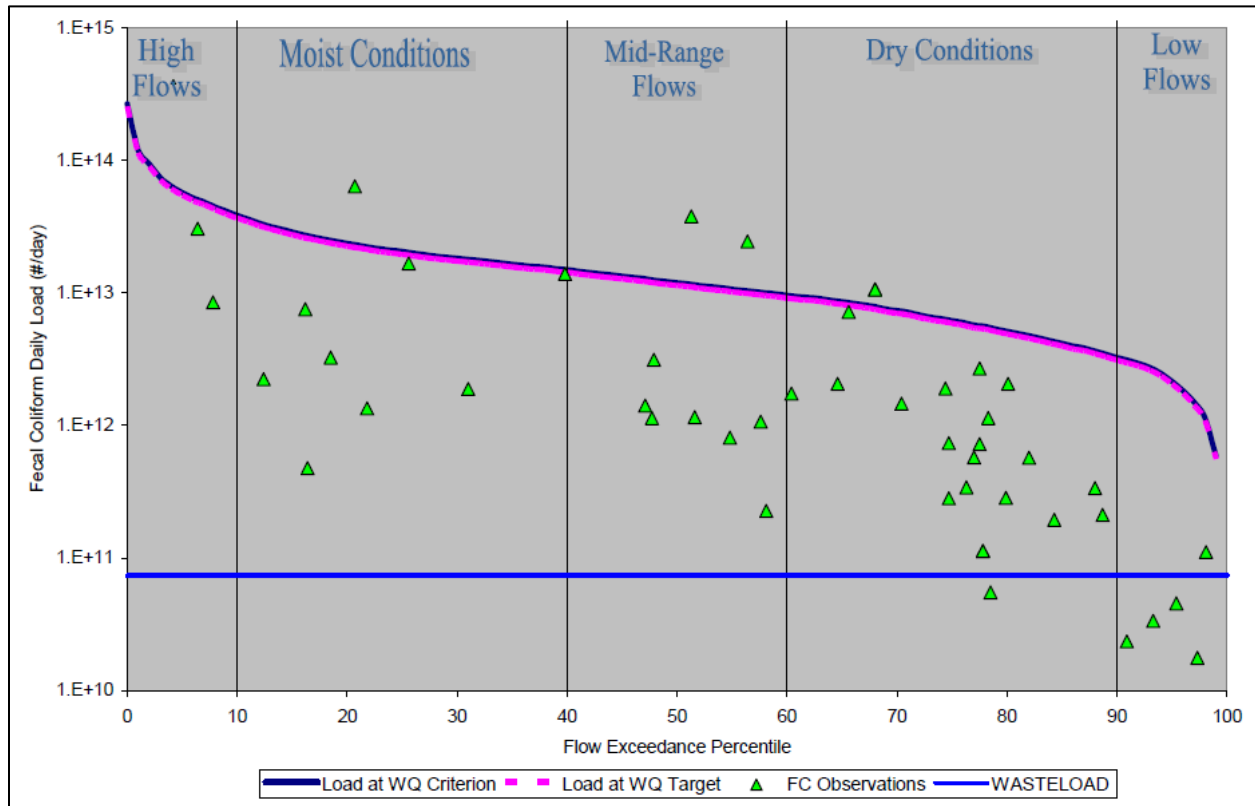
**Figure 4.12 Fecal Coliform Load Duration Curve 1994-2002, Station B-337 (Broad River)**

The TMDL document states that for WQM Station B-337 (Broad River), comparison of ambient fecal coliform data and NOAA precipitation data (46 data points) for the period examined (1994 and 2002) revealed four days in which the 3-day average rainfall exceeded 0.1 inches, and on those dates the fecal coliform measurements exceeded the WQS. There were two other exceedances; however, those occurred when there was no measurable rainfall recorded. This suggests that higher fecal coliform concentrations may be associated with wet weather conditions, but there are also sources affecting water quality during dry conditions.

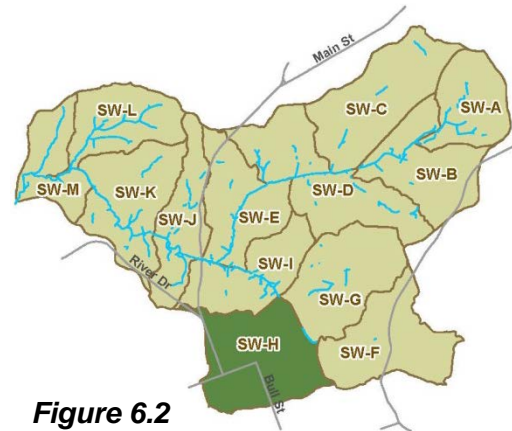
**Figure 6.2**  
**Subwatershed H**

- Subwatershed H (SW-H) is the southwestern-most subwatershed within the Smith Branch watershed.
- The northernmost boundary crosses River Drive and Bull Street/SC-277, the eastern boundary runs parallel and to the east of Gregg Street, Blanding Street to the south, and the western boundary is west of Main Street.
- 464 acres or 0.73 square miles in drainage area
- SW-H contains no open stream channel, and 10.60 miles of mapped storm drain/pipe
- Dominant land use designations (**Figure 6.1, Table 6.1**):
  - Developed, Medium Intensity: 44%
  - Developed, High Intensity: 25%
  - Developed, Low Intensity: 22%
- Impervious surface cover: 59%
