Rocky Branch Watershed Management Plan

# ROCKY BRANCH WATERSHED ASSESSMENT

McCormick Taylor Inc., supported by KCI Technologies, Inc., has been contracted by the City of Columbia, South Carolina to conduct an assessment of the Rocky Branch watershed to identify potential improvement opportunities to identify existing flooding and water quality conditions.

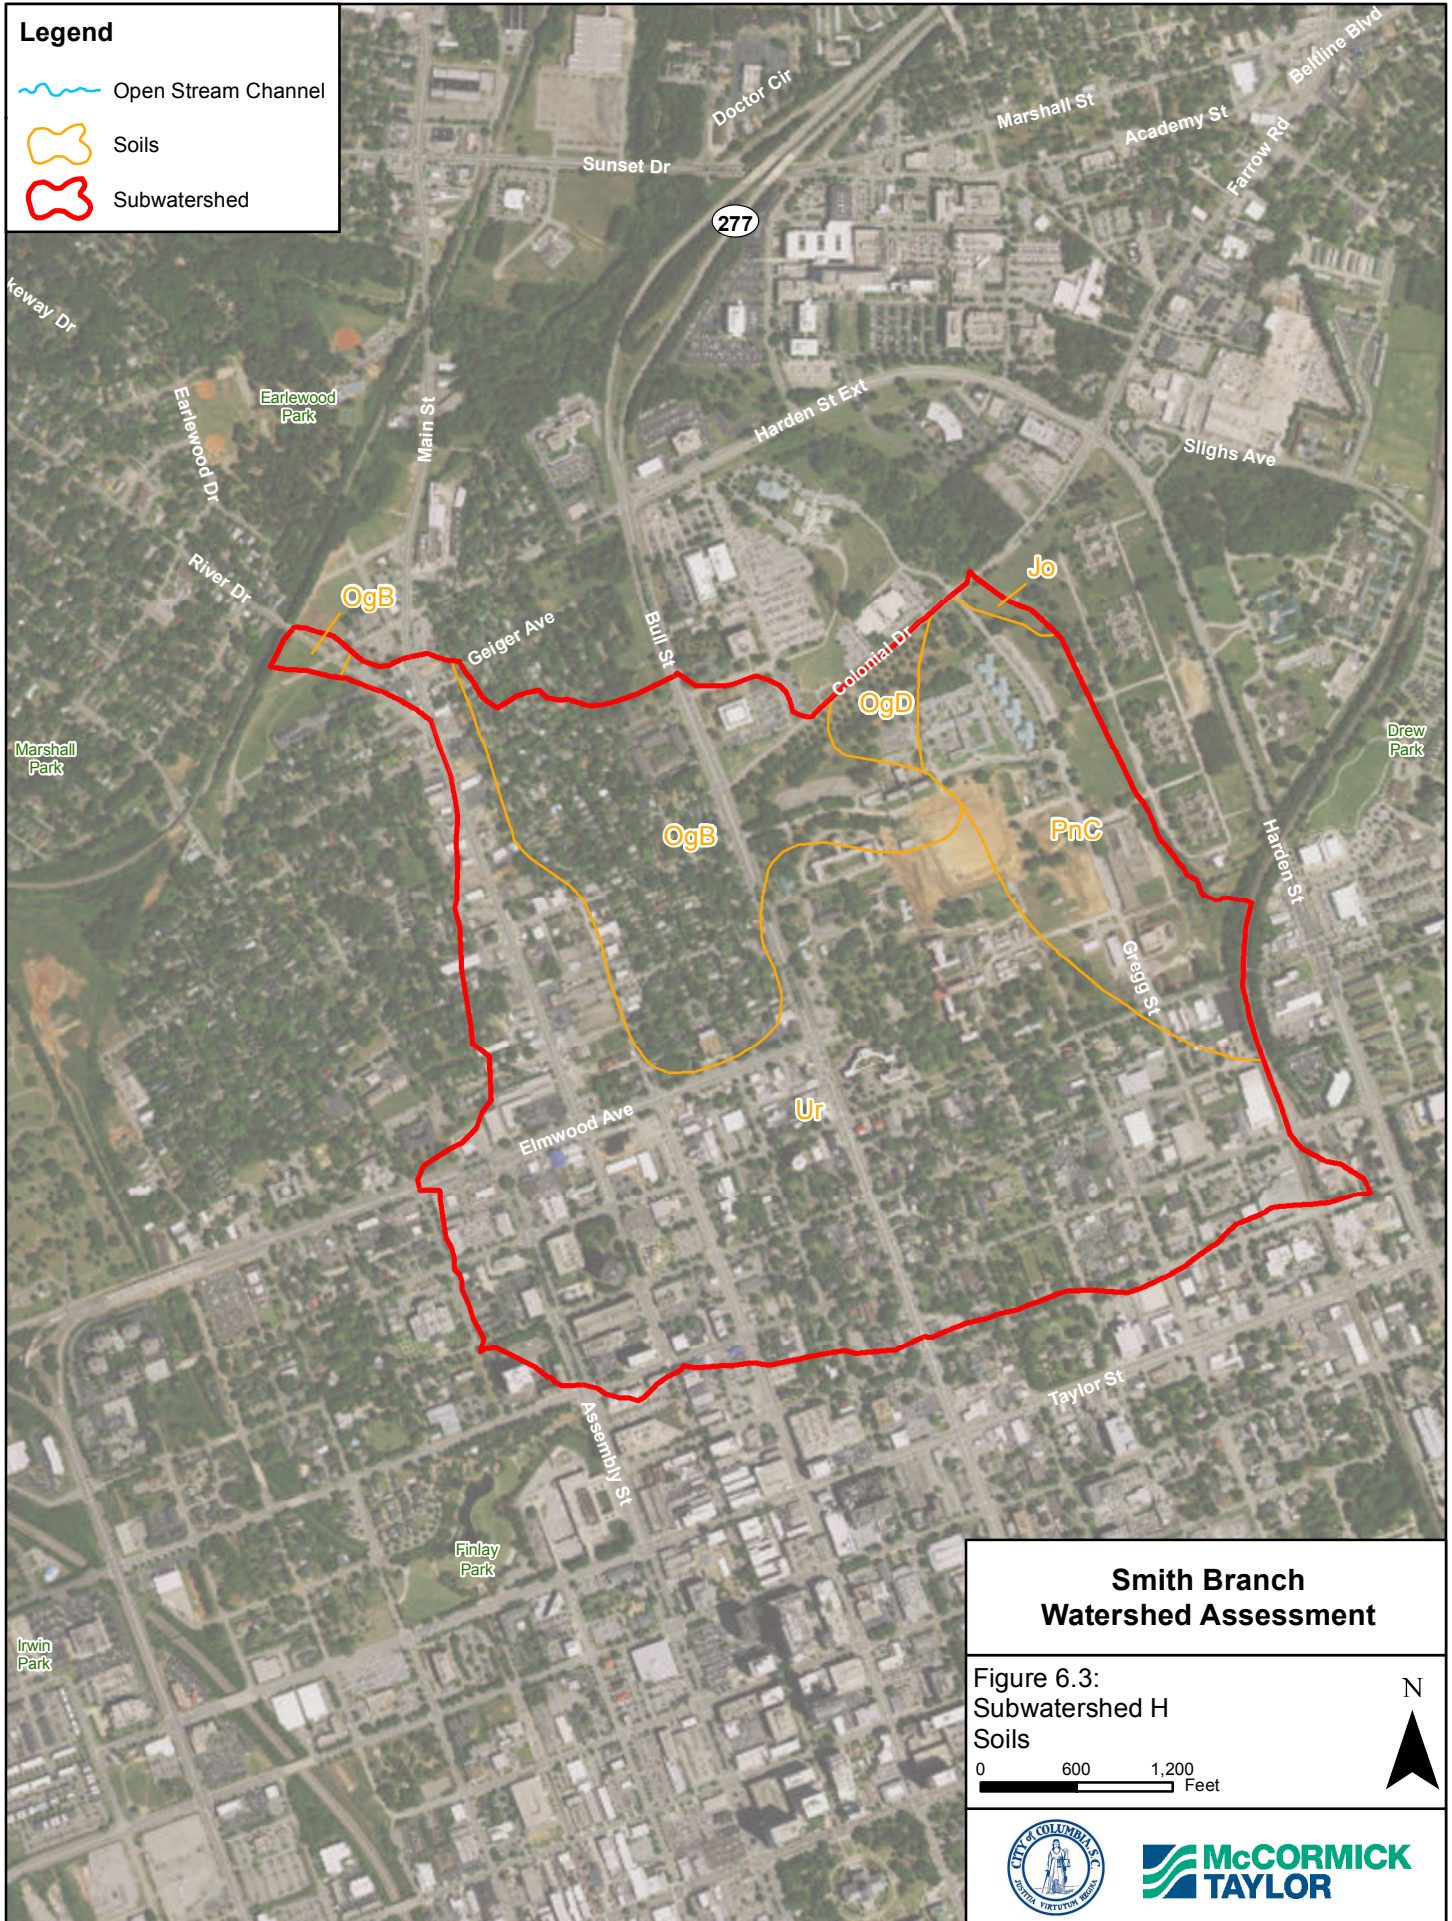
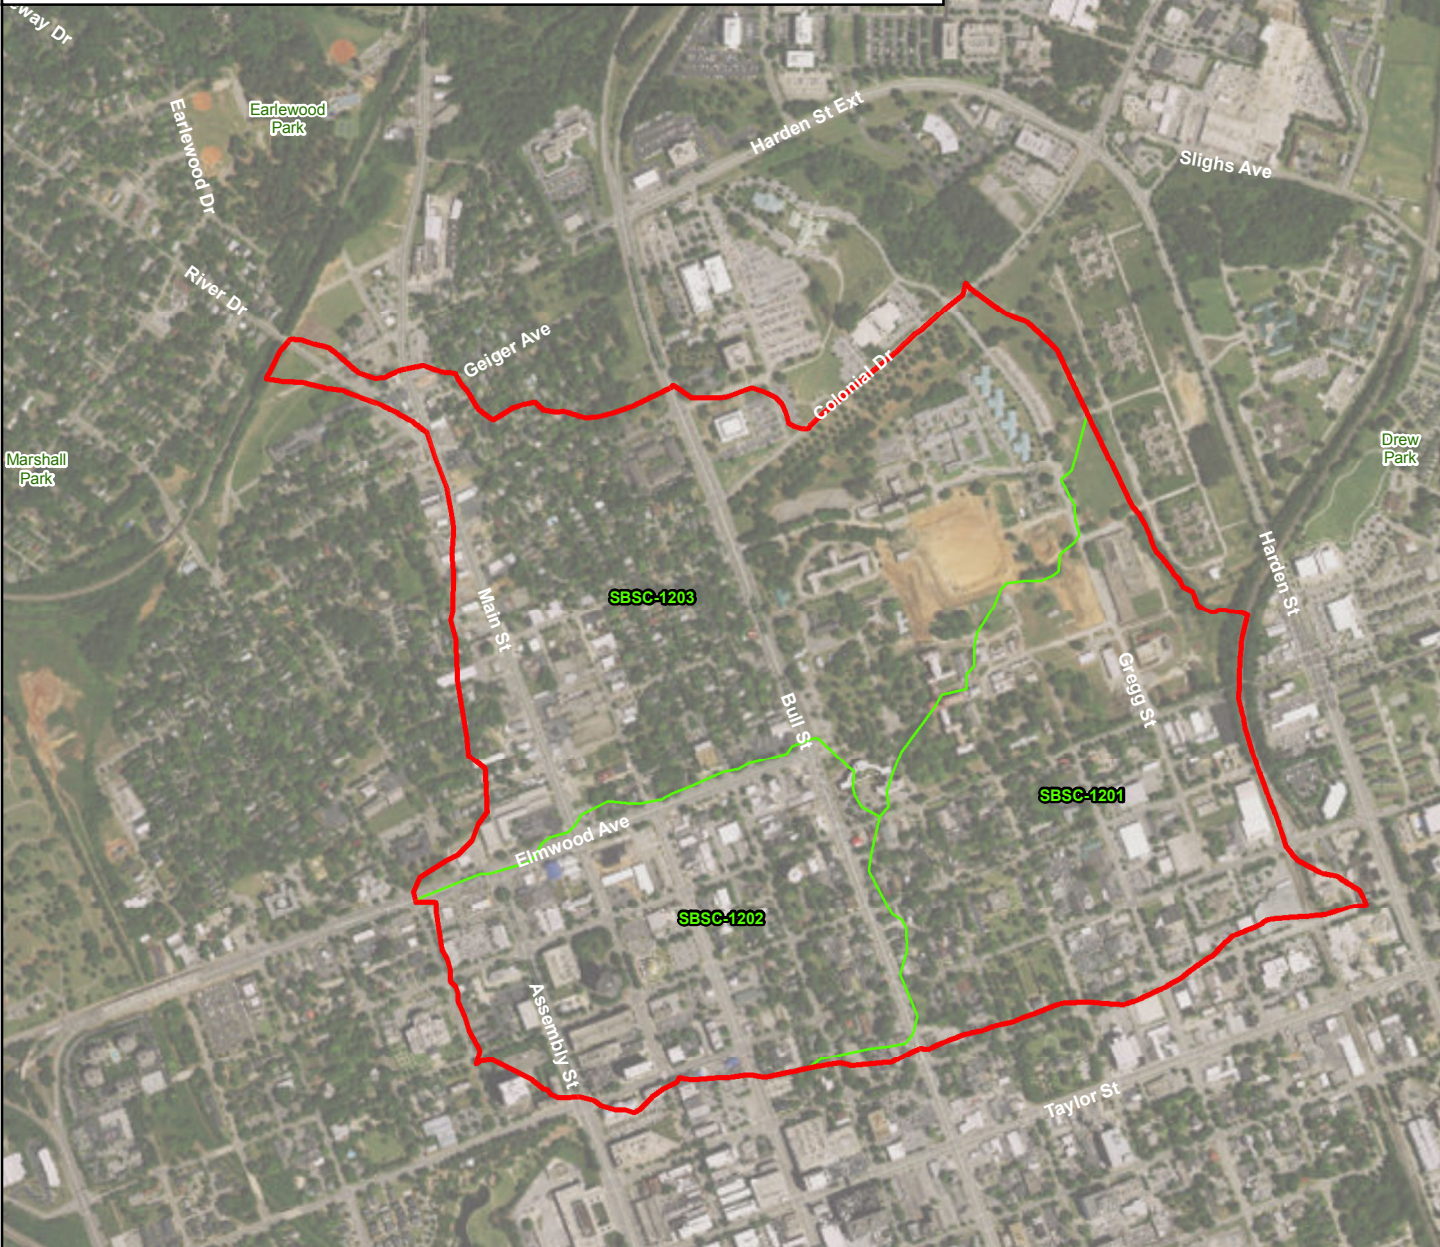
Figure 6.4:  
Subwatershed H  
Existing Conditions

**Figure 6.4** highlights existing conditions that were either captured during the stream cruising effort or developed using GIS data.

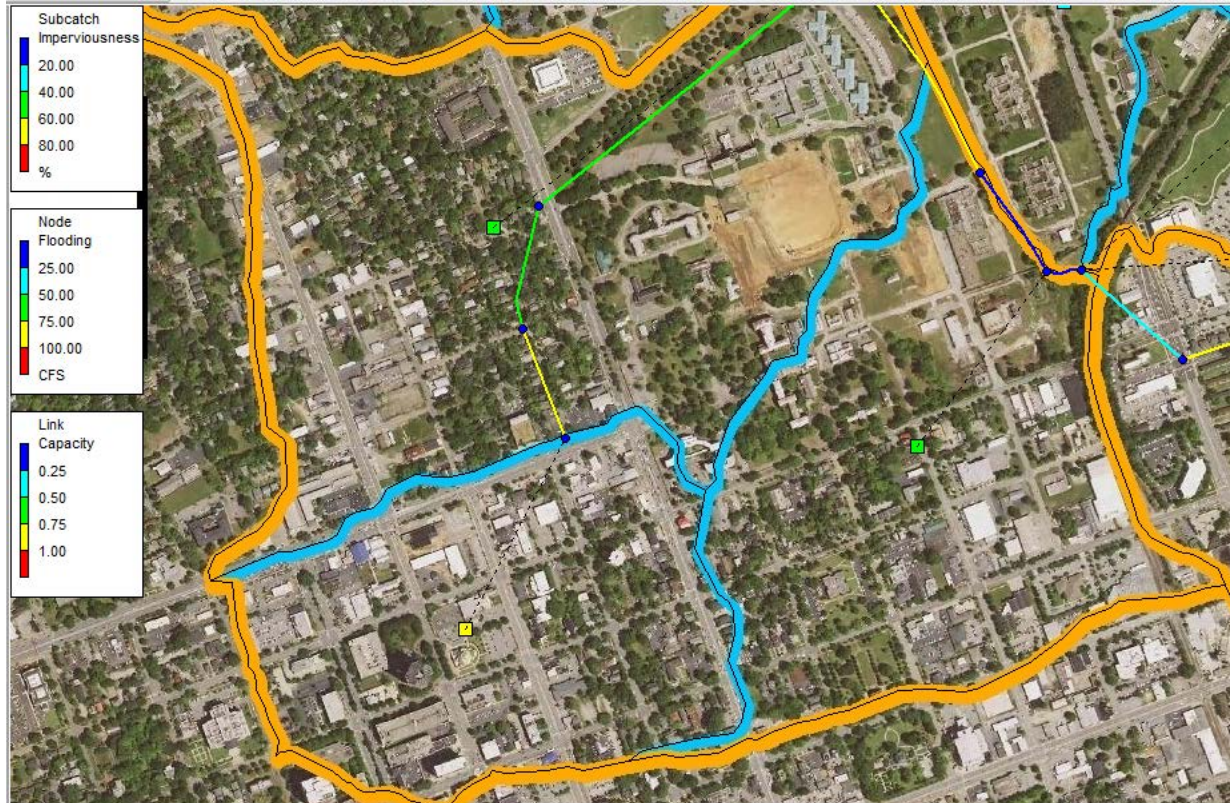
**Figure 6.5 SW-H SWMM Model**

SW-H is modeled as three subcatchments in SWMM, as shown in **Figure 6.5**. It is greater than 75% impervious in the southwestern catchment. According to the model, SW-H produces the most runoff per acre, and this runoff flows via concrete pipes directly to the headwaters of Smith Branch above Colonial Drive.

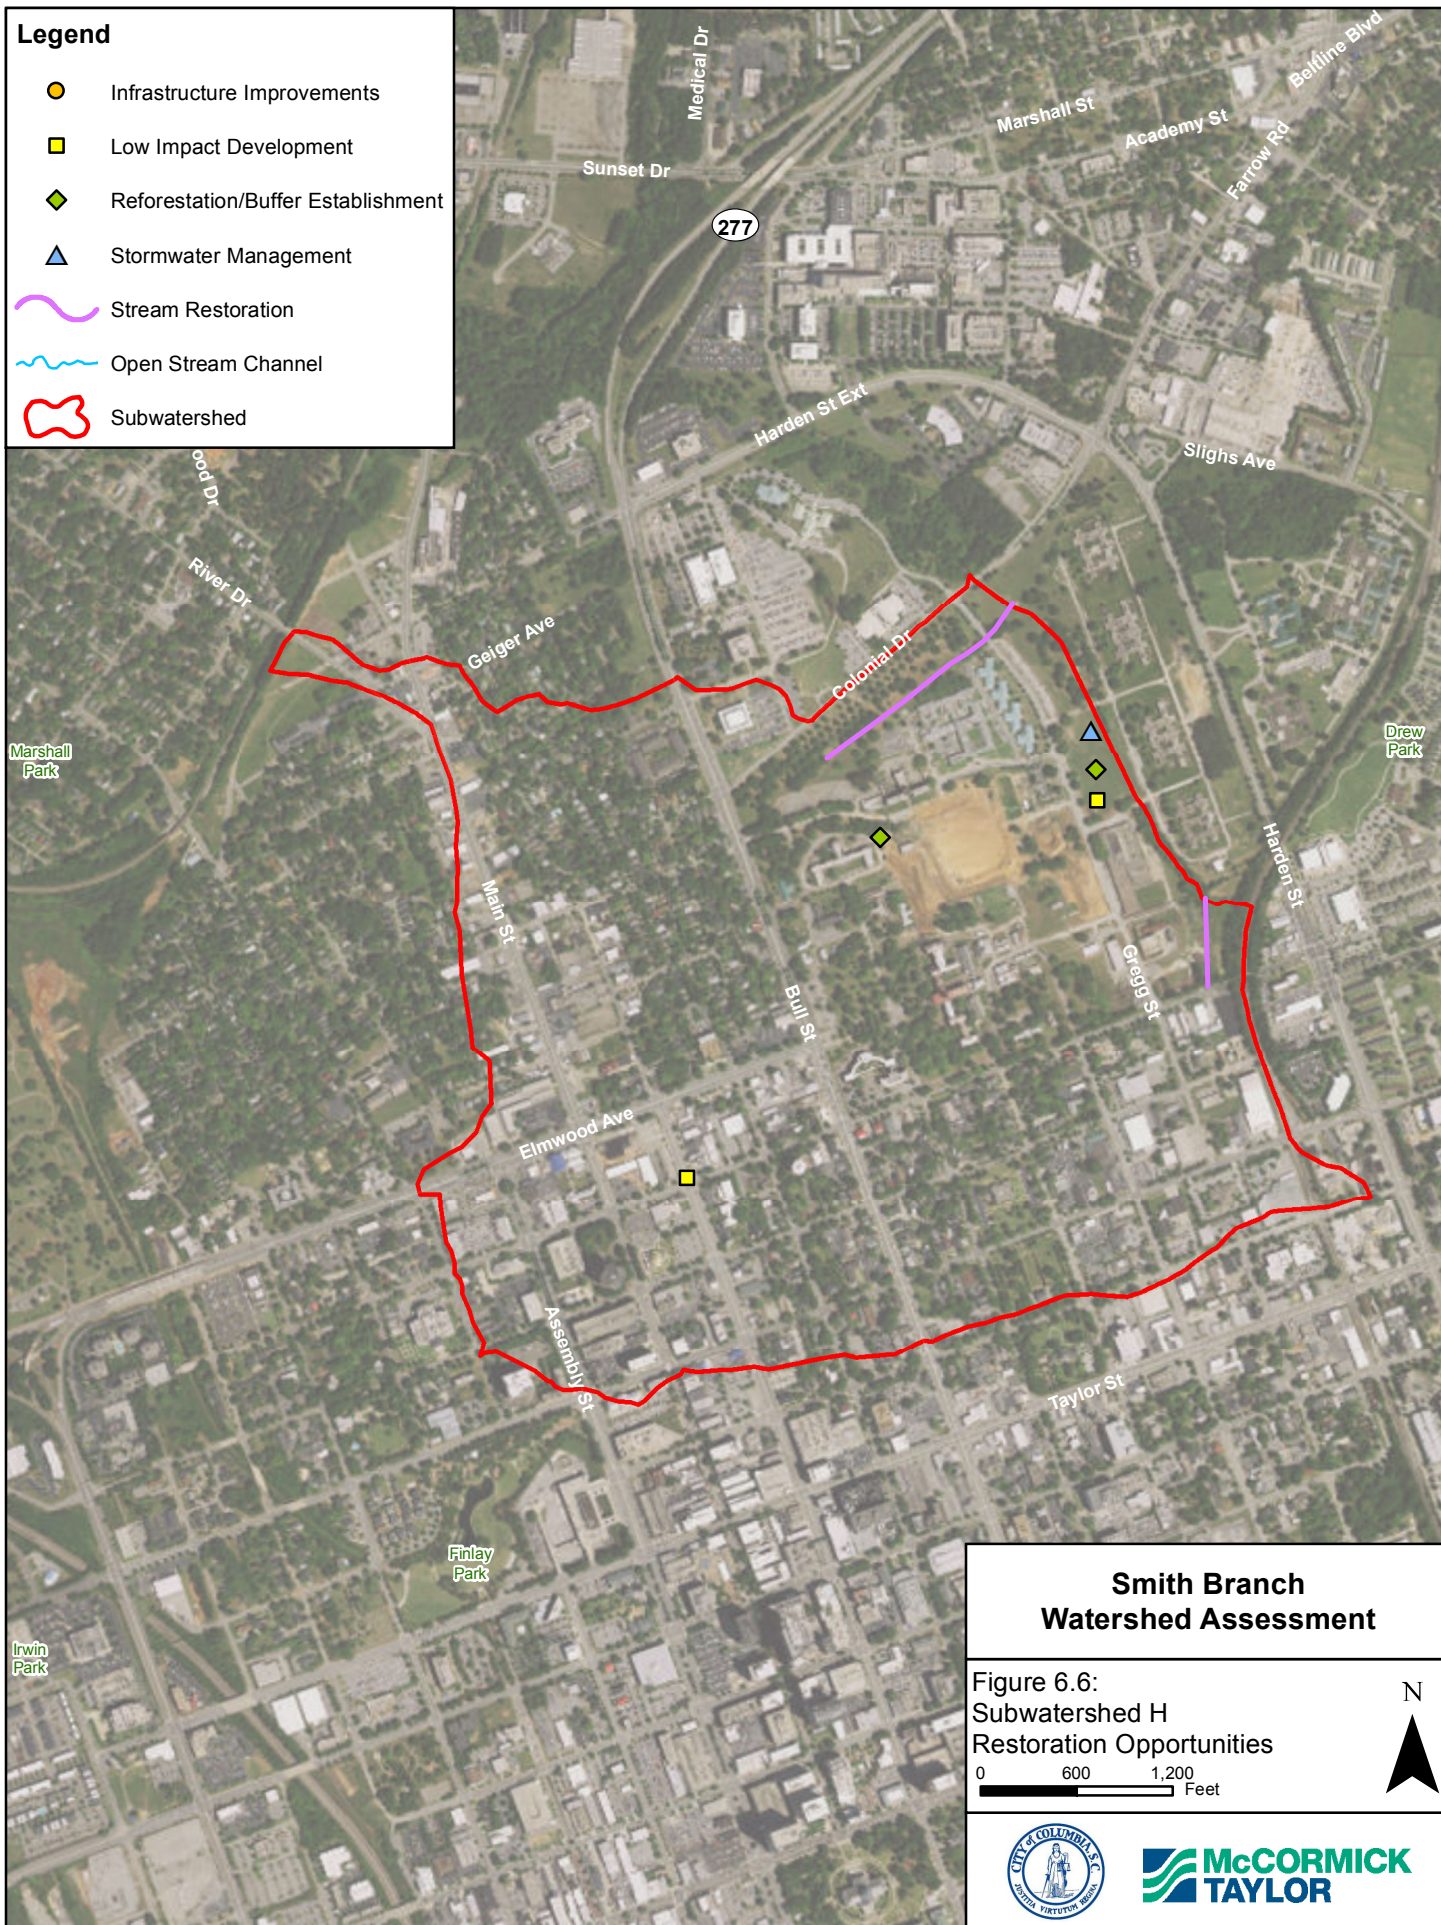
Figure 6.6:  
Subwatershed H  
Restoration Opportunities

The following projects or similar improvements may be considered to address conditions identified in SW-H. These projects are included in **Figure 6.6**.

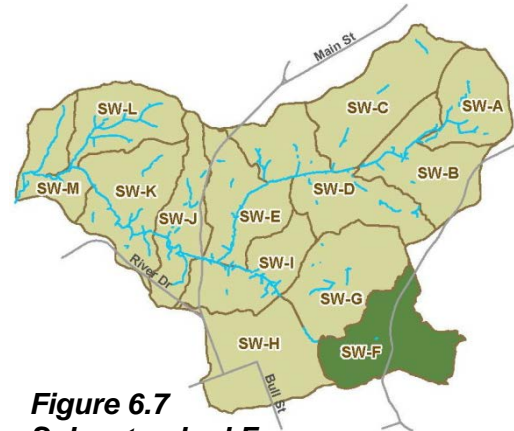
**Figure 6.7**  
**Subwatershed F**

- Subwatershed F (SW-F) is the southeastern-most subwatershed within the Smith Branch watershed.
- SW-F boundaries are roughly Taylor Street to the south, Harden Street to the west, Harrison Road to the north, and Devonshire Drive to the east.
- 400 acres or 0.63 square miles in drainage area
- Contains 0.20 miles of open stream channel, and 4.42 miles of mapped storm drain/pipe
- Dominant land use designations (**Figure 6.1, Table 6.1**):
  - Developed, Medium Intensity: 49%
  - Developed, Low Intensity: 28%
- Impervious surface cover: 54%

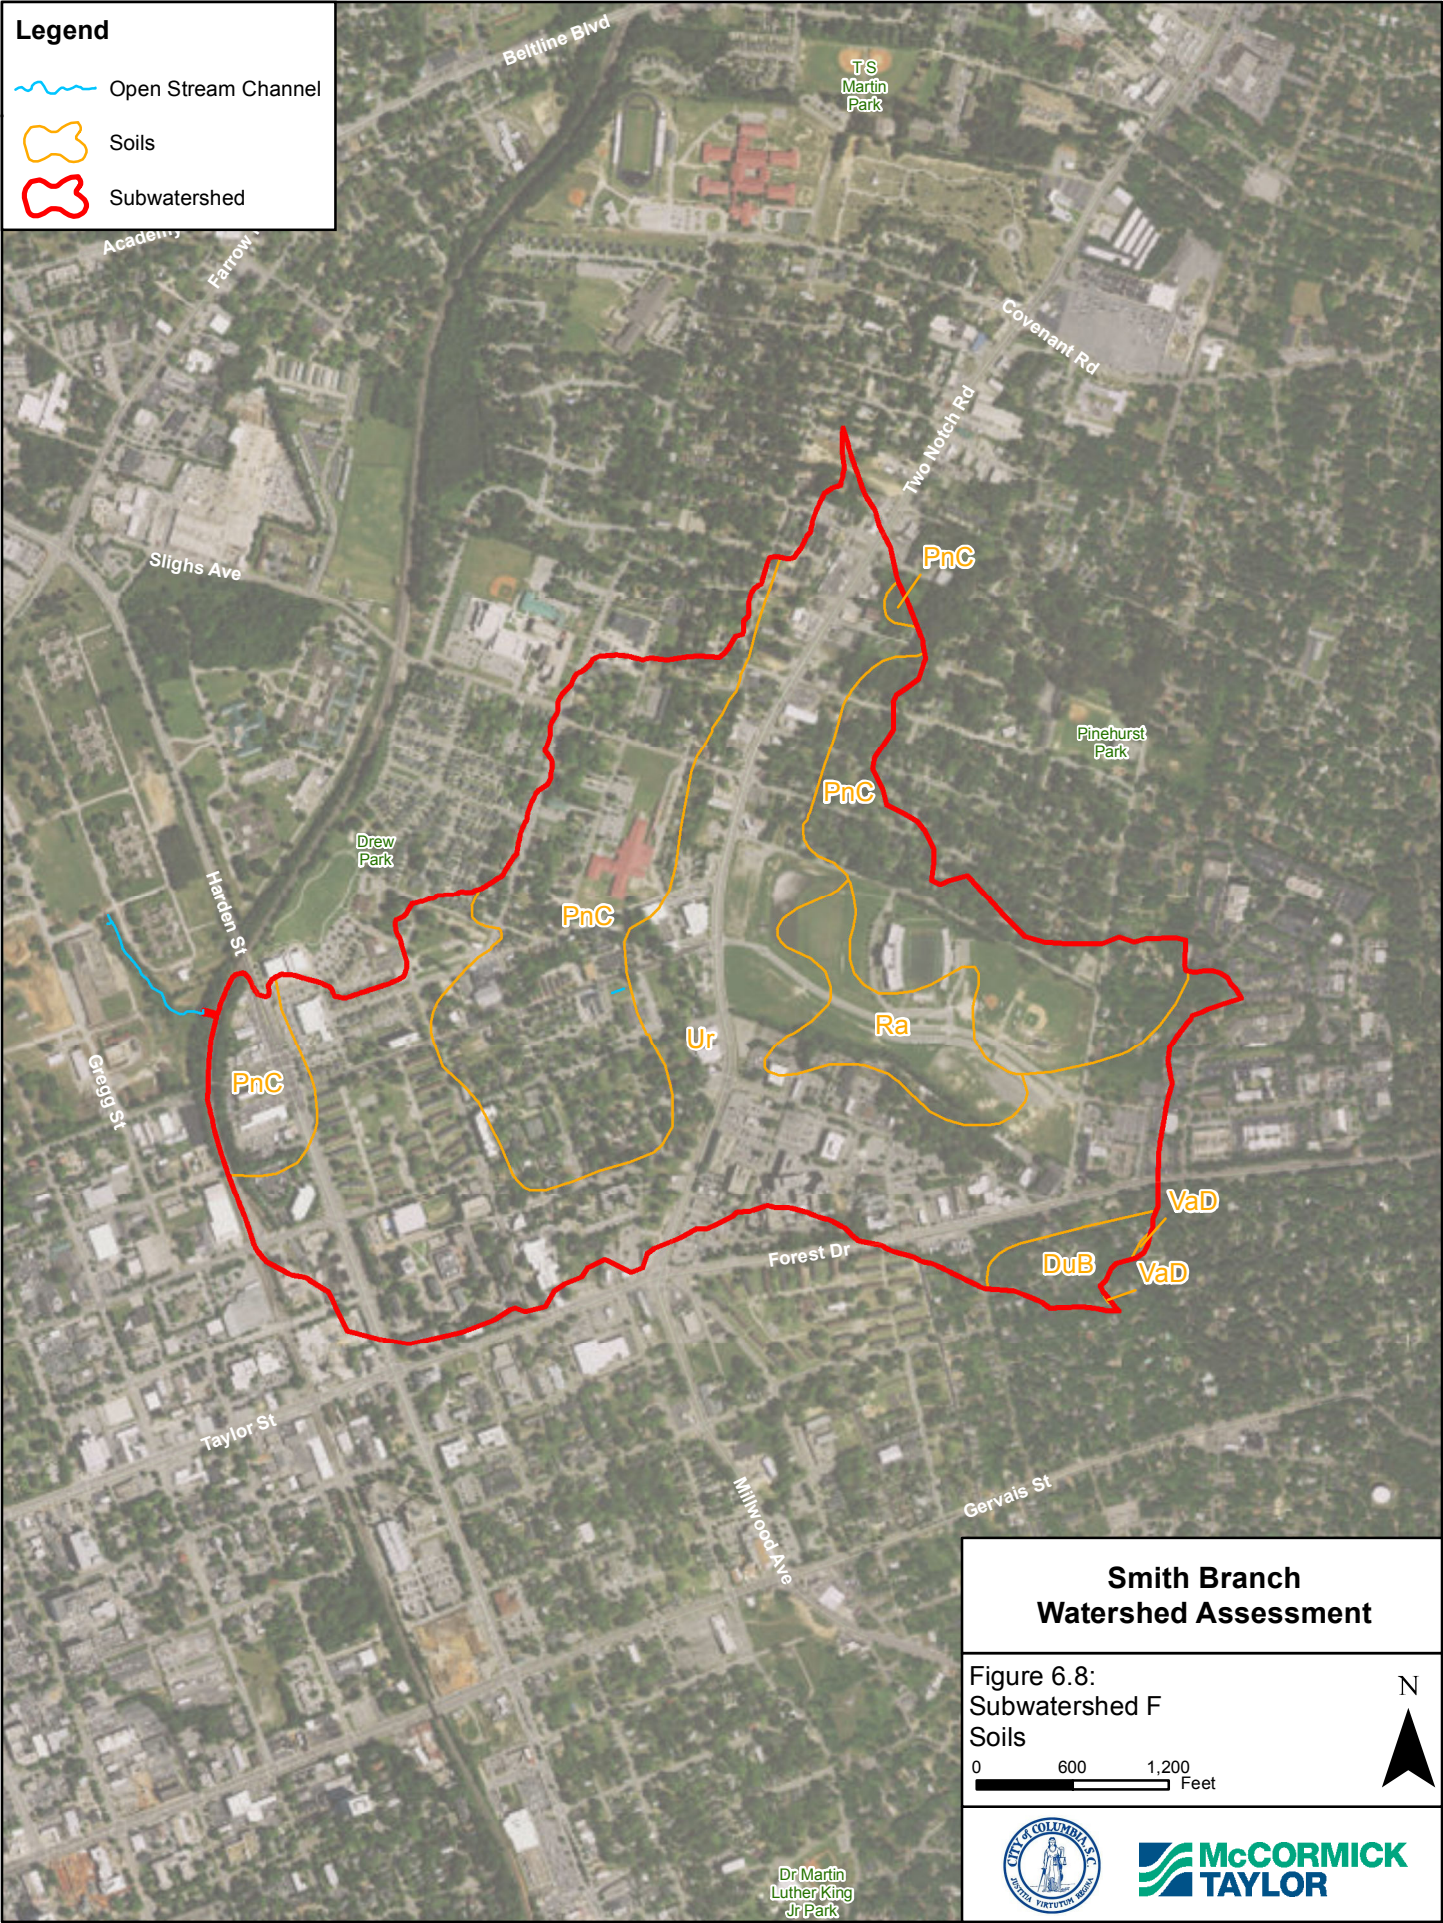
Figure 6.8:  
Subwatershed F  
Soils

**Soils:** Approximate soil type percentages within SW-F include (refer to **Section 3.4** for soil descriptions and **Figure 6.8** for soil distributions):

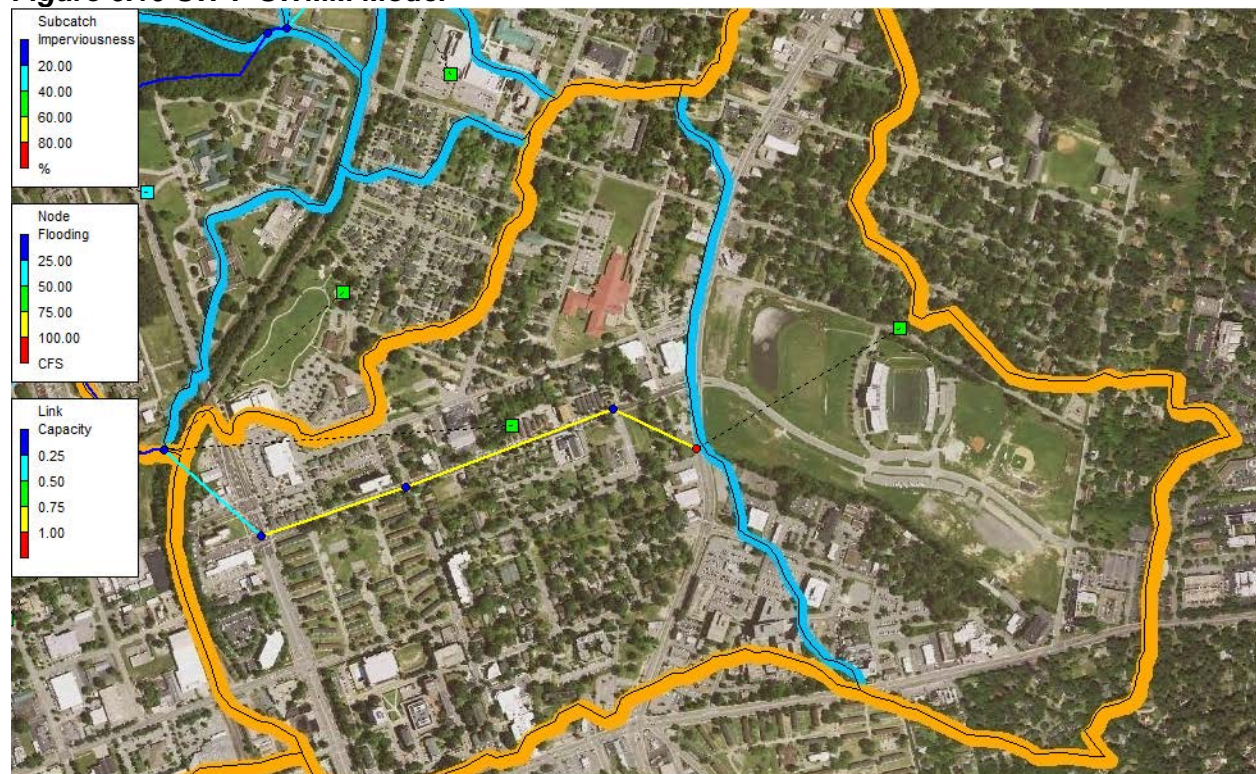
**Figure 6.10 SW-F SWMM Model**

SW-F is modeled as two subcatchments in SWMM. Concentrations of impervious commercial area can be seen at the downstream end of the watershed. The subcatchments are 58% and 48% impervious, respectively, and there is a main pipe conduit that drains both of the subcatchments that is modeled at greater than 75% capacity for the 2-year event (see mapped yellow line in **Figure 6.10**). SW-F sends flows directly to the large culverts below Preston Drive.

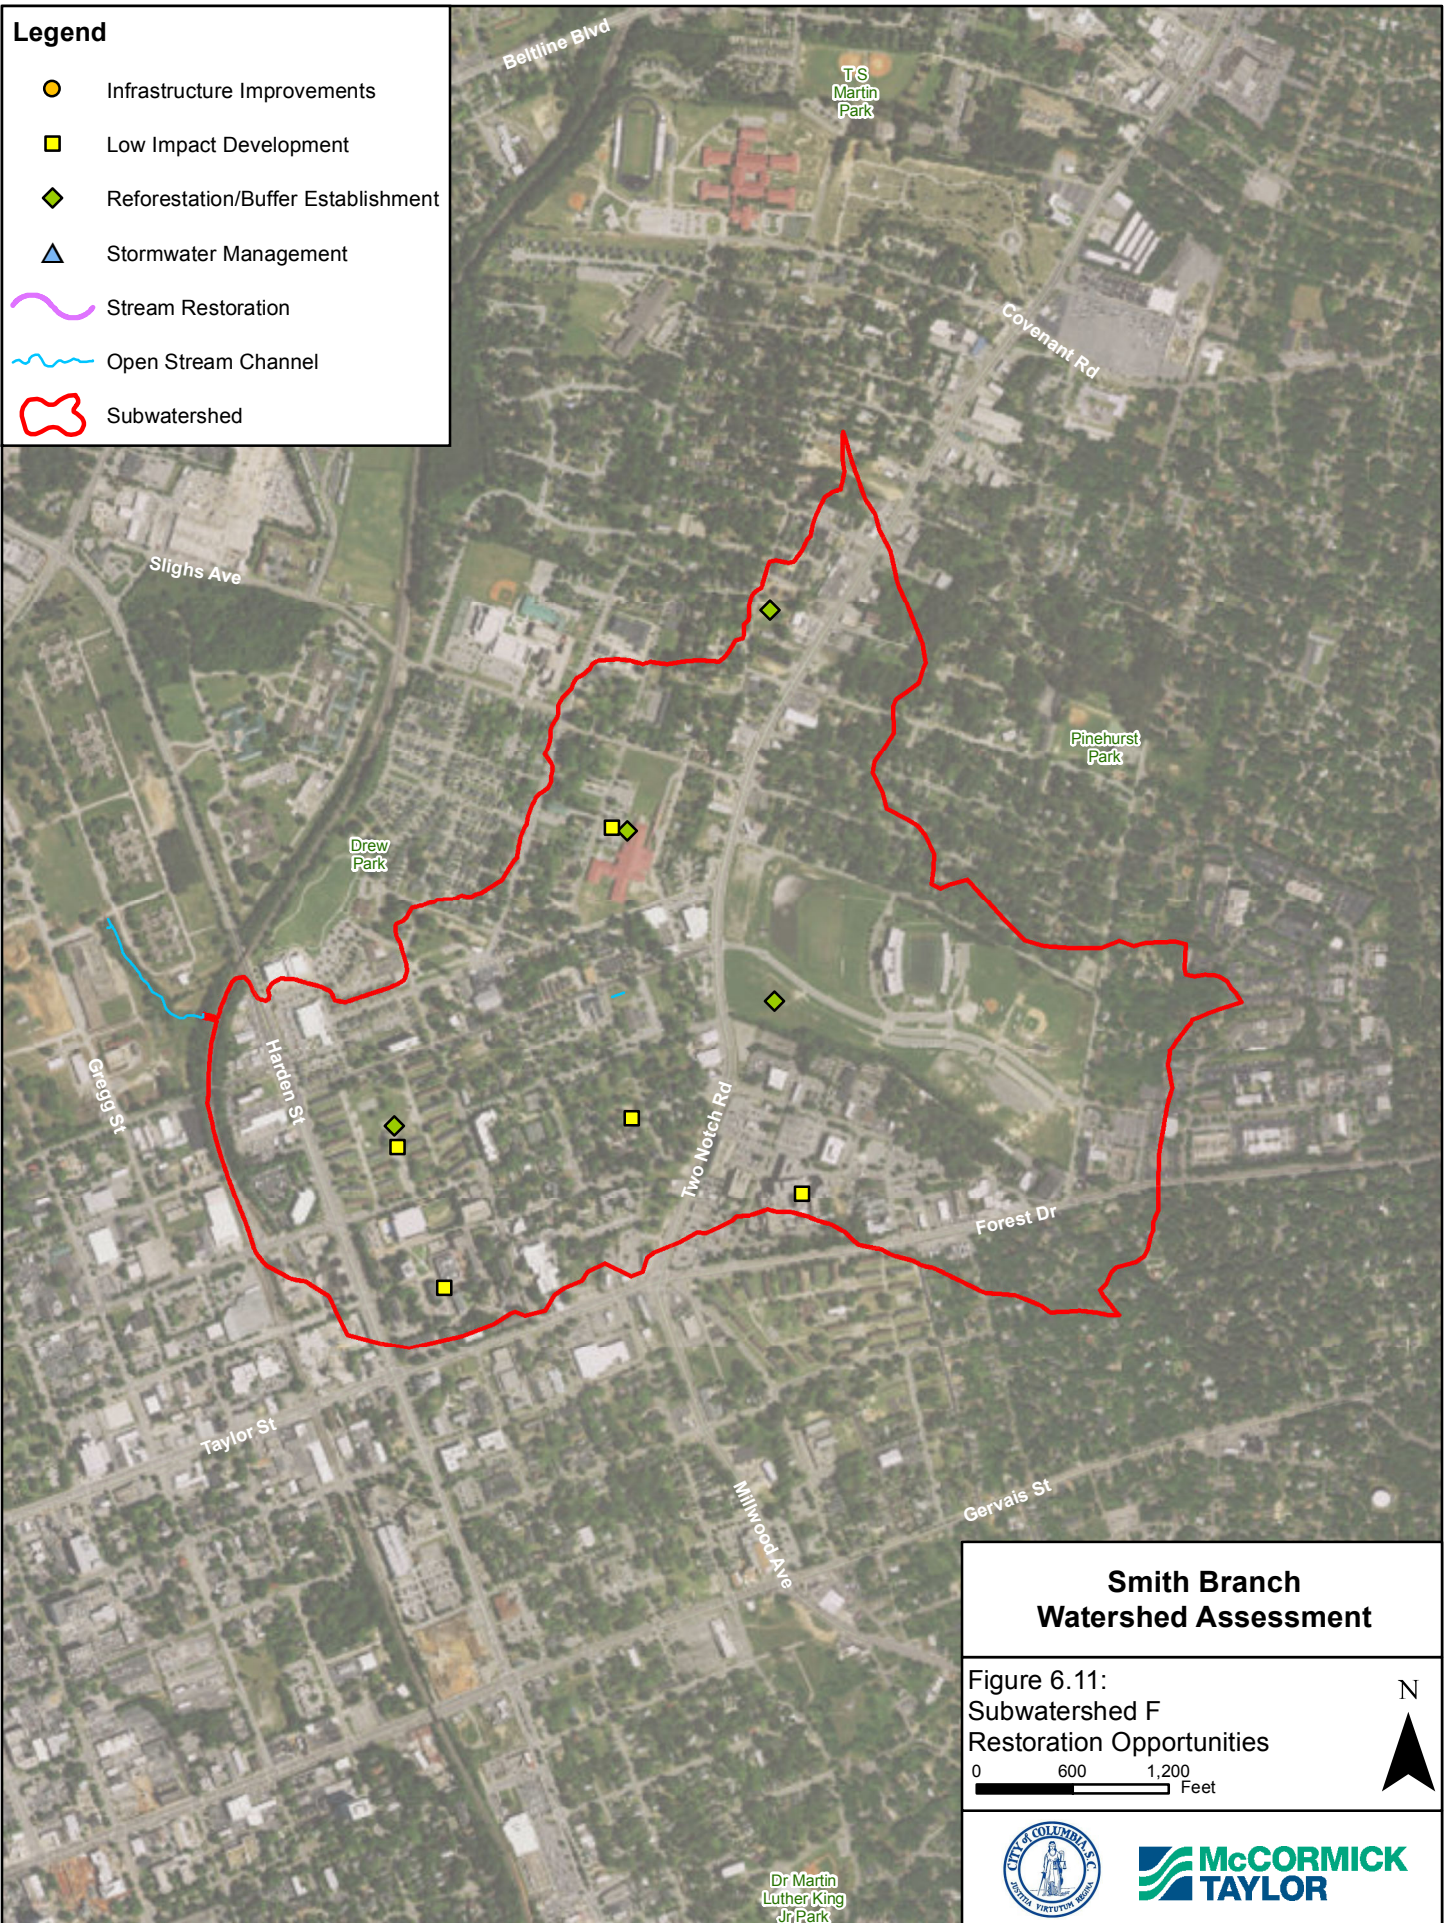
Figure 6.11:  
Subwatershed F  
Restoration Opportunities

The following projects or similar improvements may be considered to address conditions identified in SW-F. These projects are included in **Figure 6.11**.

- Opportunities for infiltration and storage should be investigated here to reduce peaks downstream.
  - Plant trees where feasible in the Benedict College Athletic Facility, Carver-Lyon Elementary School, Allen Benedict Court Complex and east of the Gordon Street and Waites Road intersection.
  - Install BMPs for parking lot at Providence Hospital, Carver Lyon Elementary School, and Benedict College.
  - Apply green streets template to reduce runoff at Allen Benedict Court, Benedict College and at the development east of Benedict College.
- As this catchment continues to develop, the development should occur in accordance with the City of Columbia BMP Manual, particularly Sections 1.2.1 and 1.2.3.
- Further division and modeling of these catchments will help to locate the areas with the most constrained infrastructure and areas where improvements will yield the most benefit.

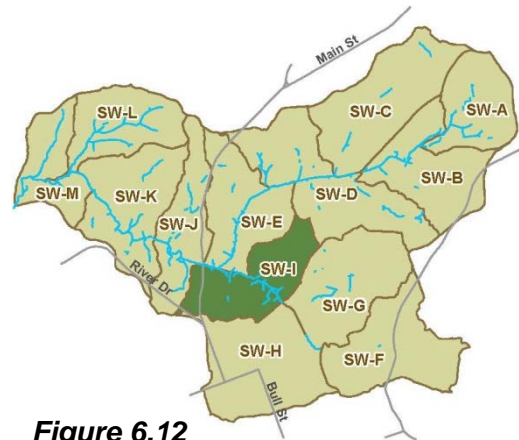
**Figure 6.12**  
**Subwatershed I**

- Subwatershed I (SW-I) is within the south central portion of the Smith Branch watershed.
- The eastern boundary of SW-I runs along Colonial Drive/Farrow Road, extends north towards SC-277, then south around the Palmetto Health - Richland Medical Park, west to Earlewood Park, then south to River Drive.
- 309 acres or 0.48 square miles in drainage area
- Contains 1.5 miles of open stream channel, and 4.0 miles of mapped storm drain/pipe
- Dominant land use designations (**Figure 6.1, Table 6.1**):
  - Developed, Medium Intensity: 38%
  - Developed, Low Intensity: 24%
- Impervious surface cover: 47%

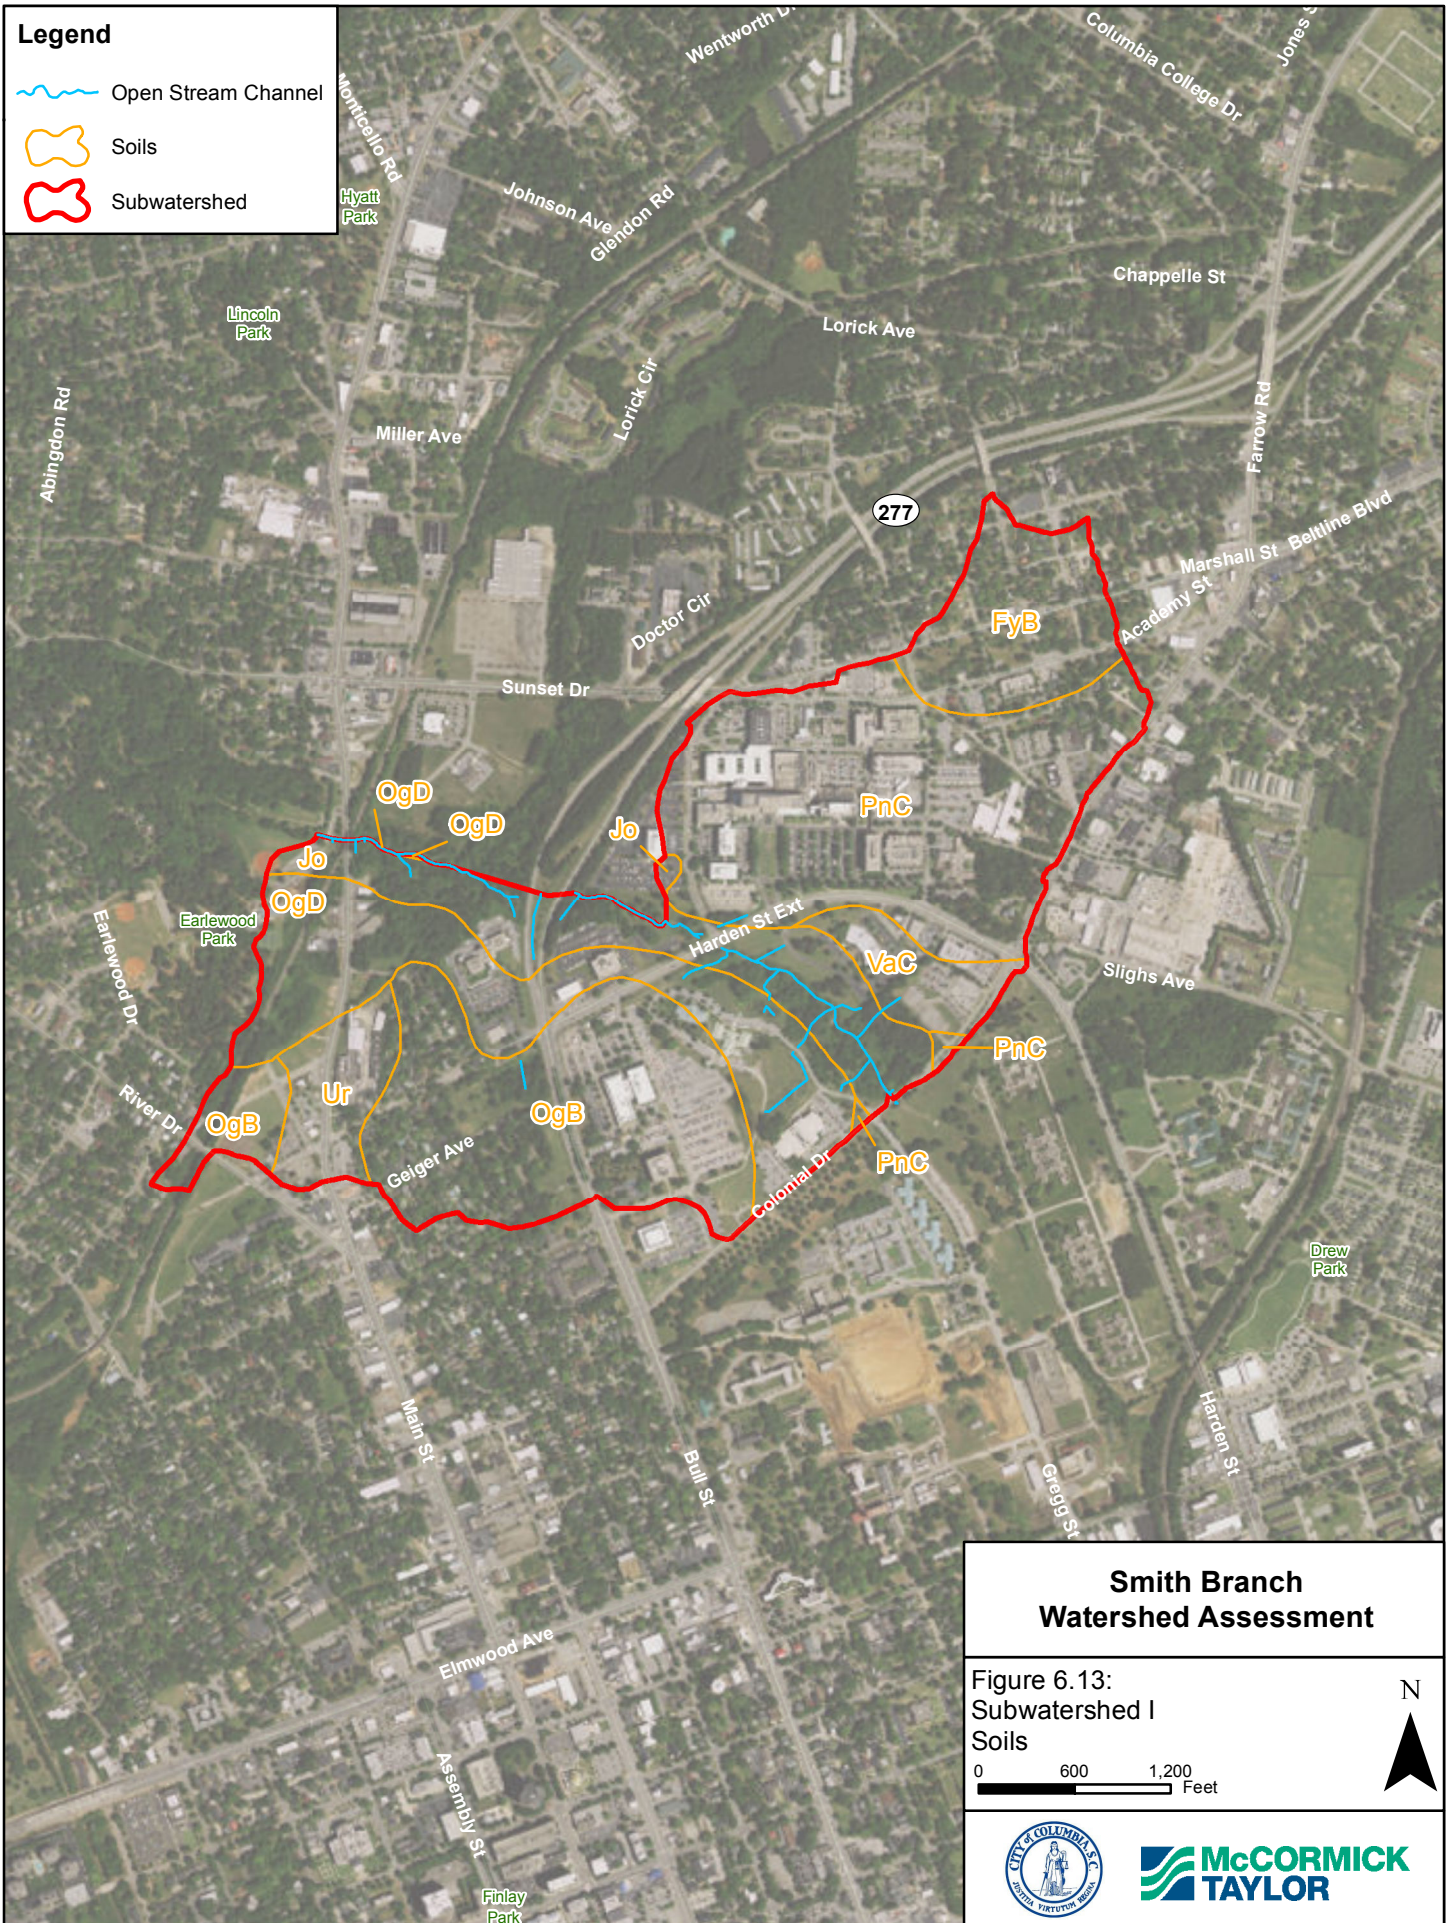
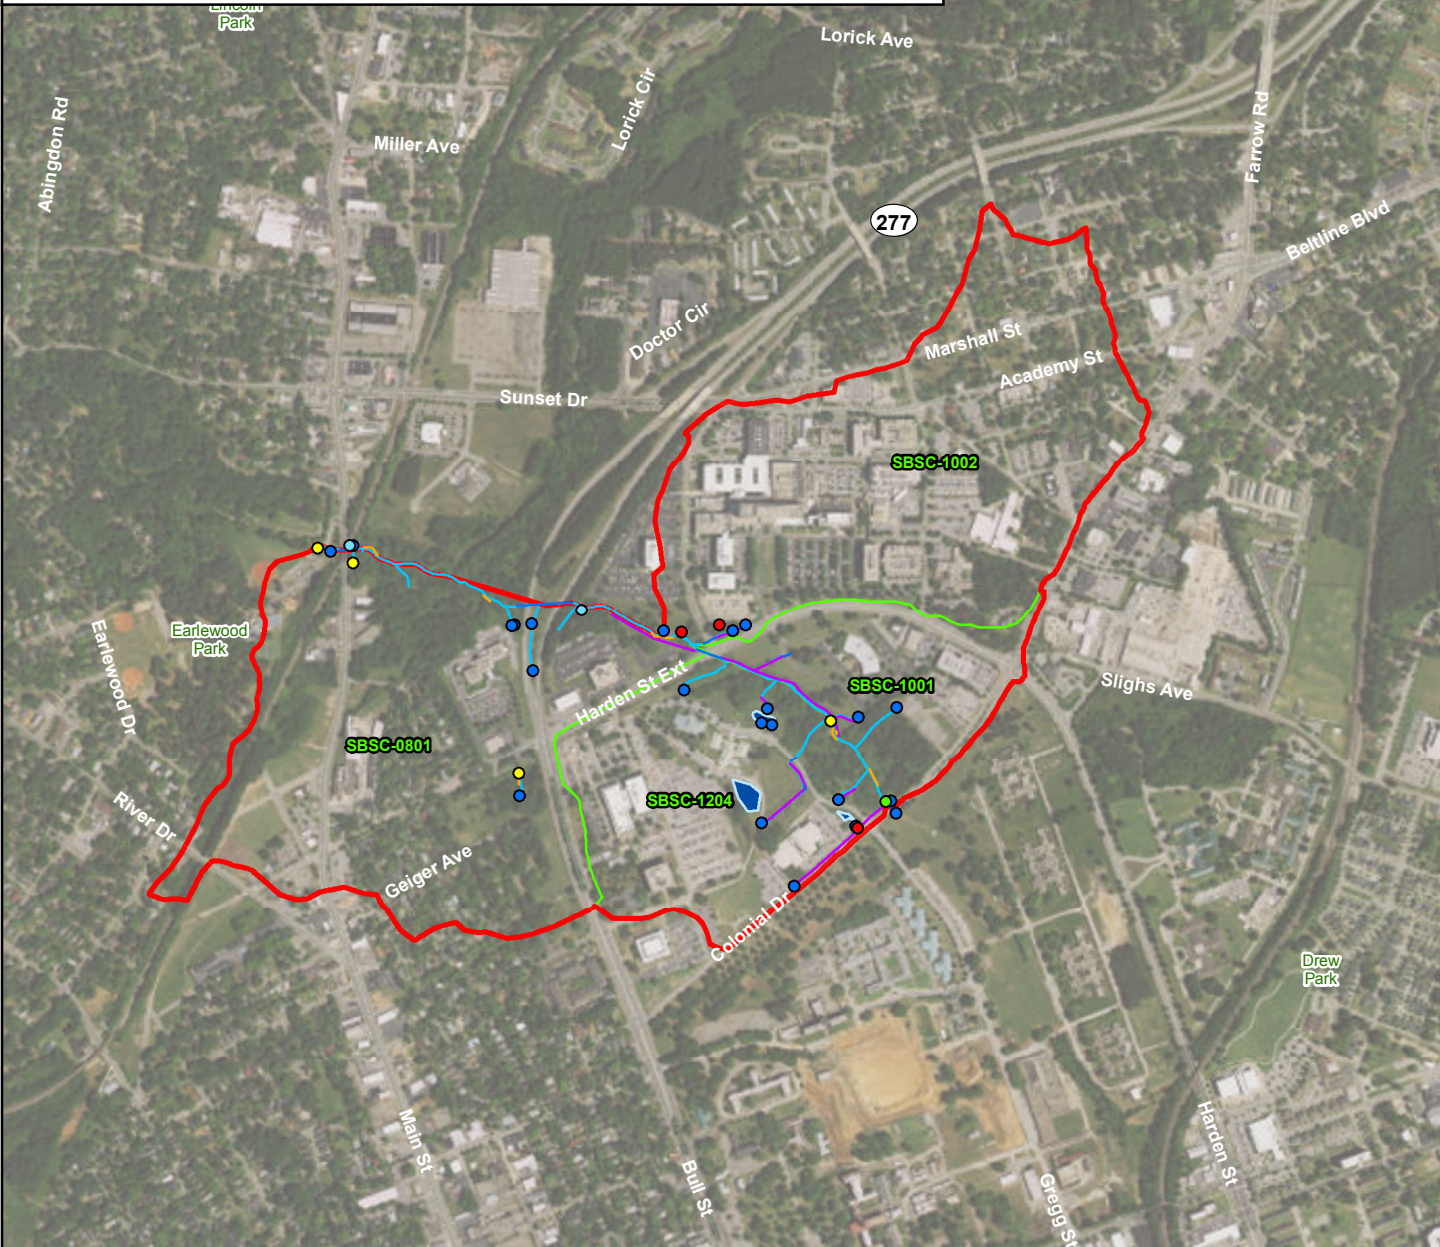
Figure 6.14:  
Subwatershed I  
Existing Conditions

**Figure 6.14** highlights existing conditions that were either captured during the stream cruising effort or developed using GIS data.

Existing Condition	Count
Exposed Pipes	2
Pipe Outfalls	22
Unmanaged Runoff	3
Unusual Condition	4
Trash Dumping	0
Possible Fish Barrier	1
	<b>Linear Feet</b>
Erosion Site	664
Channel Alteration	885
Inadequate Forest Buffer	6,795

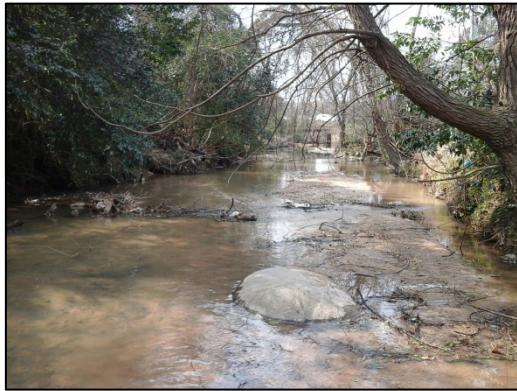
Within SW-I, the upstream extent of the mainstem of Smith Branch flows from a 10 foot wide by 10 foot tall double box culvert beneath Colonial Drive. There is a 30 inch baseflow water surface drop off at the end of the culvert apron and a deep scour pool immediately downstream. The floodplain and top of bank is heavily vegetated with thick underbrush and the 12-foot banks are relatively stable, with isolated areas of erosion. A beaver dam creates a significant backwater 650 feet downstream of the Colonial Drive culvert. Downstream of the beaver dam, the stream is shallow, with depositional midchannel and point bars. Substrate within this segment of stream is predominantly sand, with gravel, cobble, and boulder along the riffles. Riprap stabilizes the right bank and thick vegetation covers the left bank face as Smith Branch approaches the Harden Street Extension.

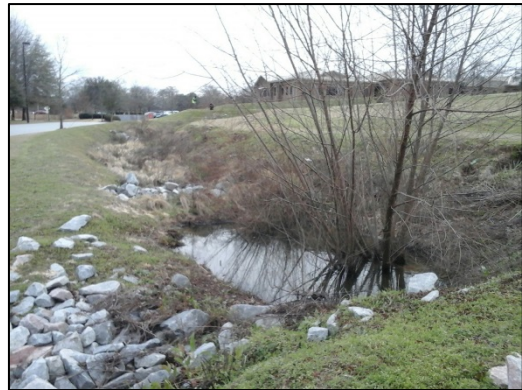
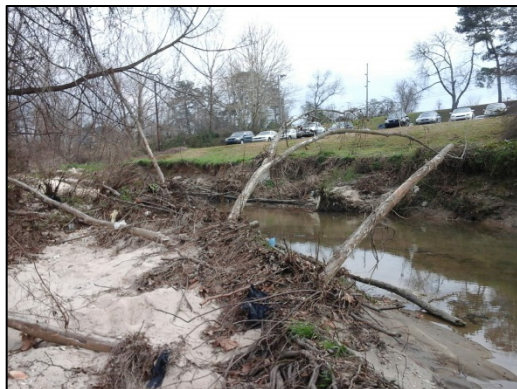
There are seven small tributaries that flow into the mainstem south (upstream) of the Harden Street Extension. Most were contributing little to no flow during the stream cruising effort. Four originate within the DHEC complex, west of the mainstem, three of which are outfalls associated with nearby stormwater facilities. The most significant tributary begins at an outfall adjacent to parking lots of the DHEC and the SC Department of Social Services buildings and may be connected to an existing stormwater facility but City GIS storm drains are discontinuous in this area. The outfall closest to the Harden Street Extension on the southwest side discharges into a wet swale with thick shrub growth and joins the mainstem from the left bank. East of the mainstem, one outfall with no recent evidence of discharge originates from the Child Support Enforcement building parking lot. The remaining two outfalls drain from the SC Department of Disabilities and Special Needs (DDSN) building entrance road and parking lot.

The Smith Branch mainstem flows west through the double box culvert underneath the Harden Street Extension. Infrastructure encroachment, excessive sediment deposition, and poor buffer management practices (mowed to top of bank) have resulted in bank instability and observed block failures extending 150 feet along the left bank, downstream (north) of the Harden Street Extension. Downstream, the banks are more heavily vegetated and stable. Two small tributaries contribute flow into this mainstem segment. The upstream tributary runs parallel to the Harden

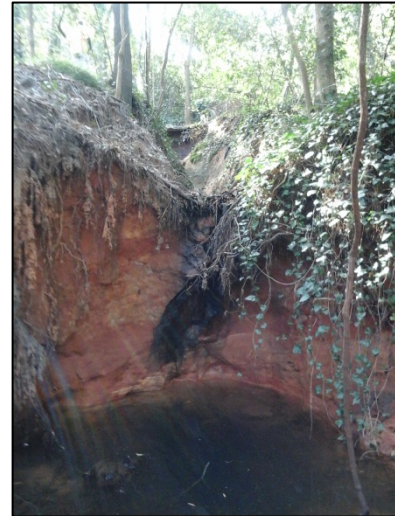
Immediately downstream of the SC-277 culvert, a segmented tributary drains into the mainstem. The upstream extent of this tributary begins northeast of Geiger Avenue at an 18 inch RCP outfall. A 20-foot tall headcut has formed downstream of the outfall, scouring the banks. The stream is open channel for 160 feet before being piped approximately 930 feet downstream, emerging from a 52 inch CMP and flowing into the mainstem. Multiple branches of mapped storm drain connect into this tributary, explaining the increased size of outfall at the downstream end. Instability was noted at the 52 inch CMP outfall and is discussed further below.

Downstream of SC-277, the Smith Branch mainstem flows through a forested parcel, with vegetated, stable banks and large points bars. Bay Branch joins the mainstem 260 feet downstream of the SC-277 culvert. Bank erosion and lateral migration threatens a utility right of way and manhole stack upstream of Main Street. The stream then flows through a 12 foot tall, 16 foot wide culvert under Main Street. Downstream of Main Street, Smith Branch enters Earlewood Park and is confined within brick and mortar walls for 70 feet, extending to the downstream side of the Parkside Drive bridge. The downstream boundary of SW-I crosses the mainstem at this point and Smith Branch continues to flow downstream through SW-J.
