Rocky Branch Watershed Management Plan

# ROCKY BRANCH WATERSHED ASSESSMENT

McCormick Taylor Inc., supported by KCI Technologies, Inc., has been contracted by the City of Columbia, South Carolina to conduct an assessment of the Rocky Branch watershed to identify potential improvement opportunities to identify existing flooding and water quality conditions.

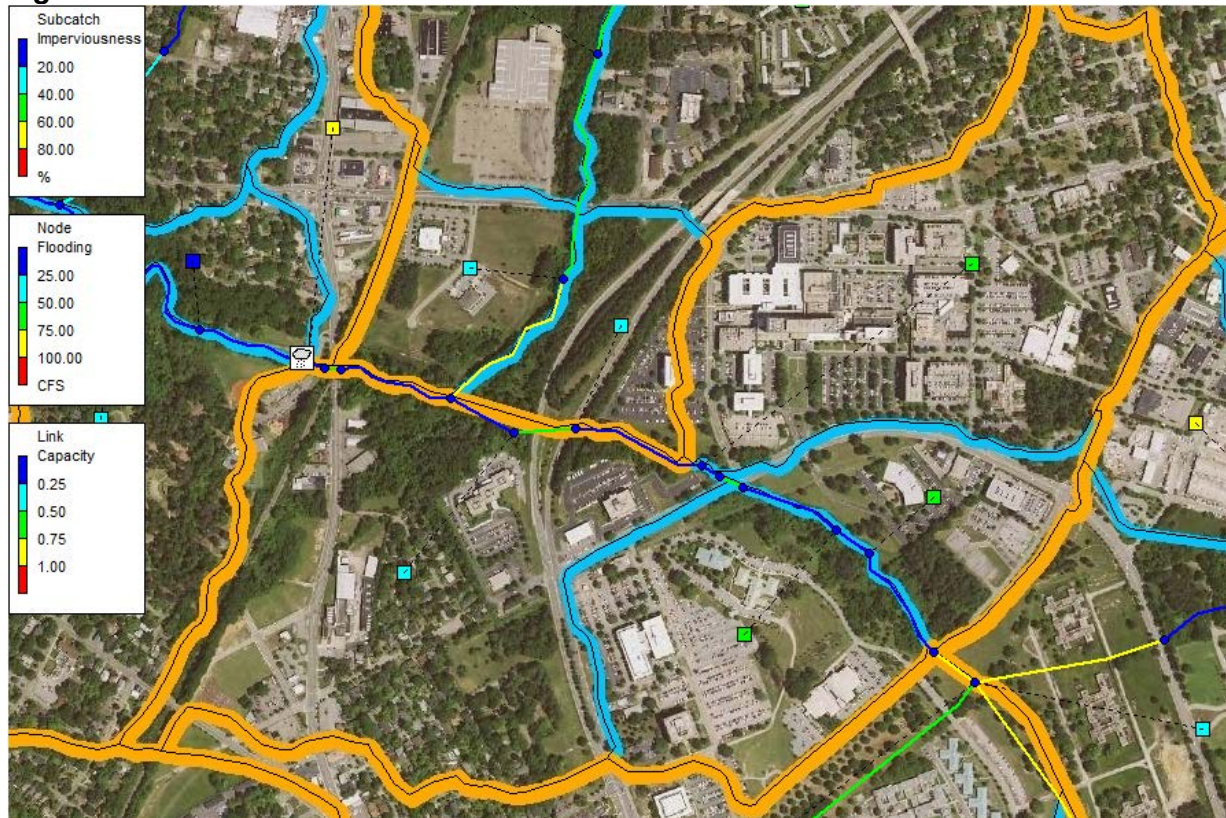
**Figure 6.15 SW-I SWMM Model**

SW-I is modeled as four subcatchments in SWMM that contribute flows directly to Smith Branch. The culvert crossings along Smith Branch can be seen as the green links in the model (**Figure 6.15**), meaning they have reached at least 50% capacity for the 2-year event. The arch culvert at Main Street, near the City's stream and rain gage SWIA, is recommended for upgrade.

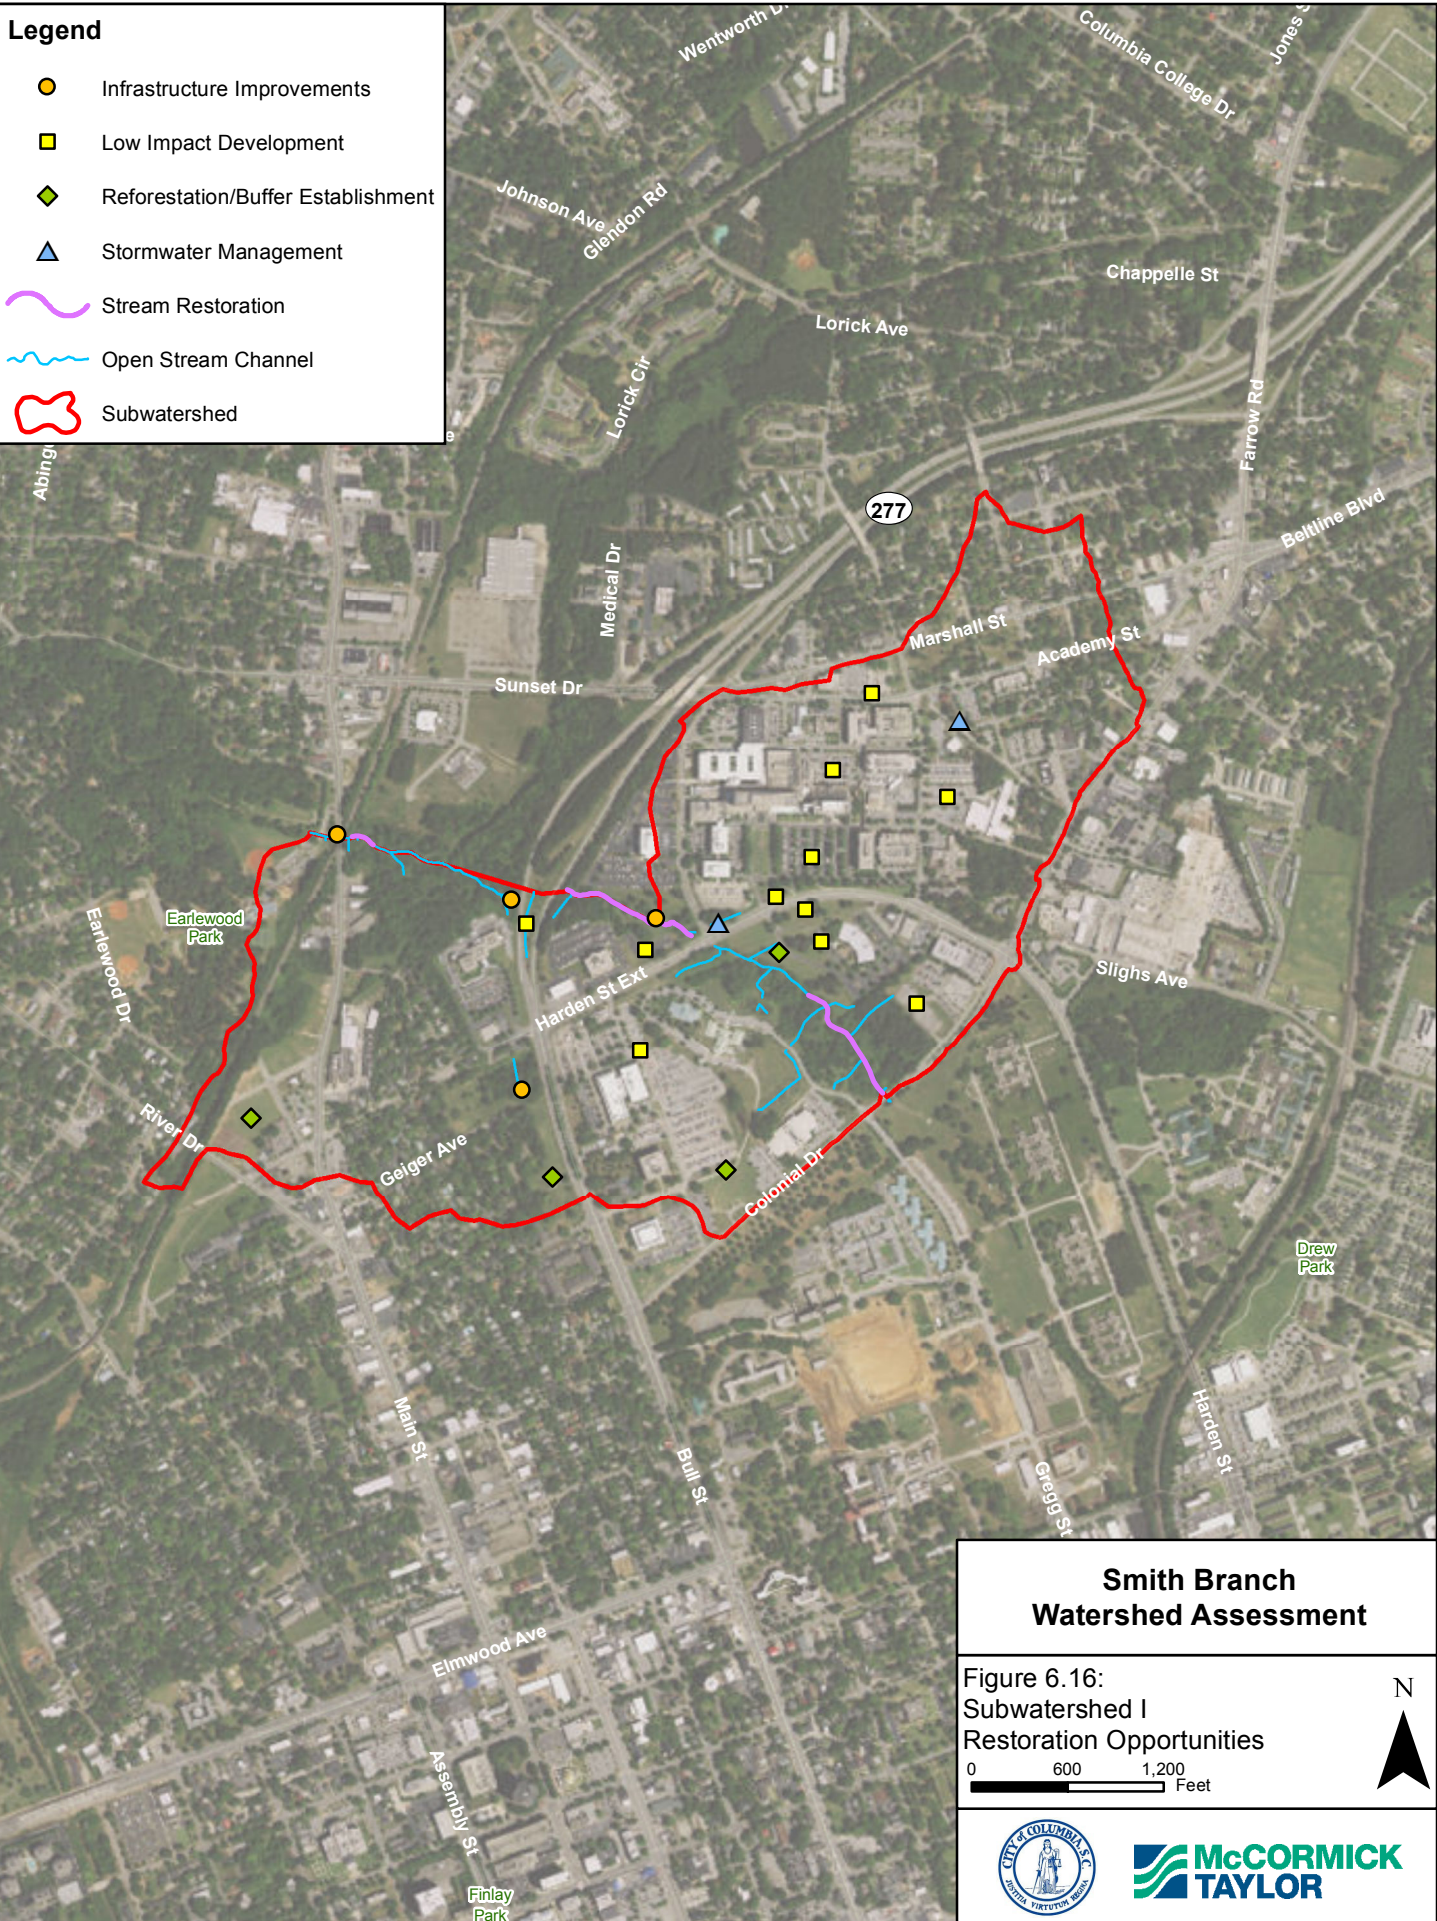
The following projects or similar improvements may be considered to address conditions identified in SW-I. These projects are included in **Figure 6.16**.

- The bridge at Main Street over Smith Branch should be improved to dual 12' x 12' culverts. Currently it is creating a backwater condition during a 2-year storm event.

- Opportunities for infiltration and storage should be investigated here to reduce peaks downstream.
  - Replace the concrete flume within the median in SC-277 with rock dissipation/step structure and bioswale or bioretention area.

- Construct bioretention cells within parking islands of the Palmetto Health-Richland Medical Park parking lots.
- Stabilize the banks of Smith Branch mainstem west of Main Street.

- Reshape and stabilize the Smith Branch mainstem channel east of SC-277 and north of Harden Street Extension.
- Remove the beaver dam and stabilize the headcuts and bank erosion in the mainstem channel between Colonial Drive and Harden Street Extension.

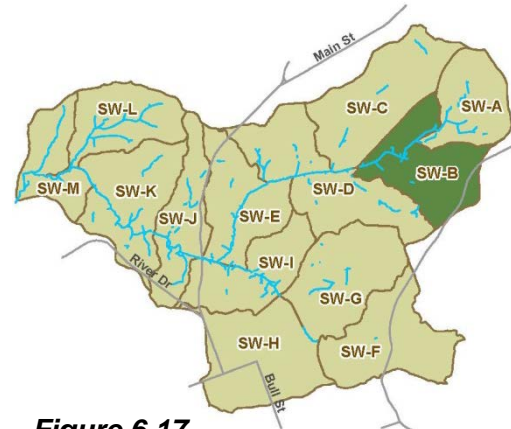
**Figure 6.17**  
**Subwatershed B**

- Subwatershed B (SW-B) is located to the northeast within the Smith Branch watershed.
- SC-277 creates the westernmost boundary and the northernmost point of the subwatershed is at the SC-277 North and railroad overpass. The southernmost point in SW-B is within the Crescent Hill Cemetery. SW-B extends slightly east of Two Notch Road.
- 369 acres or 0.58 square miles in drainage area
- Contains 1.18 miles of open stream channel, and 1.46 miles of mapped storm drain/pipe
- Dominant land use designations (**Figure 6.1, Table 6.1**):
  - Developed, Low Intensity: 39%
  - Developed, High Intensity: 20%
  - Developed, Medium Intensity: 19%
- Impervious surface cover: 47%

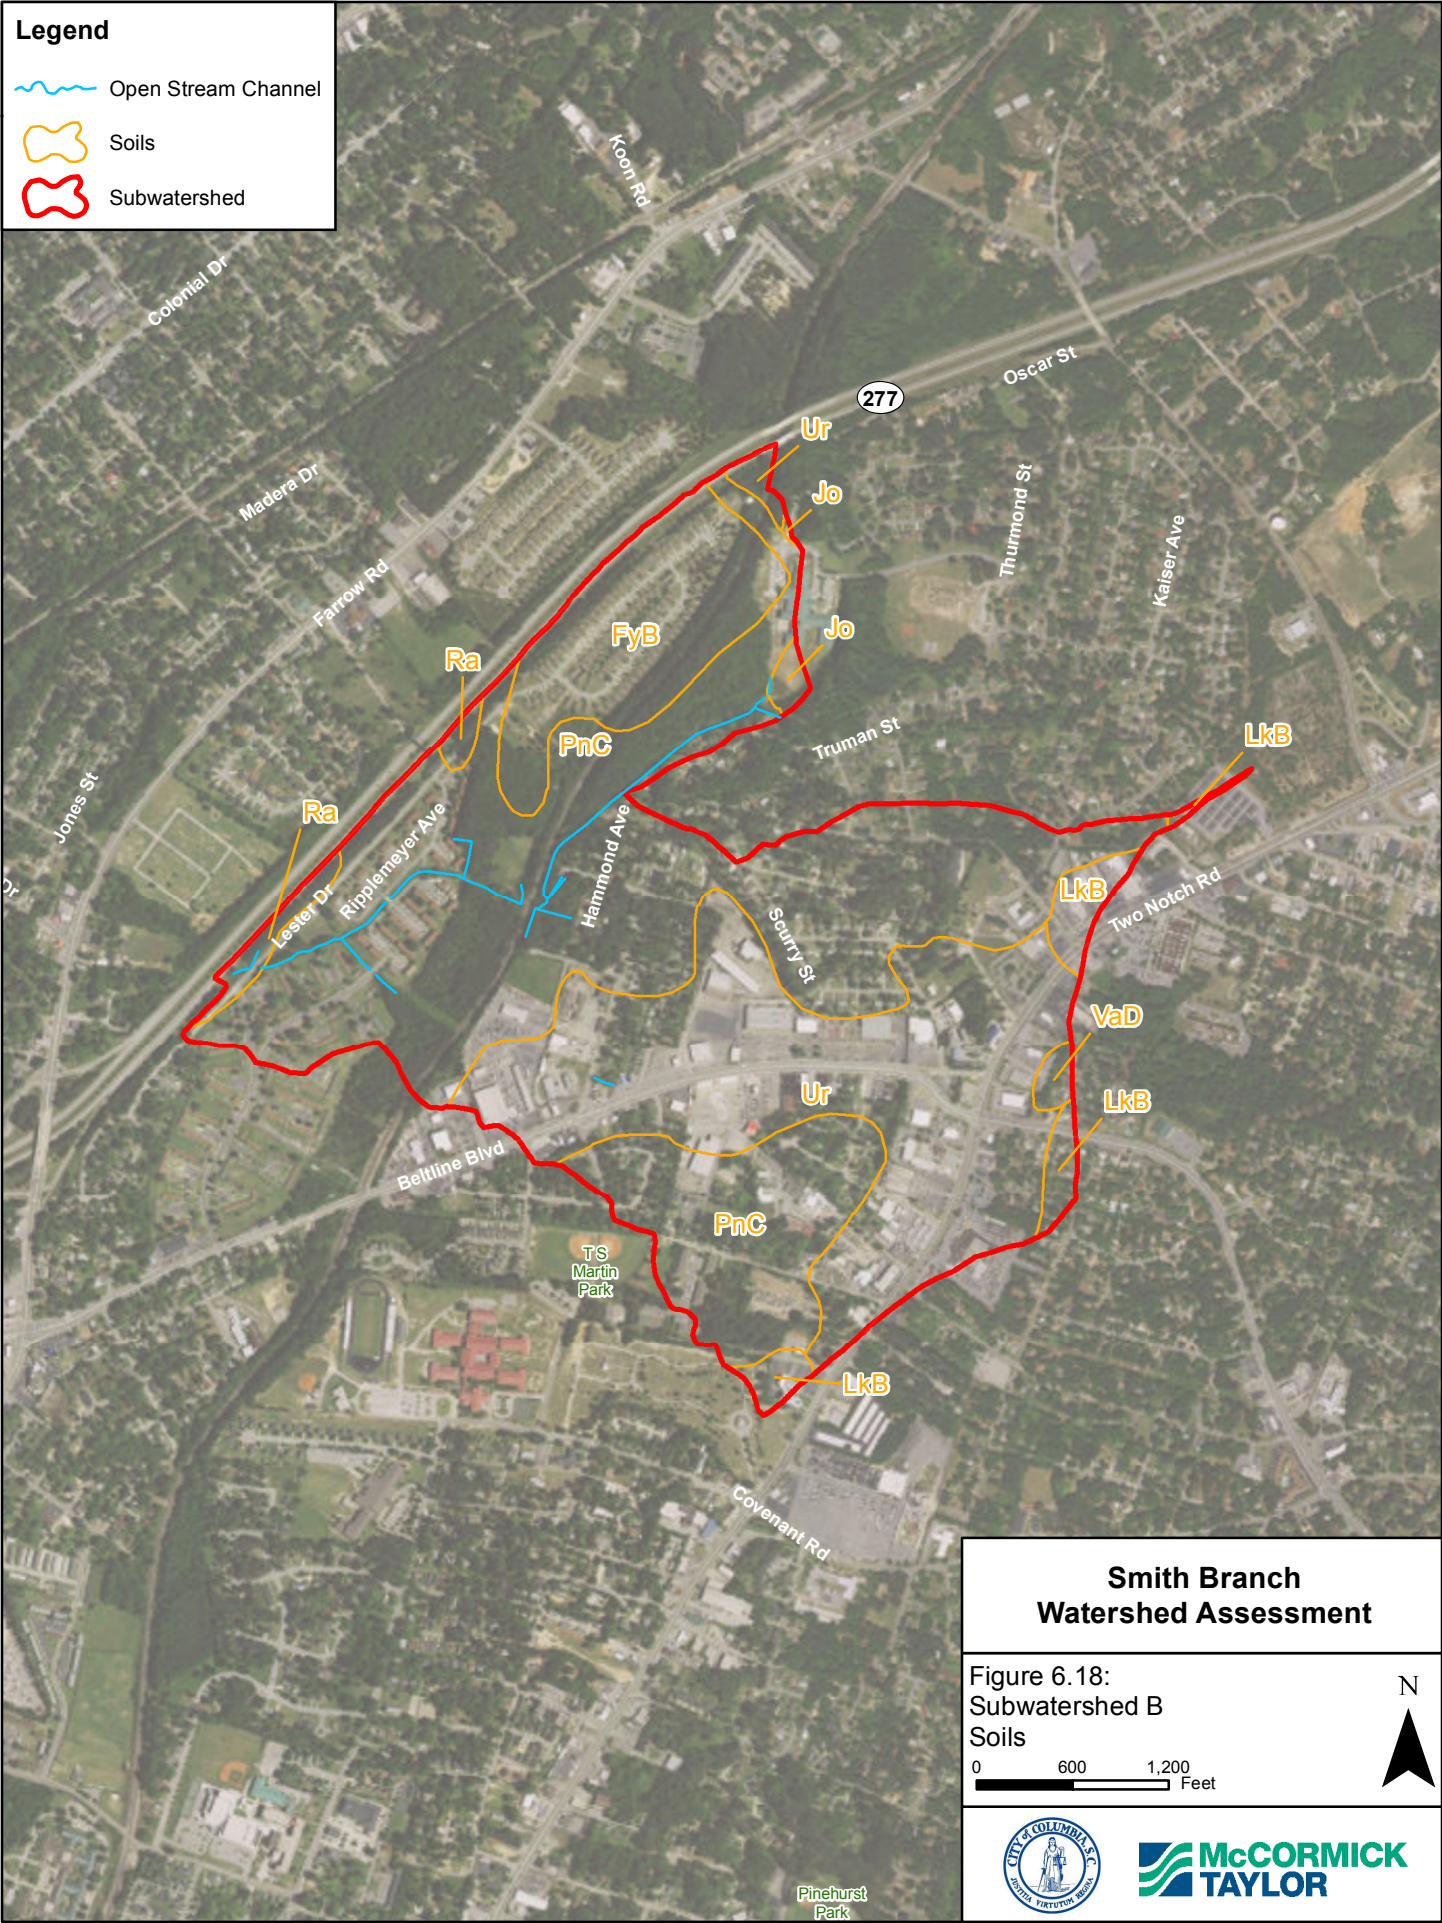
Figure 6.18:  
Subwatershed B  
Soils

**Soils:** Approximate soil type percentages within SW-B include (refer to **Section 3.4** for soil descriptions and **Figure 6.18** for soil distributions):

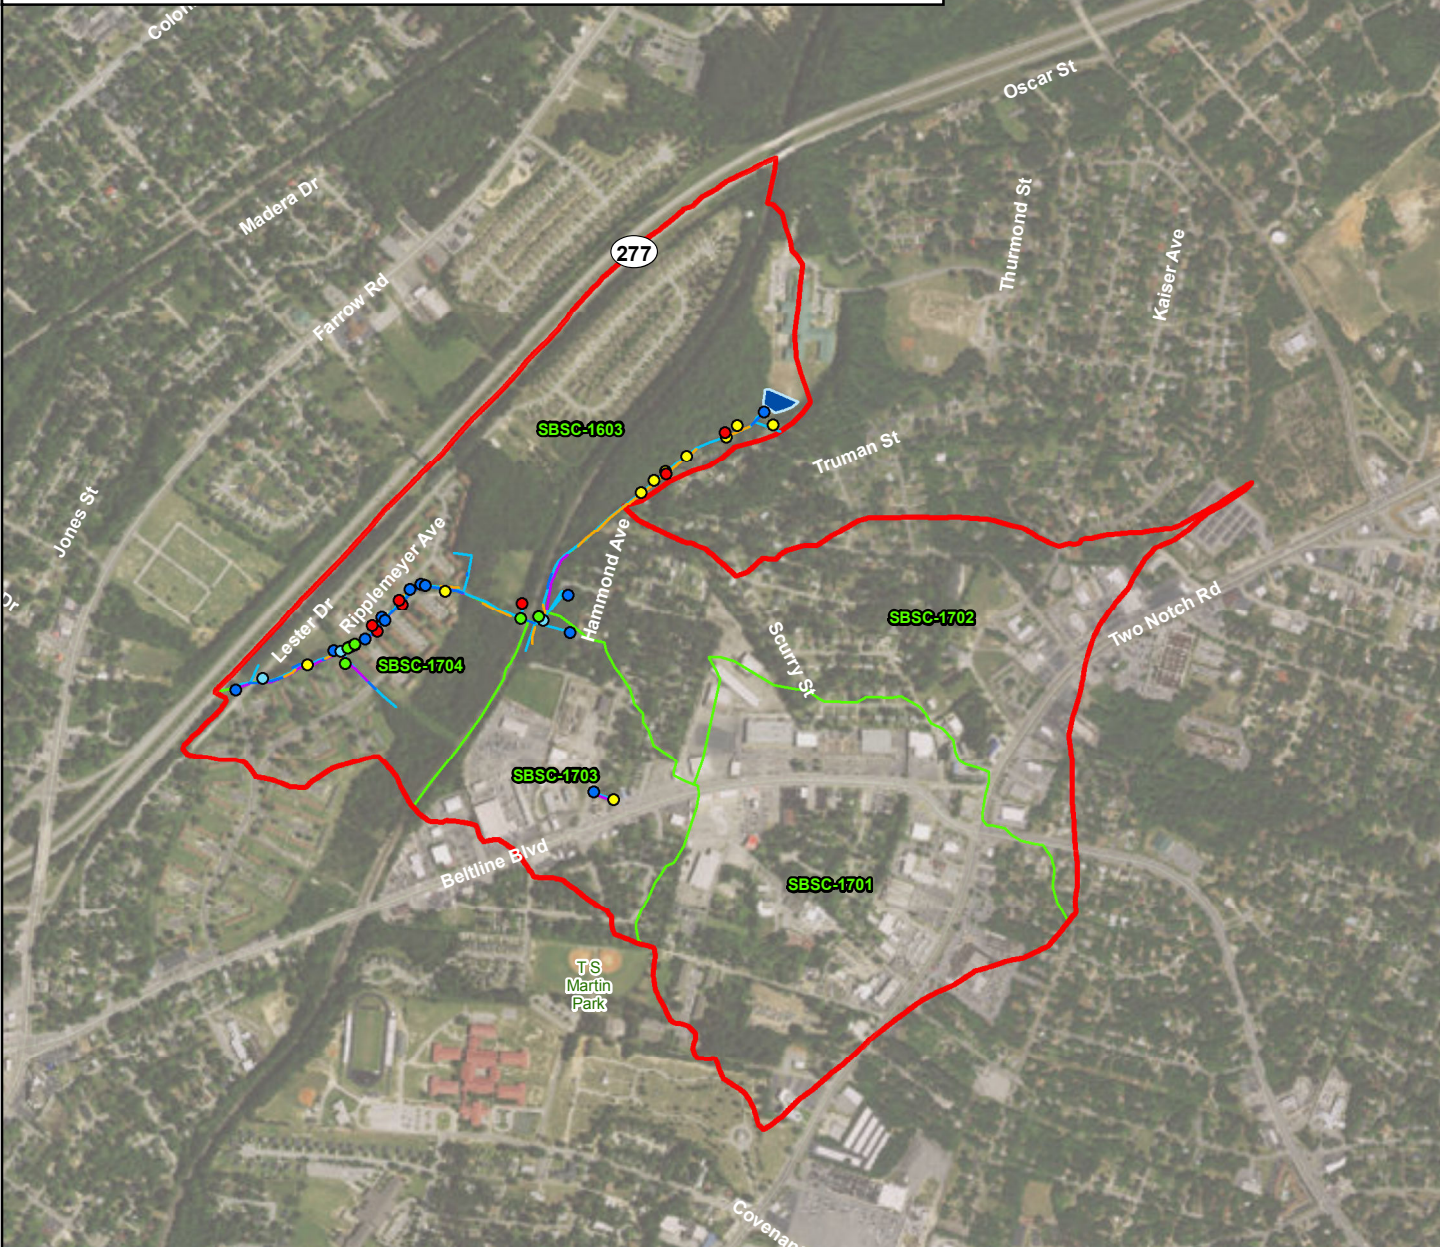
Figure 6.19:  
Subwatershed B  
Existing Conditions

**Figure 6.19** highlights existing conditions that were either captured during the stream cruising effort or developed using GIS data.

Existing Condition	Count
Exposed Pipes	6
Pipe Outfalls	13
Unmanaged Runoff	7
Unusual Condition	11
Trash Dumping	0
Possible Fish Barrier	5
	<b>Linear Feet</b>
Erosion Site	2,241
Channel Alteration	1,507
Inadequate Forest Buffer	7,942

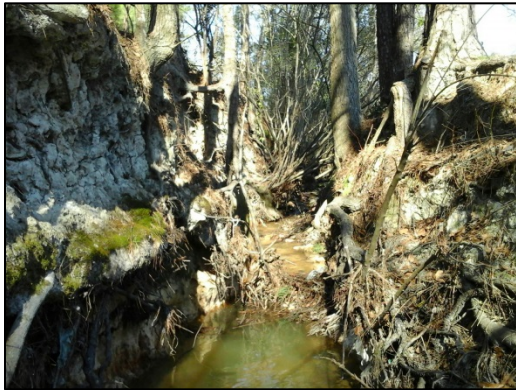
The upstream extent of the open channel network in SW-B begins north of the Truman and Scurry Street intersection. Channel bed substrate is primarily sand and silt. The right bank is near vertical and is much taller than the left bank. Both banks are vegetated yet show evidence of the channel downcutting and widening. The right bank has been heavily armored with riprap at the Burton-Pack Elementary School stormwater pond outfall and erosion on the left bank has begun to encroach upon adjacent properties. Near the northern end of Hammond Avenue, the stream channel becomes more highly incised, with bank stability decreasing and sedimentation increasing; erosion threatens adjacent residential properties, slope failures have exposed bedrock, and land clearing on the right bank has likely contributed to observed slumping.

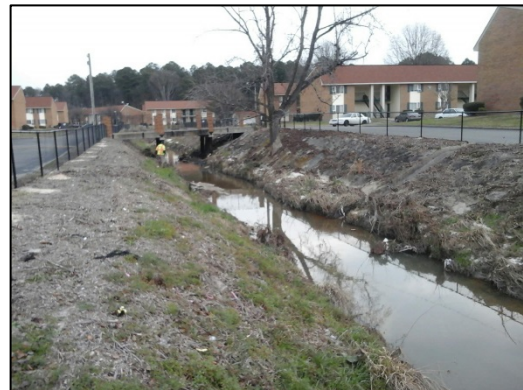
The stream then becomes channelized with concrete bed and banks, flowing parallel to Ripplemeyer Avenue. Channel conditions along this segment show signs of severe degradation of the concrete channel; soil slump has caused the right bank to fracture and sag. Downstream of the concrete channel, the stream returns to a natural state with earthen bed and banks. Debris caught in understory brush and saturated soils provides evidence of possible flooding. Stream banks are sparsely vegetated with herbaceous material and contain areas of instability. The stream then flows through an 8-foot wide, 6-foot high twin box culvert crossing westerly under Lester Drive. Large sand bars define the channel upon the streams emergence. The stream flows approximately 100 feet before being conveyed through a culvert beneath SC-277 and beyond the SW-B boundary.

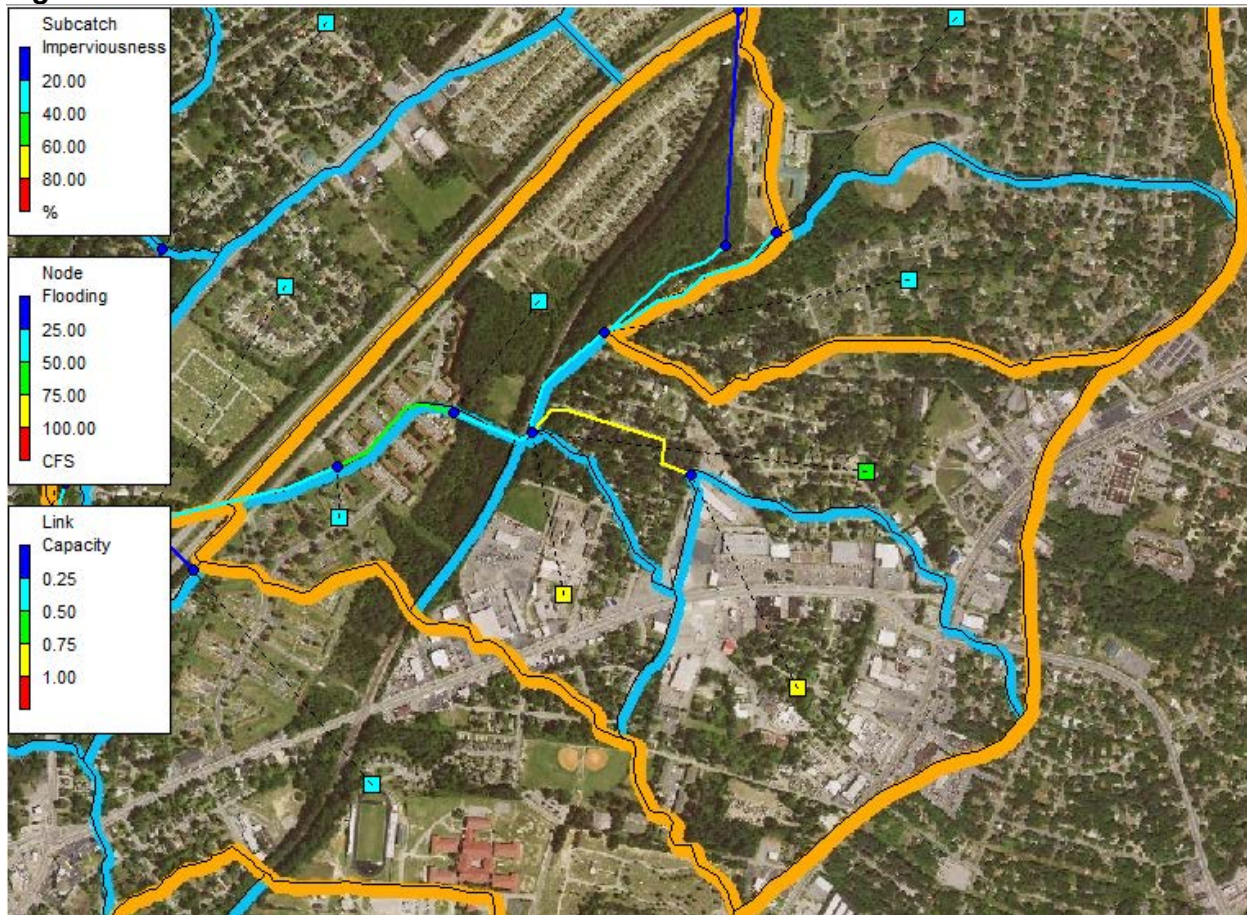
**Figure 6.20 SW-B SWMM Model**

SW-B is modeled in SWMM as five subcatchments draining to the pipe and open channel conveyance systems that make up the headwaters of Bay Branch. The large areas of impervious surface in this watershed are visible in the aerial imagery. At the modeled 2-year event in SWMM, the subwatershed's runoff is approaching capacity (81% modeled capacity) in the 54" RCP outlet pipe (seen mapped as yellow lines in **Figure 6.20**).

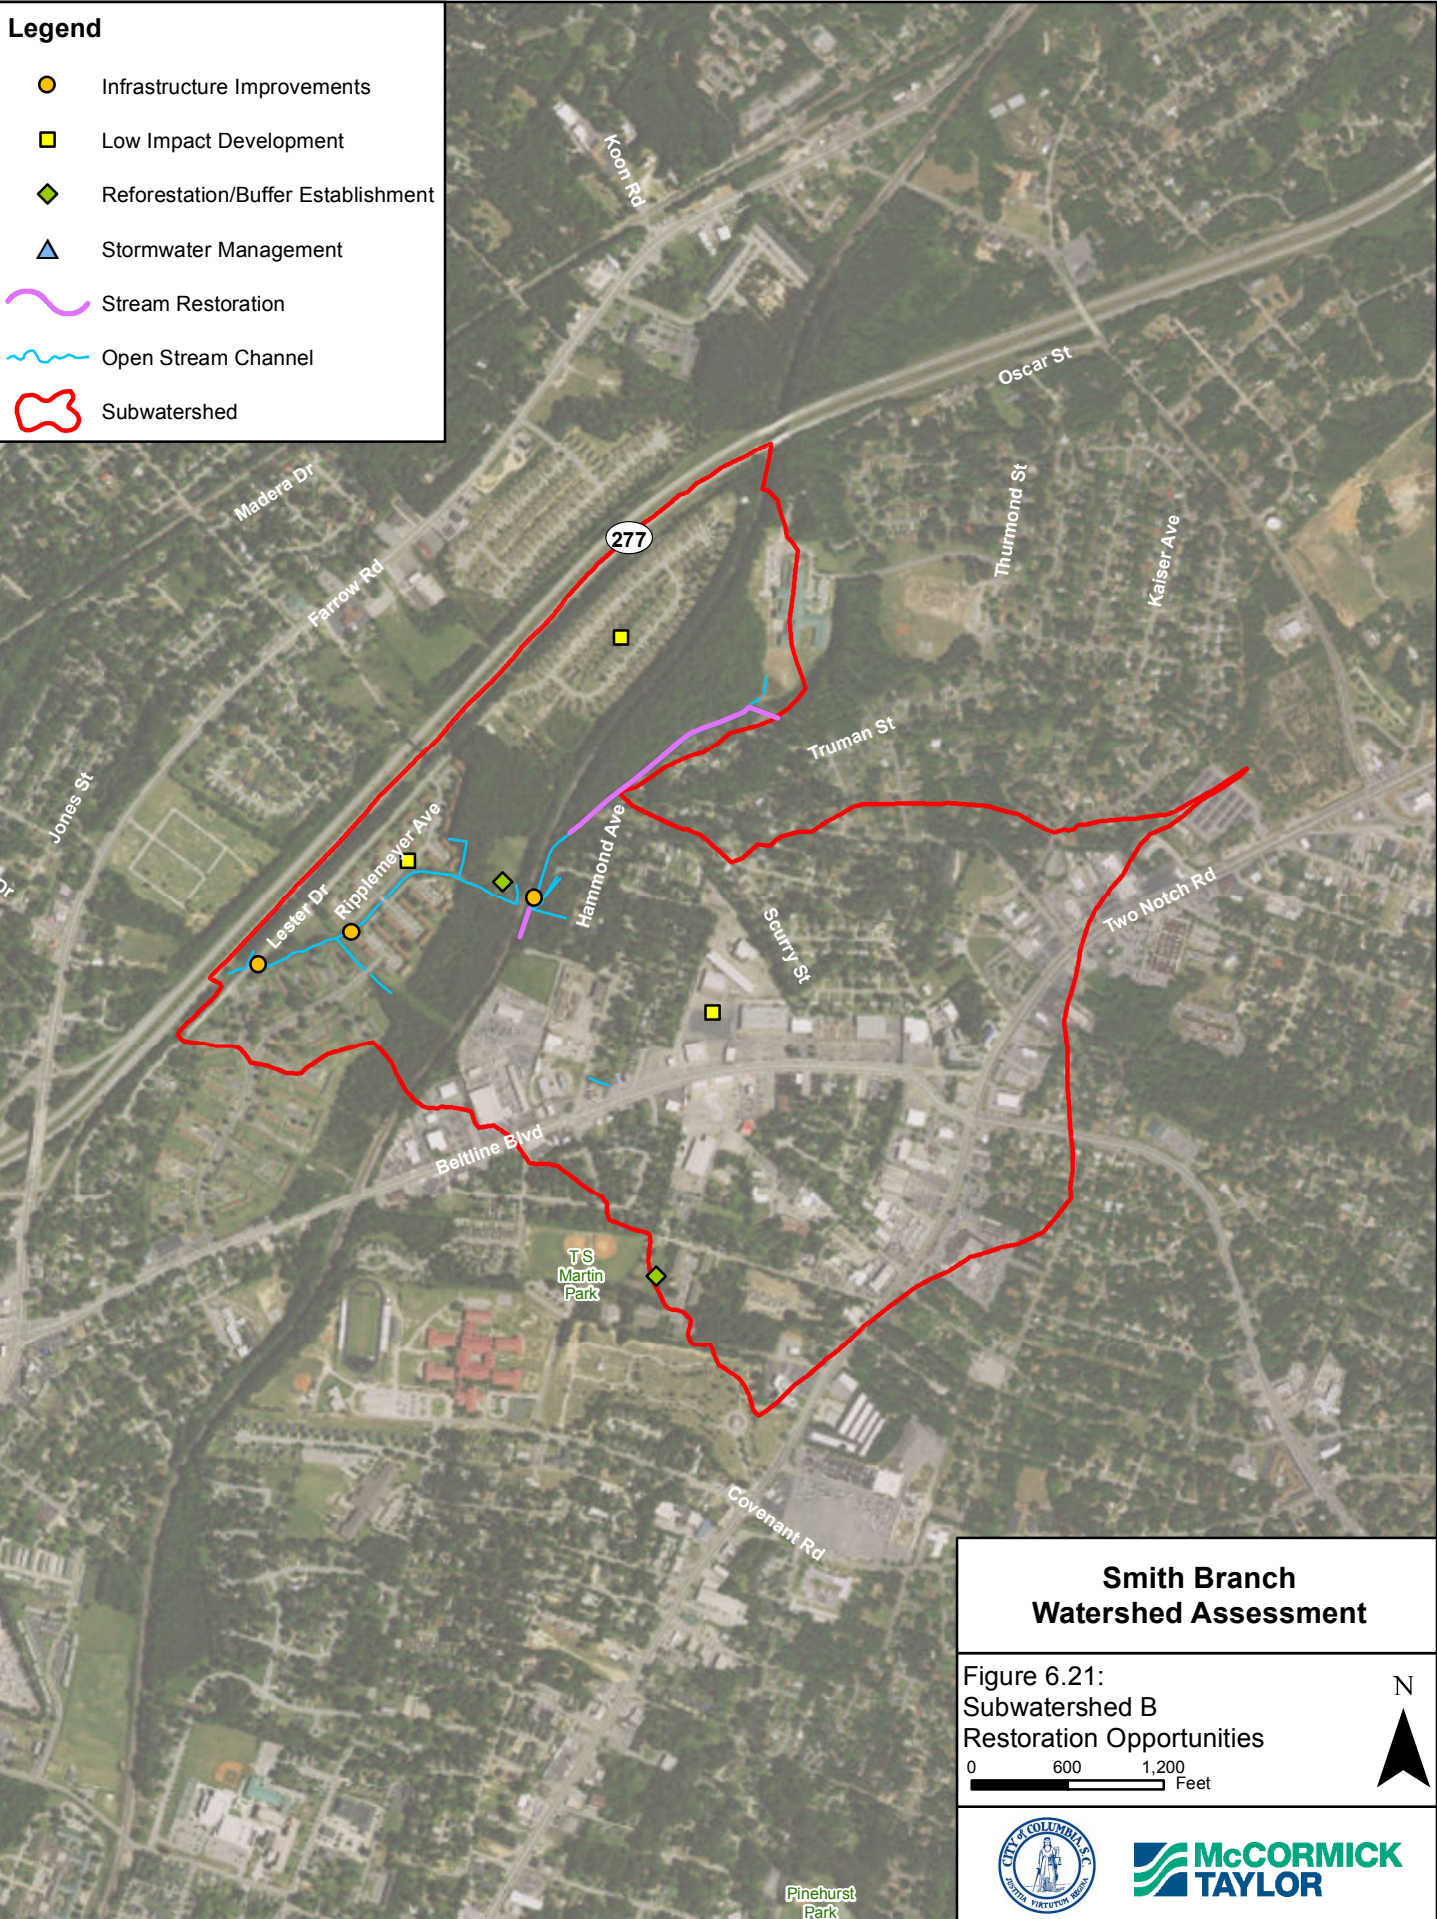
Figure 6.21:  
Subwatershed B  
Restoration Opportunities

The following projects or similar improvements may be considered to address conditions identified in SW-B. These projects are included in **Figure 6.21**.

- Improvements focused on storage and infiltration are recommended for the large impervious areas. Their location in the watershed, at the far end draining to Bay Branch, makes them high priority candidates to reduce downstream flows and disconnect peaks.

- Install BMPs for the parking lot behind the Piggie Wiggly on West Beltline Boulevard.
- Repair the exposed utility lines west of Hammond Avenue, South of Lester Drive, and West of Ripplemeyer Avenue.

- Stabilize the banks of the stream segment west of Truman Street.
- Stabilize the headcut west of Hammond Avenue, near the railroad.

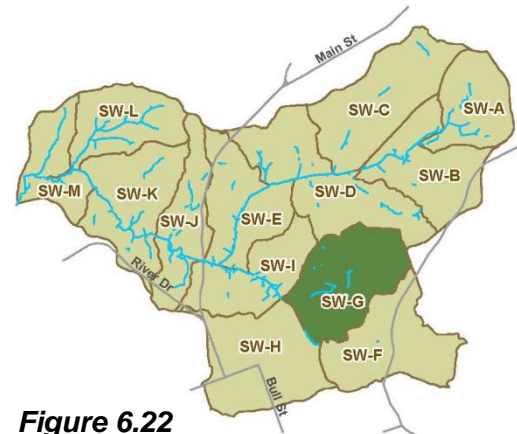
**Figure 6.22**  
**Subwatershed G**

- Subwatershed G (SW-G) is located in the southeastern portion of the watershed.
- SW-G boundaries include Farrow Road to the west, W.A. Perry Middle School to the north, Waites Road to the east, and Elmwood Avenue to the south
- 404 acres or 0.63 square miles in drainage area
- Contains 0.54 miles of open stream channel, and 6.72 miles of mapped storm drain/pipe
- Dominant land use designations (**Figure 6.1, Table 6.1**):
  - Developed, Low Density: 46%
  - Developed, Medium Density: 28%
- Impervious surface cover: 40%

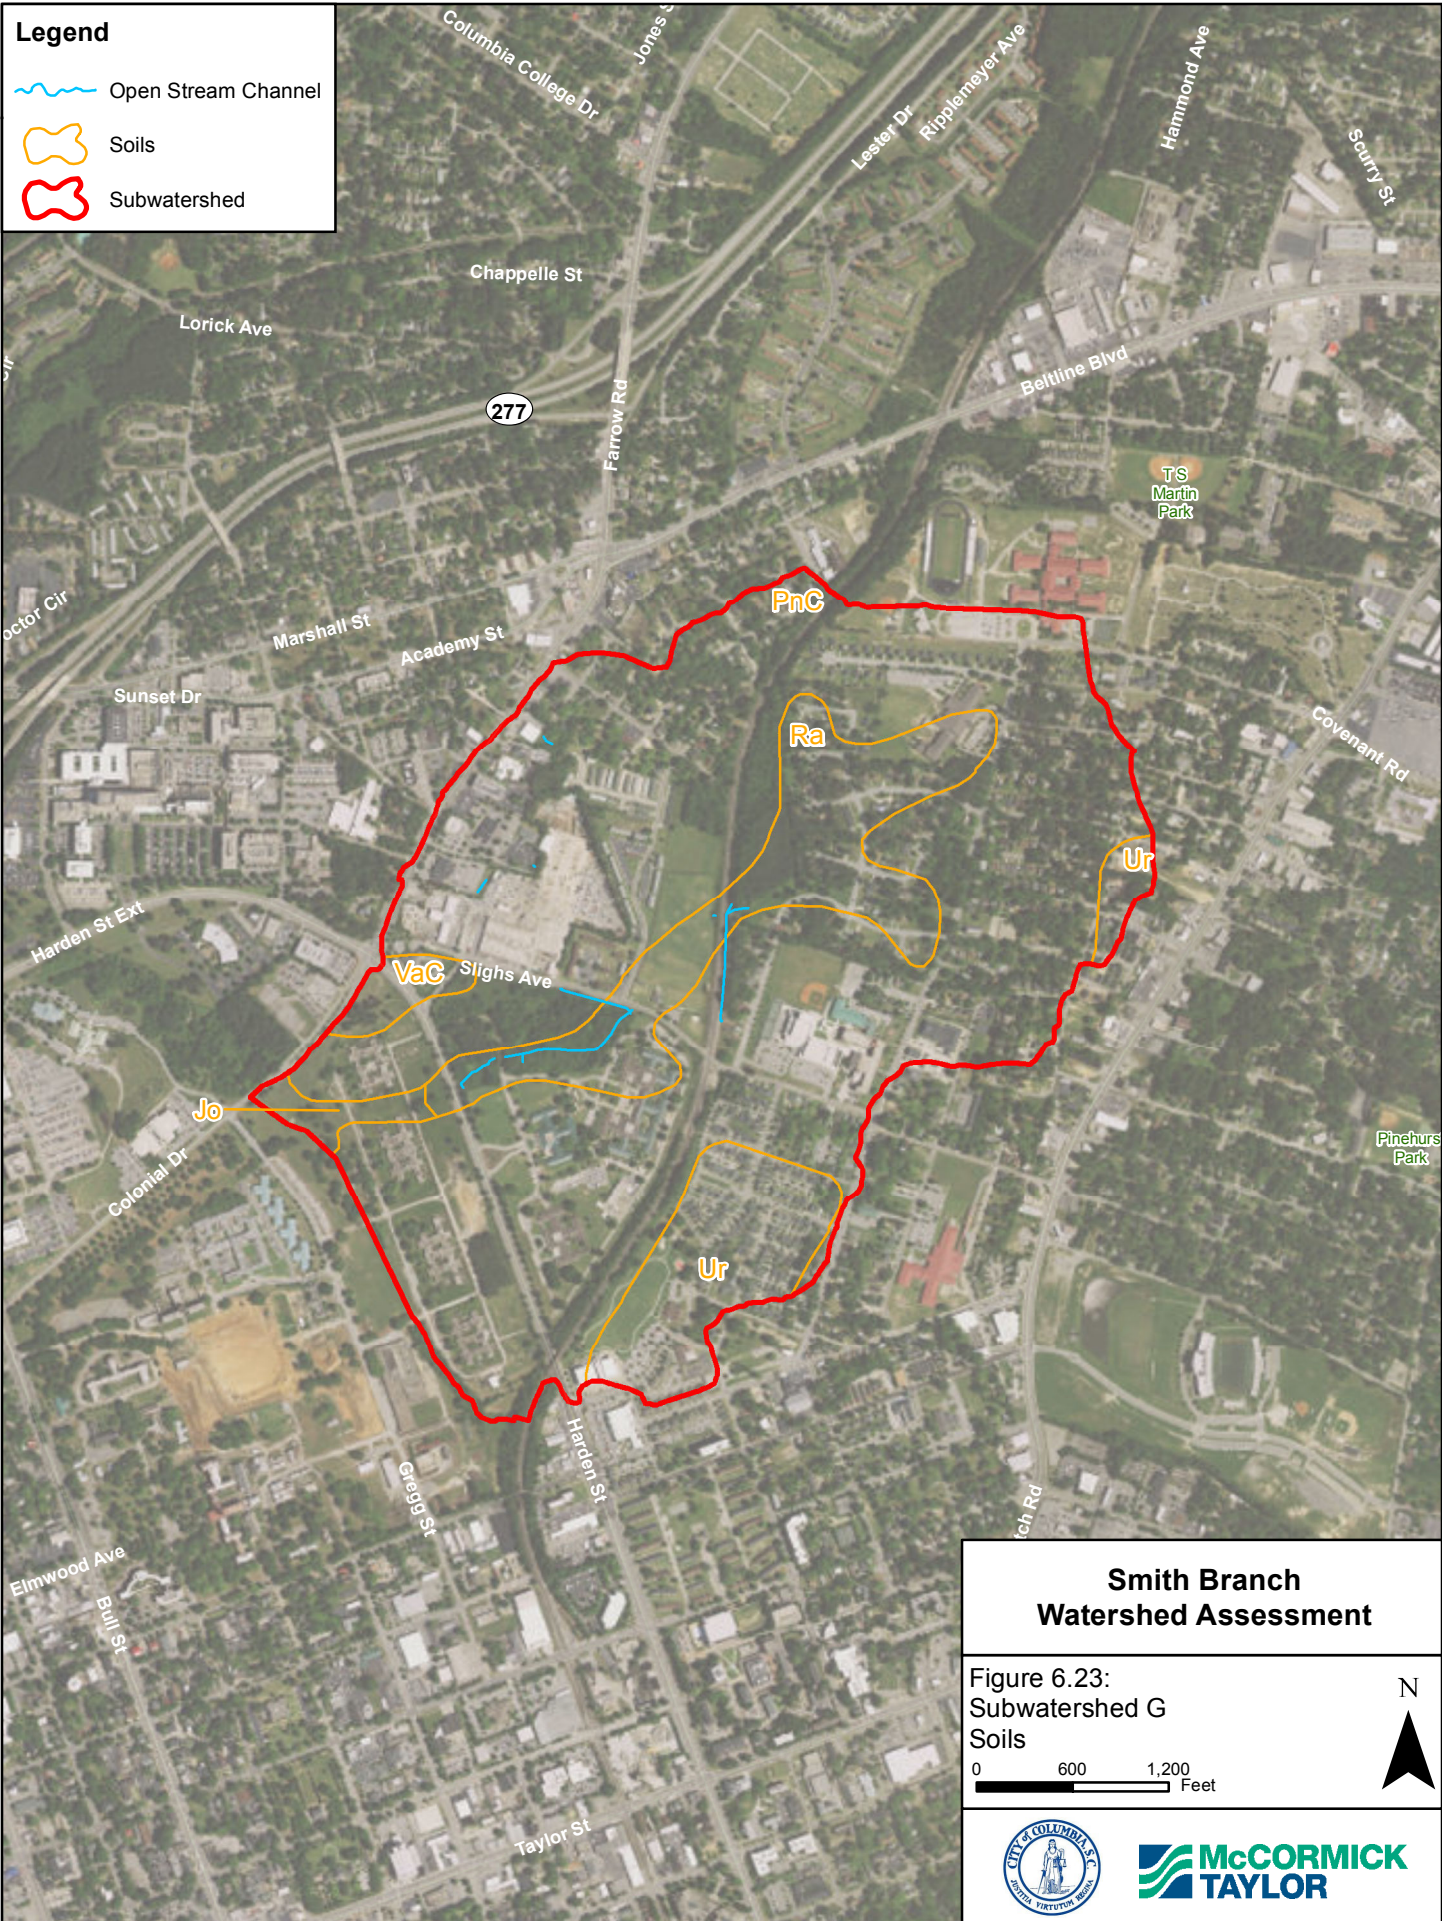
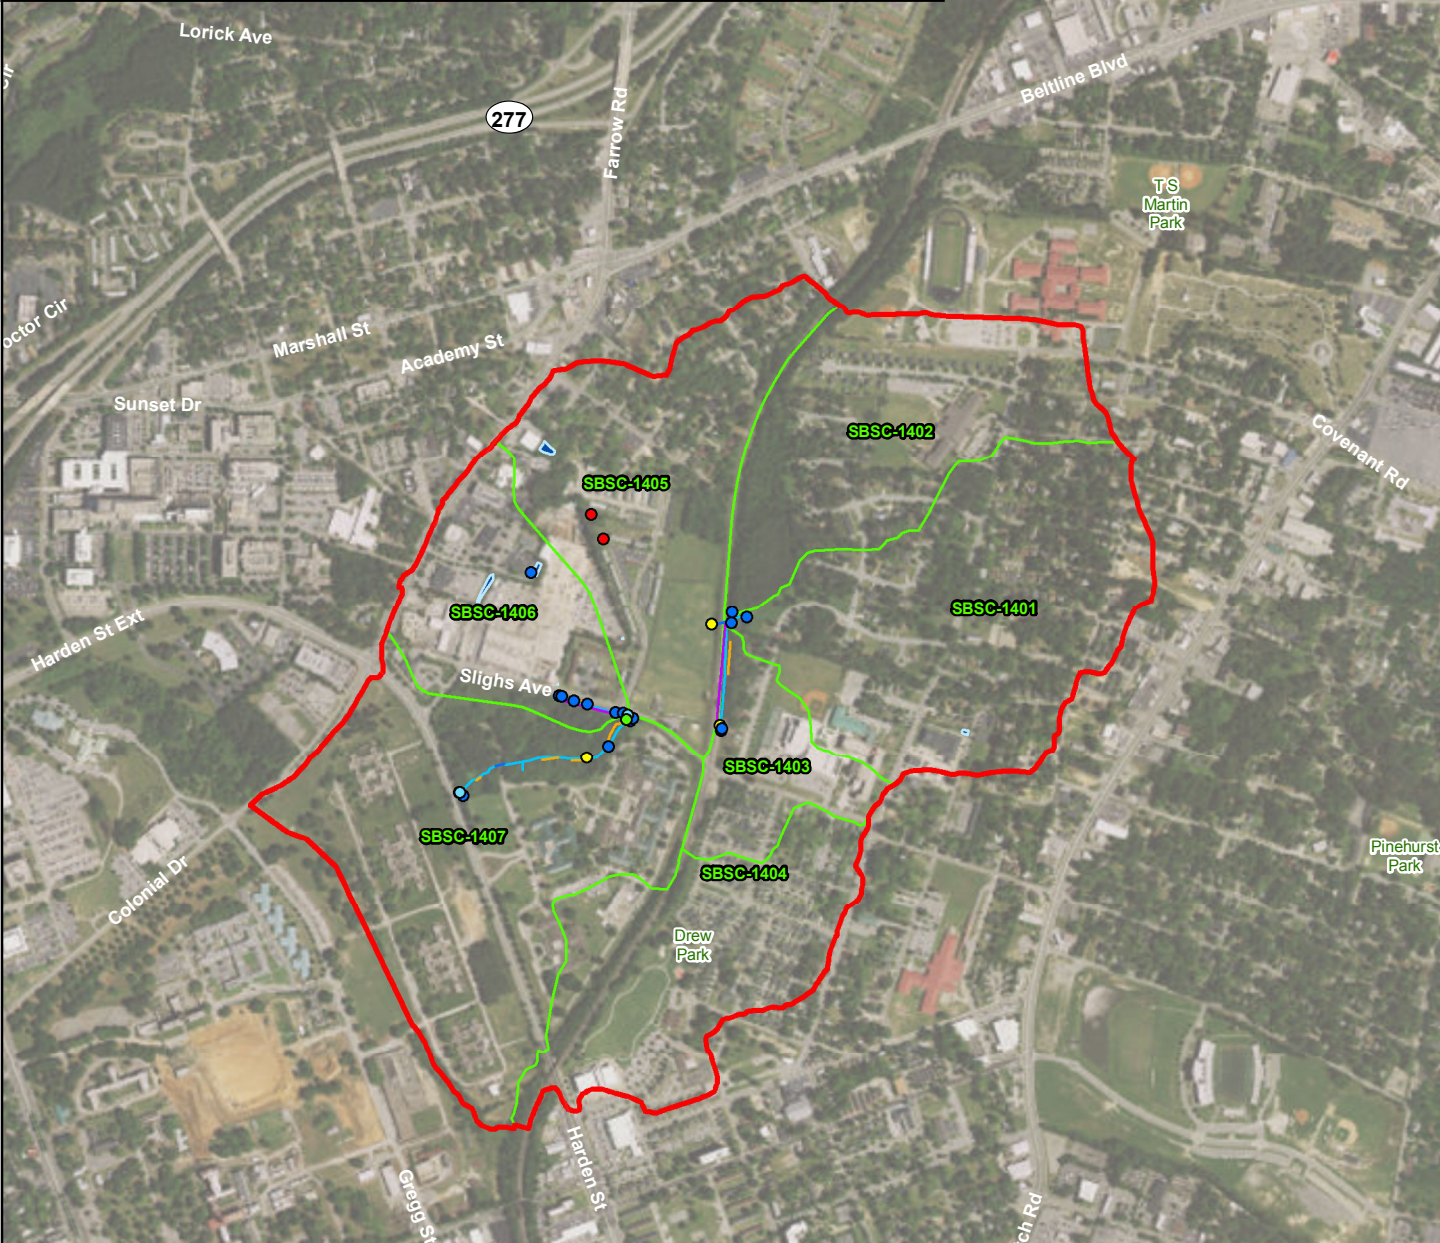
Figure 6.24:  
Subwatershed G  
Existing Conditions

**Figure 6.24** highlights existing conditions that were either captured during the stream cruising effort or developed using GIS data.

Existing Condition	Count
Exposed Pipes	2
Pipe Outfalls	16
Unmanaged Runoff	2
Unusual Condition	4
Trash Dumping	0
Possible Fish Barrier	1
	<b>Linear Feet</b>
Erosion Site	1,006
Channel Alteration	121
Inadequate Forest Buffer	1,092

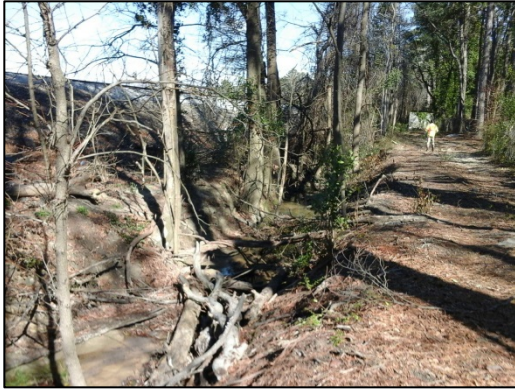
The easternmost open channel segment in SW-G is located between the railroad and C.A. Johnson High School. Flow initiates from two 36 inch RCPs that were submerged and backwatered at baseflow. Downstream, the channel is incised, pinched between the railroad embankment and residential properties along Dart Street. Woody bank vegetation adds stability through most of this segment and the channel bed material is primarily sand and silt. The main channel converges with two small tributaries before flowing east through a railroad culvert. The stream

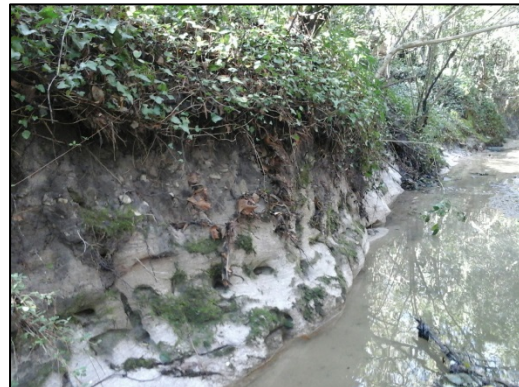
After the tributary flows into the receiving main channel, the channel becomes deeply incised downstream. The 10-foot tall banks are nearly vertical and composed mostly of silt with some bedrock at the toe. As the stream meanders west, bedrock intrusion becomes more frequent in the left bank and there are isolated areas of slumping, while the right bank is more densely vegetated and stable. Depositional mid-channel and point bars frequently constrict and divide baseflow. The stream extends through twin culverts at Eagle Avenue. Downstream

of the road crossing, there are isolated areas of erosion. The stream is then piped west under Harden Street and beyond the SW-G boundary onto the Bull Street Redevelopment property.

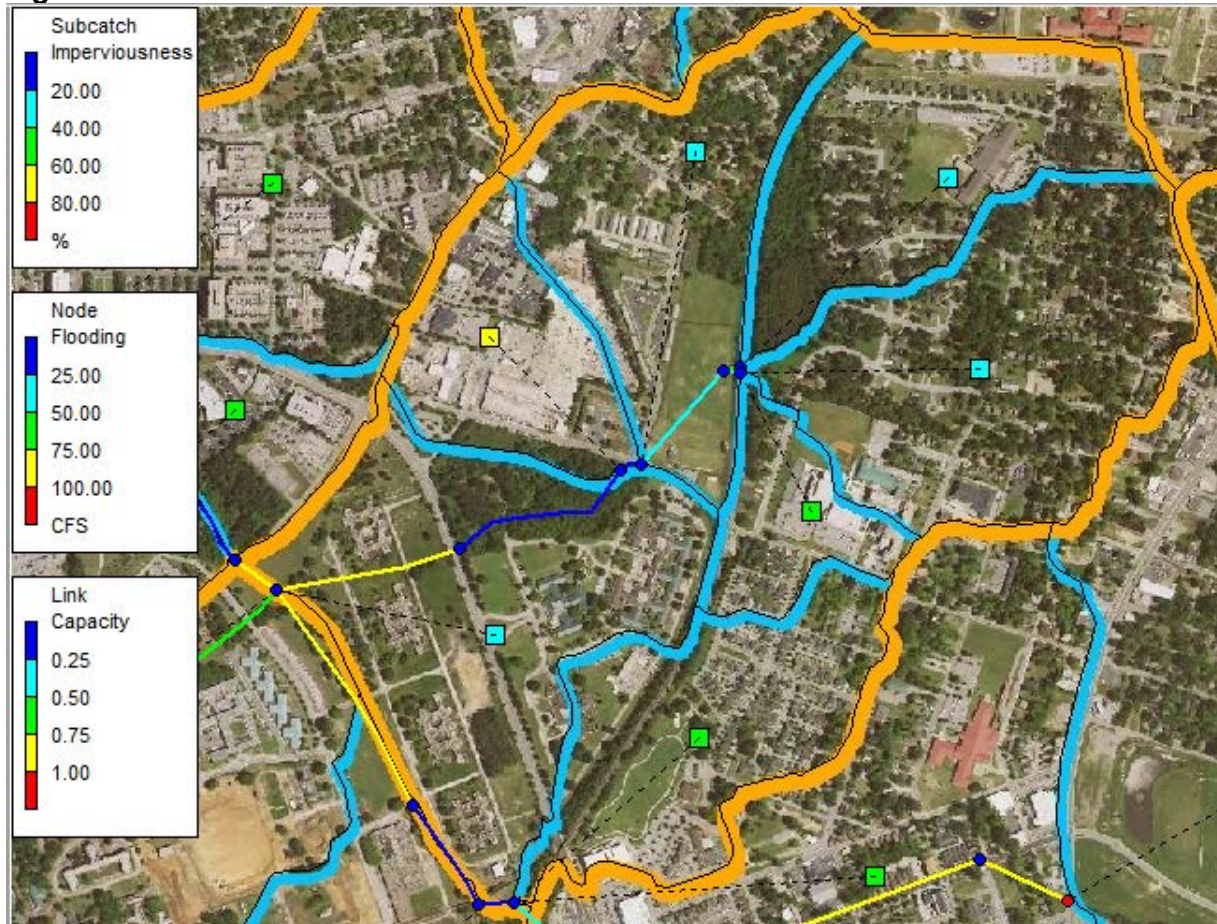
**Figure 6.25 SW-G SWMM Model**

SW-G is modeled as seven subcatchments (**Figure 6.25**). Six of these subcatchments drain to the 84 inch RCP at the western end of the subwatershed. The remaining subcatchment is modeled as draining to the upper end of the large dual culverts at Preston Drive. One subcatchment in this subwatershed is mostly commercial and approximately 70% impervious. The dual 84 inch RCPs that begin at Preston Drive are estimated to be at almost 80% capacity

due to the flows from SW-F and SW-G during a 2-year storm event. The undeveloped green space in this area should be further investigated for ways to store and infiltrate water.

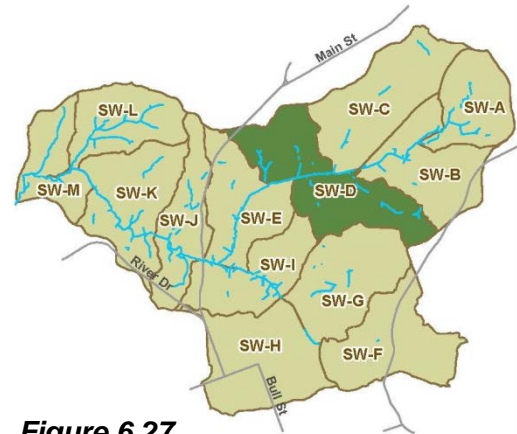
**Figure 6.27**  
**Subwatershed D**

- The northernmost point in SW-D is within the Columbia College campus. The boundary extends southeast across SC-277 to Crescent Hill Cemetery off Two Notch Road. The southern boundary extends west through W.A. Perry Middle School to Farrow Road and then northwest to the Lutheran Theological Southern Seminary off North Main Street.
- 506 acres or 0.79 square miles in drainage area
- Contains 2.02 miles of open stream channel and 3.12 miles of mapped storm drain/pipe
- Dominant land use designations (**Figure 6.1, Table 6.1**):
  - Developed, Low Intensity: 52%
  - Developed, Open Space: 20%
- Impervious surface cover: 37%
