Rocky Branch Watershed Management Plan

# ROCKY BRANCH WATERSHED ASSESSMENT

McCormick Taylor Inc., supported by KCI Technologies, Inc., has been contracted by the City of Columbia, South Carolina to conduct an assessment of the Rocky Branch watershed to identify potential improvement opportunities to identify existing flooding and water quality conditions.

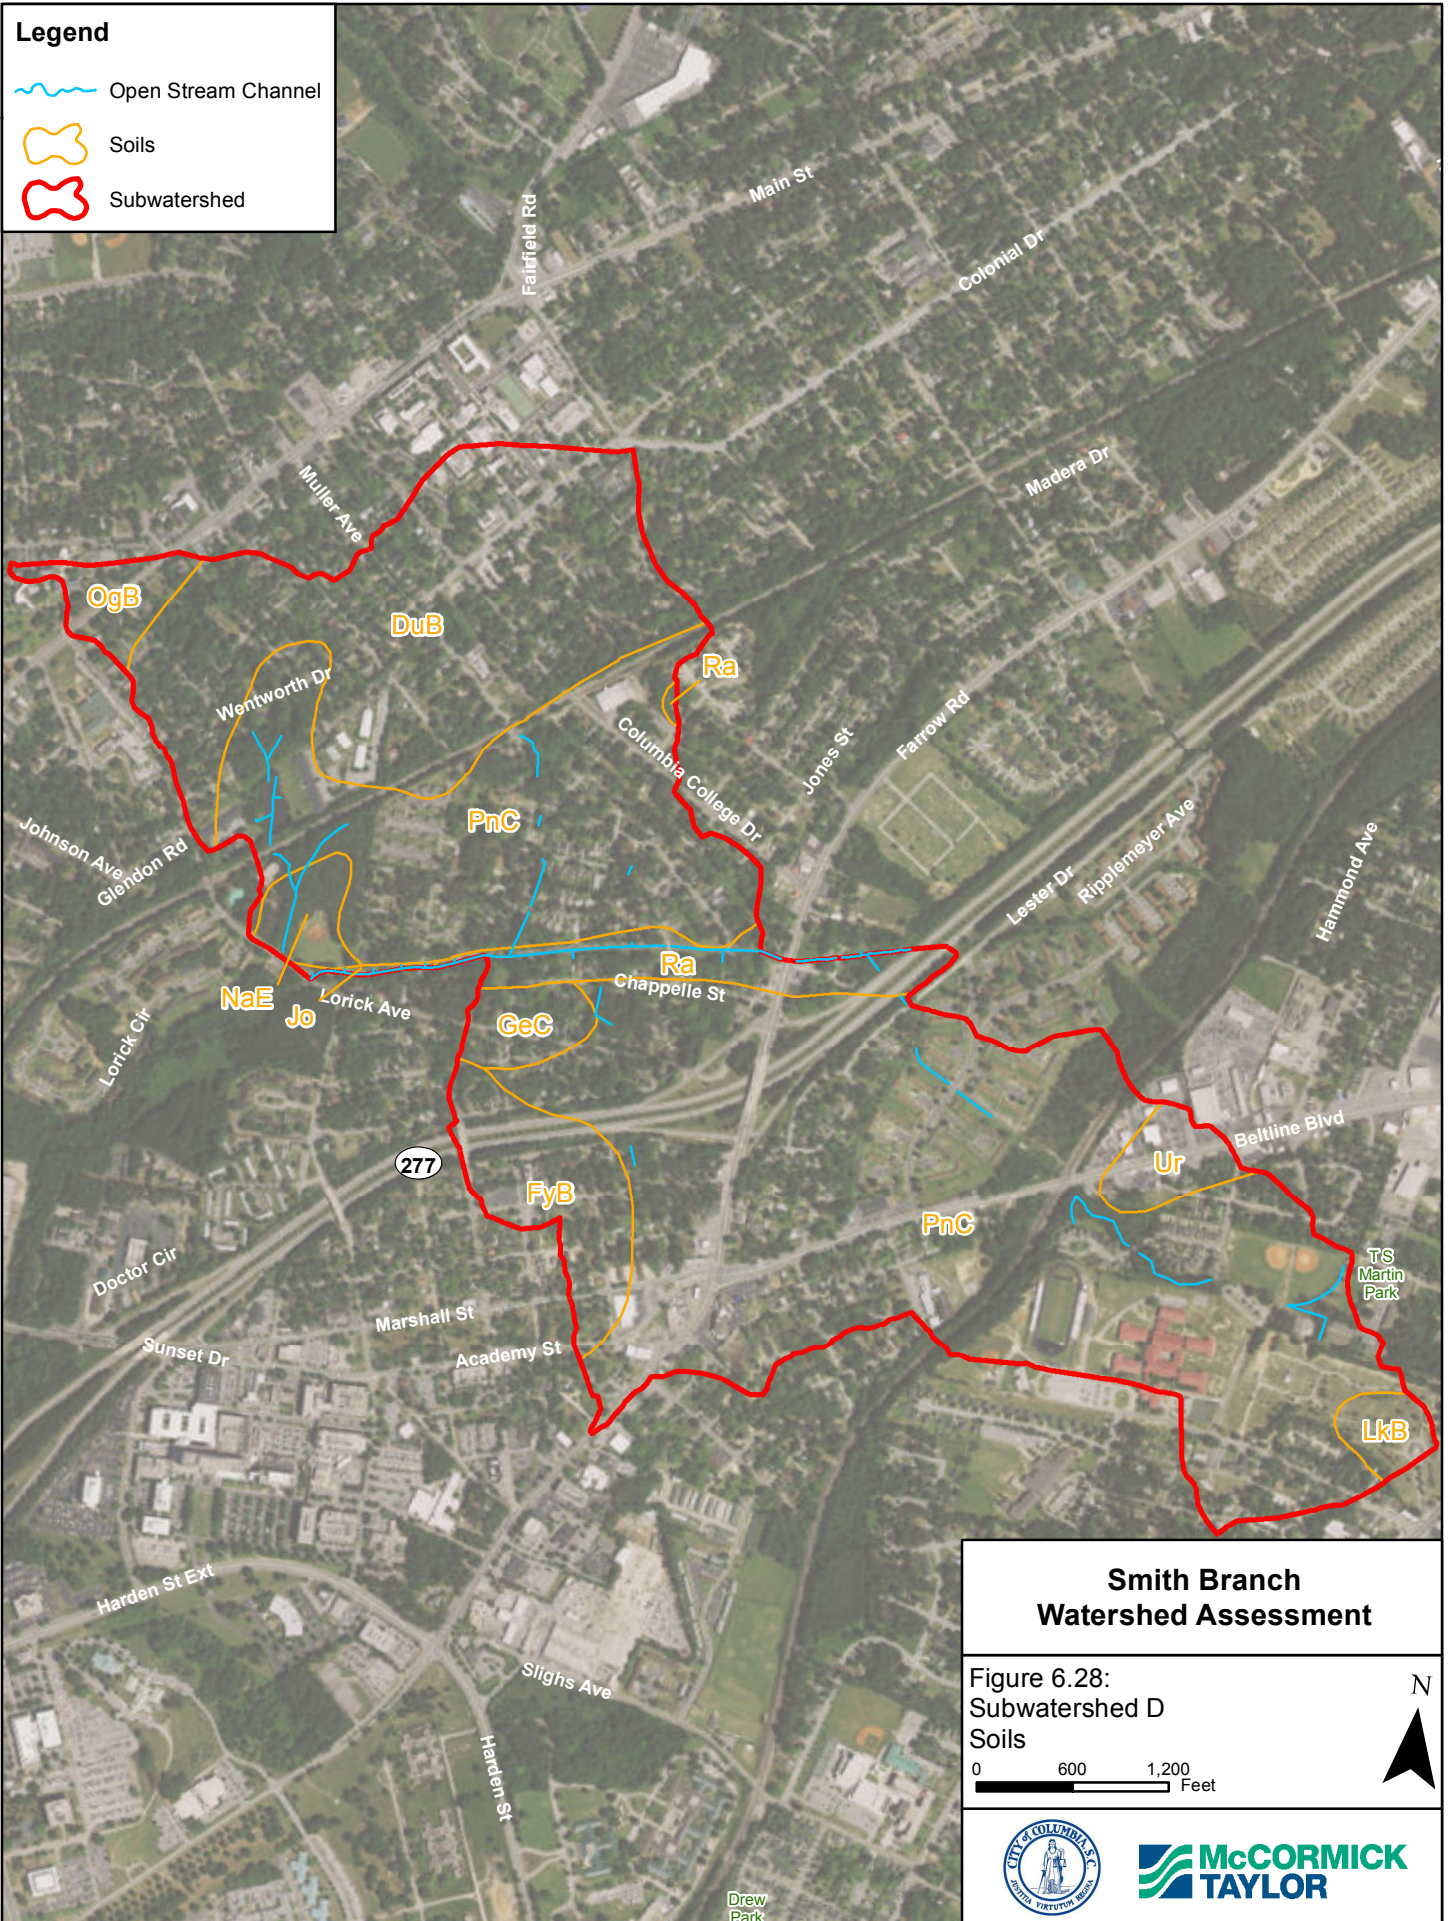
Figure 6.28:  
Subwatershed D  
Soils

**Soils:** Approximate soil type percentages within SW-D include (refer to **Section 3.4** for soil descriptions and **Figure 6.28** for soil distributions):

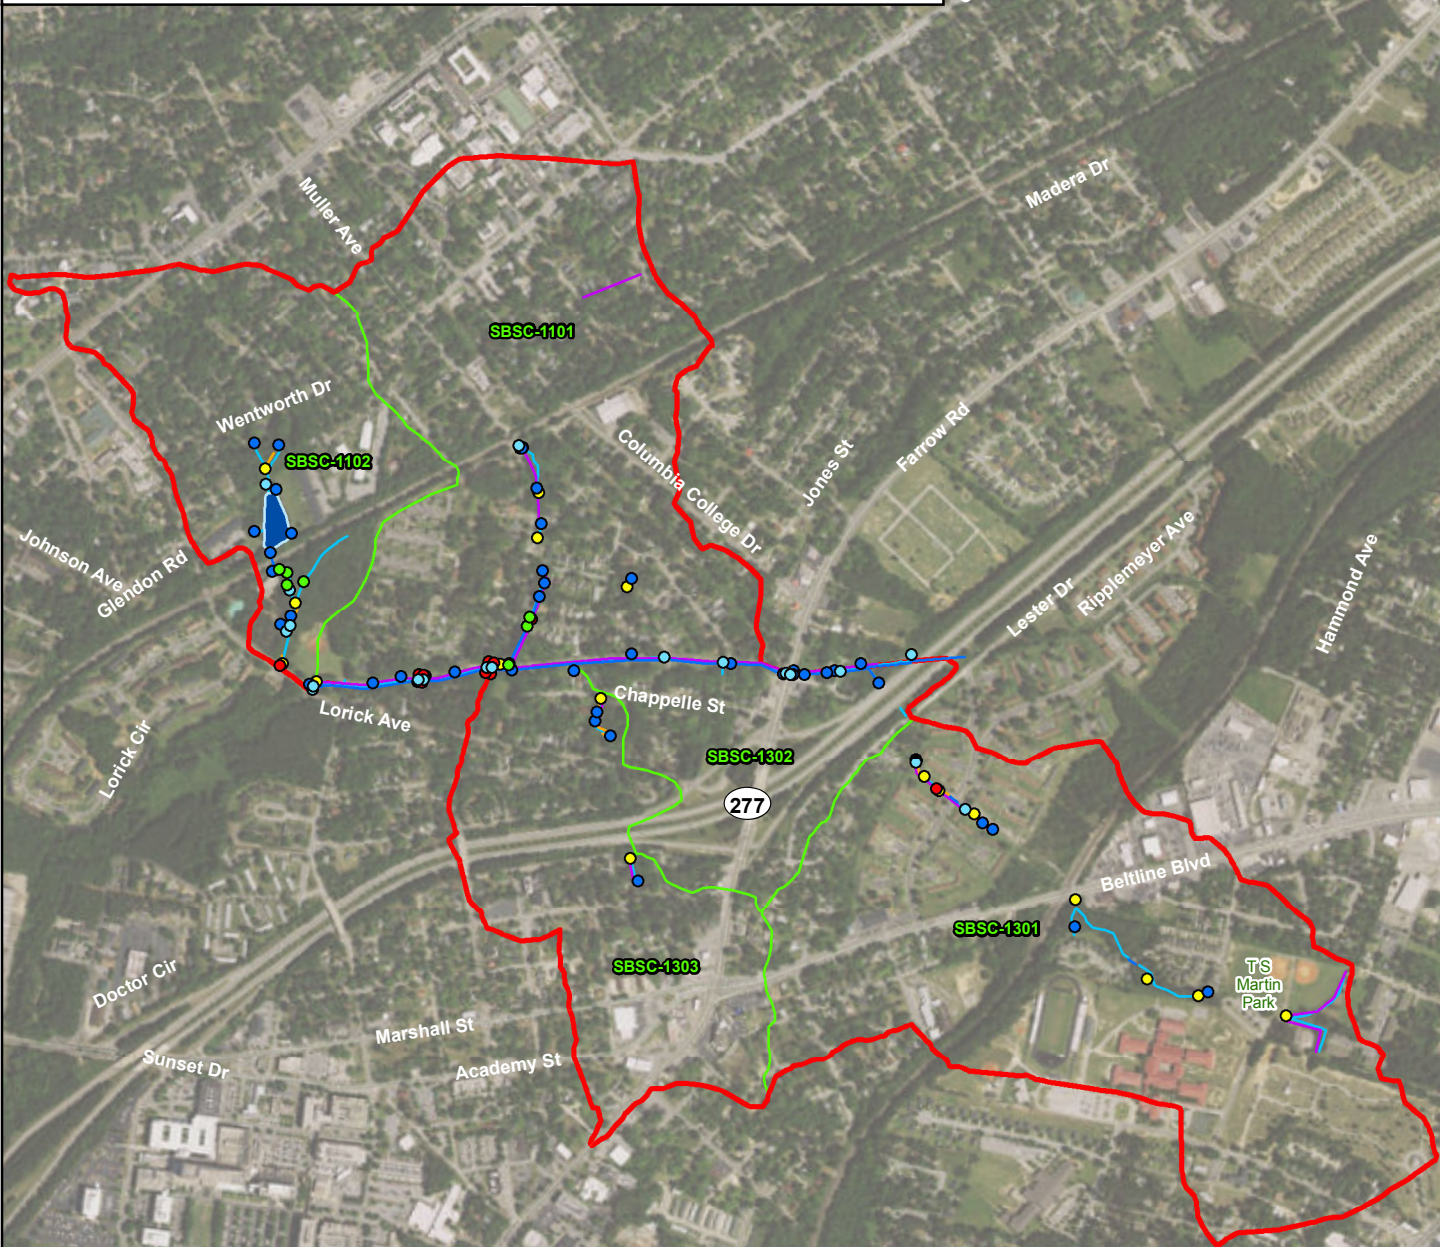
Figure 6.29:  
Subwatershed D  
Existing Conditions

**Figure 6.29** highlights existing conditions that were either captured during the stream cruising effort or developed using GIS data.

Existing Condition	Count
Exposed Pipes	24
Pipe Outfalls	43
Unmanaged Runoff	11
Unusual Condition	19
Trash Dumping	0
Possible Fish Barrier	7
	<b>Linear Feet</b>
Erosion Site	1,268
Channel Alteration	5,121
Inadequate Forest Buffer	13,613

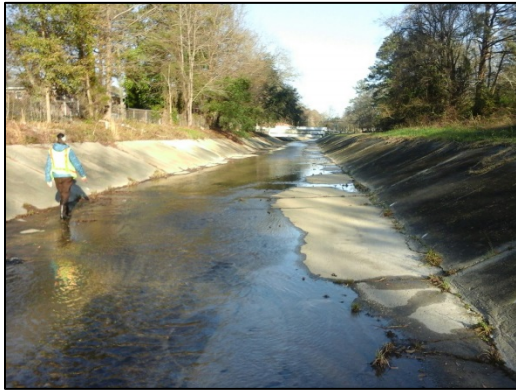
Within SW-D, the upstream extent of Bay Branch mainstem begins west of the culvert underneath SC-277. The stream flows west through a degraded trapezoidal cellular concrete channel. Large sand bars/benches are prevalent within the reach between SC-277 and Shaw Street. At Shaw Street, the condition of the channel changes, the concrete channel downstream of Shaw Street is smooth concrete, less degraded than the upstream reach, and with little to no deposition or vegetation present within the concrete margins. The channel becomes less degraded, with a

wide bed and angled 6-foot banks. This condition continues throughout the Bay Branch mainstem channel, extending downstream to the SW-D boundary at Lorick Avenue. Four significant tributaries are included within SW-D and contribute flow to Bay Branch.

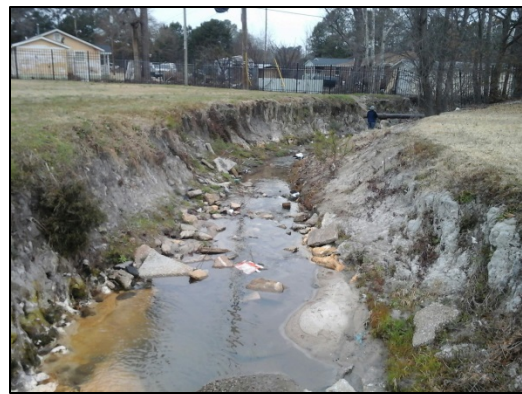
The easternmost tributary in SW-D originates from two grass drainage swales within TS Martin Park, in the southeastern region of the subwatershed. The two swales drain into an 18 inch RCP south of the baseball fields. The pipe is not included in City GIS. It is believed to extend to the western side of Edison Street where open channel originates at a 36 inch RCP outfall. Downstream of Edison Street streambanks are low and vegetated, with only isolated areas of scour. The channel network becomes open and braided further downstream, resembling a scrub-shrub wetland. Flow is conveyed under TS Martin Drive through a 48 inch RCP and continues downstream with wetland-like conditions. A piped section is not included in City GIS, but the channel is likely piped under West Beltline Boulevard and emerges east of Bailey Street. The stream here is channelized within an apartment complex. The banks are mowed to top of bank and lack vegetative protection. Highly erodible bank materials are actively sloughing into the stream. The bed material primarily consists of sand, with some gravel and cobble along the riffles. Channel incision and widening has exposed two sanitary lines and threatens the base of multiple utility poles. The channel is then piped north, emerging for a short distance north of Lester Drive before passing under SC-277 and converging with the Bay Branch mainstem, east of Bethune Court.

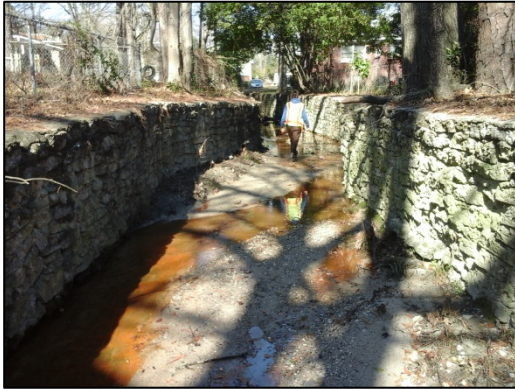
The second major tributary originates from south of SC-277 and west of Farrow Road. Open stream channel originates from a 36 inch RCP southwest of the intersection of Water Street and Adams Street. The tributary is then piped north under SC-277. Another segment of open channel originates from 52 inch RCP west of Water Street between Chappelle Street and Lorick Avenue. A third of the banks within this segment are actively eroding where the channel is tightly confined between private residential properties. The stream is piped underneath Chappelle Street then emerges from a 48 inch RCP into the Bay Branch mainstem east of Colonial Drive.

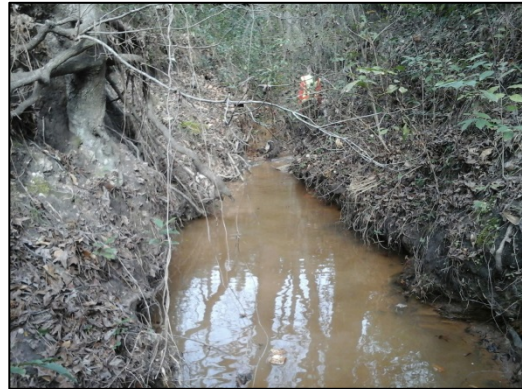
The upstream extent of the fourth major tributary initiates in a forested parcel south of Wentworth Drive and east of Kinderway Avenue. Streambanks are mostly stable and well vegetated, with some isolated areas of moderate erosion. Channel substrate consists of silt and sand, with some gravel along the riffles. Downstream, the stream is routed through a large pond before passing underneath railroad tracks to the south and entering Lorick Park. The railroad culvert appears to be blocked on the downstream side by riprap recently placed on the embankment face. Downstream of the railroad, the channel is incised with 7-foot banks, thick established vegetation, and bedrock at the toe and in the bed. A wetland seep flows into this tributary north of the baseball diamond. Stream conditions change downstream of the confluence; the bank heights lower and the understory vegetation thins as the stream enters the maintained section of the park. Bed substrate changes to primarily gravel with substantial quantities of sand and cobble. The stream is then piped along Lorick Avenue, and enters Bay Branch immediately upstream of the Lorick Avenue crossing.

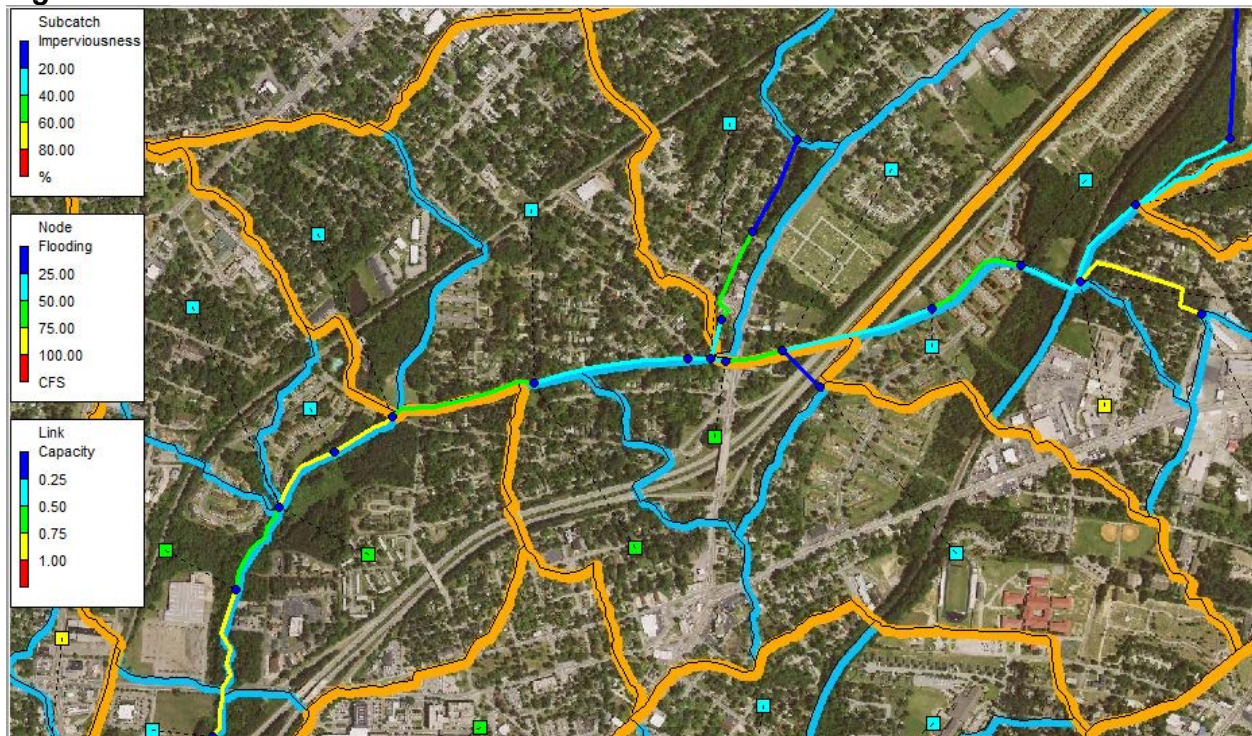
**Figure 6.30 SW-D SWMM Model**

SW-D is modeled in SWMM as five subcatchments on either side of Bay Branch. Bay Branch is a concrete-lined trapezoidal channel as it flows through the subwatershed. Due to the low Manning's roughness of concrete, water in this channel will flow at higher velocities. Where the concrete-lined portion of the channel ends, the flow is modeled to enter a backwater condition, causing the link to near its capacity, changing the mapped color to yellow (**Figure 6.30**) at 88% modeled capacity.

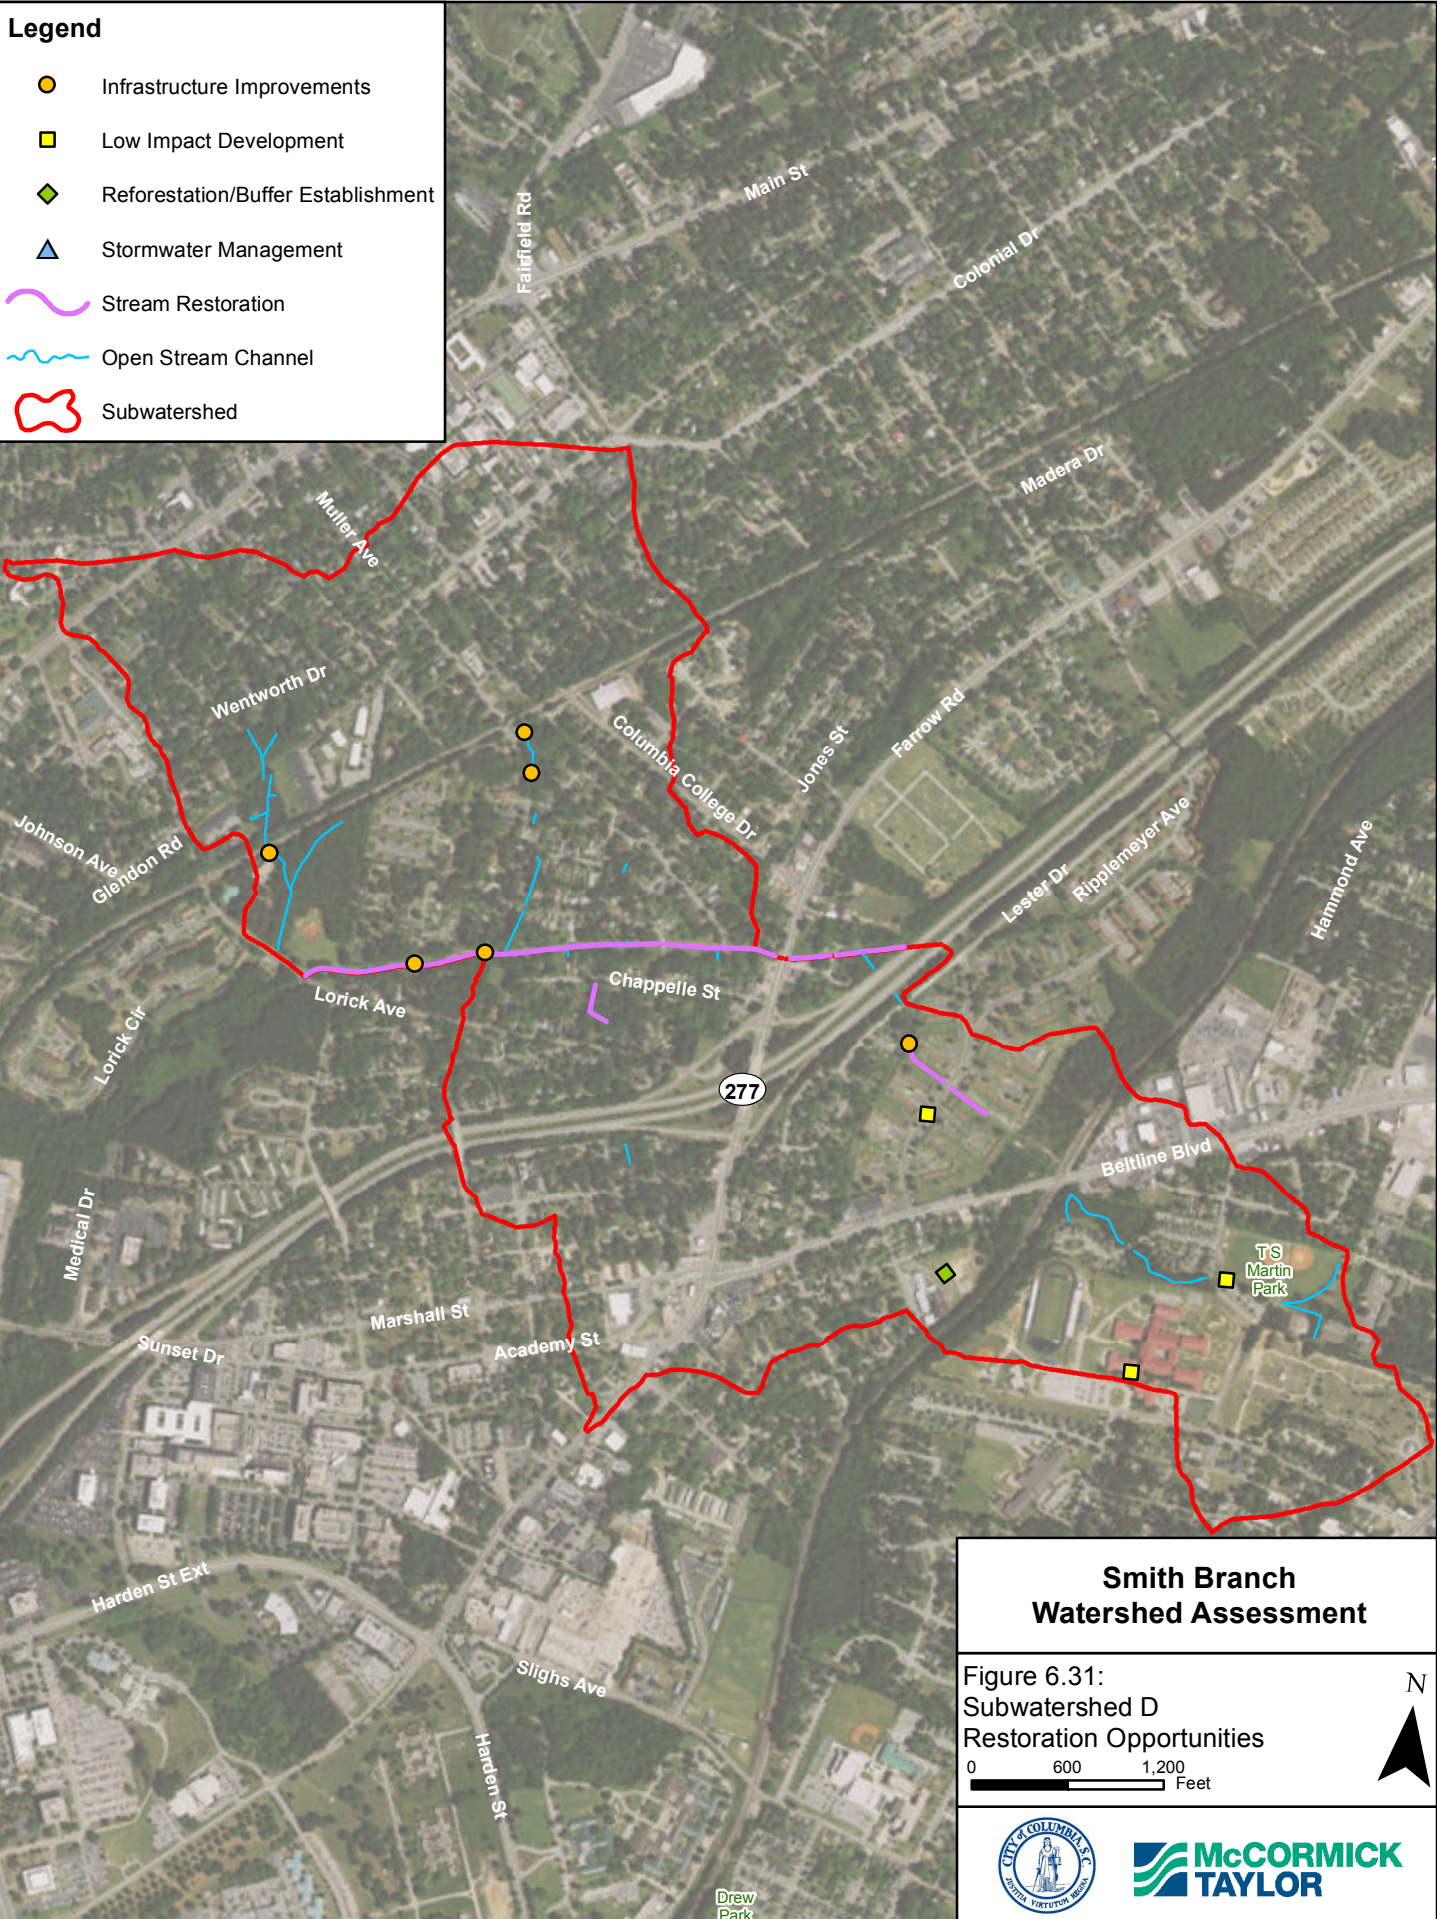
The following projects or similar improvements may be considered to address conditions identified in SW-D. These projects are included in **Figure 6.31**.

- As this catchment continues to develop, the development should occur in accordance with the City of Columbia BMP Manual, particularly Sections 1.2.1 and 1.2.3.
- Move the utility lines bracketed to the bridges at Grand Street and Colonial Drive.
- Repair the exposed water line and damaged outfalls south of Seaboard Avenue.

- Repair the exposed sanitary line suspended above the bed southeast of Lester Drive.
- Opportunities for infiltration and storage should be investigated here to reduce peaks downstream.

- Install bioretention areas and downspout disconnection for the parking lots of Watkins-Nance Elementary School and W.A. Perry Middle School.
- Stabilize banks and outfalls along the straightened and denuded stream segment within the Colony Apartments.

- Stabilize the banks of the channel south of Chappelle Street.
- Restore the trapezoidal concrete channel within the mainstem of Bay Branch to a more natural condition to help reduce peaks by allowing water to slow and infiltrate in more natural flow patterns.

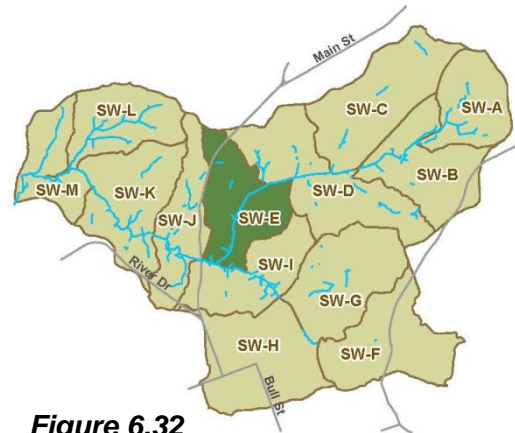
**Figure 6.32**  
**Subwatershed E**

- Subwatershed E (SW-E) is centrally located to the north within the Smith Branch watershed.
- SC-277 is adjacent to the eastern boundary of SW-E, the northeast boundary roughly follows Lorick Avenue, and the western boundary roughly follows North Main Street and Monticello Road. The northernmost point in SW-E is within the Keenan House property.
- 342 acres or 0.53 square miles in drainage area
- Contains approximately 1.37 miles of open stream channel, and 2.80 miles of mapped storm drain/pipe
- Dominant land use designations (**Figure 6.1, Table 6.1**):
  - Developed, Low Intensity: 41%
  - Developed, Medium Intensity: 25%
- Impervious surface cover: 40%

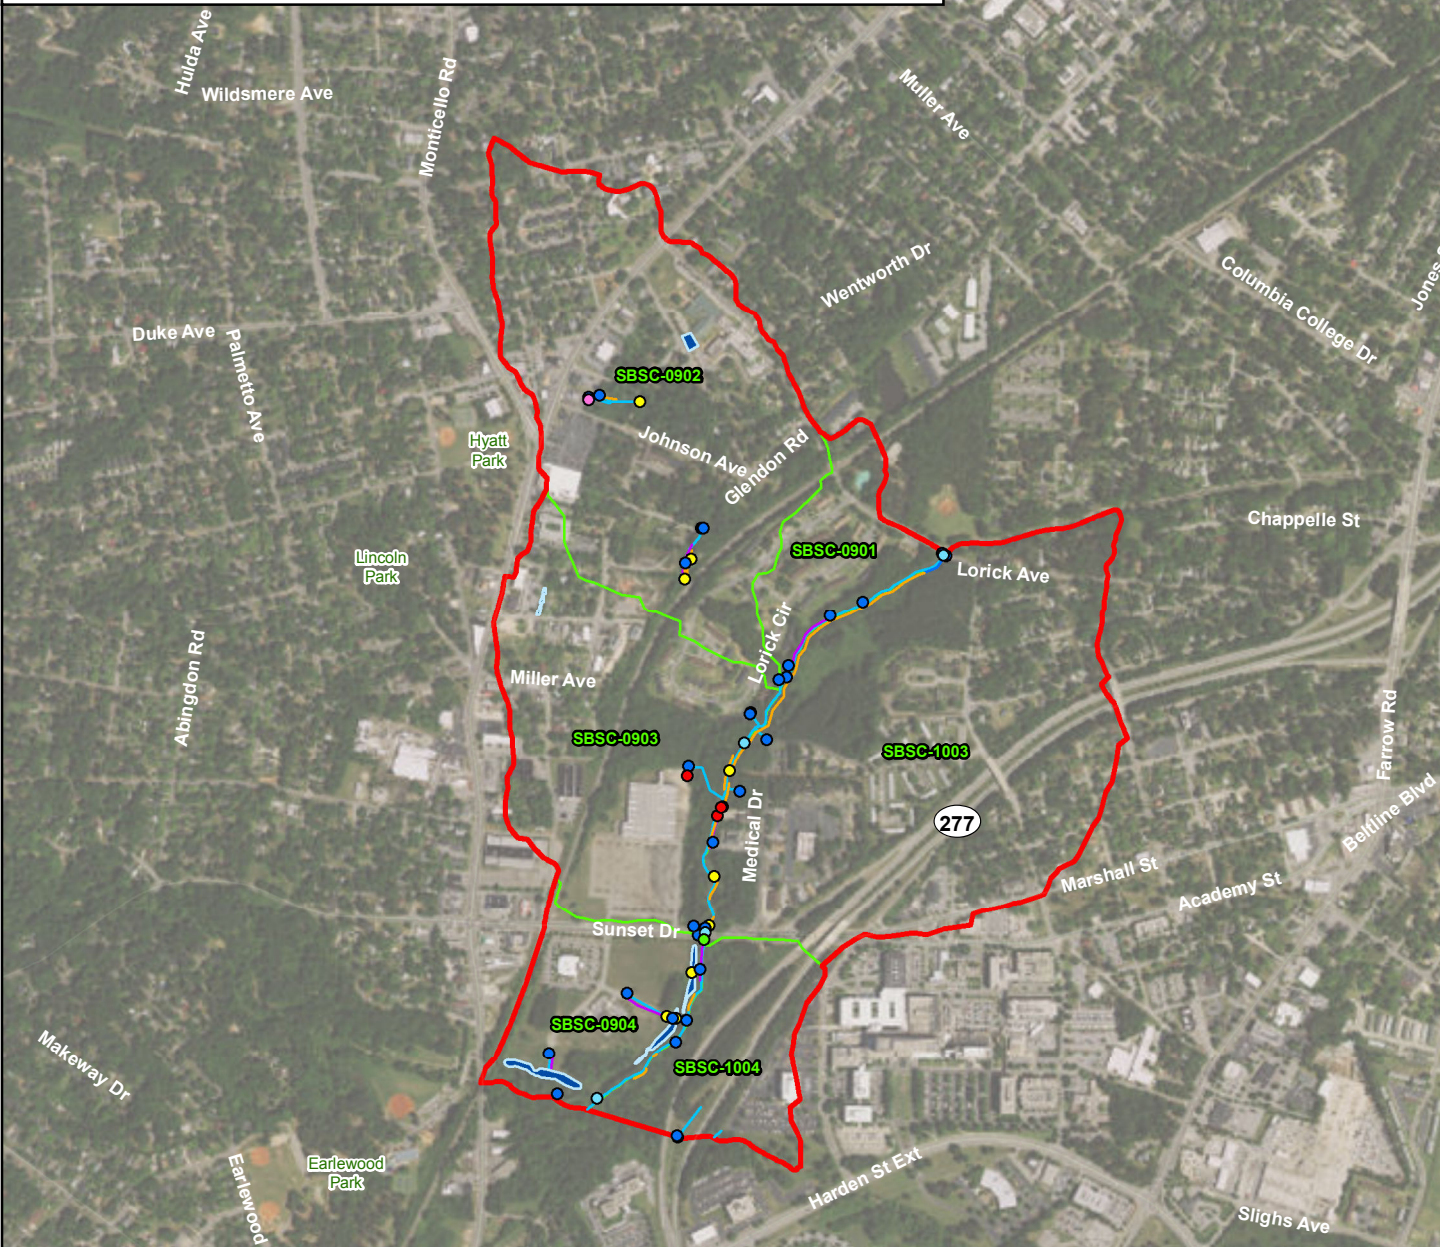
Figure 6.34:  
Subwatershed E  
Existing Conditions

**Figure 6.34** highlights existing conditions that were either captured during the stream cruising effort or developed using GIS data.

Existing Condition	Count
Exposed Pipes	4
Pipe Outfalls	29
Unmanaged Runoff	3
Unusual Condition	11
Trash Dumping	1
Possible Fish Barrier	1
	<b>Linear Feet</b>
Erosion Site	4,901
Channel Alteration	234
Inadequate Forest Buffer	2,433

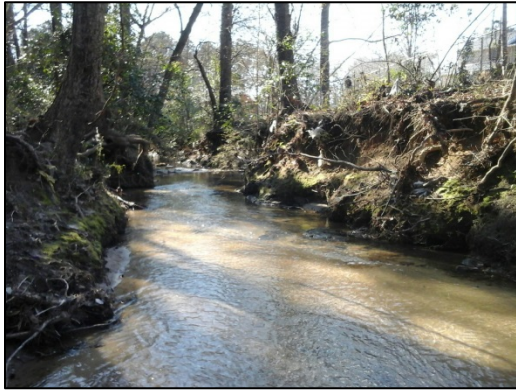
The upstream extent of the main channel (Bay Branch) in SW-E begins at the Lorick Avenue crossing. The channel bed and banks are initially concrete, changing to natural channel approximately 170 feet downstream of Lorick Avenue. Paralleling Lorick Circle and flowing in a south/southwest direction the channel is entrenched and straight. The cross-sectional area through this reach is significantly smaller than the concrete channel immediately upstream, combined with the increased roughness within the natural channel segment, a backwater condition would be anticipated

as flood flows leave the concrete channel downstream of Lorick Avenue. Channel incision and widening has begun to threaten surrounding infrastructure through this reach. Bedrock is now likely slowing the rate of incision and widening as past erosion has exposed bedrock in the bed and banks. Channel substrate consists of a mix of sand, gravel, and cobble, with bedrock exposed in cascades and riffles.

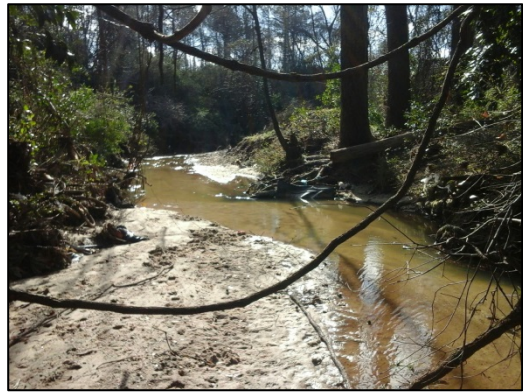
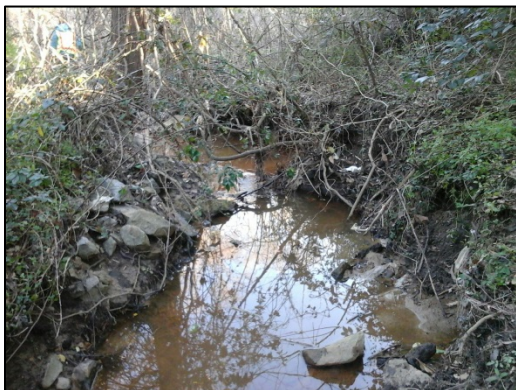
Along Bay Branch downstream of Lorick Circle, erosion continues to impact the streams surrounding environment and threatens overhead utility poles, sanitary lines, and the parking lot of the Alston Wilkes Veterans Home off Medical Drive. Downstream of the Veterans Home parking lot, sinuosity increases, and there is isolated erosion at the outside of bends with depositional point bars on the inside. The percent sand increases within the bed through this reach, with some gravel and cobble along riffles. The stream extends through a quad box culvert under Sunset Drive. Downstream of the quad culvert is an 18-inch vertical baseflow water surface drop. Downstream of Sunset Drive, the substrate is primarily sand. The banks are fairly stable and well established with woody vegetation. A few areas of isolated minor to moderate erosion exist, undercutting trees and scouring the outside of bends. Bay Branch within SW-E concludes at the downstream subwatershed boundary, where it flows into the mainstem of Smith Branch.

There are two isolated stream segments within the central and northern portions of the subwatershed. They are connected through a storm drain network. The upstream and northernmost segment originates from a 24 inch CPP outfall east of North Main Street, between Jackson and Johnson Avenues. Incision has led to bank instability within the upstream 130 feet of open channel. Bed material consists primarily of cobble with some sand and gravel. The stream drops several feet into an inlet south of the Marsteller Street and Jackson Avenue intersection. Flow is then piped

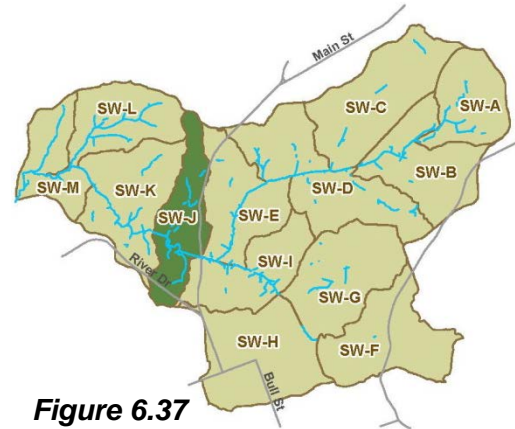
**Figure 6.37**  
**Subwatershed J**

- Subwatershed J (SW-J) contains Hyatt, Lincoln, and Earlewood Parks, as well as the historic Keenan House.
- The northern boundary crosses Monticello Road at Joan Street, the eastern boundary roughly parallels Main Street, the southern boundary is the Union and Clark Streets intersection, and Abingdon Drive is the westernmost boundary.
- 285 acres or 0.45 square miles in drainage area
- Contains 1.68 miles of open stream channel, and 1.94 miles of mapped storm drain/pipe
- Dominant land use designations (**Figure 6.1, Table 6.1**):
  - Developed, Low Intensity: 40 %
  - Developed open space: 25 %
- Impervious surface cover: 33%

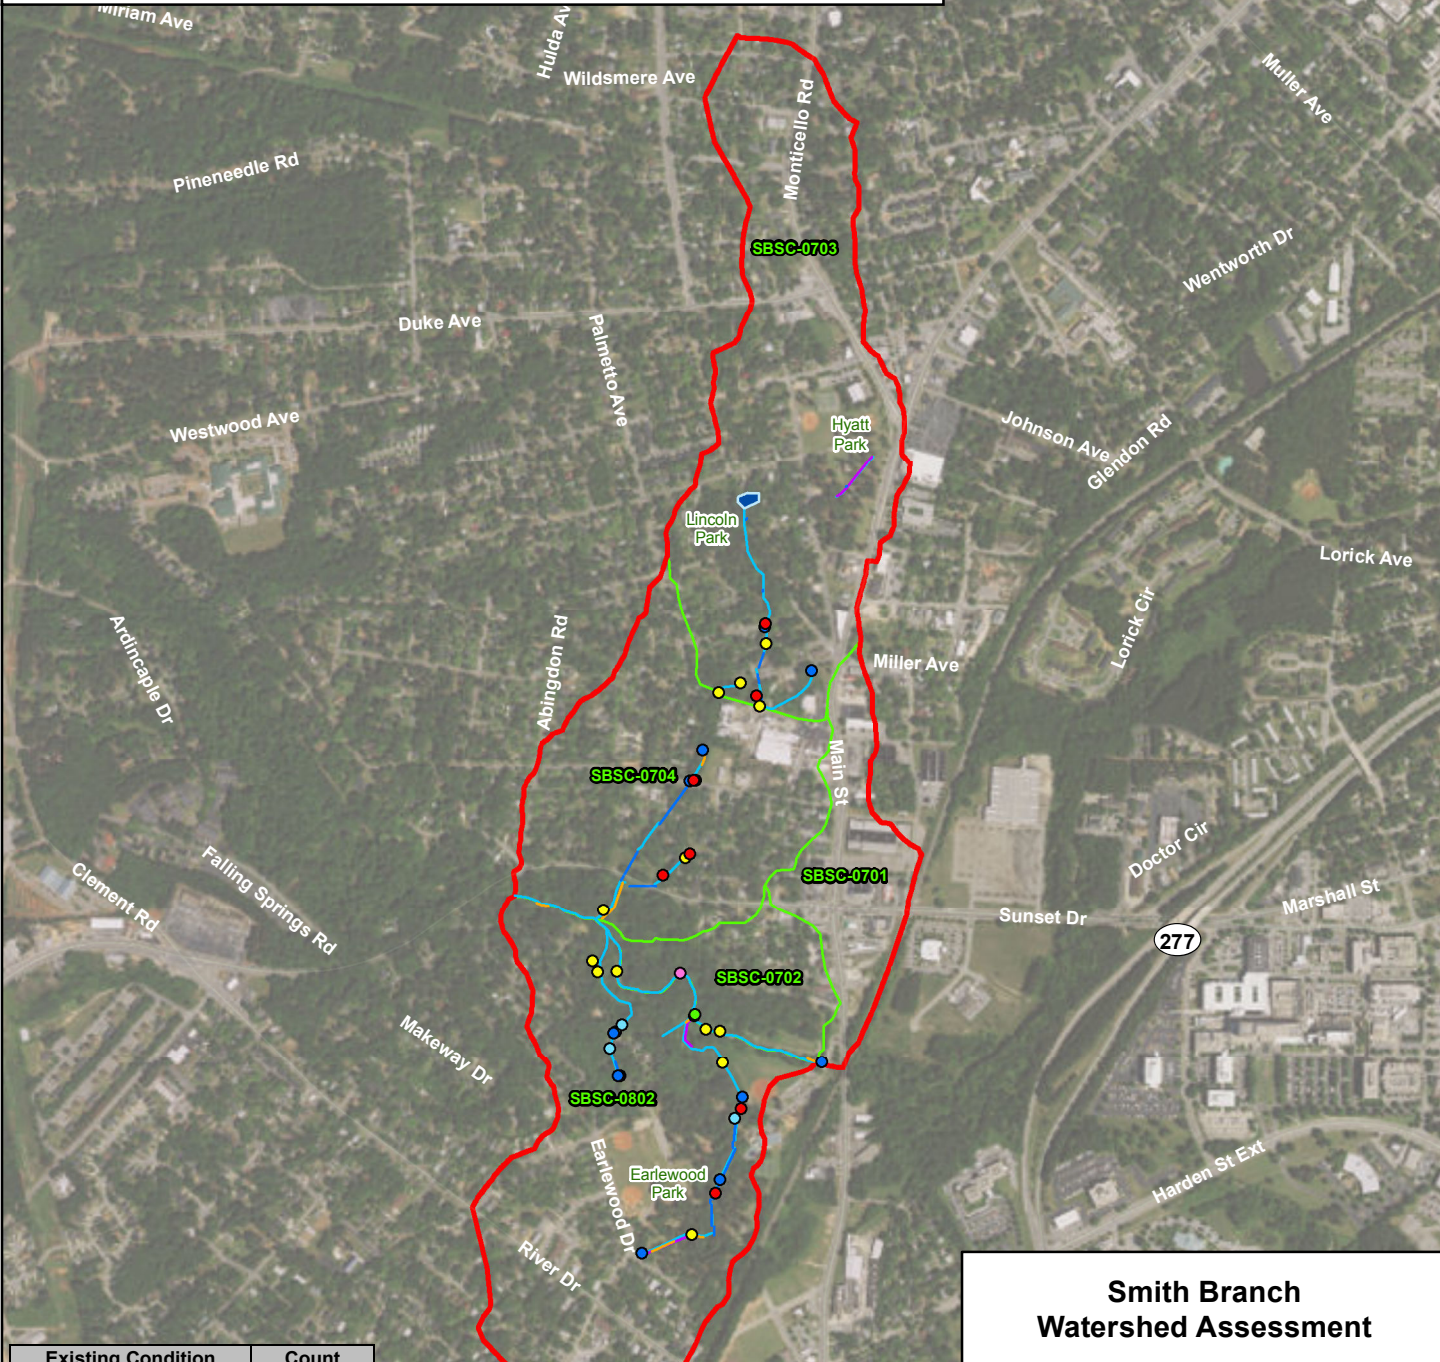
Figure 6.39:  
Subwatershed J  
Existing Conditions

**Figure 6.39** highlights existing conditions that were either captured during the stream cruising effort or developed using GIS data.

Existing Condition	Count
Exposed Pipes	3
Pipe Outfalls	12
Unmanaged Runoff	7
Unusual Condition	15
Trash Dumping	1
Possible Fish Barrier	1
	<b>Linear Feet</b>
Erosion Site	1,380
Channel Alteration	1,934
Inadequate Forest Buffer	2,670

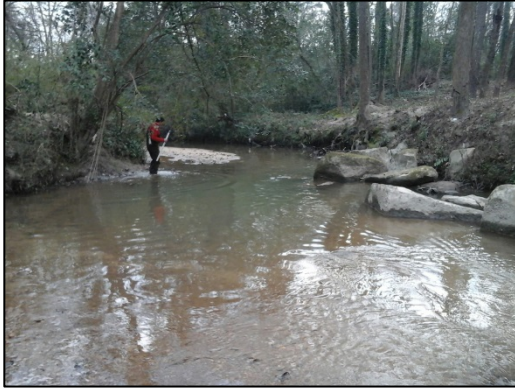
Within SW-J the upstream extent of the Smith Branch mainstem begins within Earlewood Park, approximately 120 feet west of Main Street. Banks along this segment are fairly stable, with mature vegetation offering protection. A beaver dam, approximately 800 feet downstream, has created a backwater that extends throughout the upstream limit of this segment. Downstream of the beaver dam, the channel is more sinuous. Banks remain vegetated and stable, and large point bars have formed throughout. Substrate primarily consists of sand, with boulder and

cobble along riffles. The downstream extent of the mainstem segment within SW-J is approximately 80 feet south of the Sunset Drive Summerlea Drive intersection.

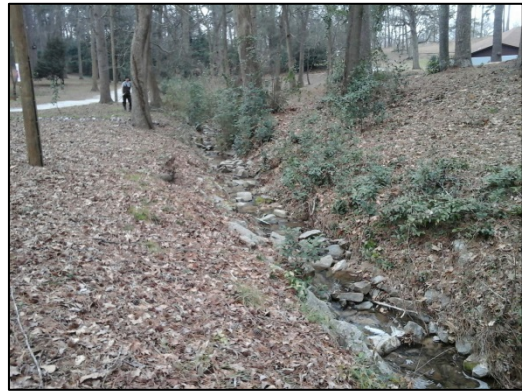
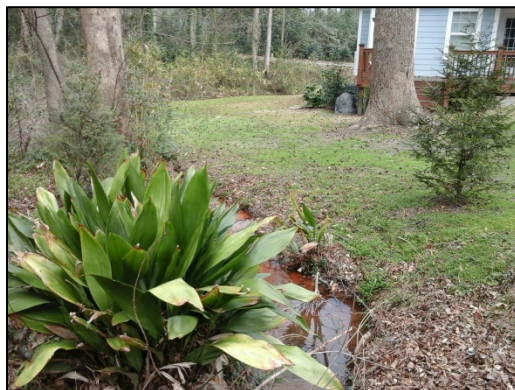
Three large tributaries drain to the Smith Branch mainstem within SW-J. The first and easternmost tributary flows into the mainstem 275 feet west (downstream) of Earlewood Park. This stream channel initiates northeast of the Earlewood Drive and Union Street intersection from a 24 inch, concrete outfall. The steep gradient downstream of the outfall has resulted in the migration of a headcut up the slope. The stream extends downstream through multiple small culverts associated with park paths. Substrate in this tributary is primarily riprap, with sand and cobble filling voids between the boulders. Downstream, north of Parkside Drive, the channel is not clearly defined due to a large beaver dam downstream that has created a wetland-like area. Downstream of the beaver dam, the stream lacks a defined single thread channel as it flows through a mudflat and drains into the mainstem at multiple points.

Downstream, the second tributary joins the Smith Branch mainstem from the left bank. The open channel begins upstream from two 18 inch RCP outfalls extending under Keenan Drive, east of the Makeaway Drive and Earlewood Drive intersection. Flow is directed almost immediately under a driveway and continues adjacent single-family residences. The stream is piped under Keenan Drive; upon its exit into the Smith Branch floodplain, the channel becomes less defined as it enters a floodplain wetland complex. The tributary continues downstream roughly parallel to the

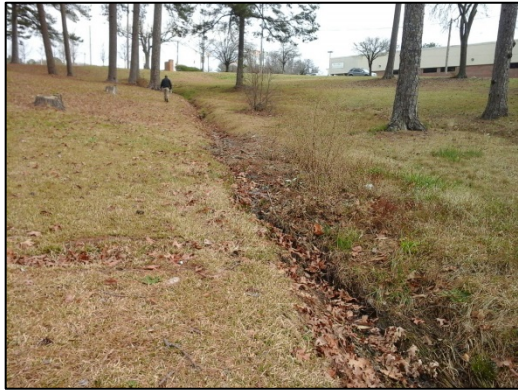
Approximately 90 feet downstream of the second tributary confluence, the third tributary joins the Smith Branch mainstem from the right bank. Upstream limits of this tributary begins within a wet swale in Hyatt Park. The stream is piped from Hyatt Park to south of Miller Avenue,

where the channel is more entrenched with thick vegetation stabilizing the banks. There is a confluence point southeast of the Miller Avenue and Ridgewood Avenue intersection with another tributary originating from Lincoln Park. The stream segment originating from Lincoln Park is characterized by low, stable banks with heavy vegetation and a sandy bed. Downstream, the channel is piped along a large commercial property southeast of the Miller Avenue and Ridgewood Avenue intersection. Open stream channel emerges from a 60 inch RCP northeast of the

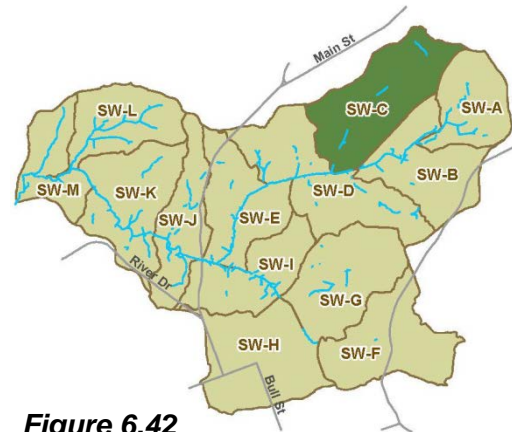
**Figure 6.42**  
**Subwatershed C**

- Subwatershed C (SW-C) is the northernmost subwatershed within the Smith Branch watershed.
- The SW-C boundaries are defined by SC-277 to the southeast, Muir Street to the north, Colonial Drive to the northwest/west, and the southernmost point lies approximately 200 feet west of the Farrow Road, Bethune Court intersection
- 463 acres or 0.72 square miles in drainage area
- Contains 0.52 miles of open stream channel, and 1.62 miles of mapped storm drain/pipe
- Dominant land use designations (**Figure 6.1, Table 6.1**):
  - Developed, Low Intensity: 45%
  - Developed, Medium Intensity: 23%
  - Developed, Open Space: 23%
- Impervious surface cover: 31%

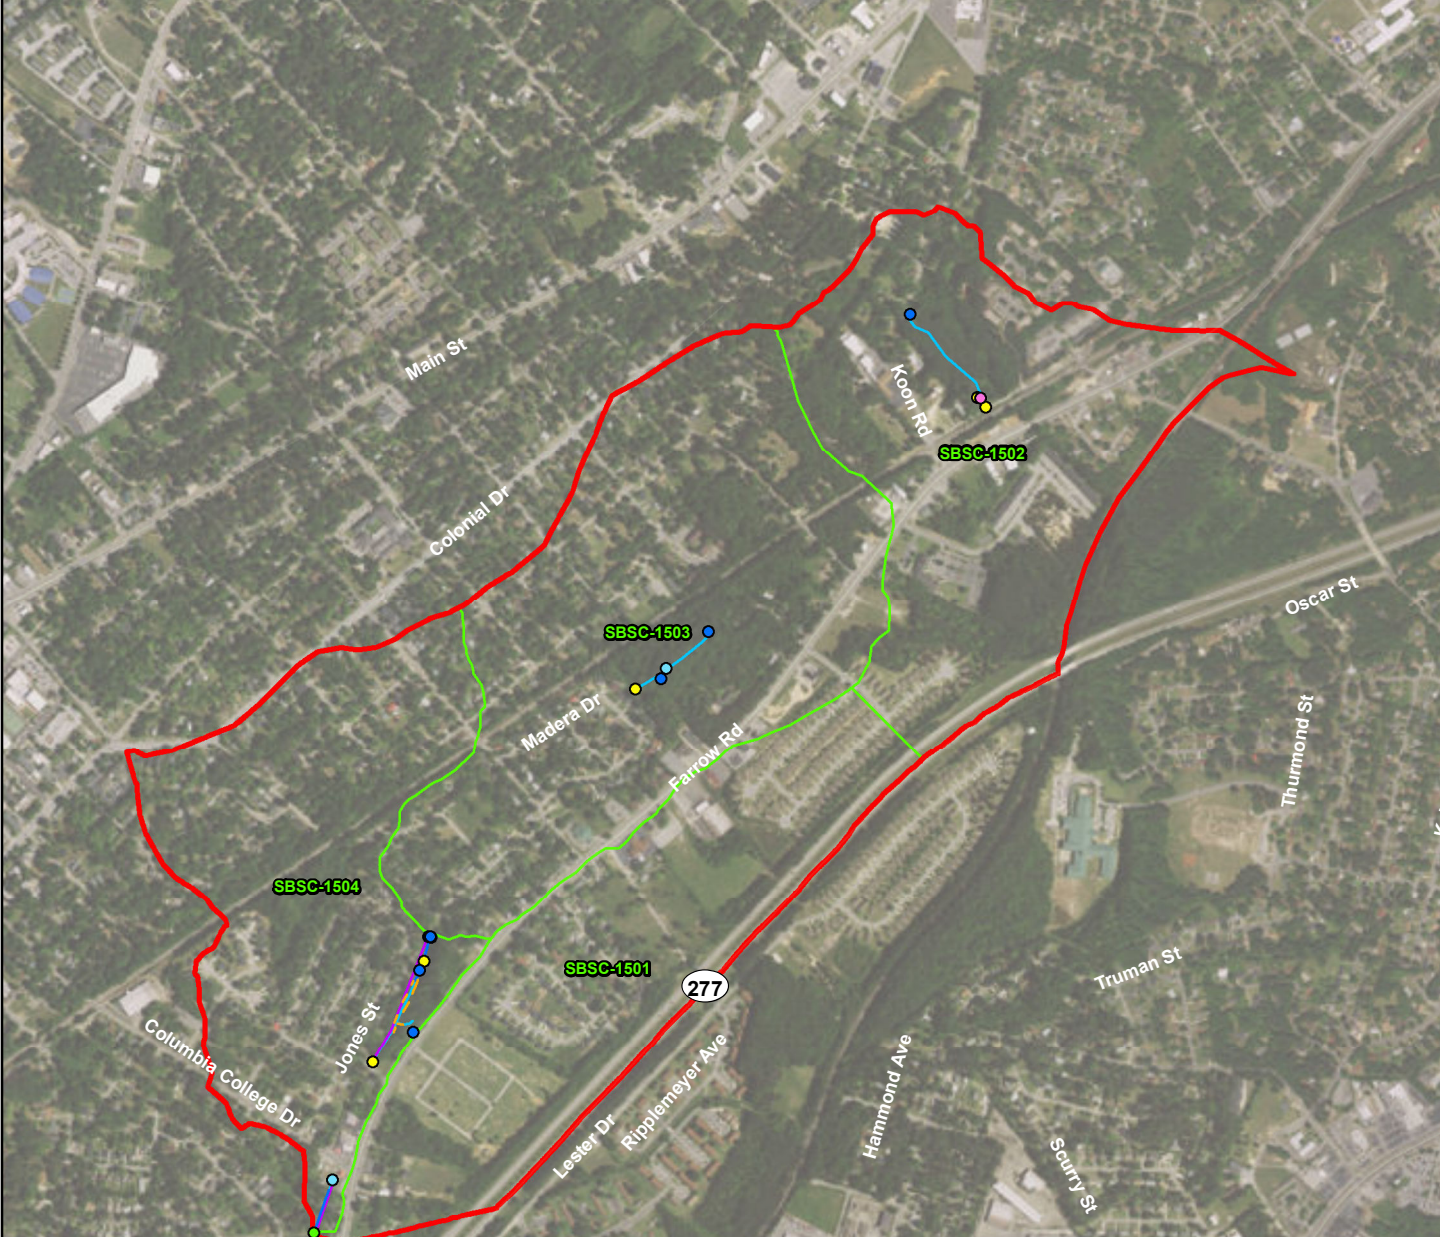
Figure 6.44:  
Subwatershed C  
Existing Conditions

**Figure 6.44** highlights existing conditions that were either captured during the steam cruising effort or developed using GIS data.

Existing Condition	Count
Exposed Pipes	2
Pipe Outfalls	9
Unmanaged Runoff	0
Unusual Condition	5
Trash Dumping	1
Possible Fish Barrier	1
	Linear Feet
Erosion Site	403
Channel Alteration	631
Inadequate Forest Buffer	1,554

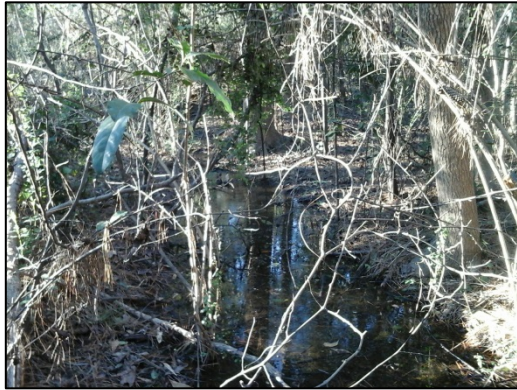
There are four open channel segments in SW-C. The upstream segment begins at an outfall on the south side of Koon Road and flows through a densely vegetated area before entering a pipe at Ames Road. Channel substrate is comprised of mostly sand and silt. Stream banks are very low, there are various locations of split flow and points where the channel takes on wetland like characteristics with shallow low velocity flow and subtly defined bank margins dense with vegetation.

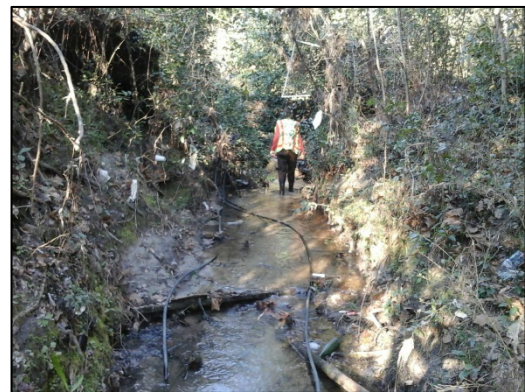
Immediately downstream of the grouted segment the banks become sheer and near vertical, and consist of highly erodible materials. Sediment deposition has created small point bars, and riprap and brick in the bed alter flow. A small tributary with a severe headcut contributes flow to the receiving channel approximately 280 feet downstream of the end of concrete channelization. This tributary appears to collect drainage from Farrow Road and an outfall point was collected in the location of suspected drainage along the western side of Farrow Road and is discussed further below. The main open stream channel in this segment enters a 48 inch RCP under Isabel Street.

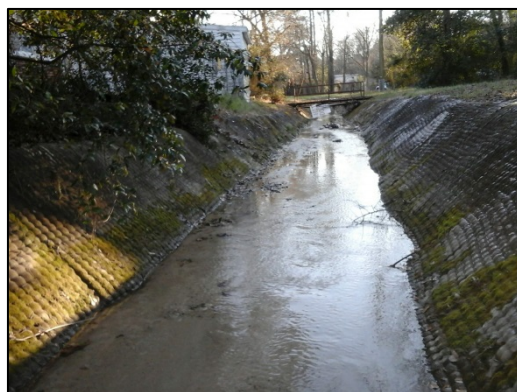
The downstream most segment of open channel emerges from a 48-inch CMP with a grouted stone headwall south of Columbia College Drive. A 6-inch smooth metal pipe utility crosses the downstream opening of the 48-inch CMP. The left bank is steep and layered with thick vegetation. Approximately 70 feet downstream of the culvert, the stream is channelized with concrete bed and banks. Fine sand deposits are extensive throughout the stream bed within the concrete channel. The stream converges with the receiving main channel (Bay Branch) at the
