Rocky Branch Watershed Management Plan

# ROCKY BRANCH WATERSHED ASSESSMENT

McCormick Taylor Inc., supported by KCI Technologies, Inc., has been contracted by the City of Columbia, South Carolina to conduct an assessment of the Rocky Branch watershed to identify potential improvement opportunities to identify existing flooding and water quality conditions.

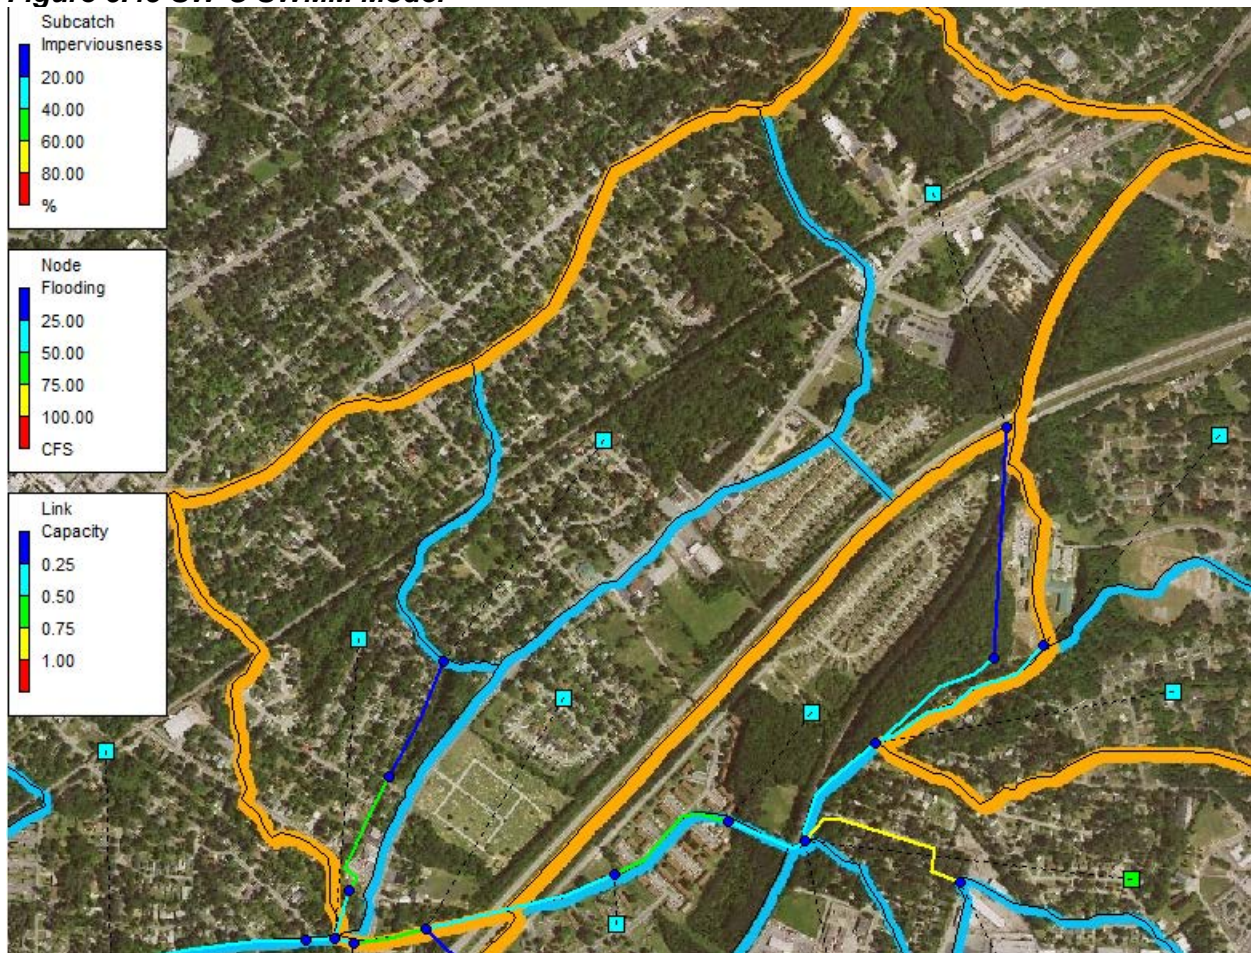
**Figure 6.45 SW-C SWMM Model**

SW-C is modeled as four subcatchments in SWMM. Its suburban nature and undeveloped areas can be seen in **Figure 6.45** below. There is a 48 inch RCP, mapped in green below, at the southern end of this subwatershed that is already at approximately 60% modeled capacity during the 2-year event.

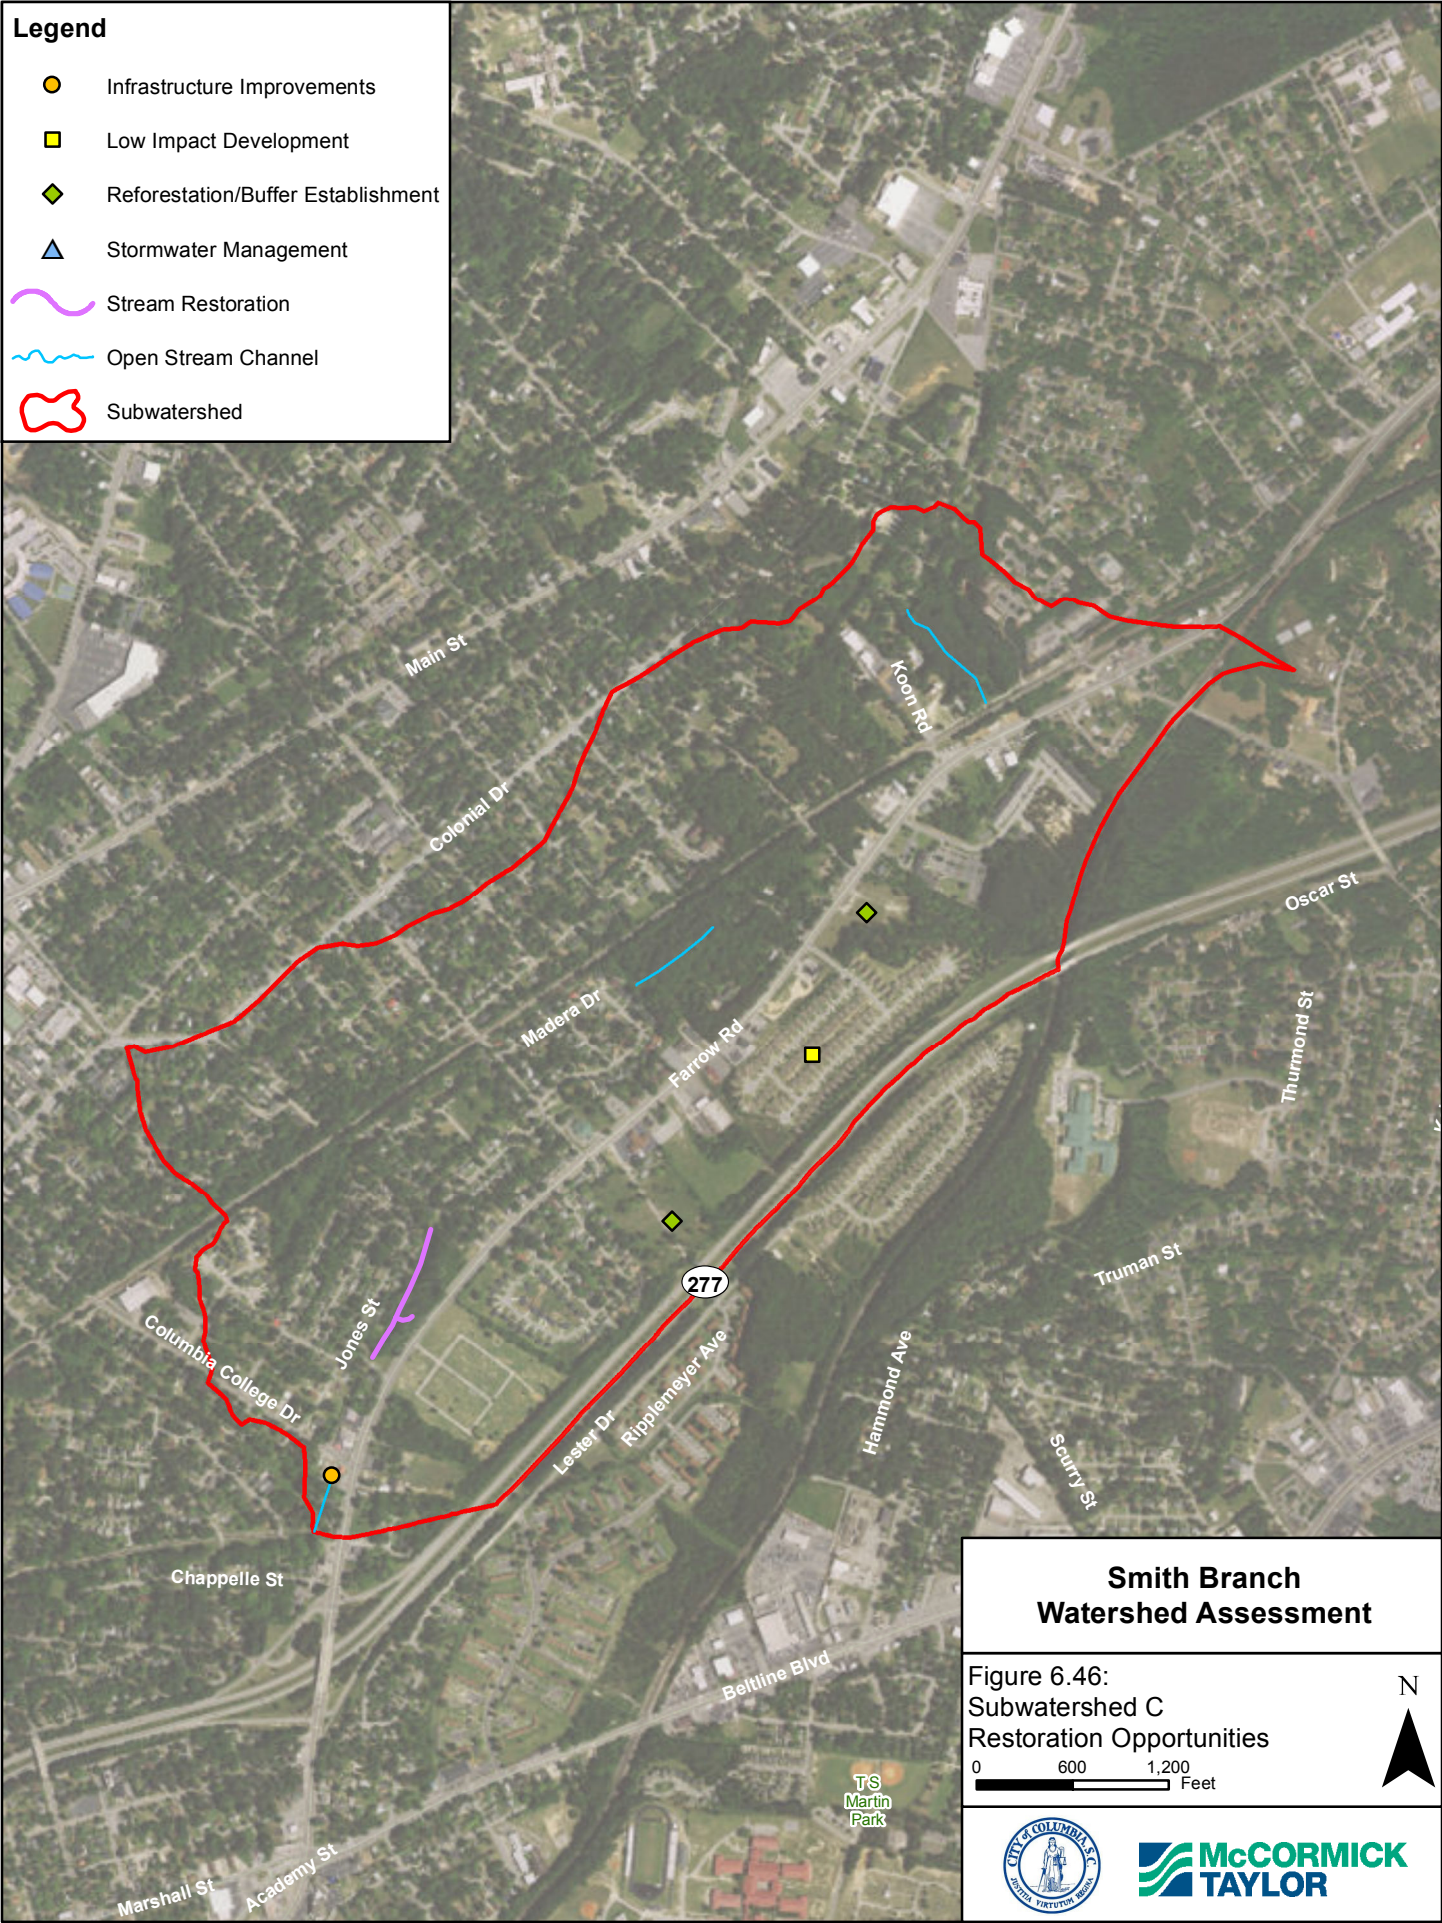
Figure 6.46:  
Subwatershed C  
Restoration Opportunities

The following projects or similar improvements may be considered to address conditions identified in SW-C. These projects are included in **Figure 6.46**.

- Opportunities for infiltration and storage should be investigated here to reduce peaks downstream due to its location on the edge of the watershed draining to Bay Branch.

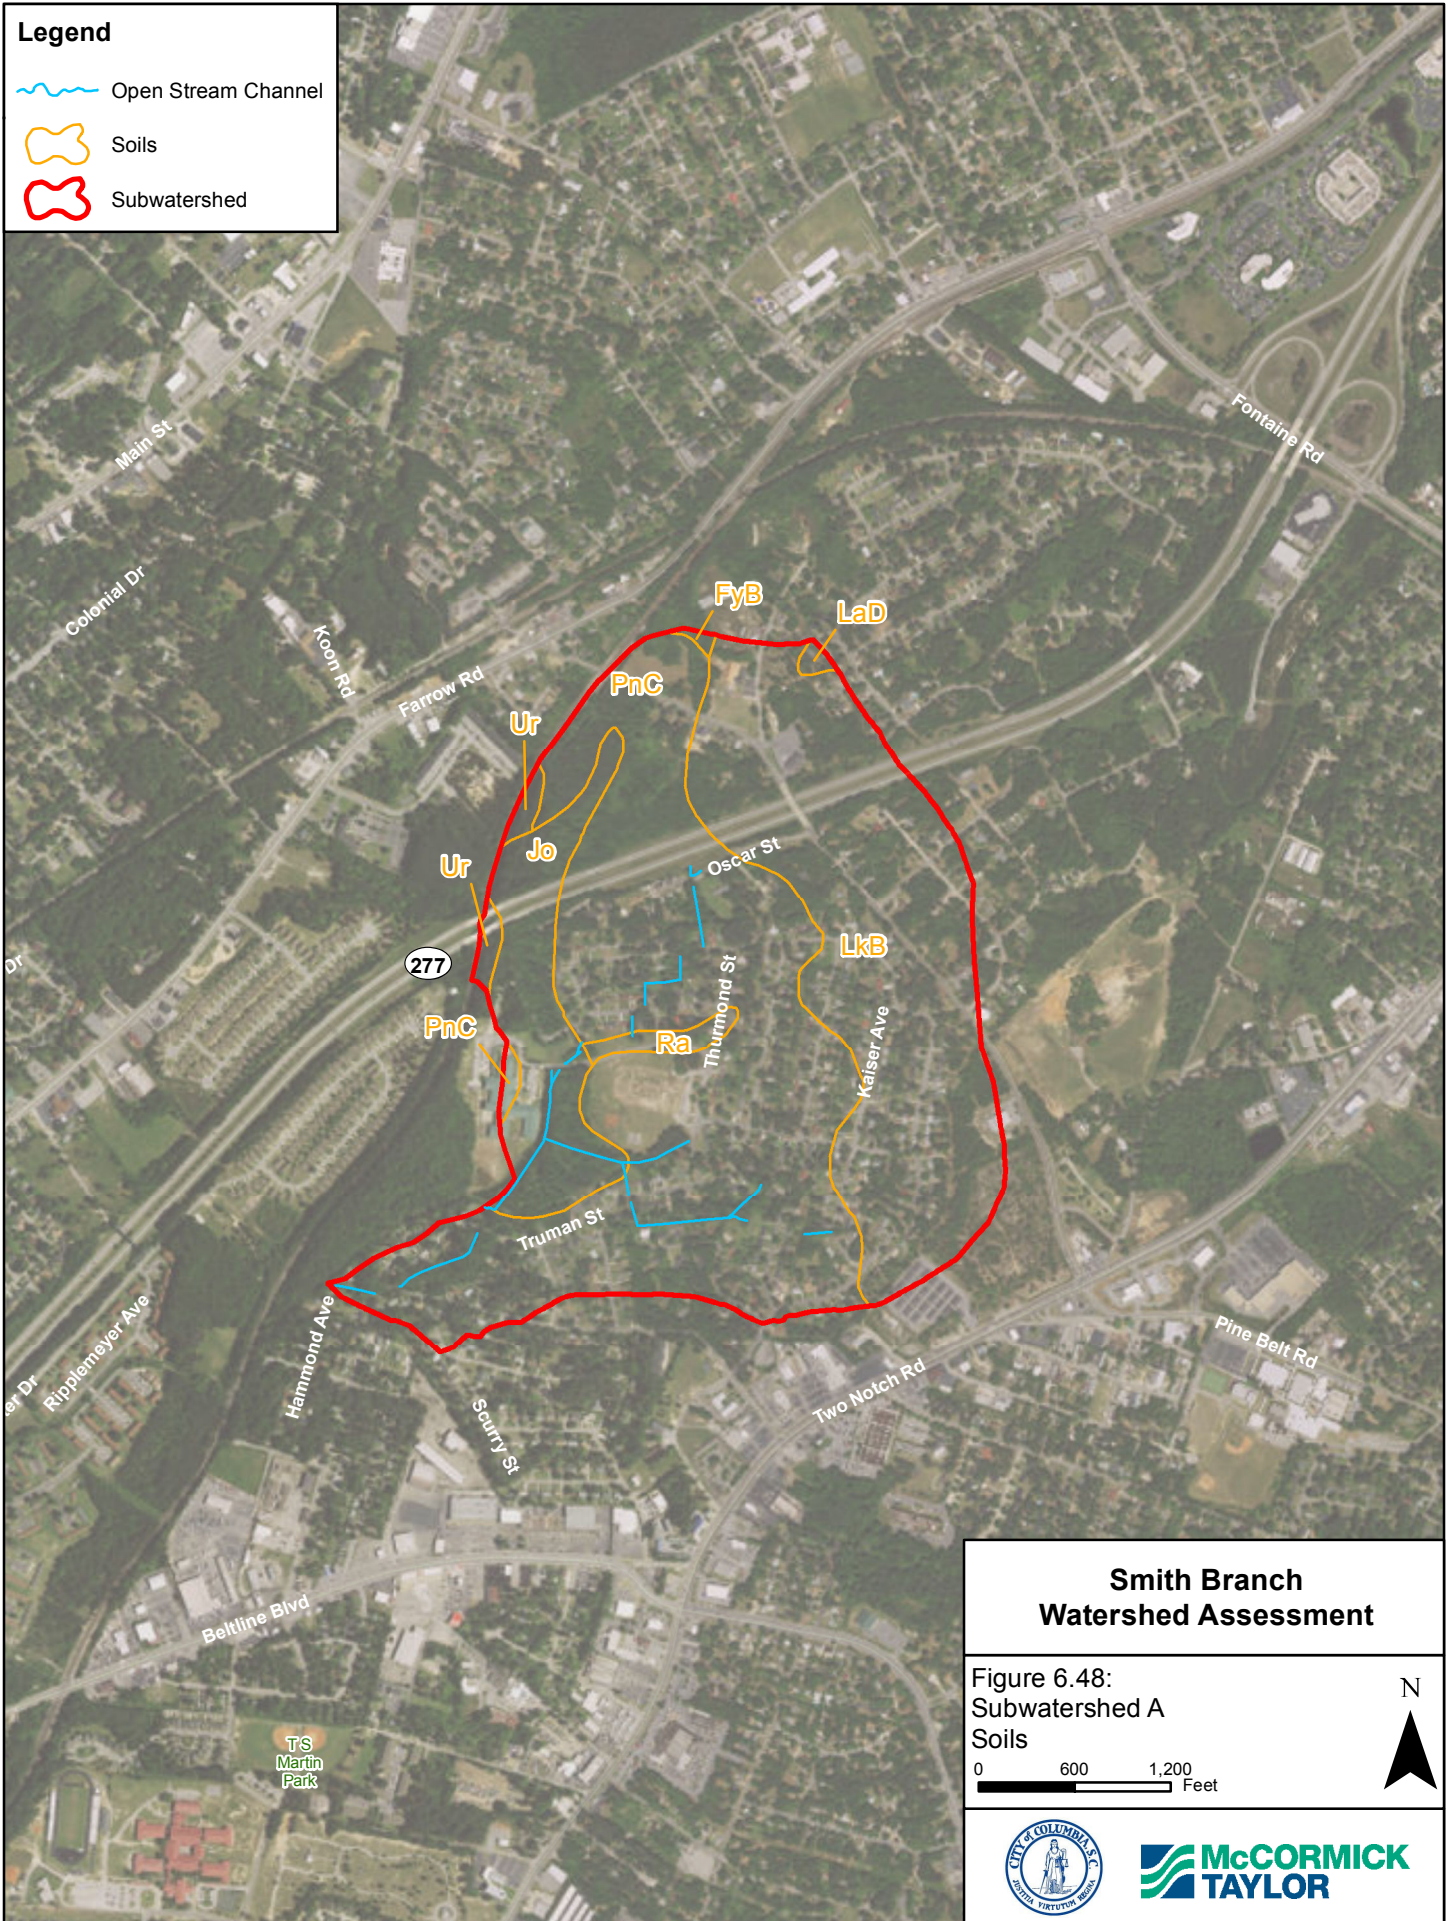
Figure 6.48:  
Subwatershed A  
Soils

**Soils:** Approximate soil type percentages within SW-A include (refer to **Section 3.4** for soil descriptions and **Figure 6.48** for soil distributions):

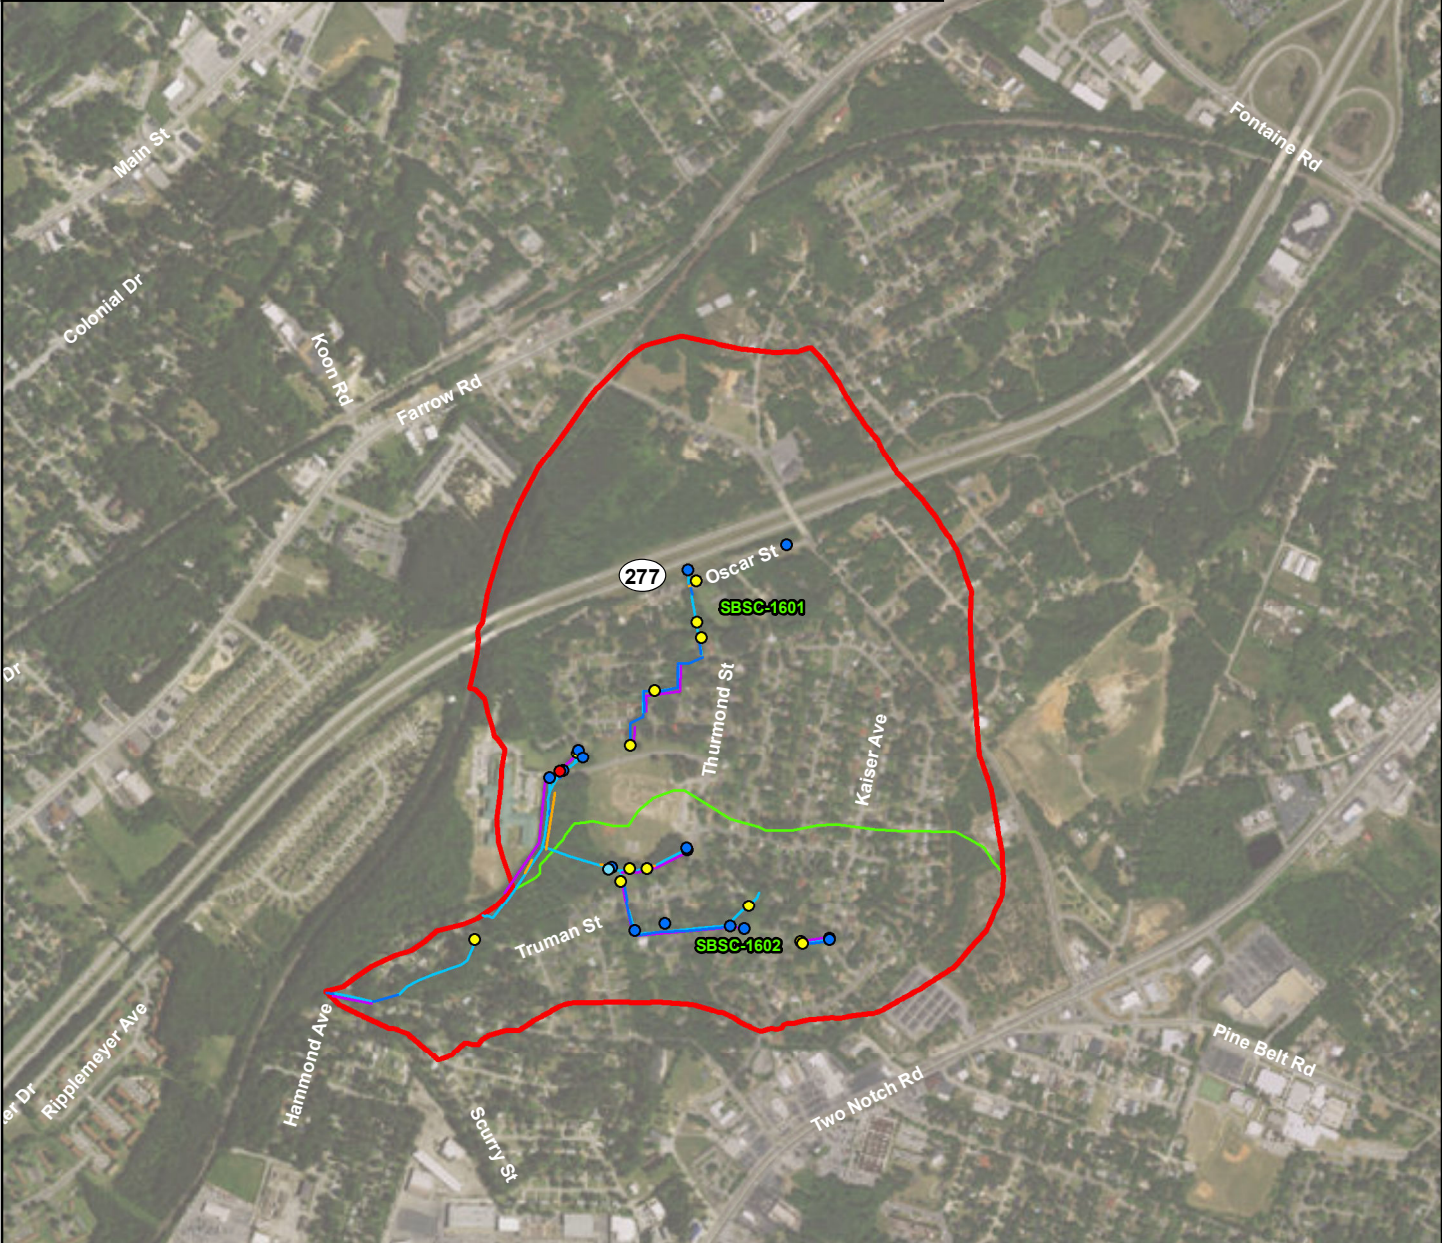
Figure 6.49:  
Subwatershed A  
Existing Conditions

**Figure 6.49** highlights existing conditions that were either captured during the stream cruising efforts, or developed using GIS data.

Existing Condition	Count
Exposed Pipes	1
Pipe Outfalls	15
Unmanaged Runoff	1
Unusual Condition	13
Trash Dumping	0
Possible Fish Barrier	0
	<b>Linear Feet</b>
Erosion Site	1,001
Channel Alteration	2,475
Inadequate Forest Buffer	6,125

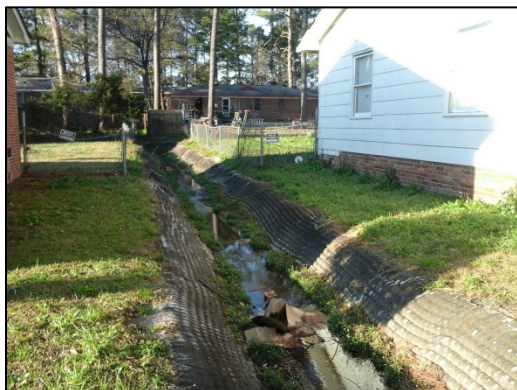
The upstream and northern extent of open stream channel within SW-A begins at an outfall emerging from underneath SC-277. The main outfall channel converges with a concrete flume extending along the northern shoulder of Oscar Street. The concrete flume is ephemeral, conveying roadway drainage during storm events. Erosion and flanking along the southern bank of the concrete channel has exposed the base of a fire hydrant. The stream extends downstream through a culvert beneath Oscar Street and opens into a natural stream bed within a forested parcel. Channel substrate consists primarily of sand, with some gravel and cobble present primarily in riffles. Banks are low, stable and well vegetated. The stream flows approximately 260 feet before it is channelized, with concrete bed and banks. The stream takes multiple abrupt turns, while confined between single-family, detached homes. The concrete channel extends downstream, continuing south of the Webb Court culvert before being piped through a 36-inch RCP north of the entrance road of Burton-Pack Elementary School.

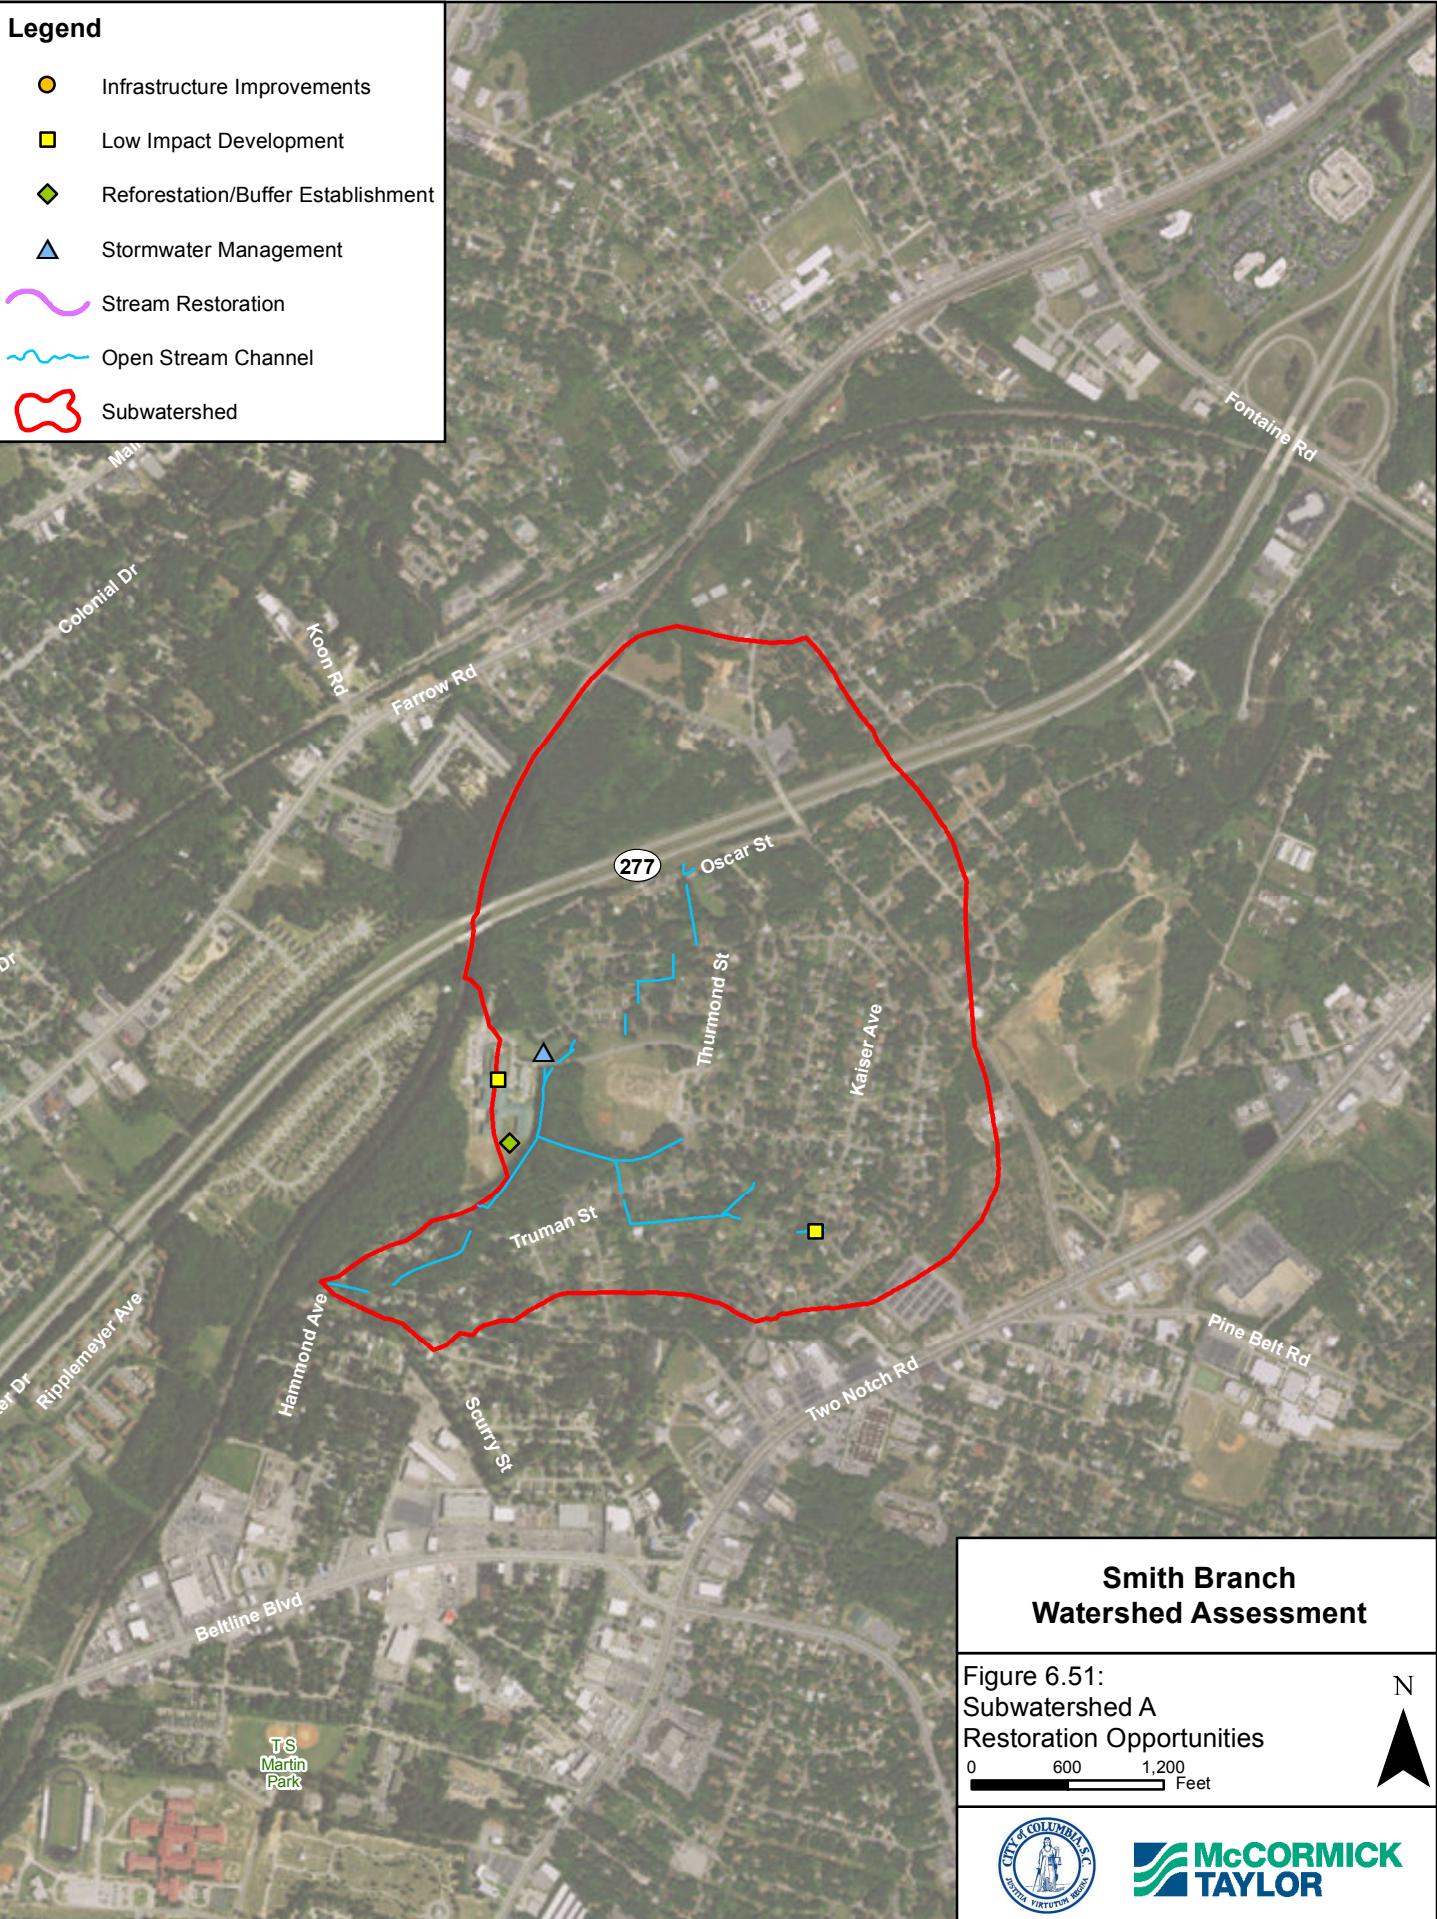
The following projects or similar improvements may be considered to address conditions identified in SW-A. These projects are included in **Figure 6.51**.

- As this catchment continues to develop, the development should occur in accordance with the City of Columbia BMP Manual.
- Opportunities for infiltration and storage should be investigated here due to the subwatershed's location on the edge of the watershed draining to Bay Branch.
  - Replace concrete flume west of Kaiser Avenue with rock dissipation/step structure.
  - Build a retention pond to control runoff from SC-277 at Burton-Pack Elementary School and plant trees where feasible.
- Additional mapping of the conveyance system above SC-277 is recommended in order to determine how the water flows from the developed area at the northern end through undeveloped areas to the south side of SC-277.

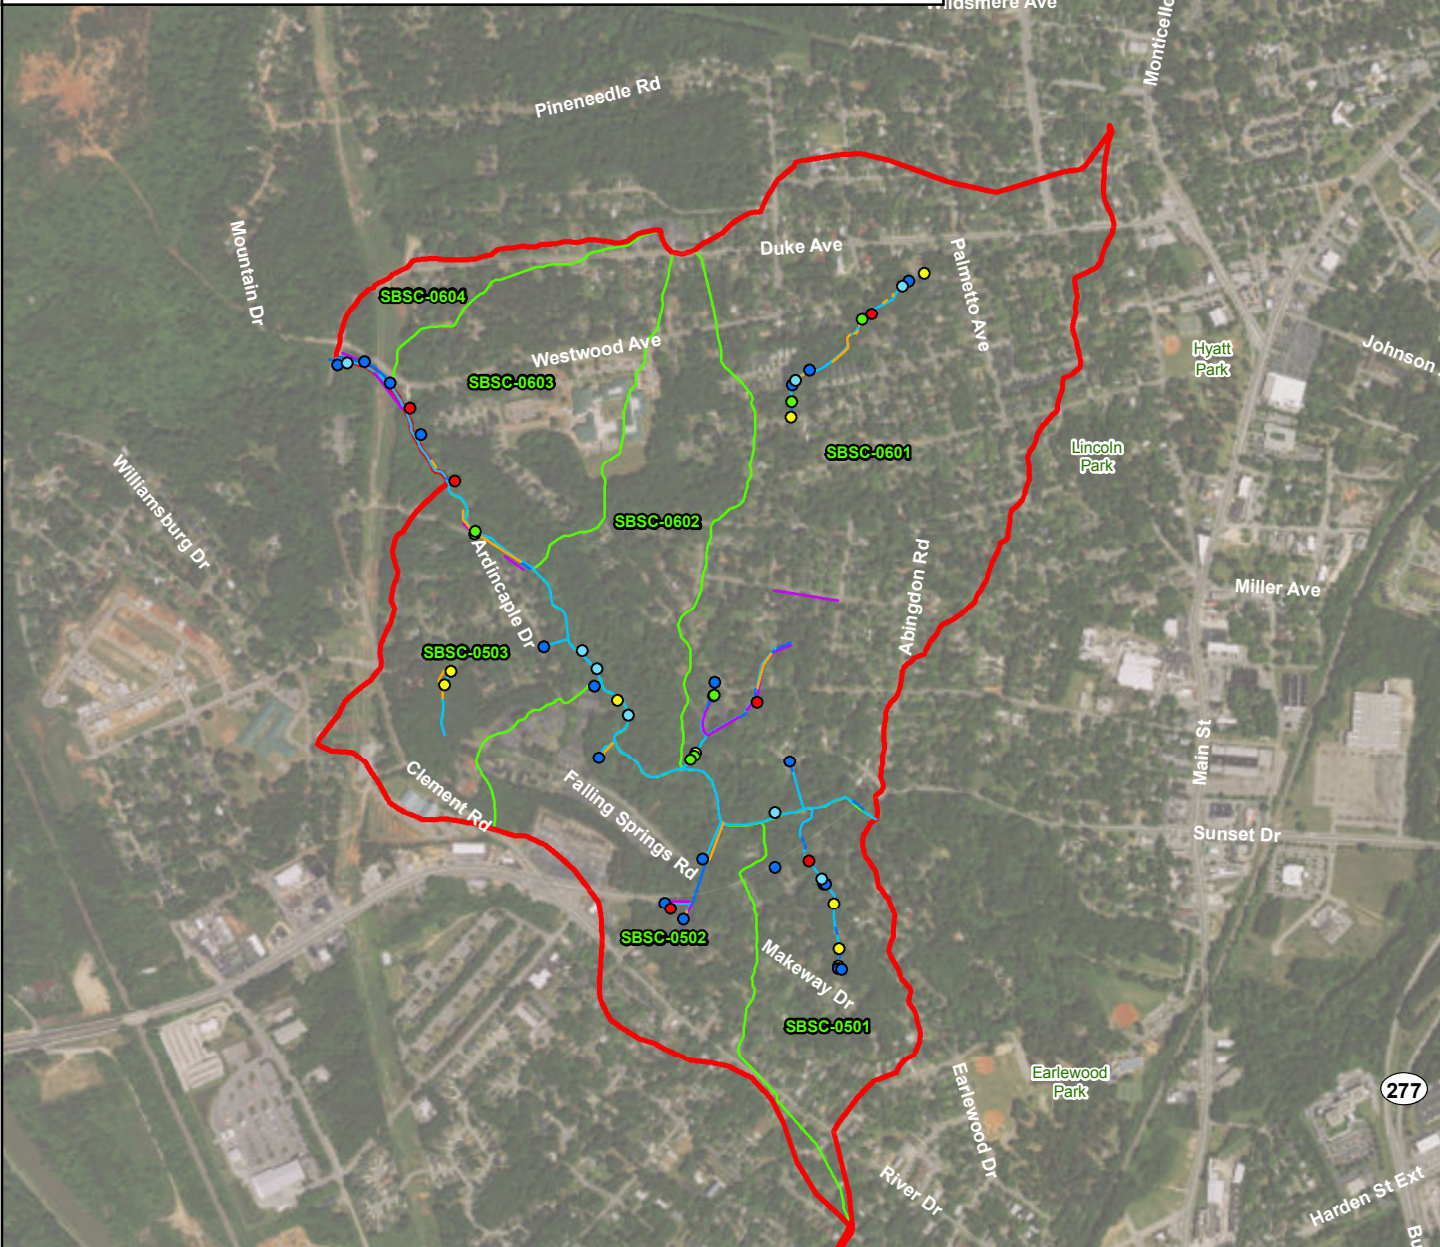
Figure 6.54:  
Subwatershed K  
Existing Conditions

**Figure 6.54** highlights existing conditions that were either captured during the stream cruising effort or developed using GIS data.

Existing Condition	Count
Exposed Pipes	10
Pipe Outfalls	19
Unmanaged Runoff	6
Unusual Condition	10
Trash Dumping	0
Possible Fish Barrier	6
<b>Linear Feet</b>	
Erosion Site	2,912
Channel Alteration	1,674
Inadequate Forest Buffer	4,413

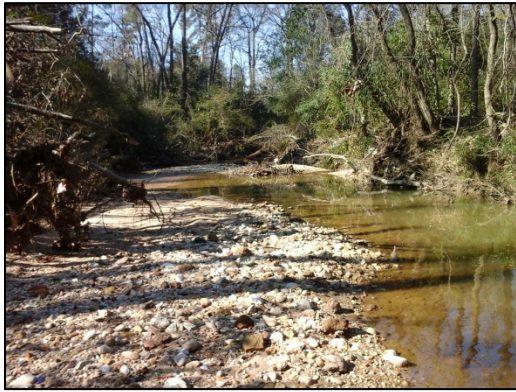
Within SW-K, the upstream extent of the Smith Branch mainstem channel begins southwest of the Sunset Drive and Summerlea Drive intersection. Smith Branch passes through a 9.8 foot wide by 9 foot high double box culvert under Sunset Drive and enters a forested floodplain parcel between residential communities. There are indications (lateral scour and fine sediment deposition) that suggest a severe meander bend immediately downstream of the Sunset Drive creates a backwater during storm events. This area (specifically the right bank downstream of Sunset

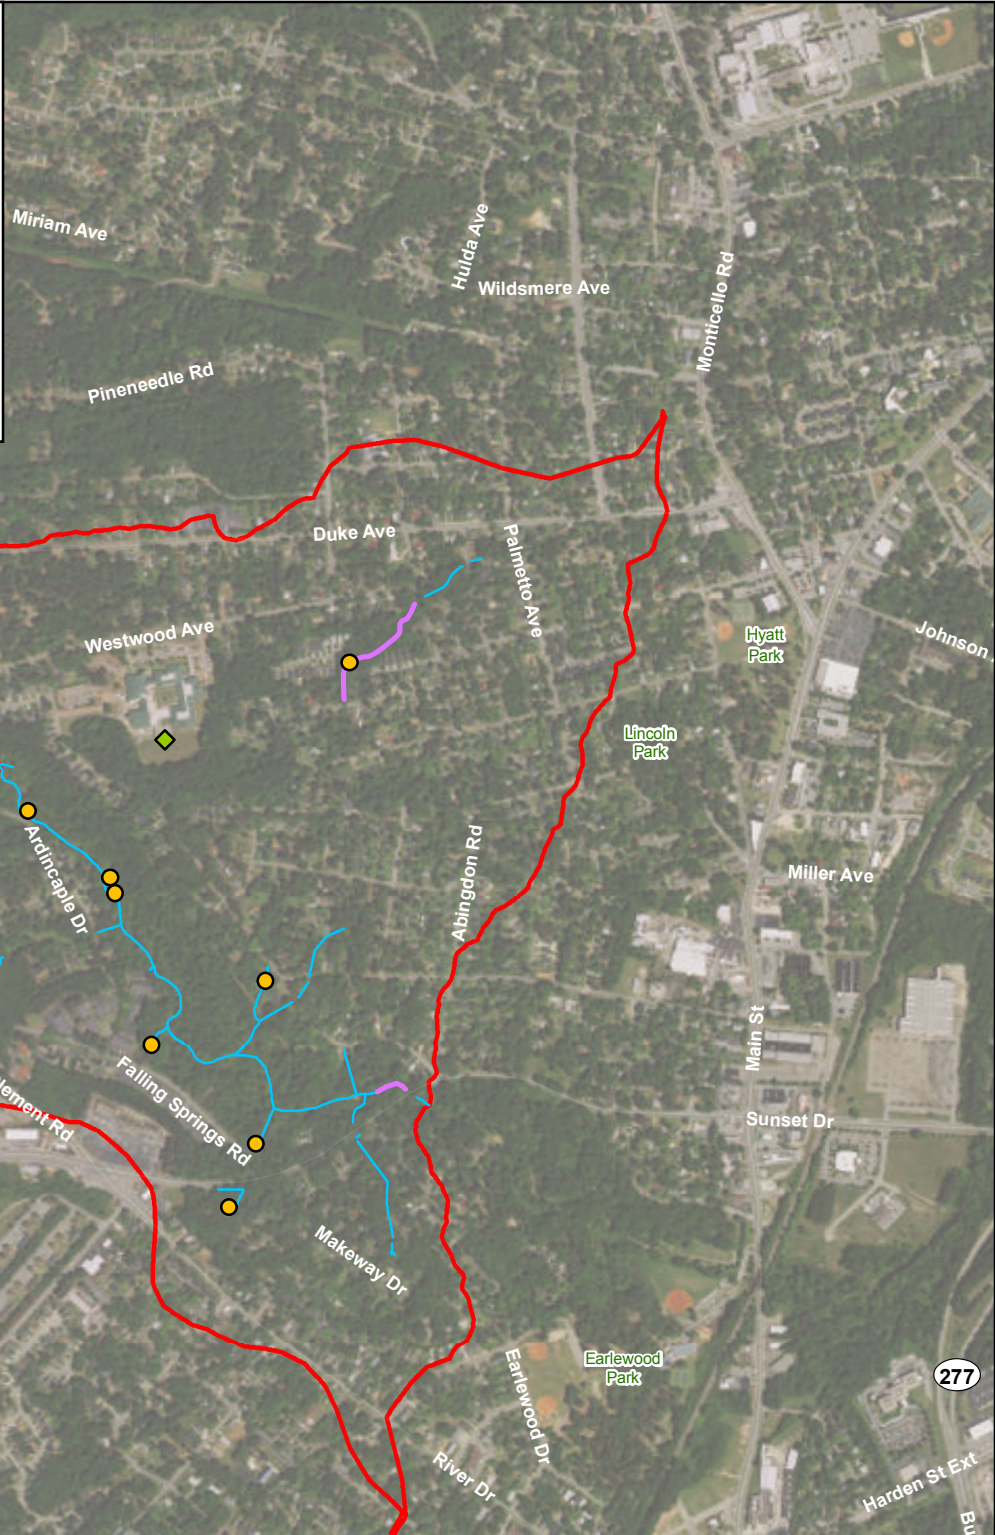
Figure 6.56:  
Subwatershed K  
Restoration Opportunities

The following projects or similar improvements may be considered to address conditions identified in SW-K. These projects are included in **Figure 6.56**.

- Development in flood-prone areas near Smith Branch should be restricted. In addition, open space floodplains where this catchment is at the bottom of the watershed should be investigated for permanent protection under easements or restrictive covenants.
- Stabilize the outfalls north of Makeway Drive, north of Falling Springs Road, and east of Ardincaple Drive.
- Bank stabilization downstream of Sunset Drive
- Repair the utility lines exposed in the bed north of Myles Avenue, east of Clement Road, and east of Ardincaple Drive.
- Stabilize the banks west of Abingdon Road.
- Plant trees where feasible at Heyward Gibbes Middle School.
- As this catchment continues to develop, the development should occur in accordance with the City of Columbia BMP Manual.

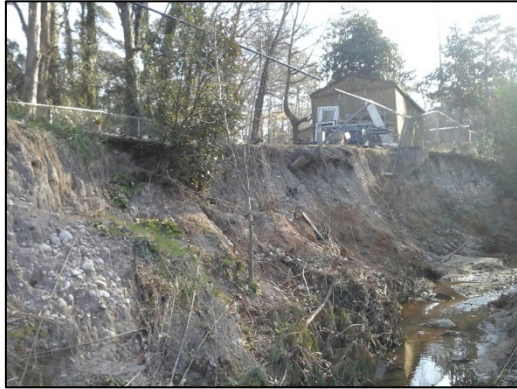
Upstream limits of the open channel network within SW-L begin between Steadham and Wildwood Avenue, west of Palmetto Avenue. Banks are low, stable, and well vegetated. Channel substrate is primarily sand, with gravel and cobble along riffles. The left bank is stabilized with a brick wall upstream of the Abingdon Road crossing. After the stream extends under Abingdon Road, the channel becomes deeply incised extending within a cleared utility right of way; raw vertical banks threaten infrastructure and private property on both sides. Bedrock intrusion

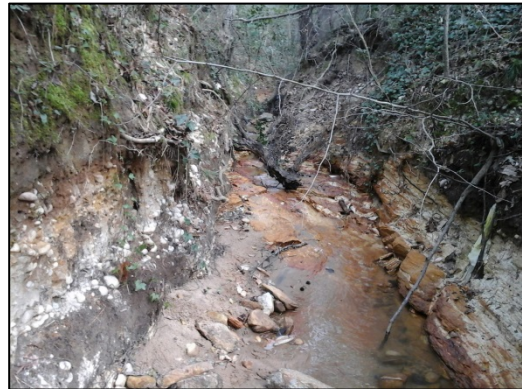
Downstream of the confluence of the two tributaries previously described, the channel incision continues, with 6 to 8 foot banks. Downtcutting into bedrock has created a series of steep cascades with large scour pools downstream. Substrate in this segment is mainly bedrock with sand in the pools and gravel and cobble along the riffles. The stream then extends through a 42 inch road culvert under Woodridge Drive.

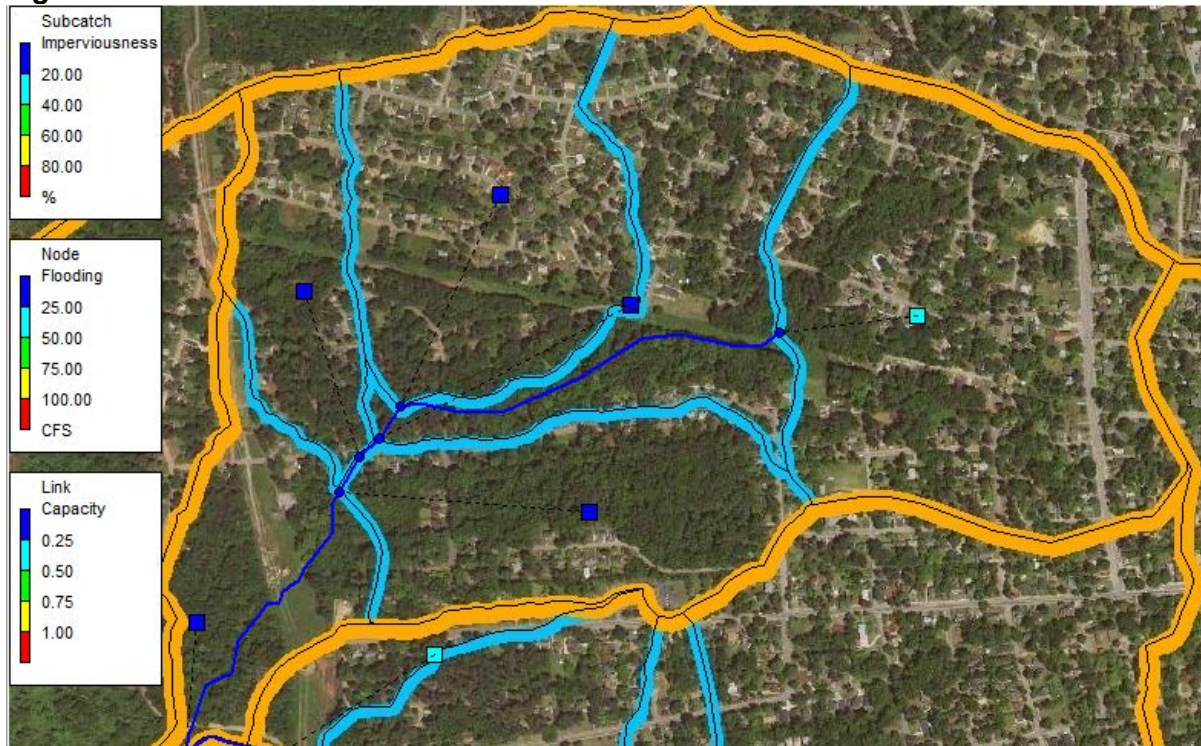
**Figure 6.60 SW-L SWMM Model**

SW-L is modeled in SWMM as six subcatchments (**Figure 6.60**), with five of them contributing flows directly to a tributary in the center of it. All of these subcatchments are low in imperviousness, with the highest only about 23%. Due to its location at the downstream limit of Smith Branch, the relatively low amount of runoff generated here is allowed to flow out of the watershed without exacerbating flooding issues.

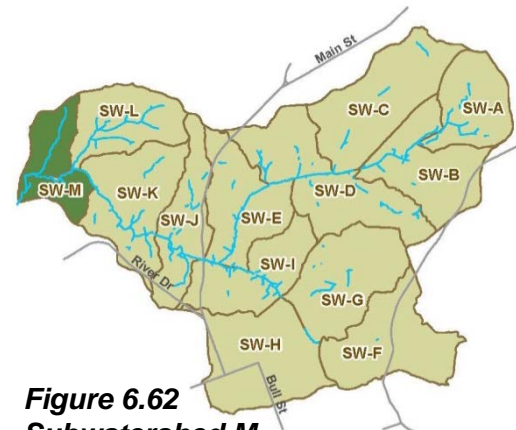
**Figure 6.62**  
**Subwatershed M**

- Subwatershed M (SW-M) is the westernmost subwatershed within the Smith Branch watershed.
- The northernmost point is located at Revel Stoke Drive, Mountain Drive roughly parallels the eastern boundary, Wellesley Drive to the south, and the Broad River to the west.
- 230 acres or 0.36 square miles in drainage area
- Contains 1.57 miles of open stream channel, and 0.02 miles of mapped storm drain/pipe
- Dominant land use designations (**Figure 6.1, Table 6.1**):
  - Forest: 45%
  - Herbaceous: 19%
- Impervious surface cover: 7%

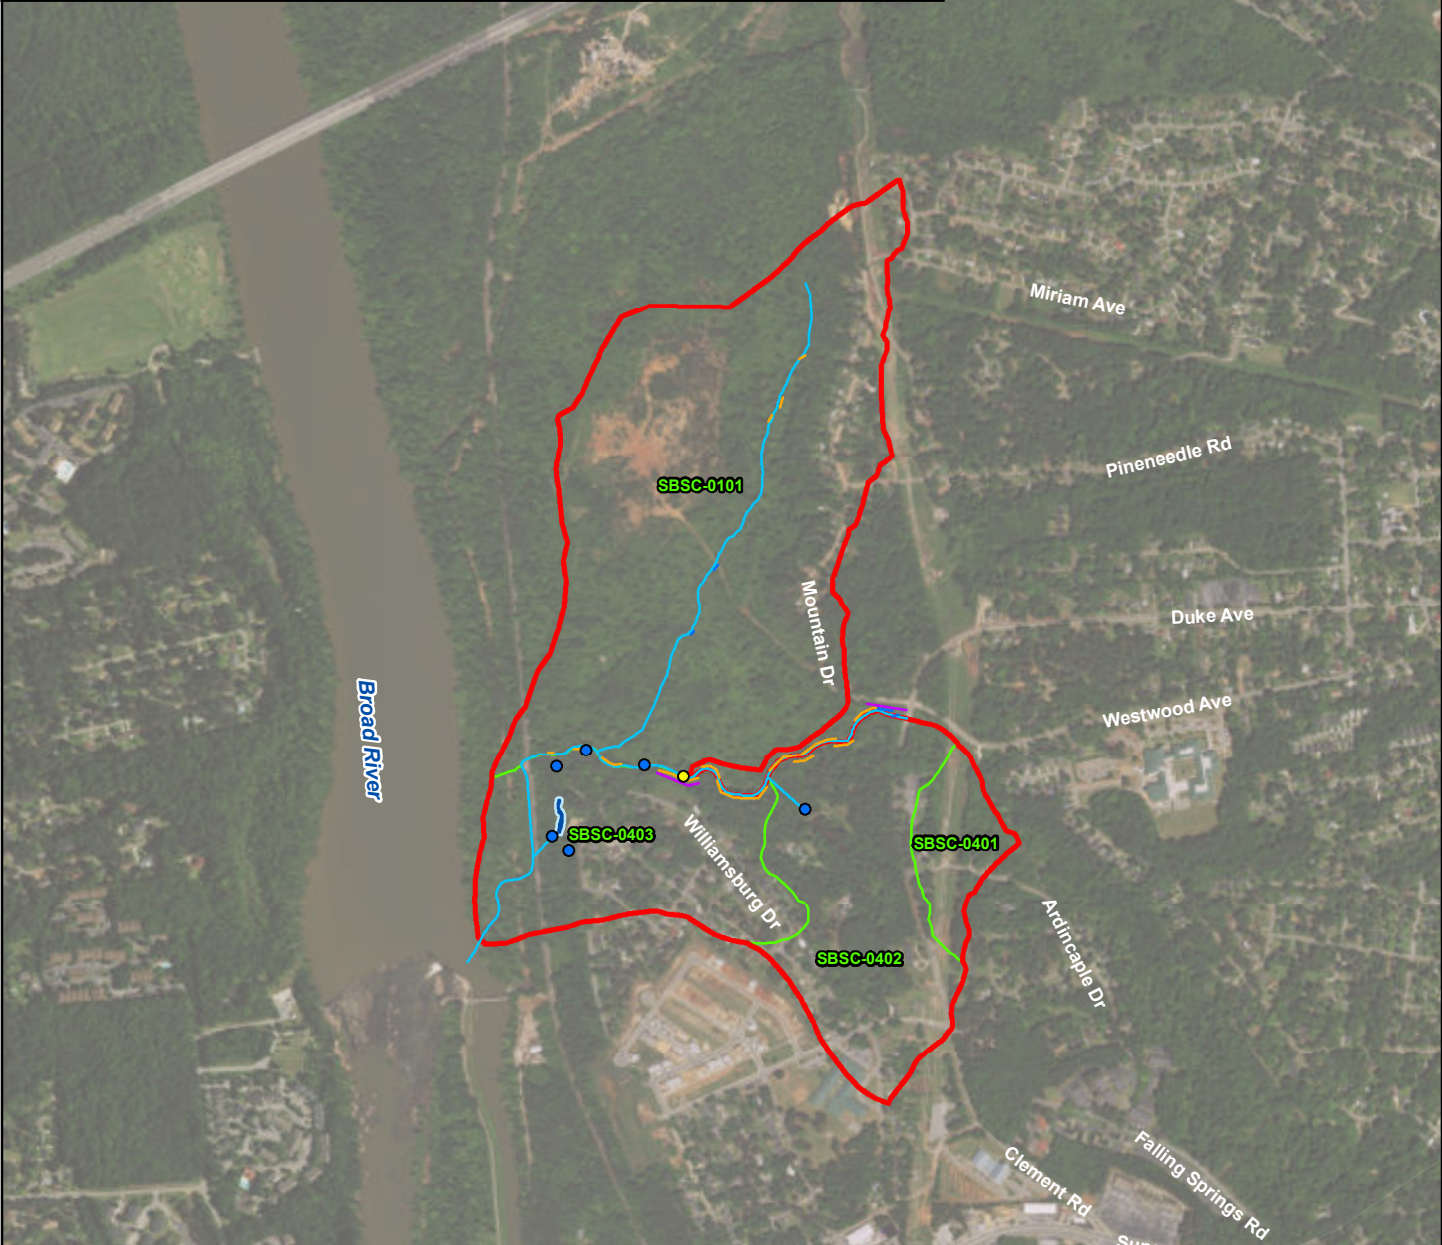
Figure 6.64:  
Subwatershed M  
Existing Conditions

Existing Condition	Count
Exposed Pipes	0
Pipe Outfalls	6
Unmanaged Runoff	0
Unusual Condition	1
Trash Dumping	0
Possible Fish Barrier	0
	<b>Linear Feet</b>
Erosion Site	2,255
Channel Alteration	226
Inadequate Forest Buffer	532

**Figure 6.64** highlights existing conditions that were either captured during the stream cruising effort or developed using GIS data.

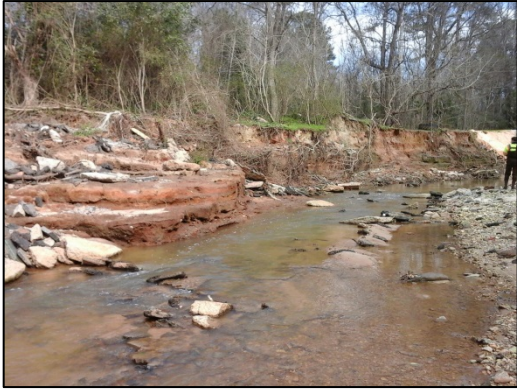
Within SW-M, the Smith Branch mainstem begins at the subwatershed's eastern most boundary from a bridge crossing at Clement Road. Riprap and gabion baskets have been placed on the right bank to mitigate severe bank erosion that has endangered Mountain Drive. Downstream of the riprap, the right bank is severely eroded, slumping into the bed and migrating towards Mountain Drive. A large coarse point bar has formed on the left bank. Downstream, a large debris jam at the confluence with the major tributary from SW-L has obstructed flow, resulting in flanking and scour around the obstruction on the left bank. Substrate consists of mostly sand, with significant quantities of cobble and gravel along the riffles and point bars. Erosional activity continues downstream, impacting the outside of bends. Large depositional bars have formed on the inside of bends. A small tributary originating from a pond outfall contributes flow from the left bank. As the channel approaches Williamsburg Drive, another significant debris jam obstructs flow, storing large amounts of fine sediment upstream of the obstruction. Downstream of the debris jam, the 40-foot tall left bank becomes raw, with no vegetation on the bank face or at the top of the bank. As the channel moves away from Williamsburg Drive, banks stabilize. Cobble and gravel quantities diminish within the bed. A significant tributary that runs roughly parallel to Mountain Drive joins the Smith Branch mainstem north of Williamsburg Drive. The channel then passes under a railroad, turning sharply south where it is confined between the railroad trestle on the left and an access road on the right. Backwater from the Broad River and associated dam influences the channel from this point to the confluence with the Broad River.
