Rocky Branch Watershed Management Plan

# ROCKY BRANCH WATERSHED ASSESSMENT

McCormick Taylor Inc., supported by KCI Technologies, Inc., has been contracted by the City of Columbia, South Carolina to conduct an assessment of the Rocky Branch watershed to identify potential improvement opportunities to identify existing flooding and water quality conditions.

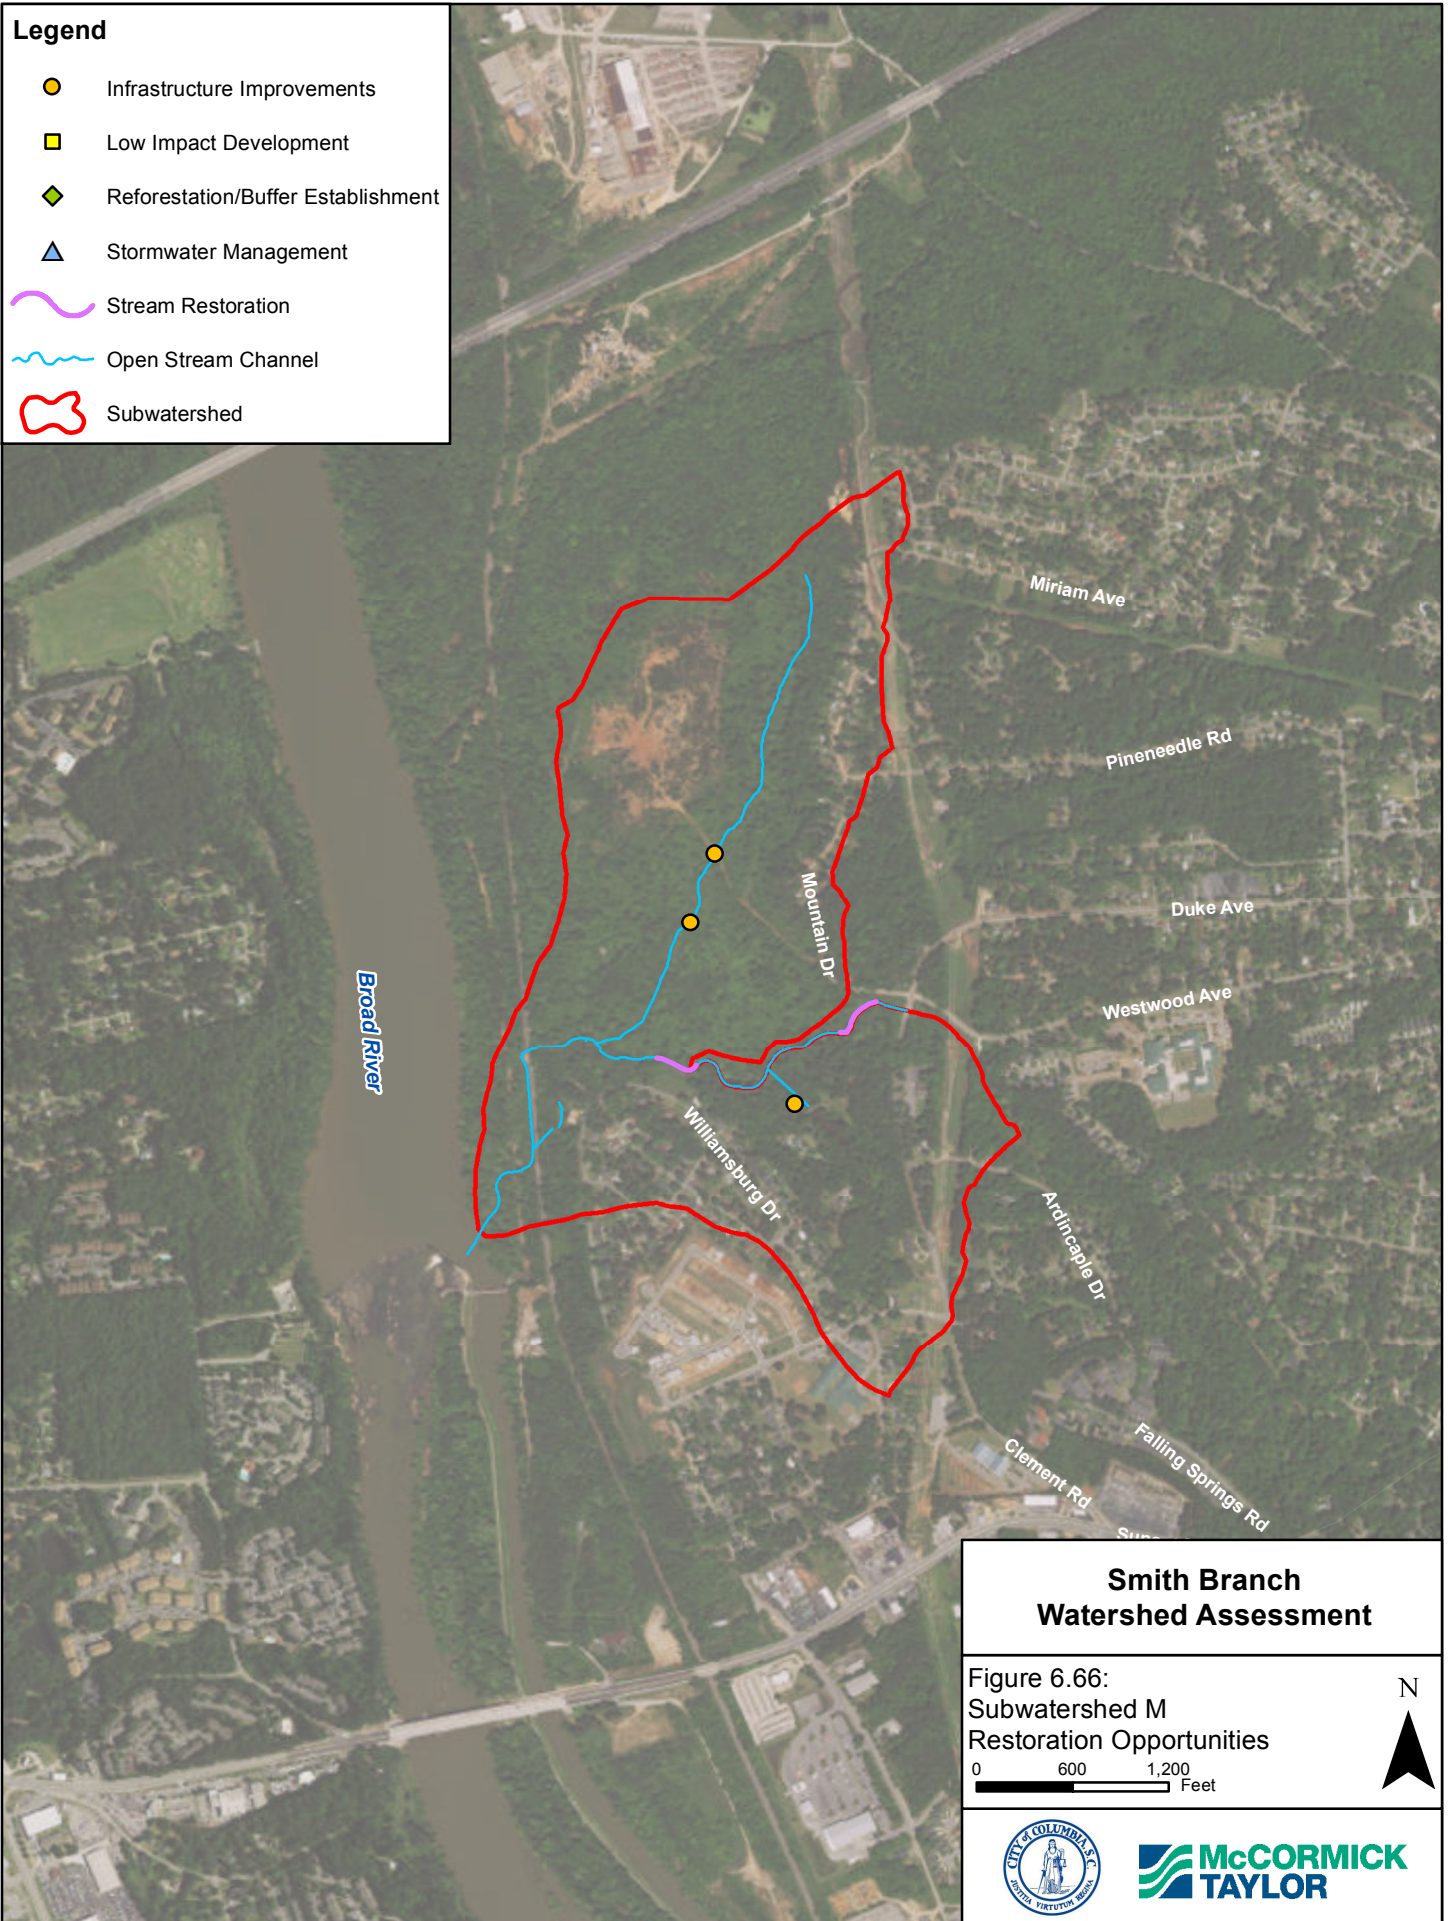
Figure 6.66:  
Subwatershed M  
Restoration Opportunities

The following projects or similar improvements may be considered to address conditions identified in SW-M. These projects are included in **Figure 6.66**.

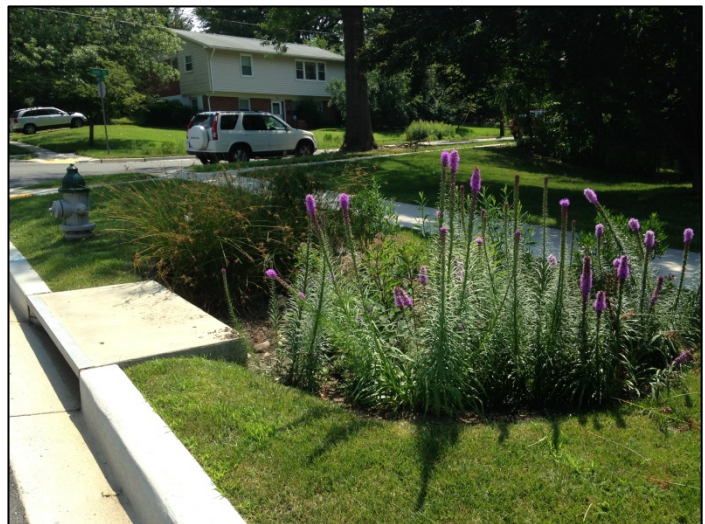
These facilities have many water quality benefits such as filtration of pollutants from runoff, recharging groundwater supply, and reducing total runoff and flooding potential. Bioretention and Rain Garden facilities are shallow basins that utilize engineered soil media and vegetation to reduce contaminants through filtration and infiltration. Additionally, due to the detention time within these facilities, they provide peak management control for smaller storm events such as the two year, and possibly ten year storms. They also provide beautification of yards, attract and provide habitat for pollinators and birds,

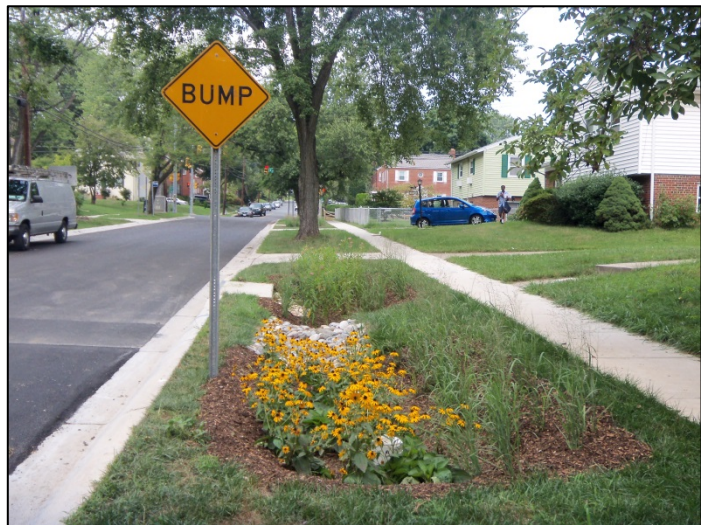
Green Streets are roadways that are designed to reduce and filter stormwater runoff. The benefits of green streets are that they can be utilized in areas where there is not enough open space for larger traditional stormwater practices. Green streets use LID techniques such as bioretention BMPs, tree box filters, and pervious surfaces that are constructed within the street right of ways while utilizing existing drainage infrastructure. Green streets can be coupled with roadway maintenance or utility projects or act as stand-alone projects. The green street methodology can be applied to parking lots as well. Micro stormwater facilities can be installed in parking islands and along the perimeter of the lot. To acquire additional space for these facilities, parking lots may be restriped to reduce the required foot print, but allow for the same number of spaces by using diagonal parking with one way parking aisles.

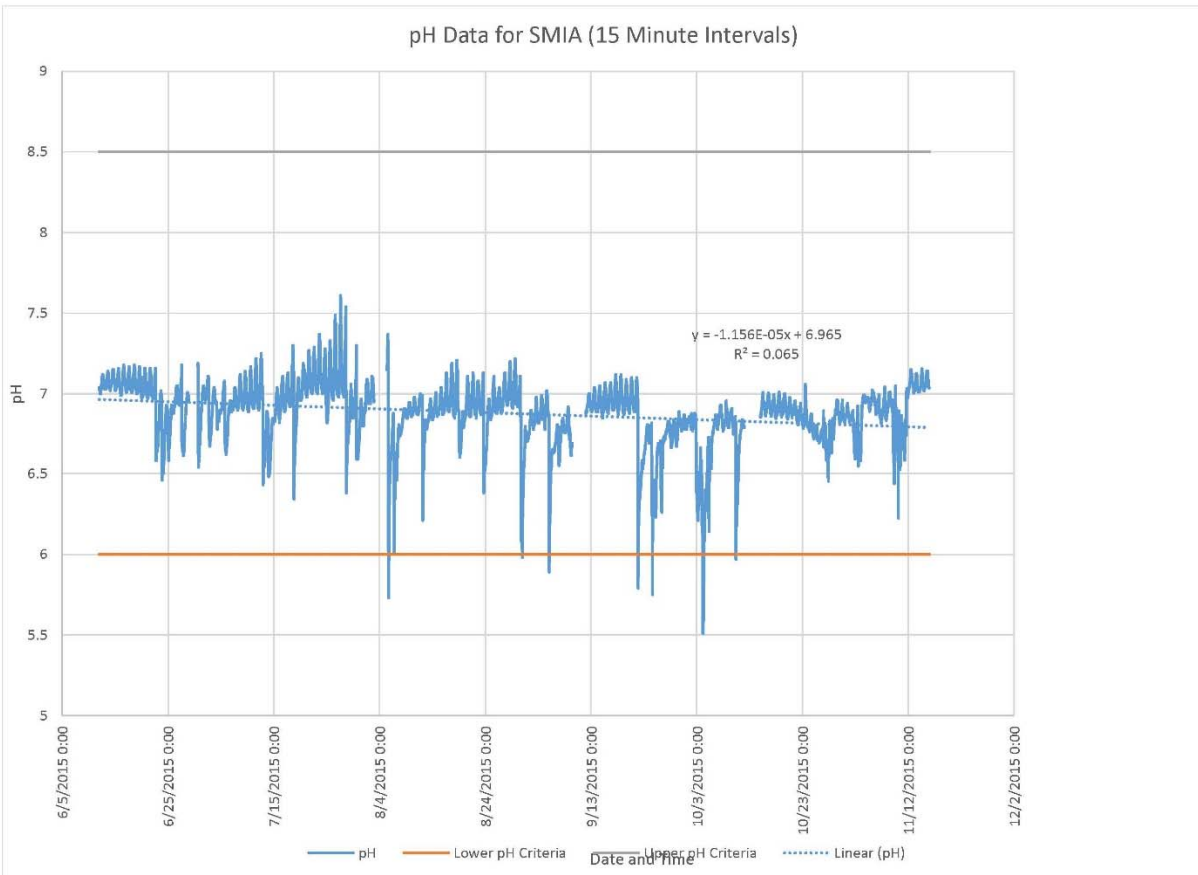
A linear regression analysis was performed for 15-minute interval pH data from SMIA. The results of the linear regression analysis show a slight negative slope (-1.1557E-05), which was significant at the  $p < 0.01$  level ( $p < 0.001$ ). This indicates that the likelihood of this decreasing pH relationship occurring by chance is very small. The negative slope of the line indicates that pH values are decreasing very slightly throughout this dataset. This rate of change is so small that changes in observed pH values would happen over several tens of thousands of measurements. If this relationship holds true with data collected over additional time periods, it would take over 2.5 years for a realized 1.0 decrease in pH value.

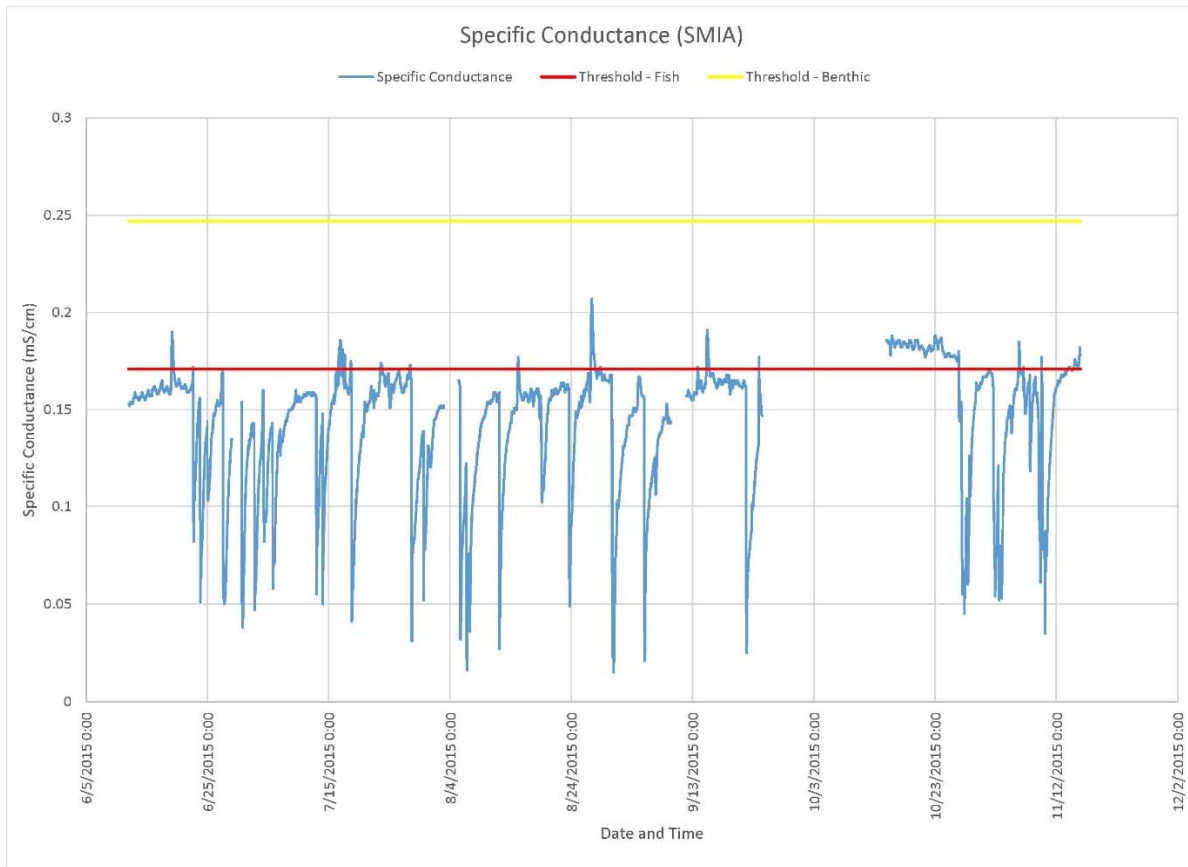
South Carolina does not have water quality criteria for specific conductance, which is a measure of dissolved inorganic ions such as chloride, nitrate, sulfate and phosphate anions and sodium, magnesium, calcium, iron, and aluminum cations. Morgan et al., 2007, found biological assemblage impairment thresholds for biological impairment of 0.247 mS/cm for benthic macroinvertebrates and 0.171 mS/cm for fish in urban streams in Maryland. Smith Branch is an urban stream so the impairment thresholds from Maryland data may be applicable. When compared against these values, the possible specific conductance impairment thresholds were exceeded in SMIA for fish assemblage 13.99% of the time (1,744 records out of 12,465 total records). Specific conductance was not exceeded for benthic macroinvertebrates. Specific conductance data are missing for a large period of time starting September 24<sup>th</sup>, 2015 through October 14<sup>th</sup>, 2015. These missing data affected the analysis.

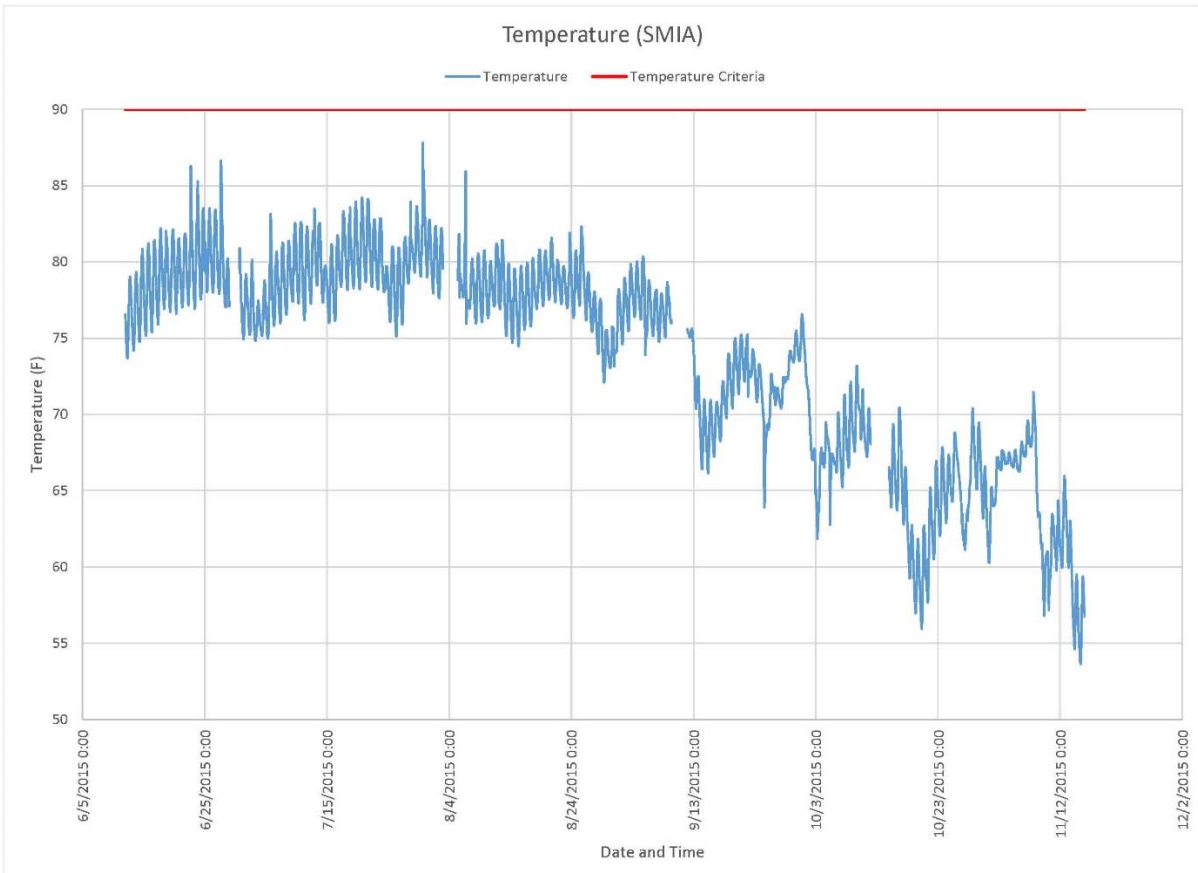
The water quality criteria for temperature of 90.0° F was not exceeded at SMIA. As expected, there is a seasonal and diurnal pattern to water temperature in Smith Branch. The highest measured water temperatures occurred during the summer time. Summer is the time of the year with the highest air temperatures, and the greatest amount of solar radiation. These factors help warm water throughout the day. The highest temperatures measured each day were in the afternoon. Afternoon is usually the period of time with the highest air temperature, and sunlight has been warming the water and stream substrates throughout the day.

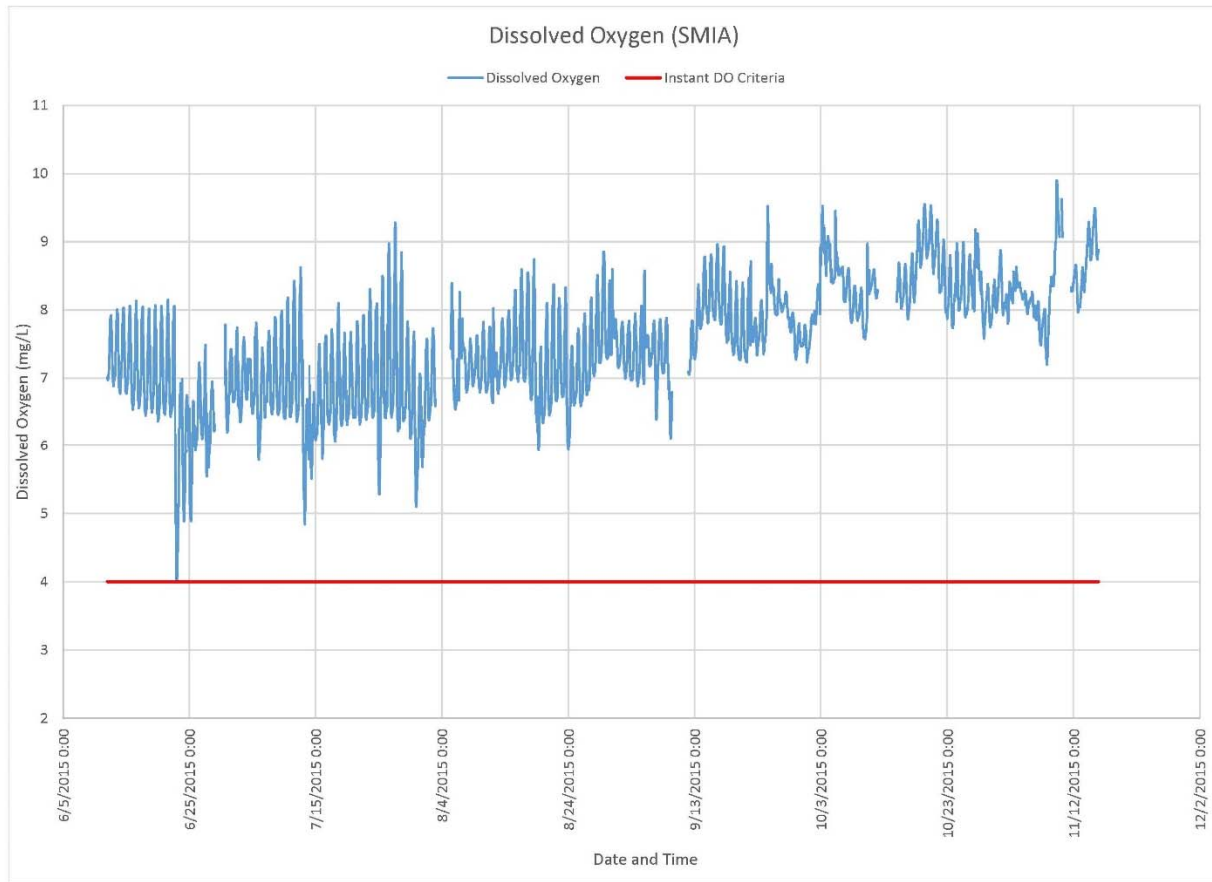
Water quality sonde data from site SMIA show that the instantaneous water quality standard for dissolved oxygen of 4.0 mg/L was not violated over the period of record (0 out of 13,986). Over the same period of time, the water quality standard for daily average dissolved oxygen of 5.0 mg/L was also not violated (0 out of 149 days). June 23<sup>rd</sup>, 2015 had the lowest observed daily average dissolved oxygen concentration of 5.82 mg/L.

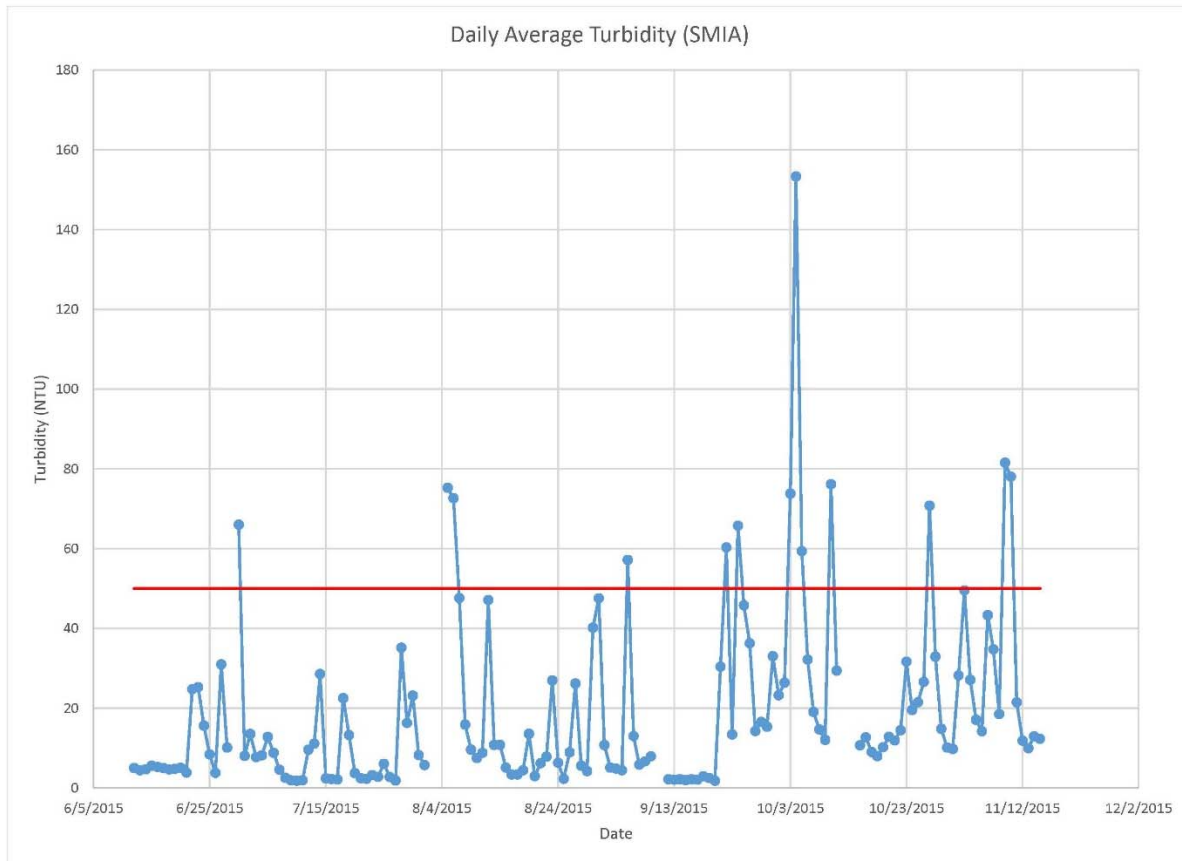
Results of turbidity data from the water quality sonde at SMIA show that the turbidity water quality standard of 50.0 NTU was exceeded 8.18% of the time (1122 records out of a total 13,713 records). High turbidity values were mostly seen during periods of intense rainfall when stormwater flow increases.

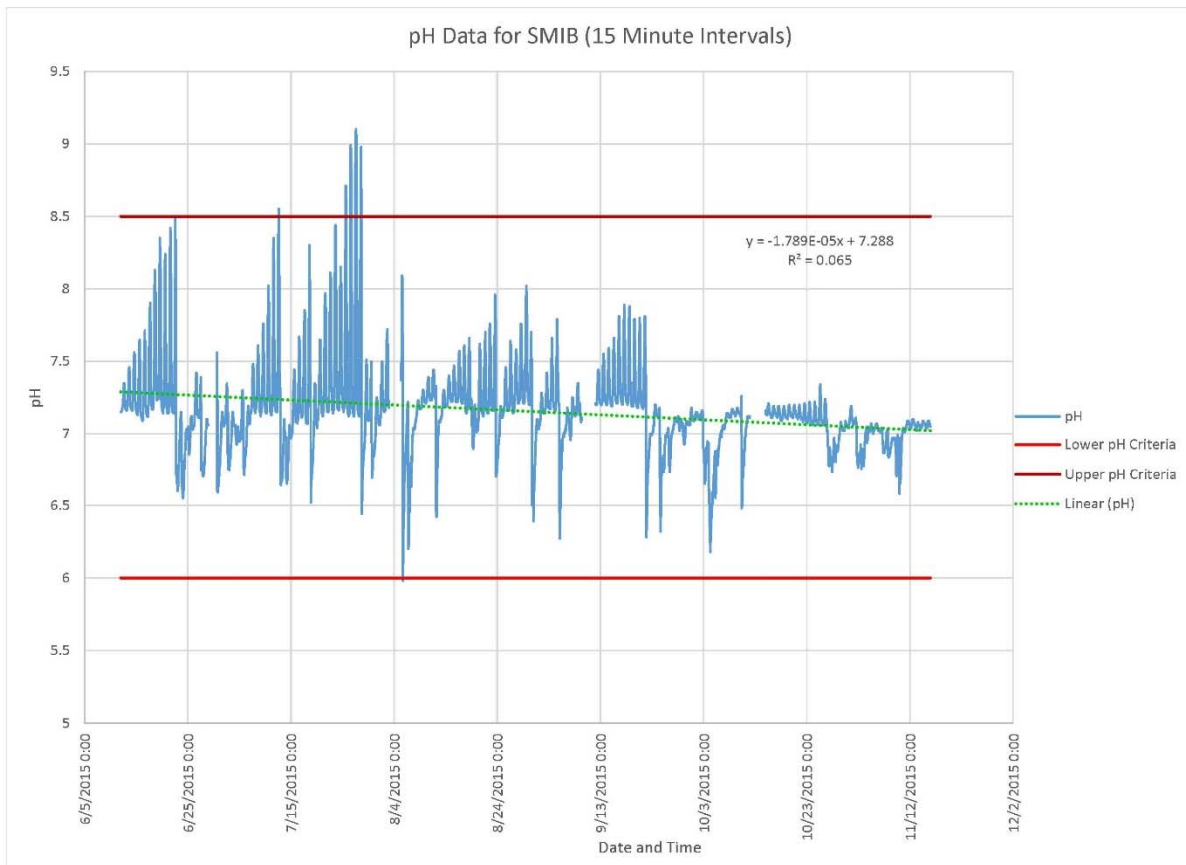
A linear regression analysis was performed for 15-minute interval pH data. The results of the linear regression analysis show a slight negative slope (-1.78904E-05), which was significant at the  $p < 0.01$  level ( $p < 0.001$ ). This indicates that the likelihood of this decreasing pH relationship occurring by chance is very small. The negative slope of the line indicates that pH values are decreasing very slightly throughout this dataset. This rate of change is so small that changes in observed pH values would happen over several tens of thousands of measurements. If this relationship holds true with data collected over additional time periods, it would take over a 1.5 years for a realized 1.0 decrease in pH value.

<i>Coefficients</i>	<i>Standard Error</i>	<i>t Stat</i>	<i>P-value</i>
Intercept	7.288478514	0.004918	1481.932	0
Slope	-1.78904E-05	5.69E-07	-31.460	4.82E-210

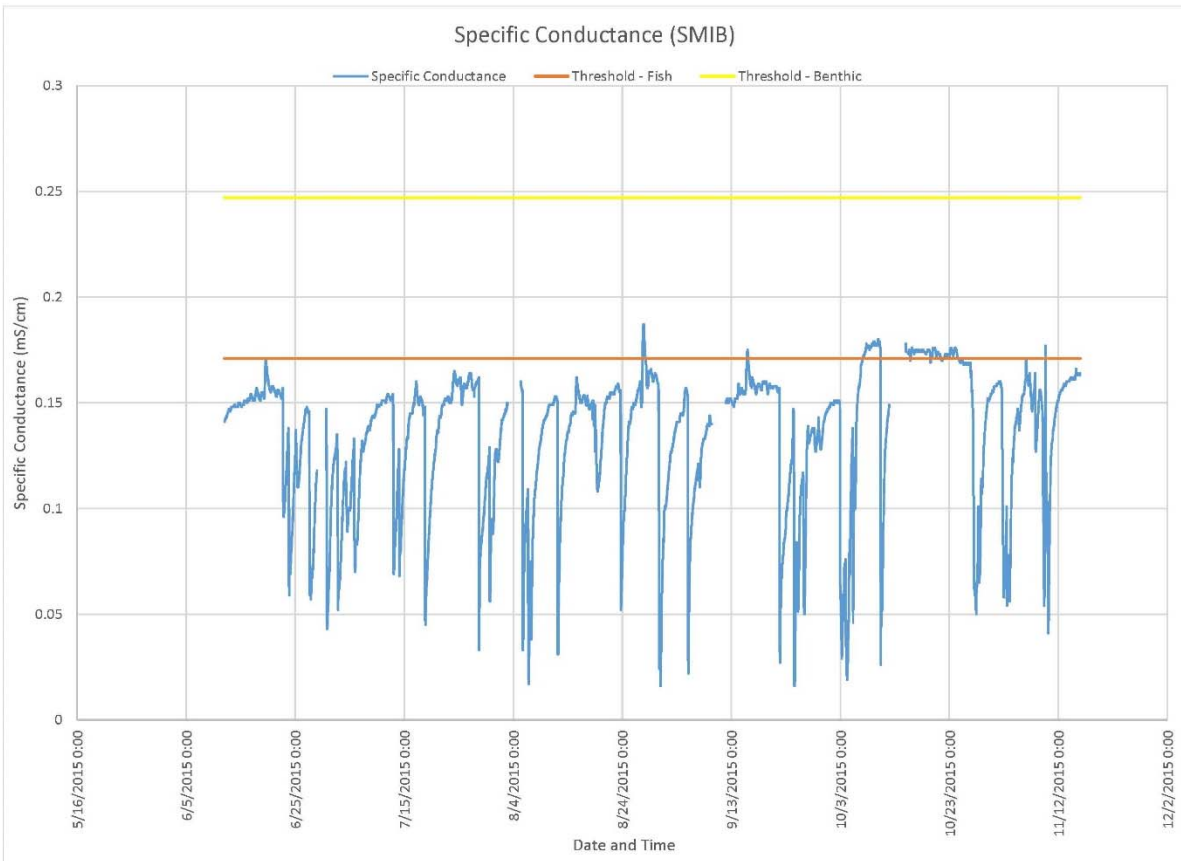
South Carolina does not have water quality criteria for specific conductance, which is a measure of dissolved inorganic ions such as chloride, nitrate, sulfate and phosphate anions and sodium, magnesium, calcium, iron, and aluminum cations. Morgan et al., 2007, found biological assemblage impairment thresholds for biological impairment of 0.247 mS/cm for benthic macroinvertebrates and 0.171 mS/cm for fish in urban streams in Maryland. Smith Branch is an urban stream so the impairment thresholds from Maryland data may be applicable. When compared against these values, the possible specific conductance impairment thresholds were exceeded in SMIB for fish assemblage 9.22% of the time (1,304 out of 14,145 total records). Specific conductance was not exceeded for benthic macroinvertebrates.

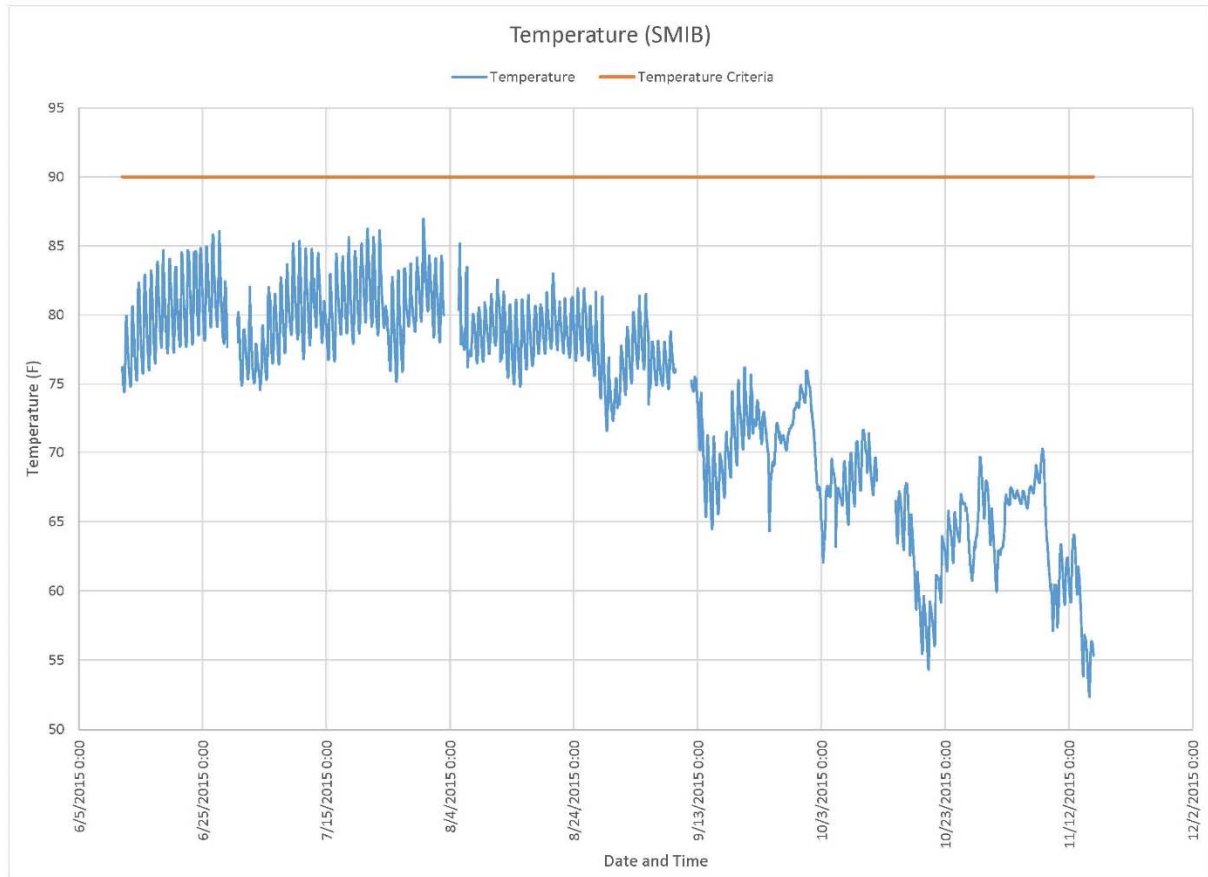
The water quality criteria for temperature of 90.0° F was not exceeded at SMIB. As expected, there is a seasonal and diurnal pattern to water temperature in Smith Branch. The highest measured water temperatures occurred during the summer time. Summer is the time of the year with the highest air temperatures, and the greatest amount of solar radiation. These factors help warm water throughout the day. The highest temperatures measured each day were in the afternoon. Afternoon is usually the period of time with the highest air temperature, and sunlight has been warming the water and stream substrates throughout the day.

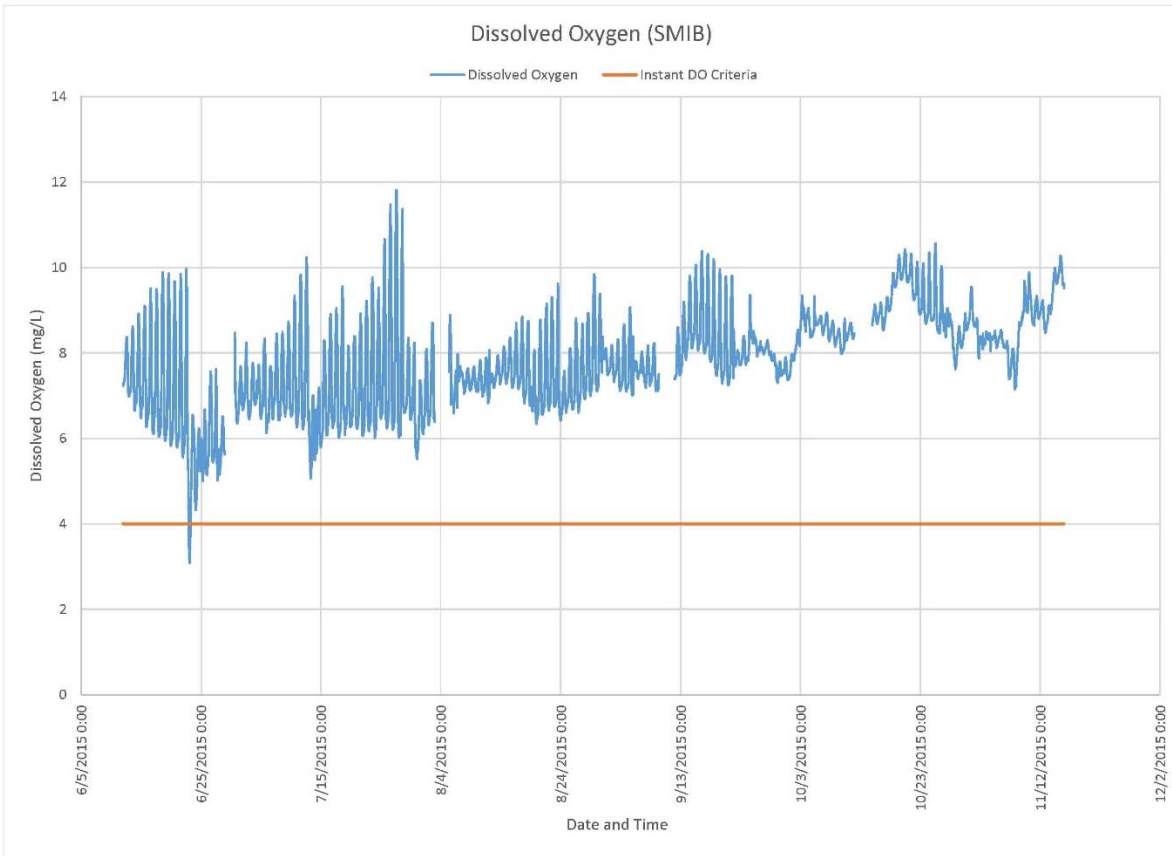
Water quality sonde data from site SMIB show that the instantaneous water quality standard for dissolved oxygen of 4.0 mg/L was violated 0.18% of the time (25 out of 14,144 records) over the period of record. Over the same period of time, the water quality standard for daily average dissolved oxygen of 5.0 mg/L was not violated (0 out of 149 days). June 23<sup>rd</sup>, 2015 had the lowest observed daily average dissolved oxygen concentration of 5.12 mg/L.

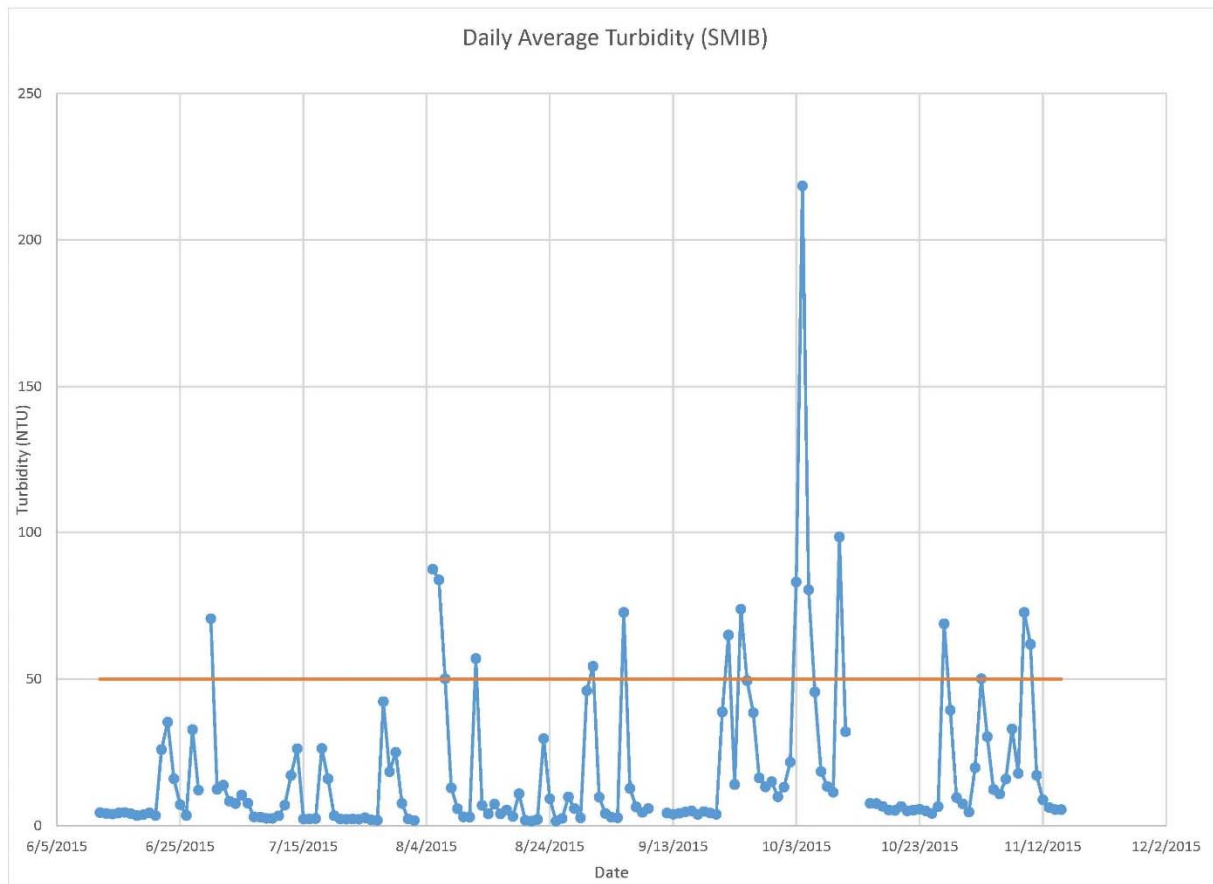
Water quality sonde data from site SMIB show that water quality standard for turbidity of 50 NTU was violated 8.70 % of the time (1,231 out of 14,144 records) over the period of record. High turbidity values were mostly seen during periods of intense rainfall when stormwater flow increases.

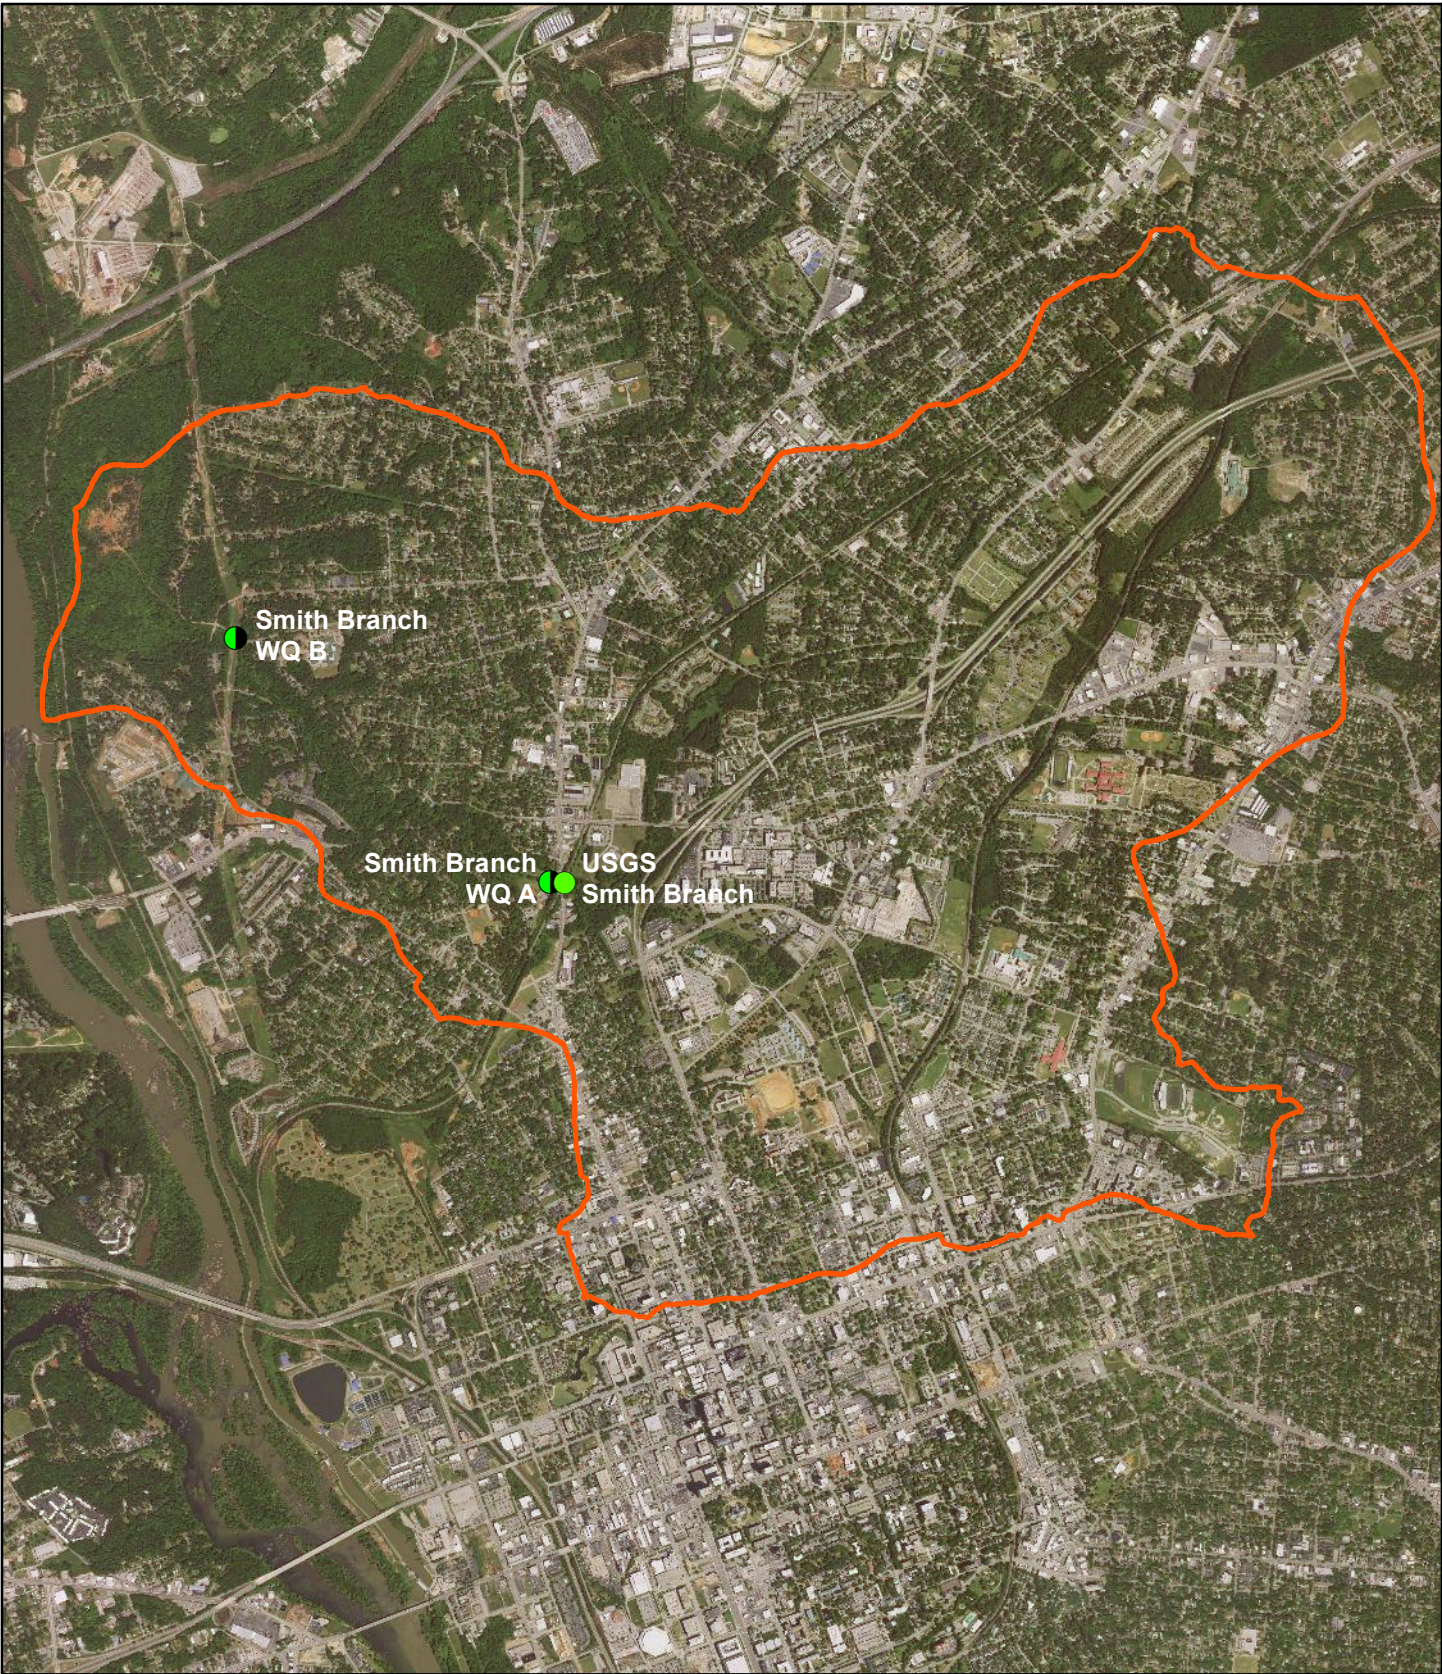
**Smith Branch Watershed - Stream and Precipitation Gages**

- Stage/Precipitation
- Stage
- ▭ Watershed Boundary

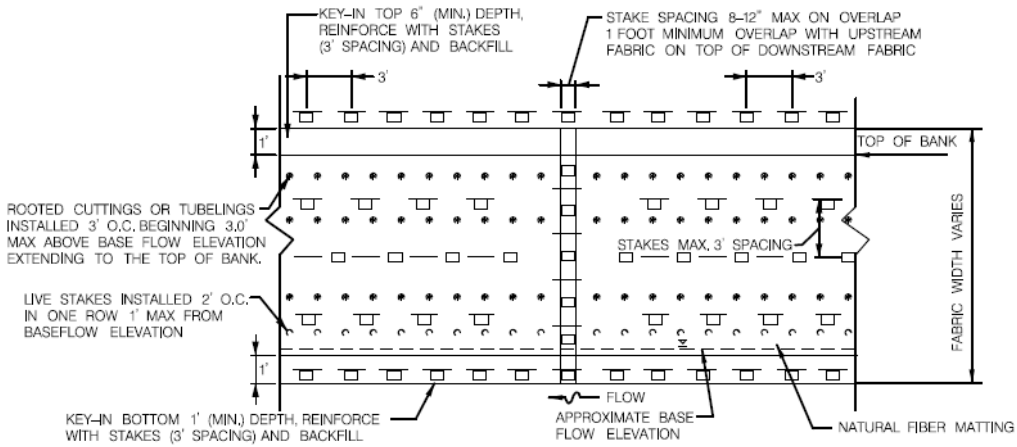
**NATURAL FIBER MATTING – PLAN VIEW**

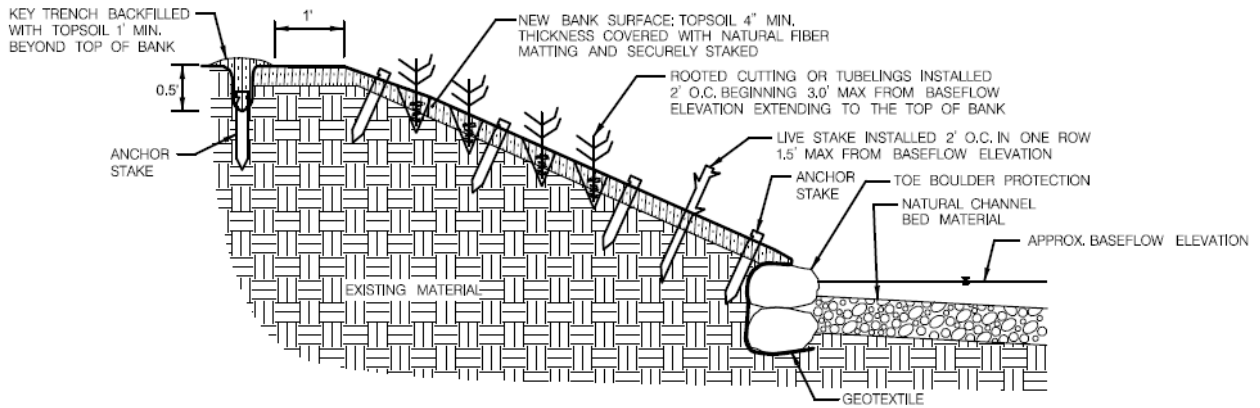
**TOE BOULDER PROTECTION TYPICAL**

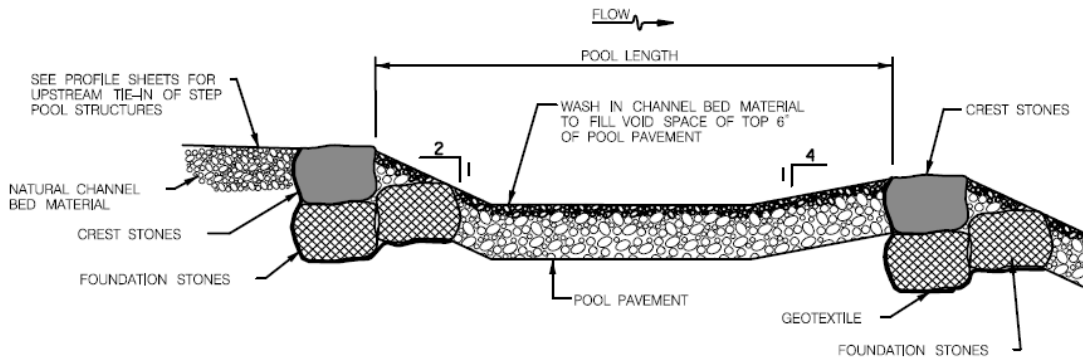
TYPICAL PROFILE THROUGH STEP-POOL

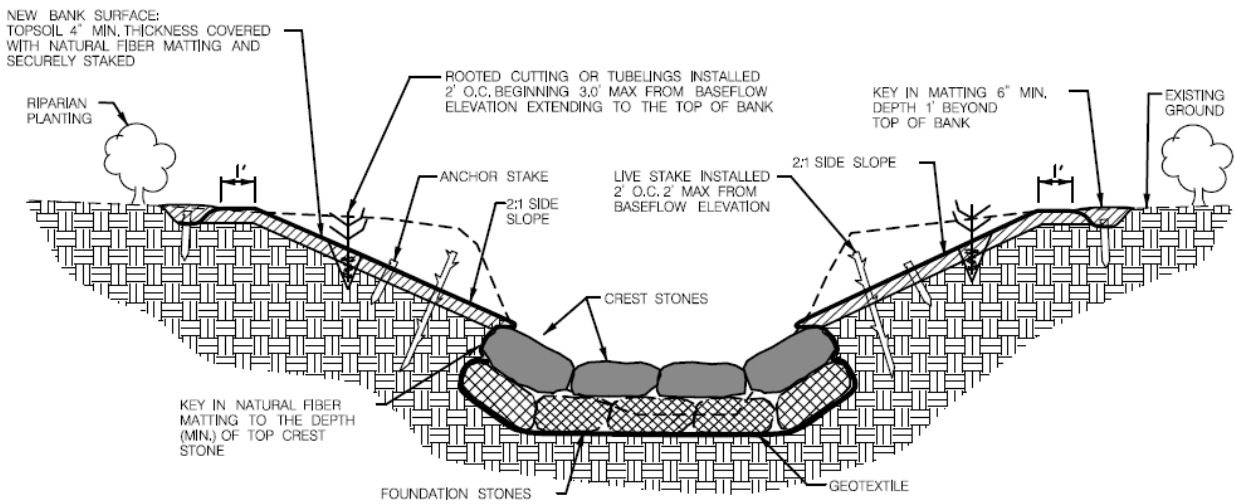
TYPICAL CROSS SECTION OF STEP-POOL CREST

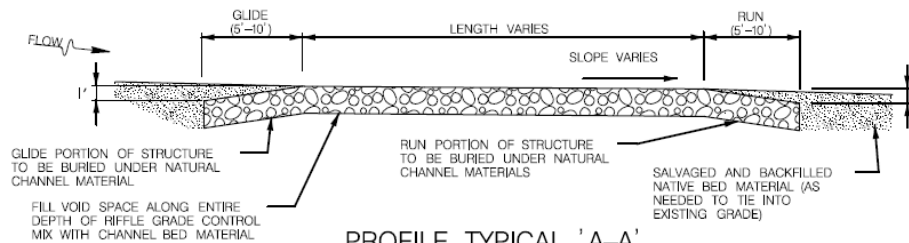
PROFILE TYPICAL 'A-A'  
RIFFLE GRADE CONTROL  
NOT TO SCALE

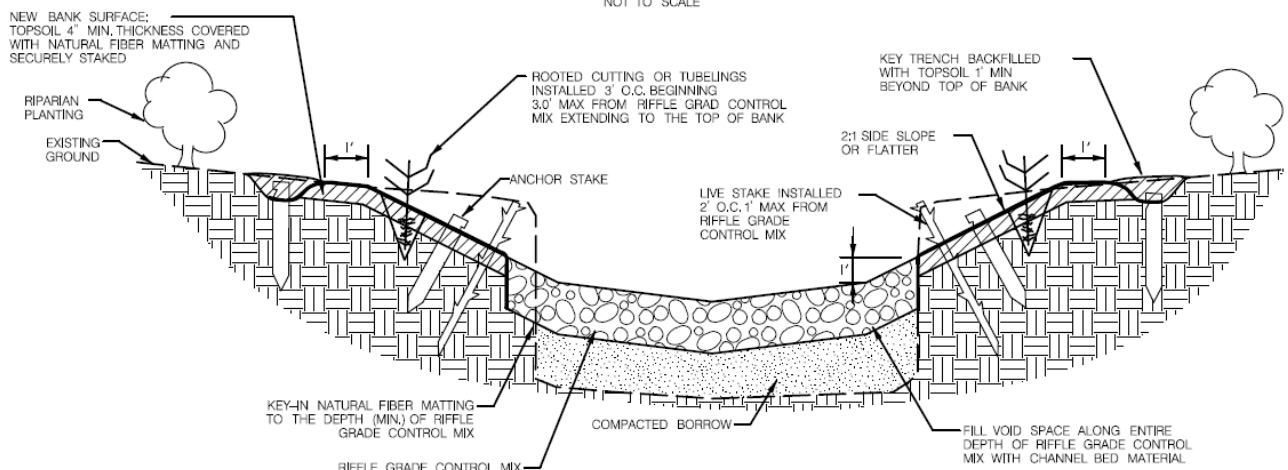
CROSS SECTION TYPICAL 'B-B'  
RIFFLE GRADE CONTROL  
NOT TO SCALE

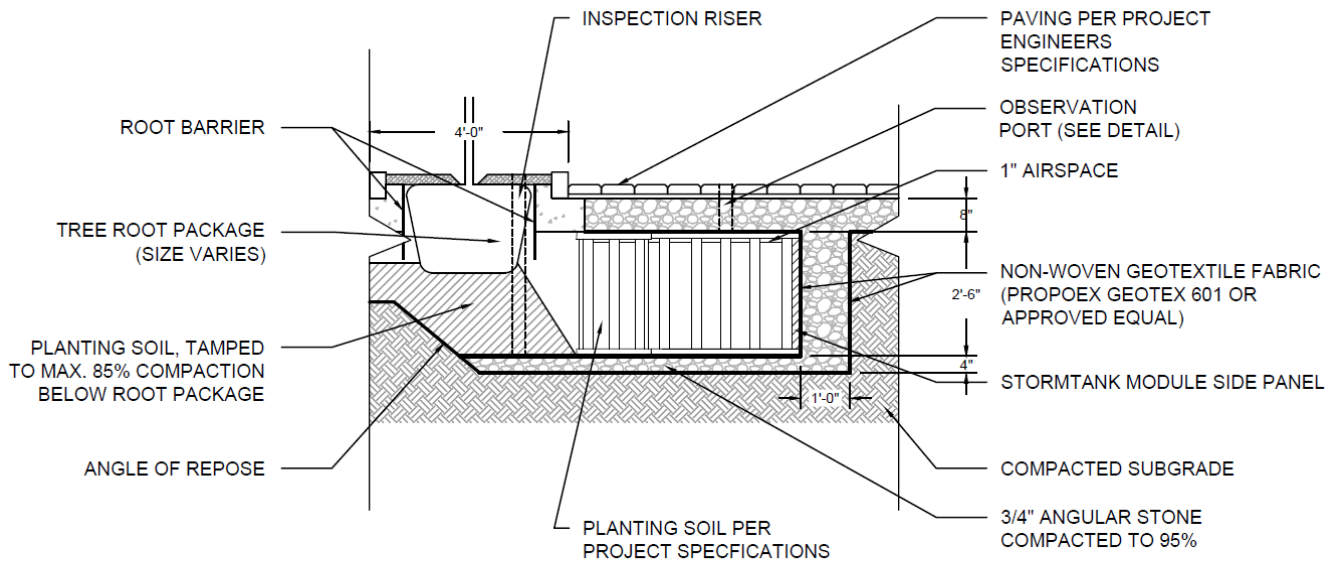
Boulevard Approach  
Tree Boxes

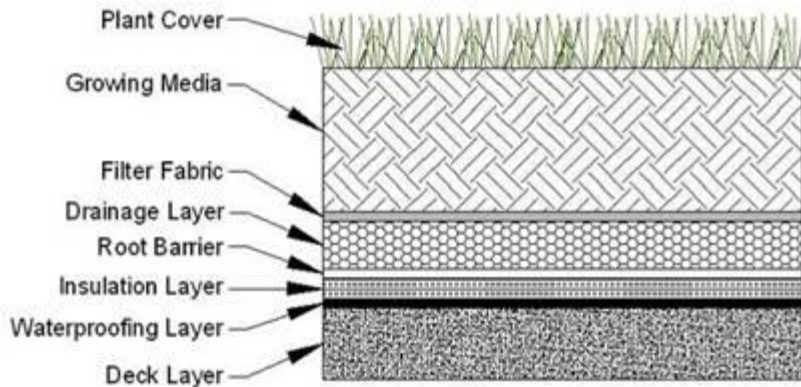
Green Roof System
