Rocky Branch Watershed Management Plan

# ROCKY BRANCH WATERSHED ASSESSMENT

McCormick Taylor Inc., supported by KCI Technologies, Inc., has been contracted by the City of Columbia, South Carolina to conduct an assessment of the Rocky Branch watershed to identify potential improvement opportunities to identify existing flooding and water quality conditions.

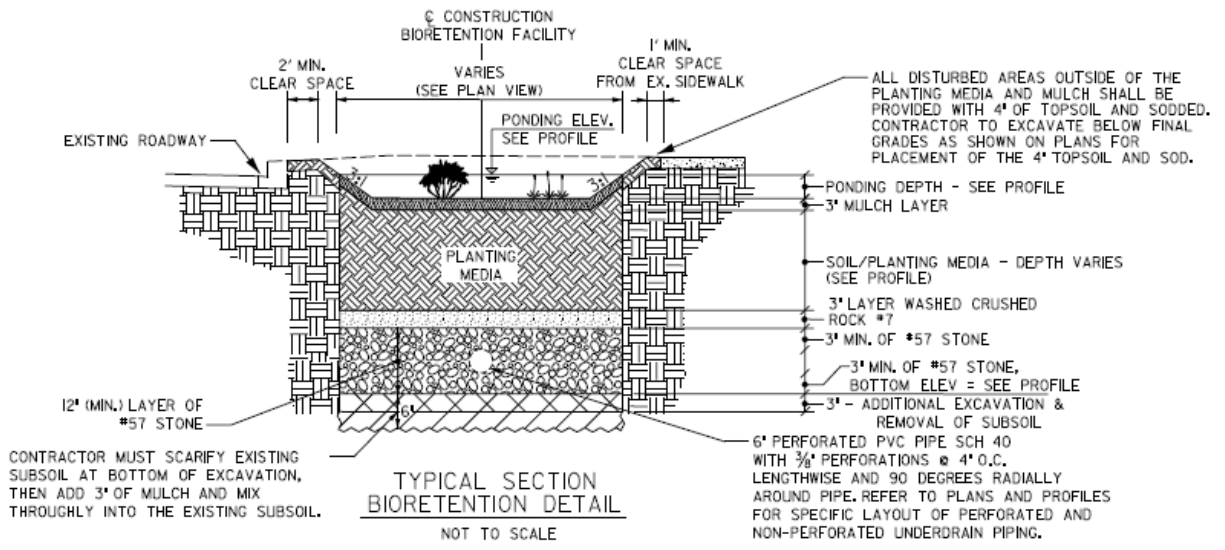
# LID Treatments: Rain Gardens and Bioretention Areas,

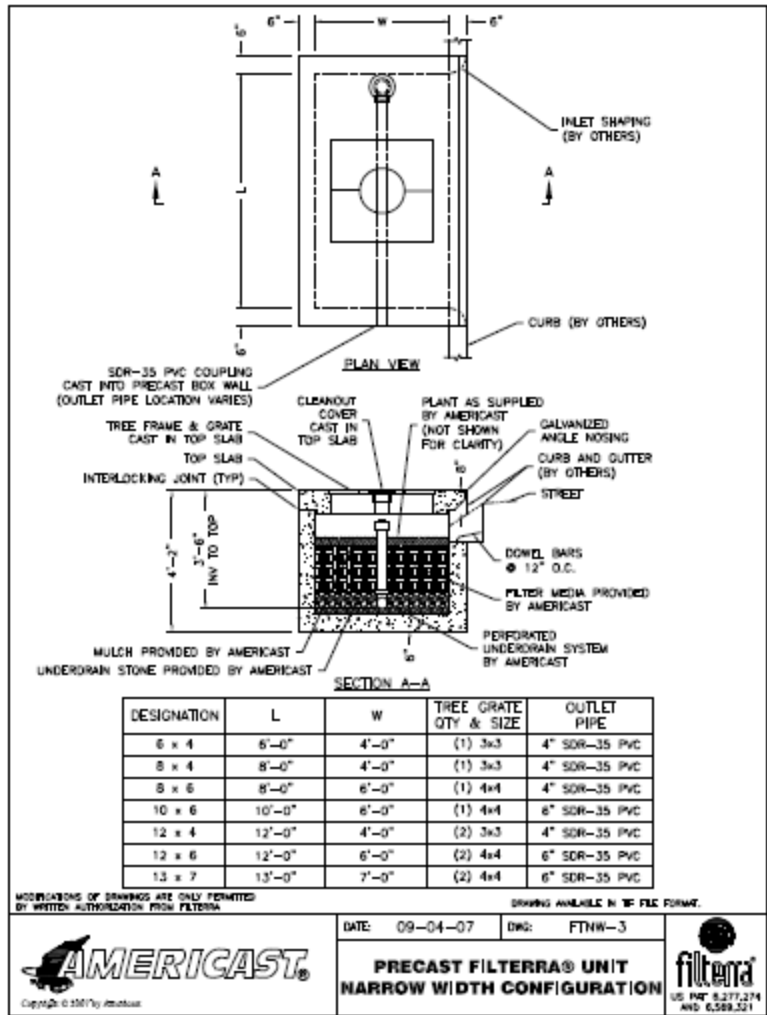
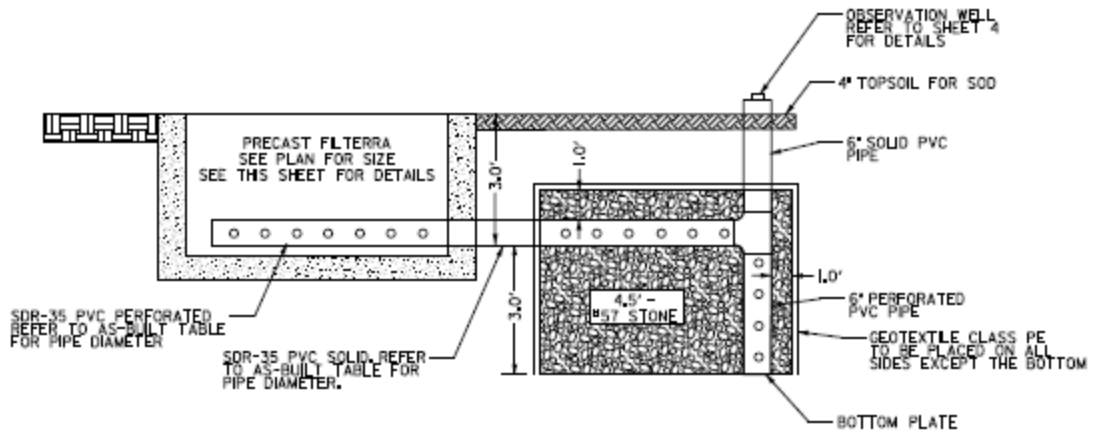
TYPICAL FILTERRA AND STONE TRENCH DETAIL  
NOT TO SCALE

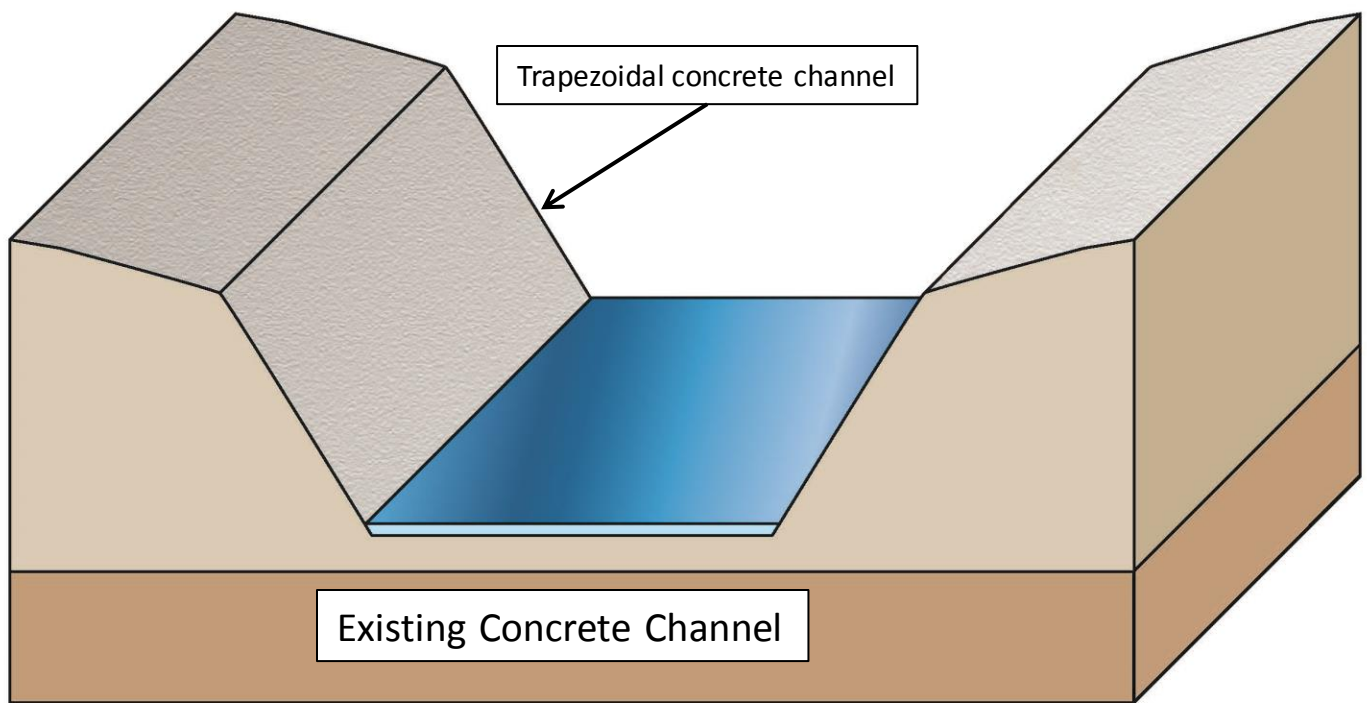
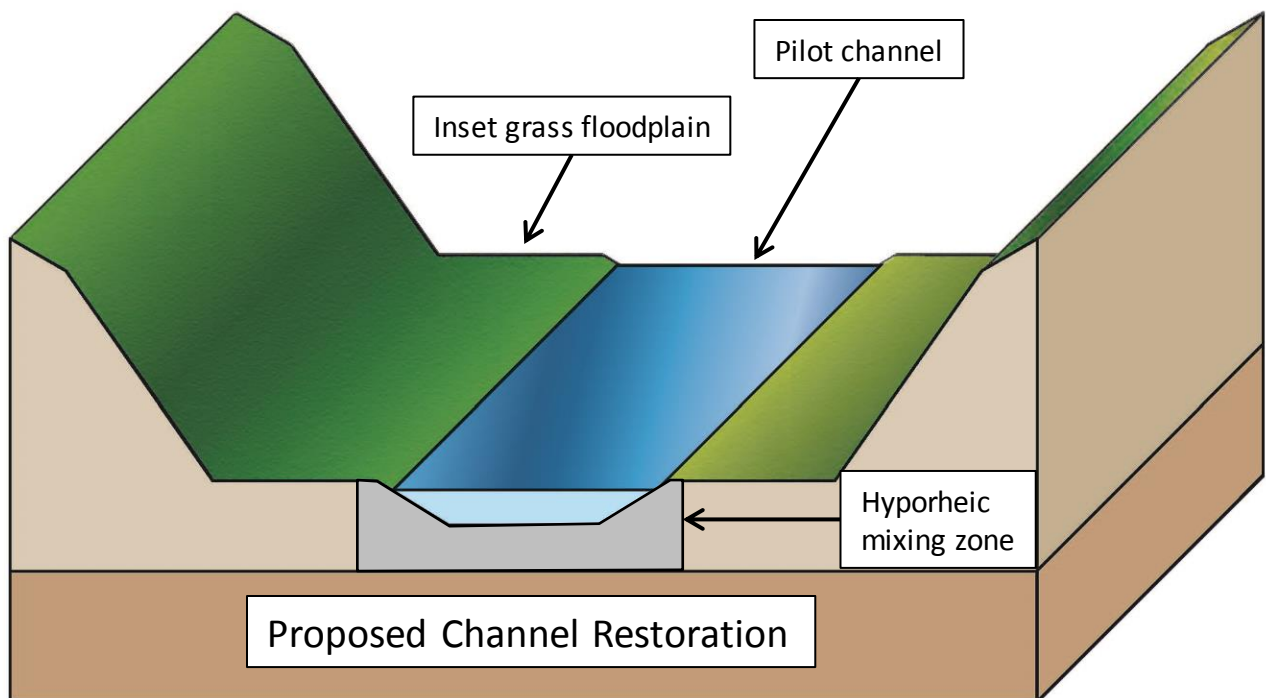
# Stream Restoration Concept: Concrete Channel Removal from SW-D

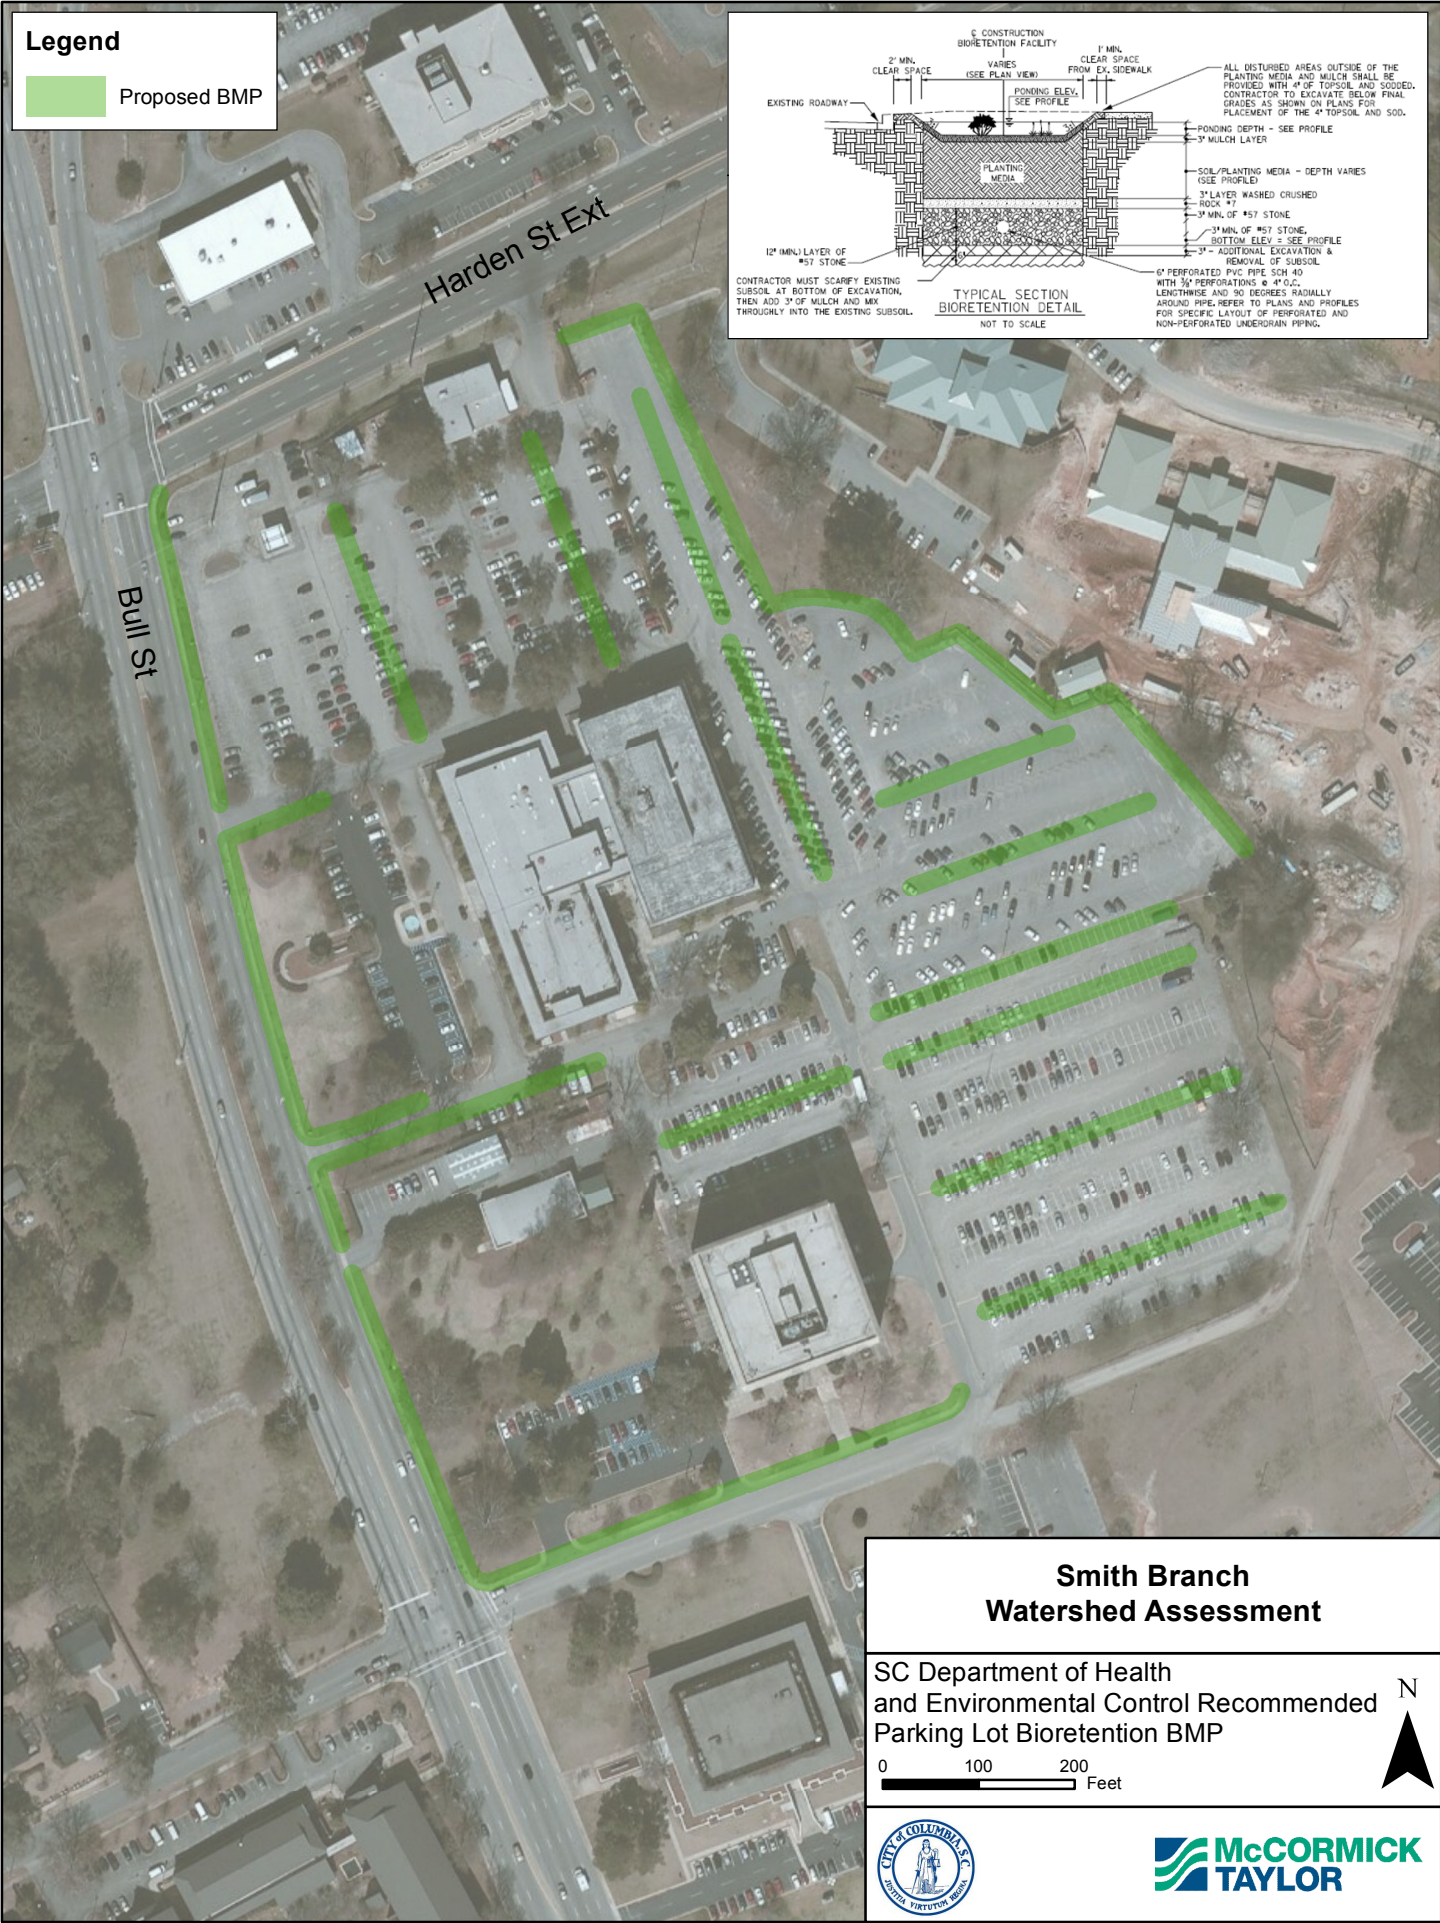
SC Department of Health  
and Environmental Control Recommended  
Parking Lot Bioretention BMP

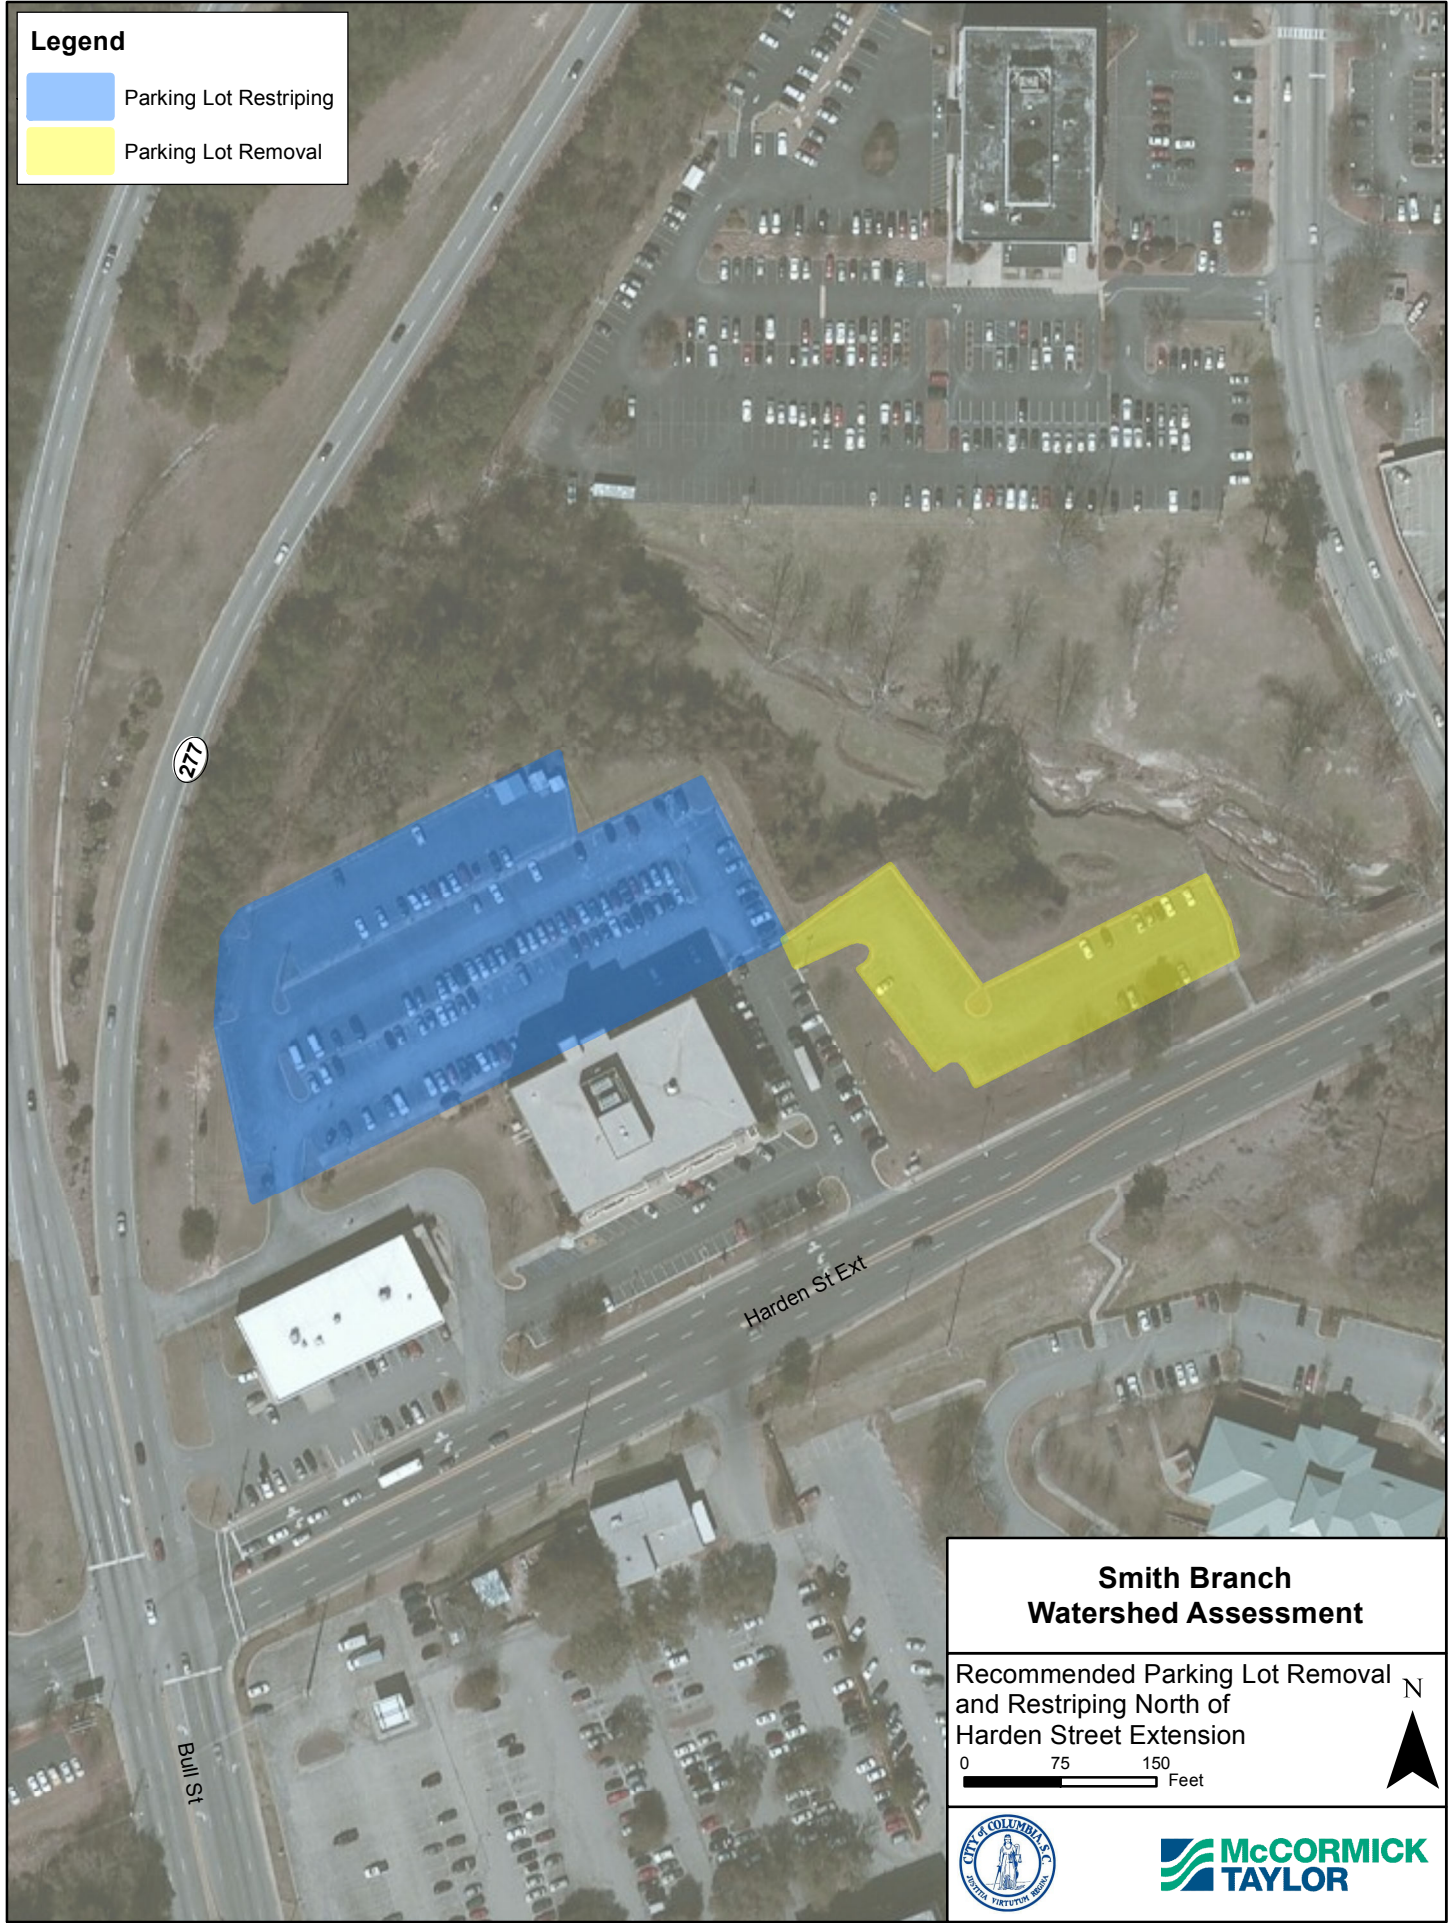
Recommended Parking Lot Removal  
and Restriping North of  
Harden Street Extension

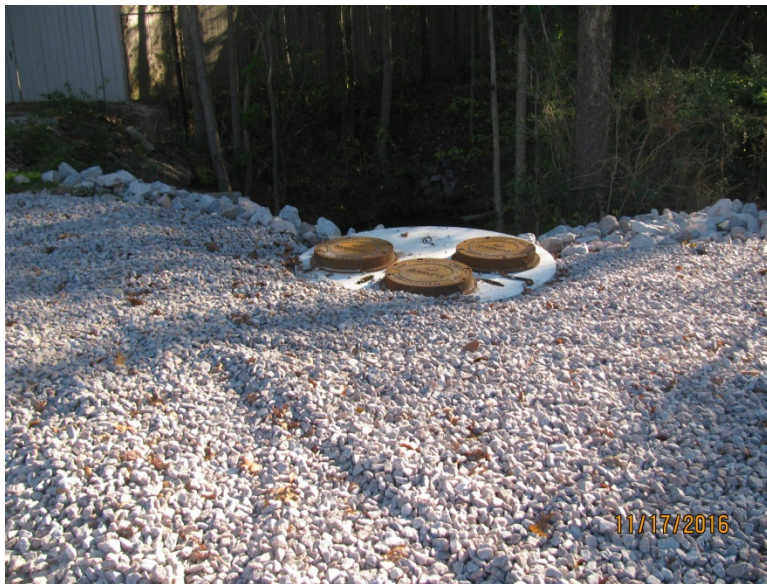
A Manufactured Treatment Device (MTD) was selected for this site. The site is located at a 90 degree road turn, with a wide outside shoulder. Based on observation of the site and discussions with City Streets personnel, it was determined that vehicular traffic on the shoulder would prevent long-term success of a vegetated control on the surface. The subsurface MTD is well-suited to the site characteristics, and is installed online with the existing storm drains. It effectively treats low flows from the drainage area, while equipped to bypass larger flow volumes. Observations of the unit following rainfall events indicate the unit is functioning as designed.

*Surface view of the Site 1 MTD*

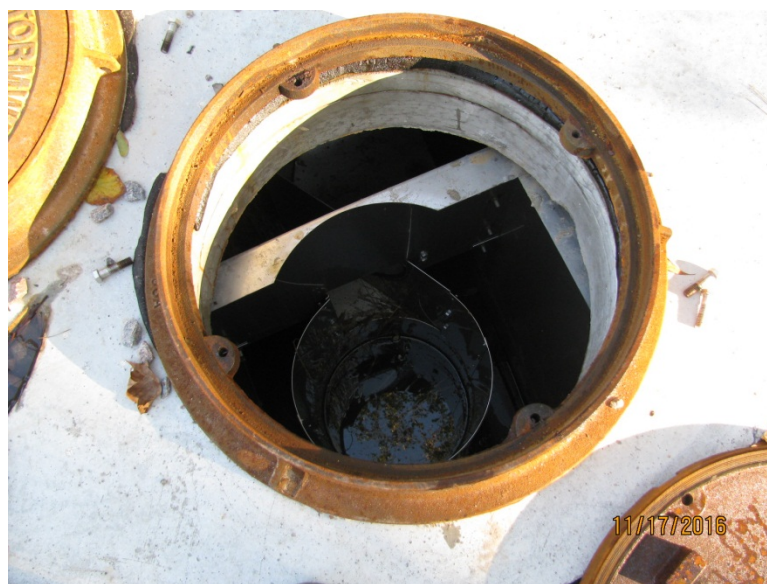
*Interior view of the Site 1 MTD*

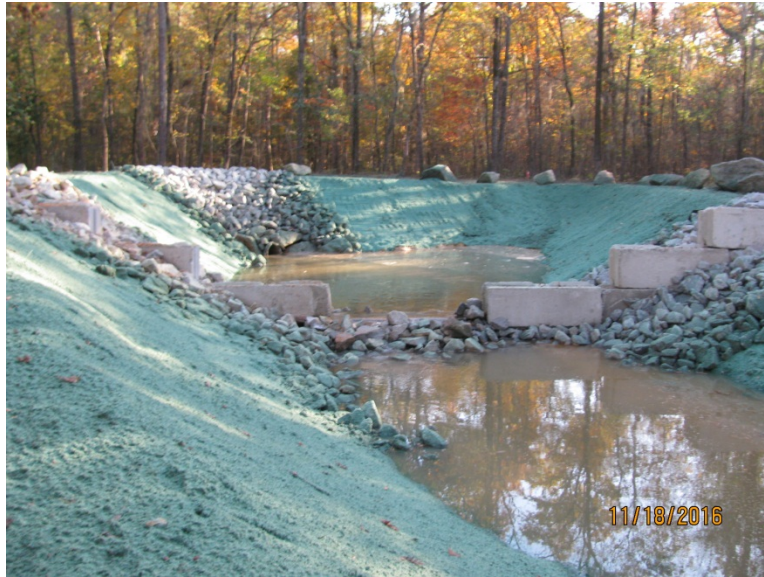
Broad rectangular weirs were constructed to regulate flow from pool to pool, and at the exit into the wetland. Under most low flow conditions, the first pool is expected to retain water at nearly full capacity, the second to retain water between half and full capacity, and the third to rarely retain water above half capacity. Treatment of low flows will be a combination of that expected from a wet retention pond and that expected in an infiltration basin. This control is well-suited to function fully as either a wet pond or an infiltration basin, though it is expected to serve as a combination of the two under most conditions.

*View of the first and second pools, facing upstream*

Flow from a nearby hydrant was introduced to the pond upon completion, to test the functionality. Observations of the pond during this test indicate the pond is functioning as intended. The following photos were taken during the test.

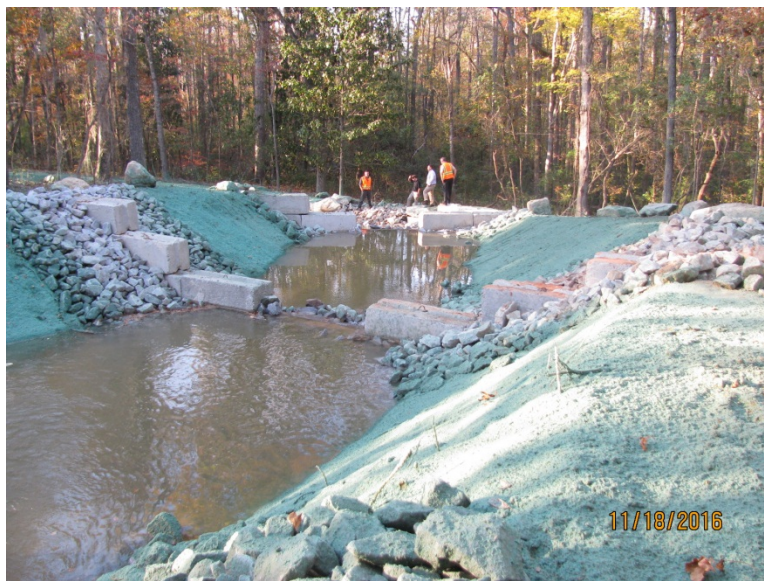
*View of the first and second pools, facing downstream.*

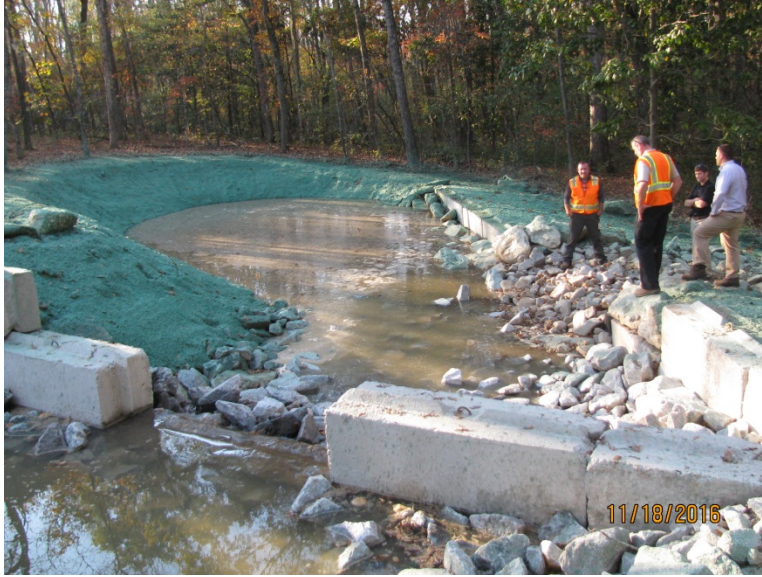
*View of the third pool, facing downstream.*

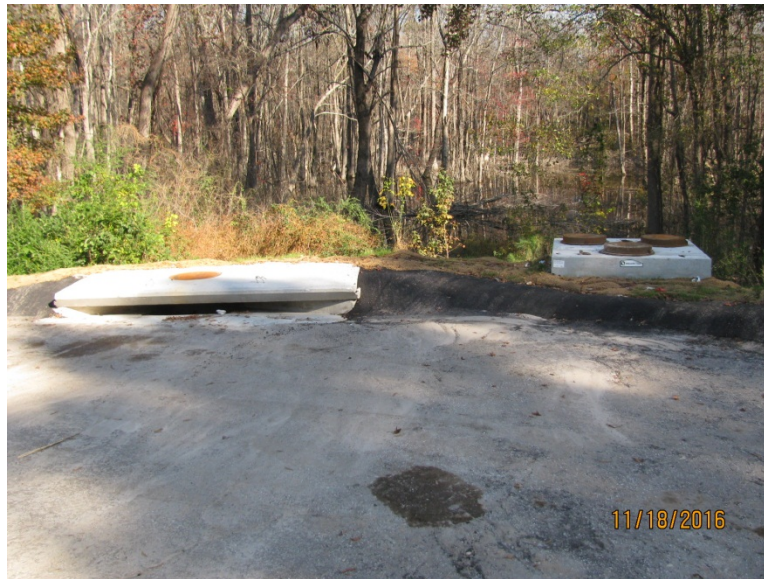
A Manufactured Treatment Device (MTD) was selected for this site. This site is restricted primarily by the square footage available for installation of a water quality control. Water collected in the inlet at the end of the cul-de-sac is routed to the MTD for treatment prior to discharge into the adjacent wetland. The subsurface MTD effectively treats low flows from the drainage area, while equipped to bypass larger flow volumes. Observations of the unit following rainfall events indicate the unit is functioning as designed.

*Surface view of Site 3 MTD and inlet*

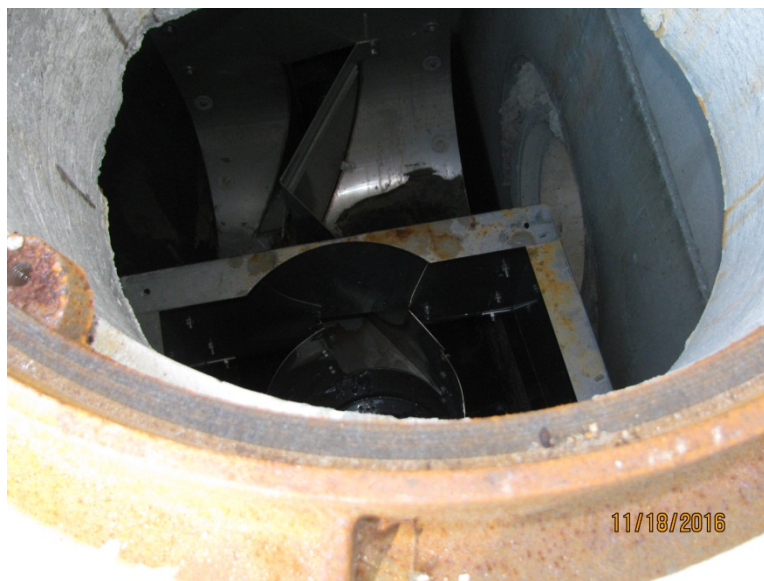
*Interior view of Site 3 MTD*

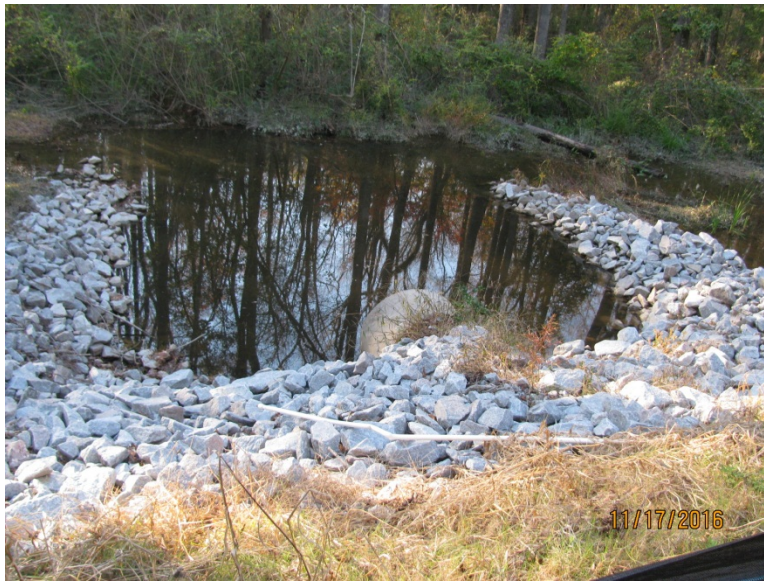
Large riprap plunge pools were selected to serve as erosion control at the two locations, 4B and 4C (note: 4A was eliminated early in the planning process). The plunge pools are of sufficient size and depth to dissipate energy from high velocity flows through the outfalls. Observations following several rainfall events indicate the pools are functioning as designed.

*Riprap plunge pool at Site 4B*

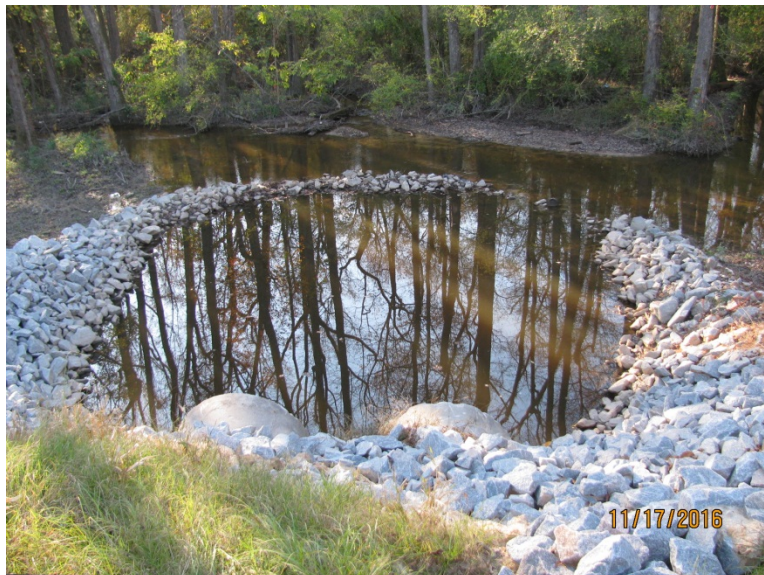
*Riprap plunge pool at Site 4C*

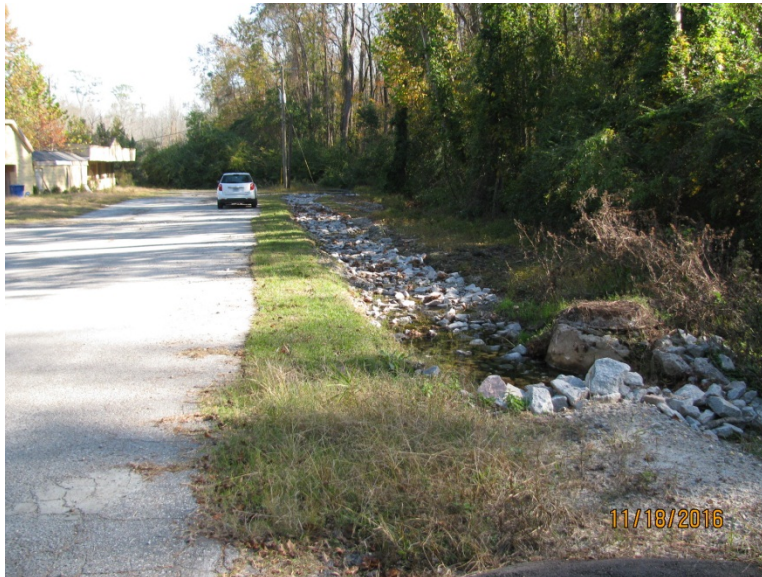
A subsurface vein of drainage stone was installed, then covered with additional stone and riprap. Low flows filter through the subsurface stone and empty into the riprap apron at the end of the swale. Larger flows will flow along the surface, over the riprap. Observations of the swale during low flows (which to date have remained constant), and after rainfall events, have indicated the swale is functioning as designed.

*Upstream side of the swale at Site 5*

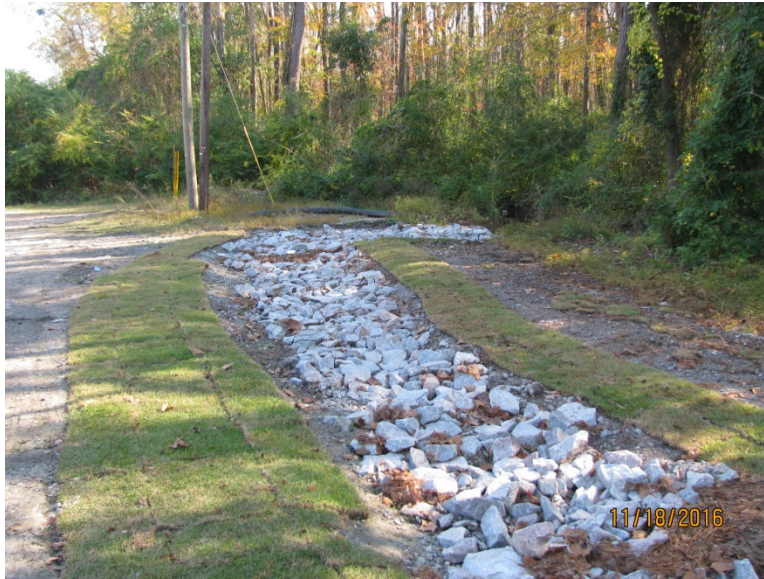
*Downstream side of the swale at Site 5*

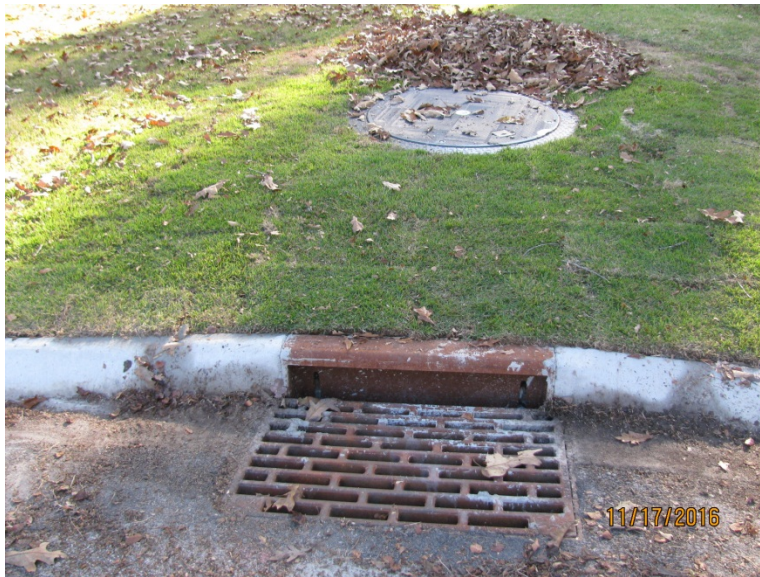
A Manufactured Treatment Device (MTD) was selected for this site. This site is in the cul-de-sac of a residential neighborhood, and the MTD provided for a minimally noticeable alteration at the surface. This selection has been well-received by the occupants of the homes between which the unit was installed. The MTD is installed online with the existing storm drains, and effectively treats low flows from the drainage area while equipped to bypass larger flow volumes. Observations of the unit following rainfall events indicate the unit is functioning as designed.

*Surface view of the Site 6 MTD*

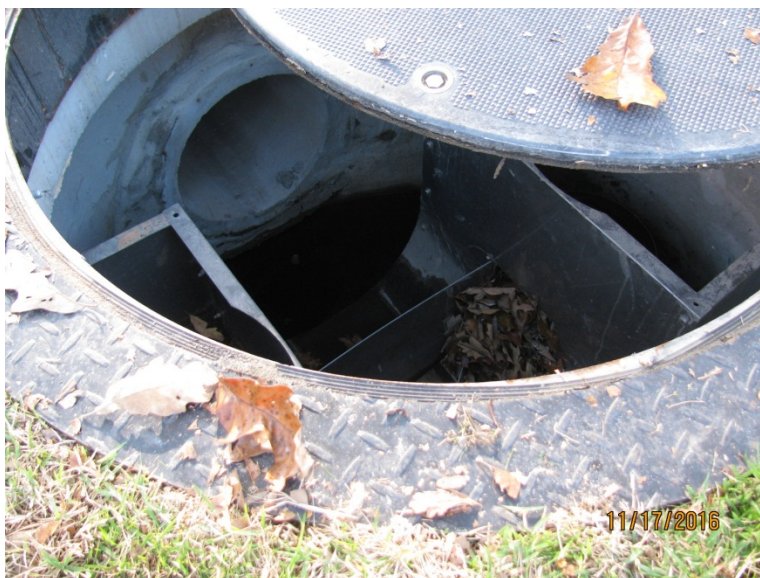
*Interior view of the Site 6 MTD*
